REMEDIATION SUMMARY AND RISK-BASED SITE CLOSURE REQUEST

BOPCO, LP

**POKER LAKE UNIT #295 FLOW LINE
&
POKER LAKE UNIT #216 FLOW LINE**

**Eddy County, New Mexico
Unit Letter "M" (SW/SW), Section 17, Township 24 South, Range 30 East
Latitude 32.211958° North, Longitude 103.911742° West
NMOCD Reference #2RP-1729 & 547**

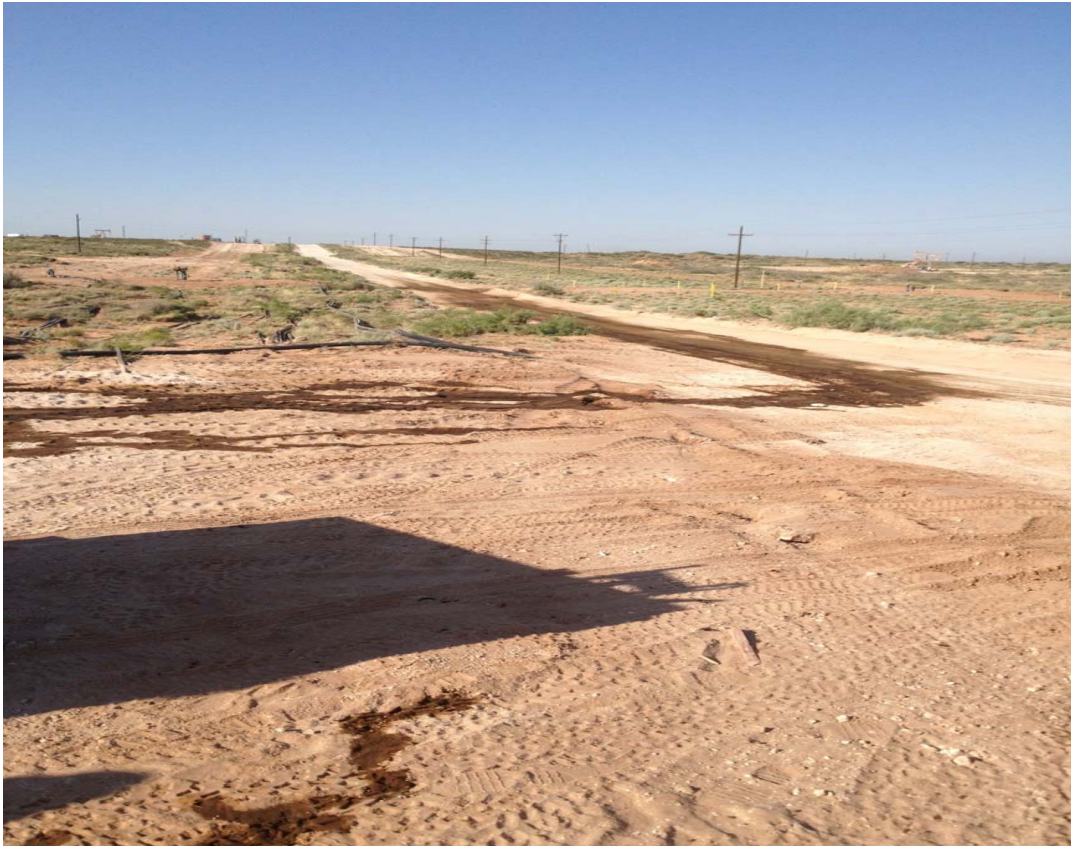
On June 26, 2013, BOPCO discovered a release had occurred on the PLU #295 flow line. The "Release Notification and Corrective Action" (Form C-141) indicated failure of a section of two and seven-eighths inch (2 7/8") steel flow line resulted in the release of two barrels (2 bbls) of crude oil and eighteen (18 bbls) of produced water. The release effected approximately one thousand square feet (1,000 ft²) of Rawhide Road and approximately five hundred square feet (500 ft²) of pasture. During initial response activities, a temporary pipeline clamp was placed on the pipe. The affected section of pipe has since been replaced. The Form C-141 is provided as Appendix A. General photographs of the release site are provided as Appendix B.

Photograph of June 26, 2013, release at the PLU #295 Flow Line Remediation Site.

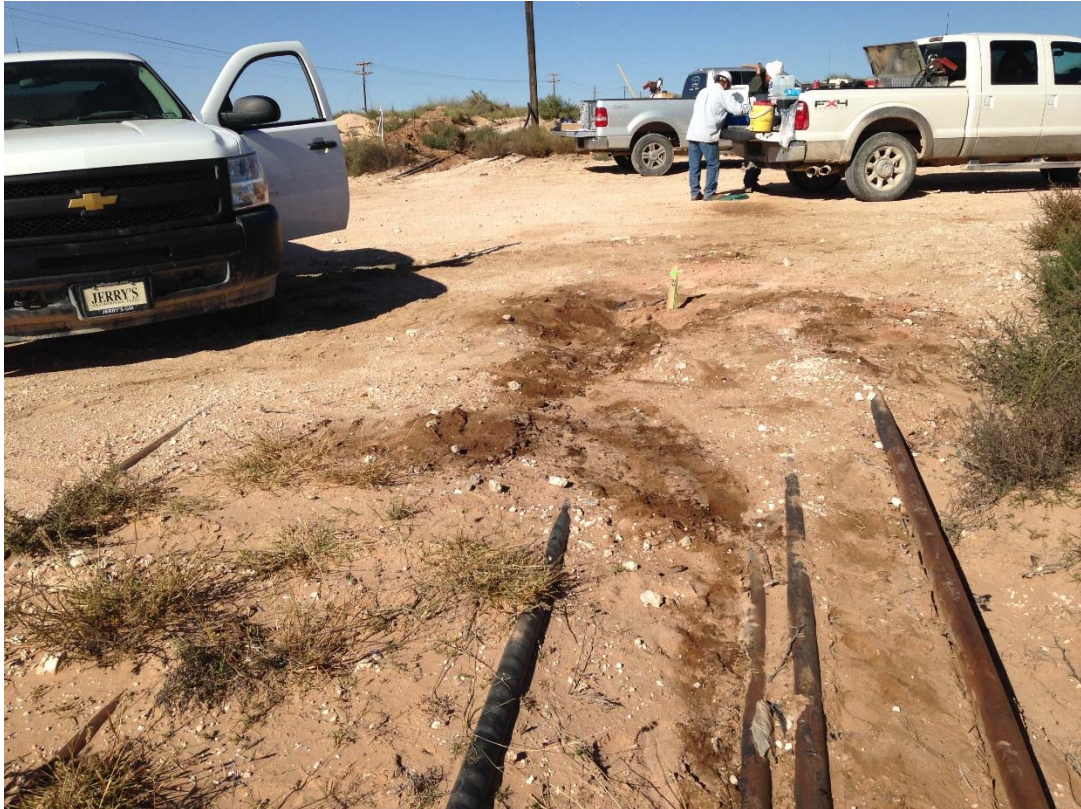
On July 1, 2014, an additional non-reportable release occurred adjacent to the previous release site. Failure of a section of two and seven-eighths inch (2 7/8") steel flow line resulted in the release of approximately two barrels (2 bbls) of crude oil and two barrels (2 bbls) of produced water. The release originated in the same area as the reportable release and flowed south, affecting soil within the bar ditch on the east side of Rawhide Road. Remediation of the June 26, 2013, reportable release and the July 1, 2014, non-reportable release will be conducted simultaneously.

Photograph of surface staining from July 1, 2014, release at the PLU #295 Flow Line Remediation Site.

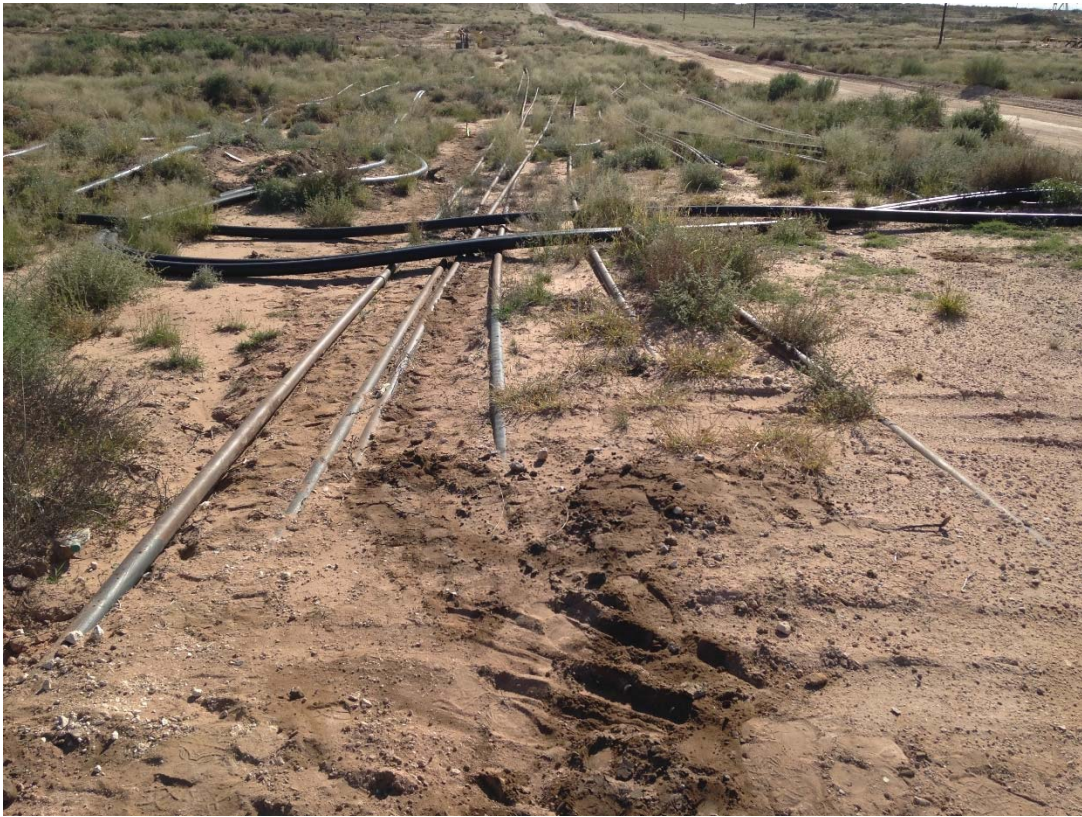
Photograph of surface staining from July 1, 2014, release at the PLU #295 Flow Line Remediation Site.

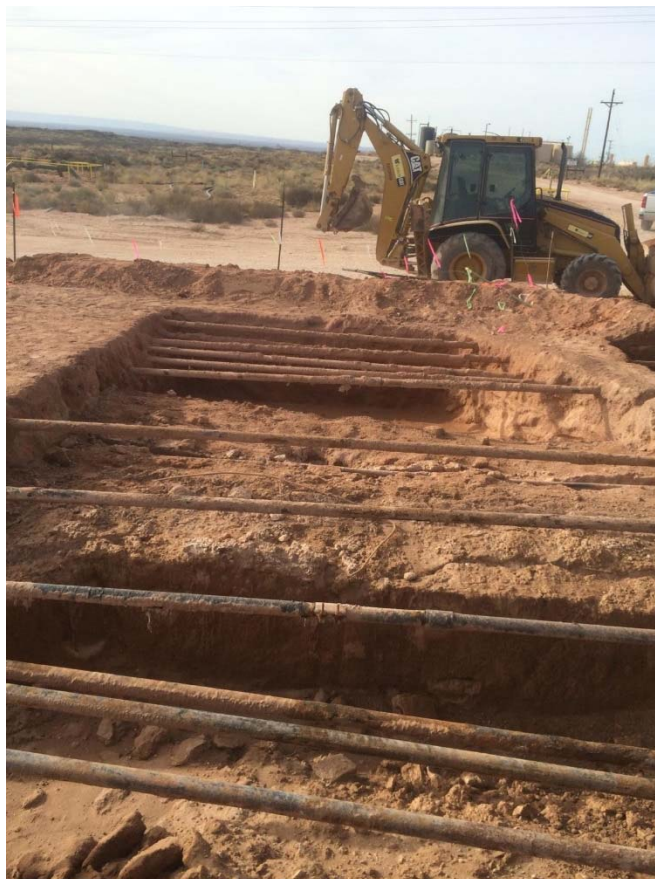
Photograph of excavation activities at the PLU #295 Flow Line Remediation Site.

On November 18, 2014, Basin began excavating impacted soil in the southern portion of the affected bar ditch. The floor and sidewalls of the excavation were advanced until field tests suggested concentrations of BTEX, TPH and chloride were below NMOCD regulatory standards. Excavated soil was stockpiled on-site, pending final disposition.

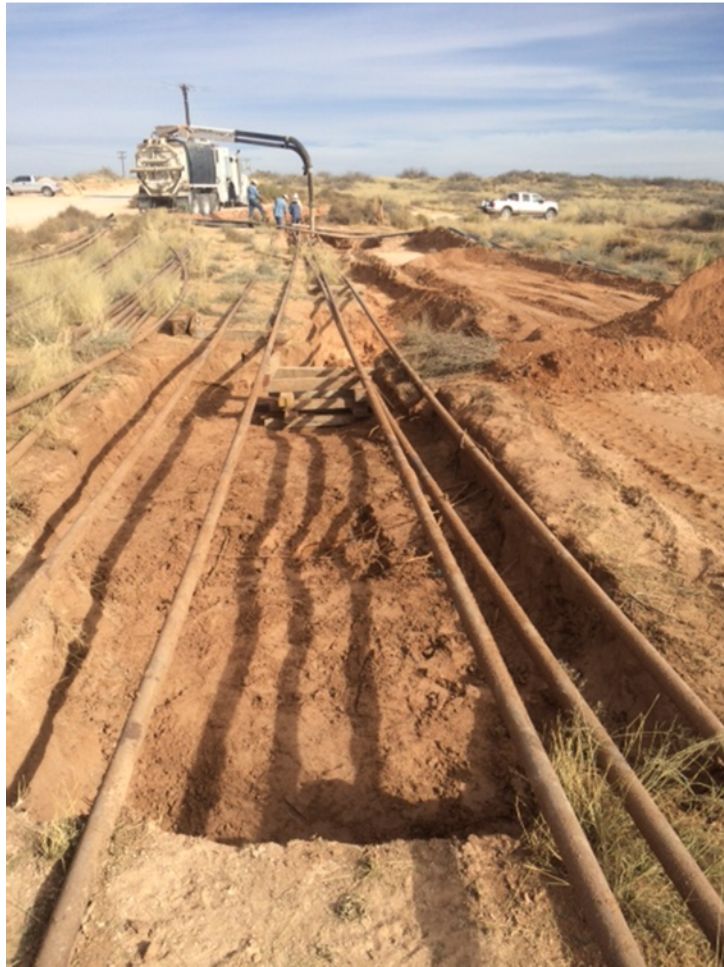
Photograph of excavation activities at the PLU #295 Flow Line Remediation Site.
