CLOSURE REPORT

**BOPCO, L.P.
JRU #62
Eddy County, New Mexico
Unit Letter "J", Section 1, Township 23 South, Range 30 East
Latitude 32.334352 North, Longitude 103.832156 West
NMOCD Reference #2RP-2465**

RE: Final Closure Report
Bopco, L.P. – JRU #62
UL-J, Section 1, Township 23 South, Range 30 East
Eddy County, New Mexico
NMOCD Reference # 2RP 2465

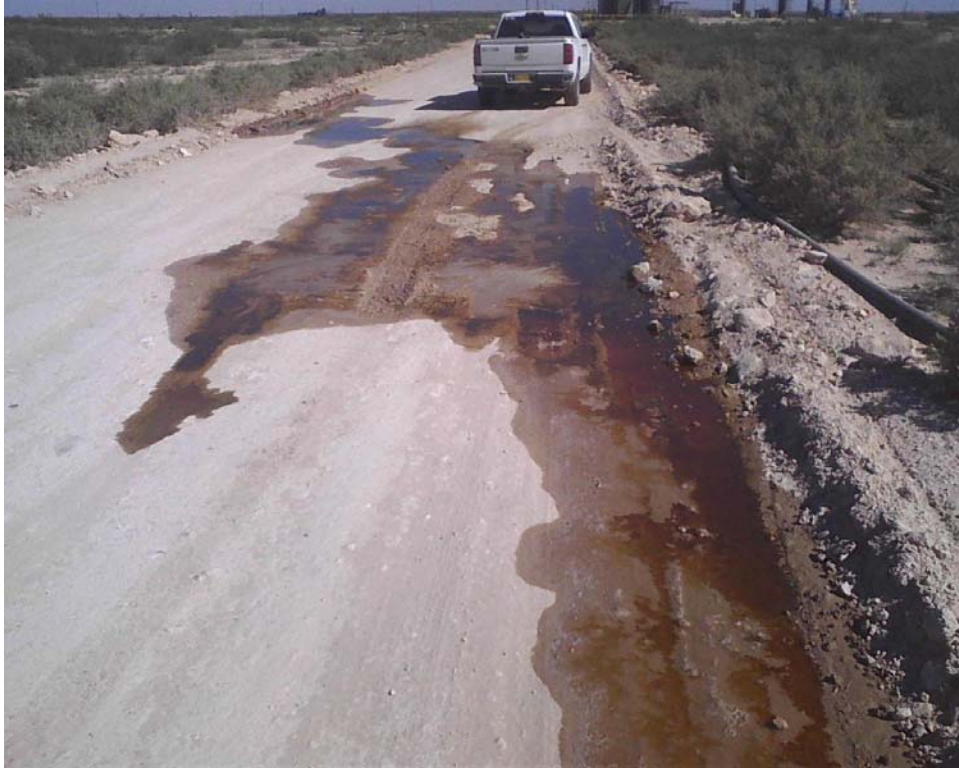
Photograph #1 – Release area

The flow line leaked due to external corrosion. The well was shut in and a temporary repair clamp was installed on the affected pipe. The spill impacted approximately 720 sq. ft. of caliche road. All of the fluid soaked into the roadway.

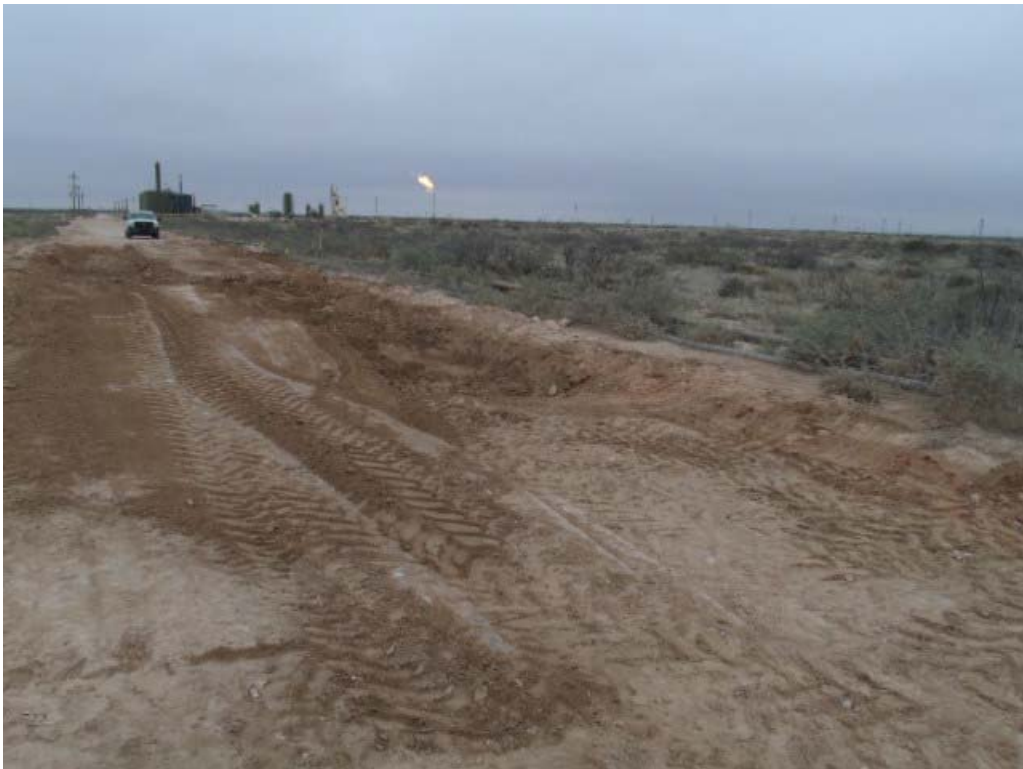
Photograph #2 – Excavated area

The release area was excavated to a depth of one (1) foot bgs with approximately 71 tons of contaminated soil excavated and hauled to a state approved facility for disposal.

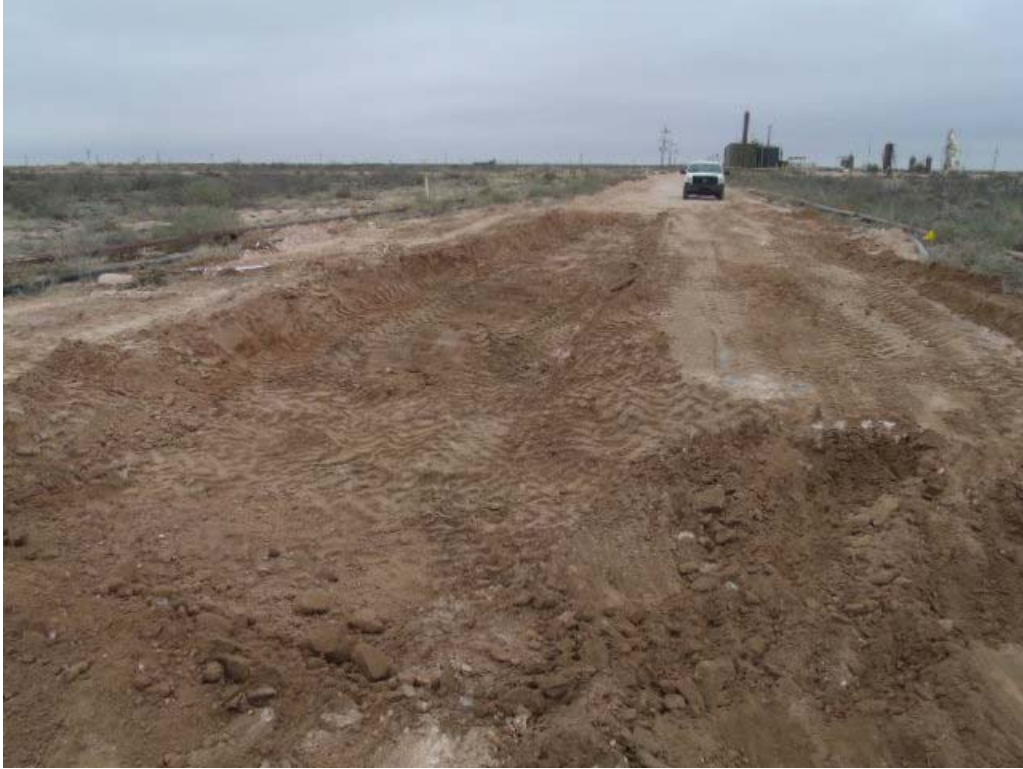
Photograph #3 – Excavated area

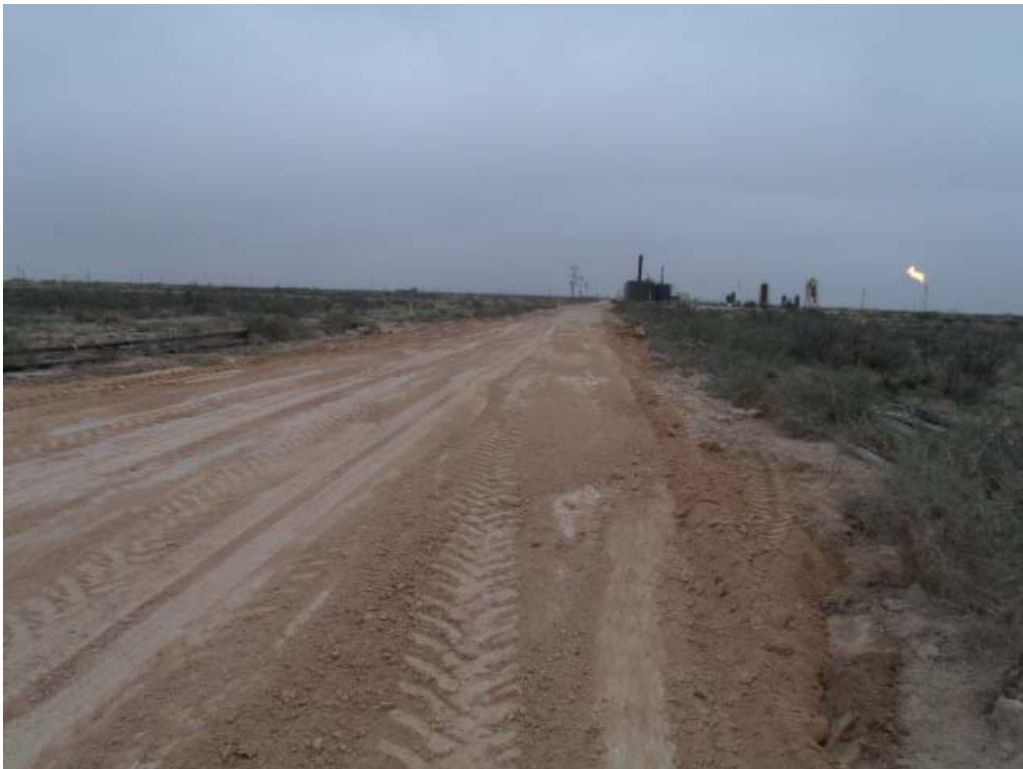
Photograph #4 – Backfilled area

On January 14, 2015, based on laboratory analytical data and NMOCD approval, the excavation was backfilled with approximately 71 tons of clean soil free of rocks, clumps or deleterious material. The entire disturbed area was then contoured to blend with existing lease road and protected against wind/water erosion.

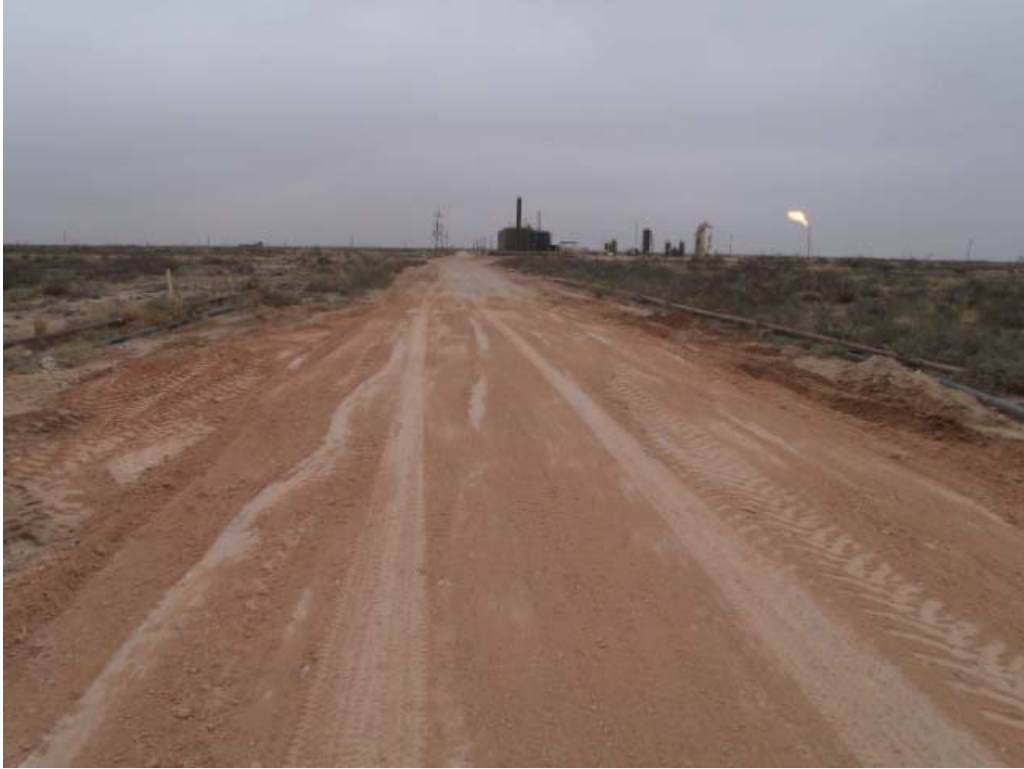
Photograph #5 – Backfilled area
