CLOSURE REPORT

BOPCO, L.P.
Poker Lake Unit #450Y
Eddy County, New Mexico
Unit Letter "B", Section 27, Township 24 South, Range 30 East
Latitude 32.19633 North, Longitude 103.56520 West
NMOCD Reference #2RP-2758

RE: Final Closure Report
Bopco – PLU #450Y
UL-B, Section 27, Township 24 South, Range 30 East
Eddy County, New Mexico
NMOCD Reference # 2RP 2758

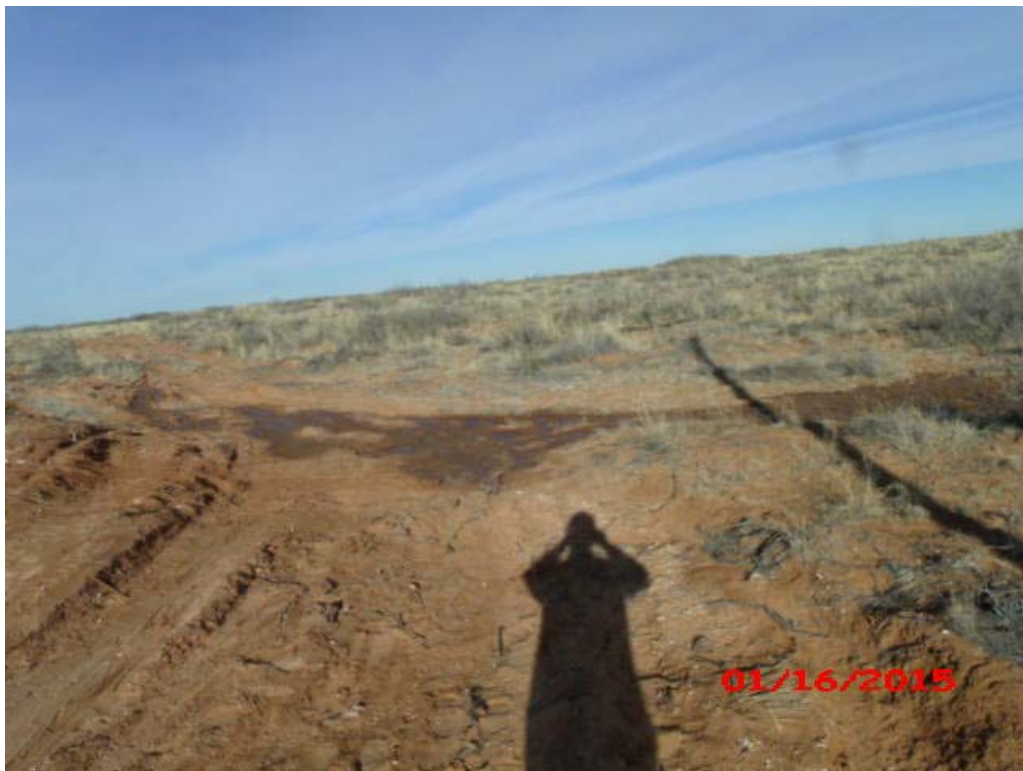
A hammer union on the flow line became loose. The union was re-tightened. The release impacted approximately 1,100 sq. ft. of pasture and pad area with a light mist of less than 1/2" saturation. It also puddled up in the pasture in an area measuring approximately 726 sq. ft. The BLM was notified the day of the release; an EPI remediation crew began removing the saturated soil on 1/16/15 and continued on 1/19/15, a total of 84 cubic yards of soil and caliche was hauled to Lea Land and clean soil was stockpiled on-site pending the out-come of the soil samples collected on 1/16/15.

Photograph #2 – Release area

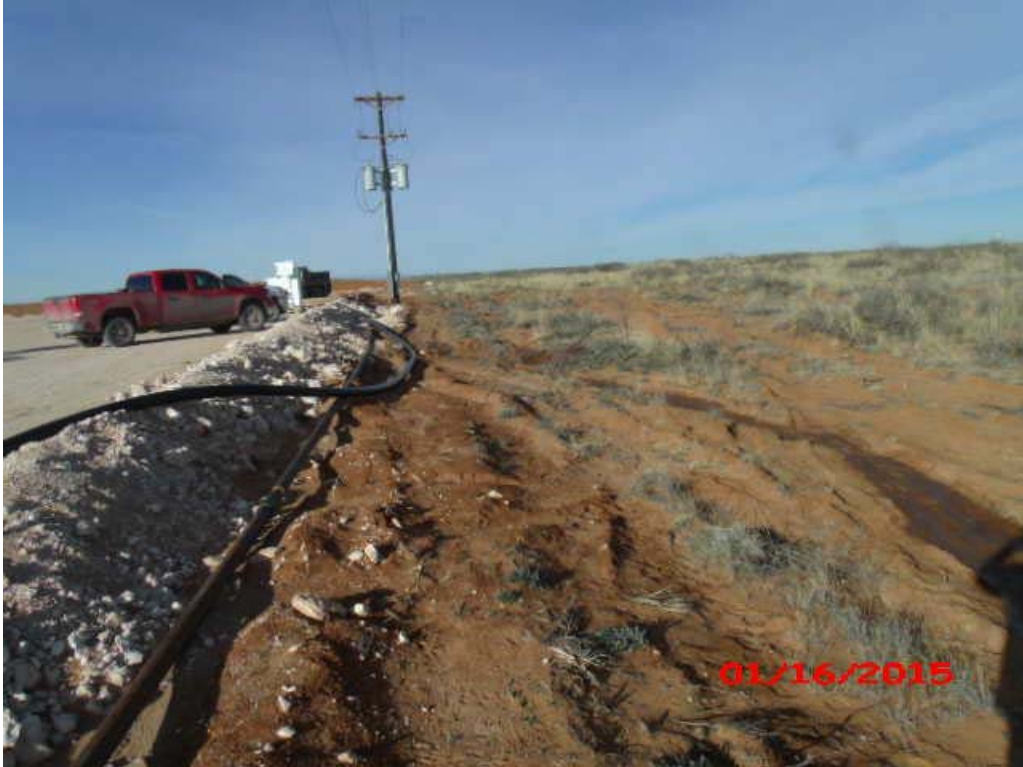
Photograph #3 – Release area

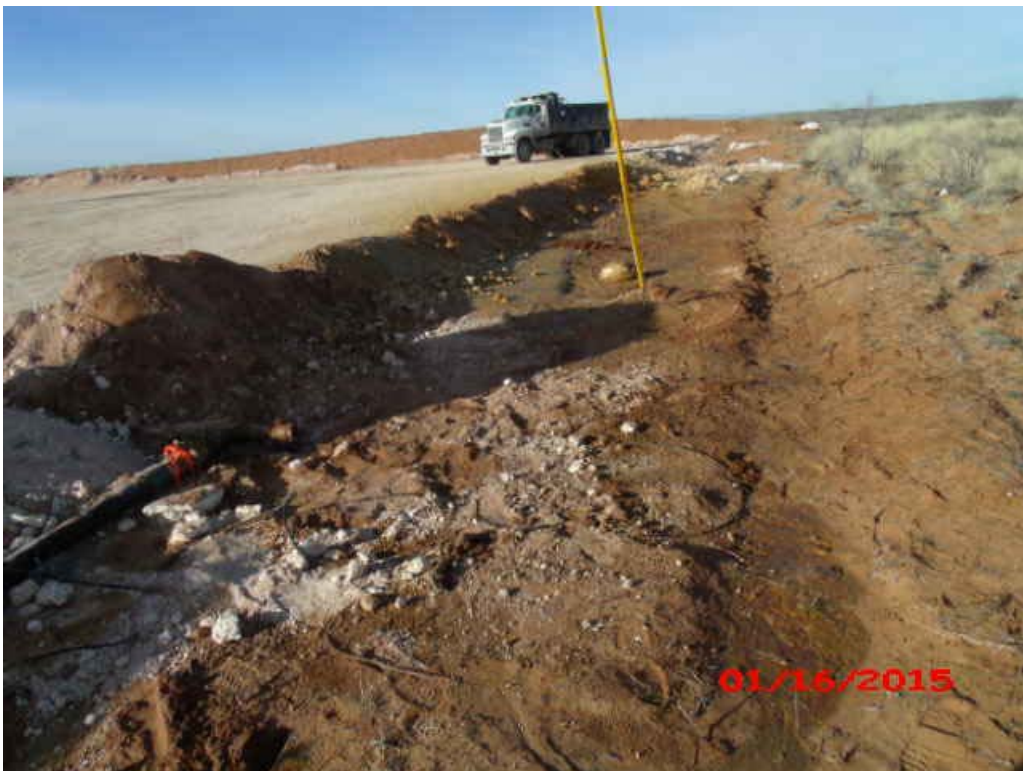
Photograph #4 – Release area

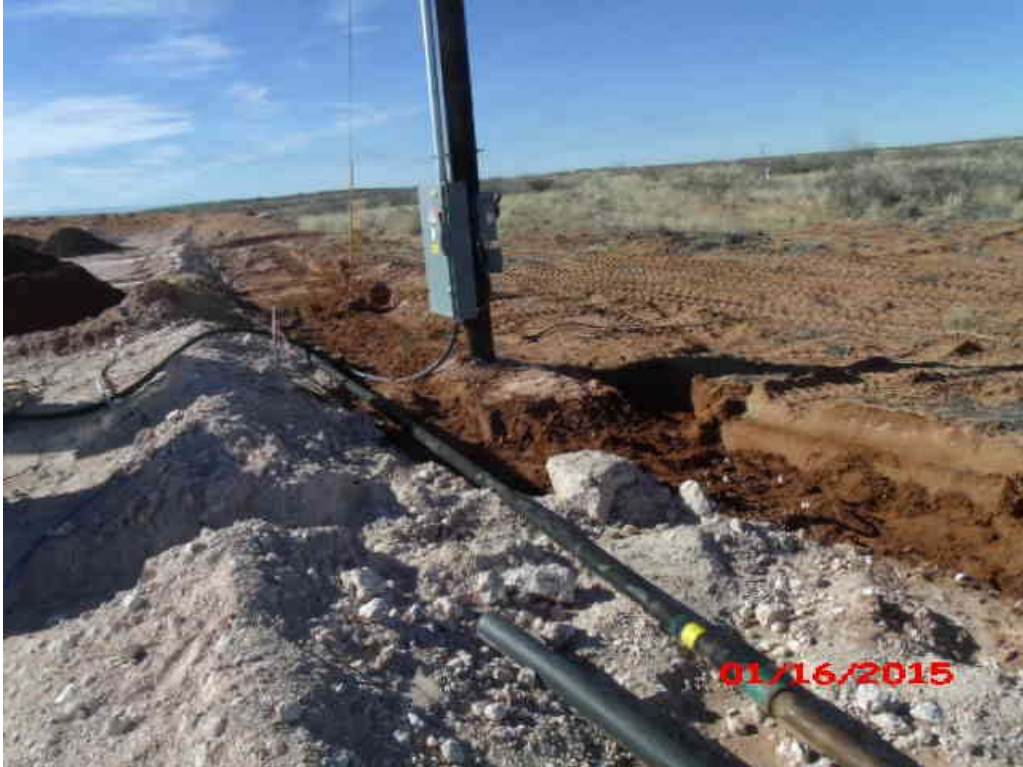
Photograph #5 – Excavated area

The release area was excavated to a depth of one (1) foot bgs with approximately 74 tons of contaminated soil excavated and hauled to a state approved facility for disposal.

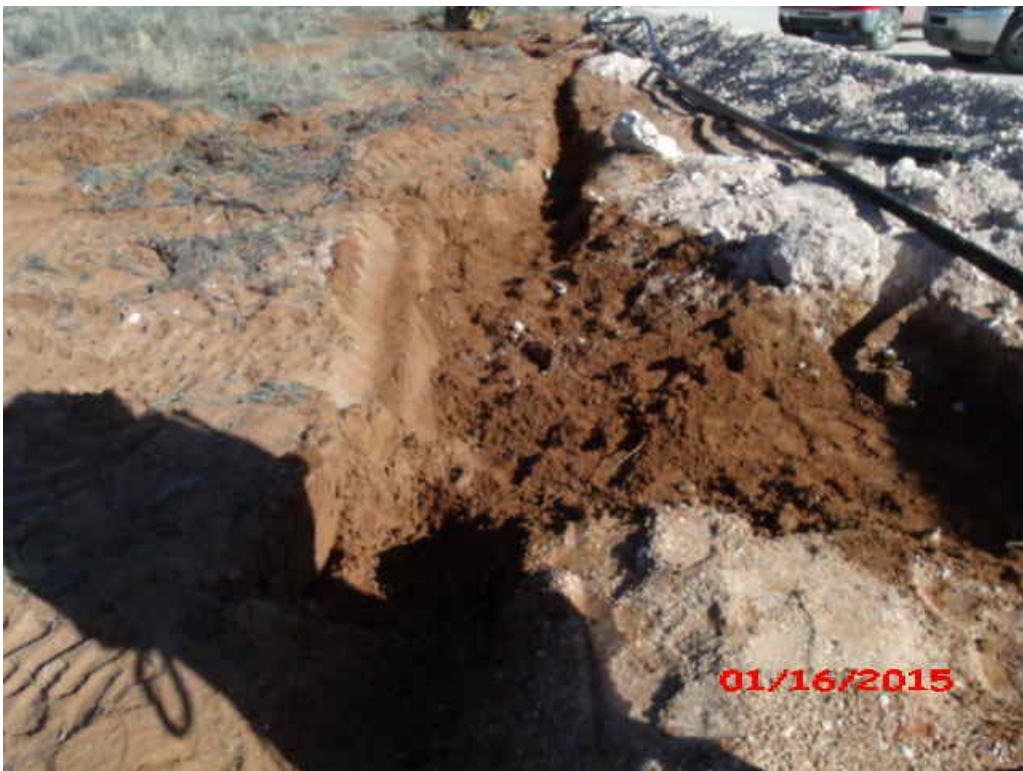
Photograph #6 – Excavated area

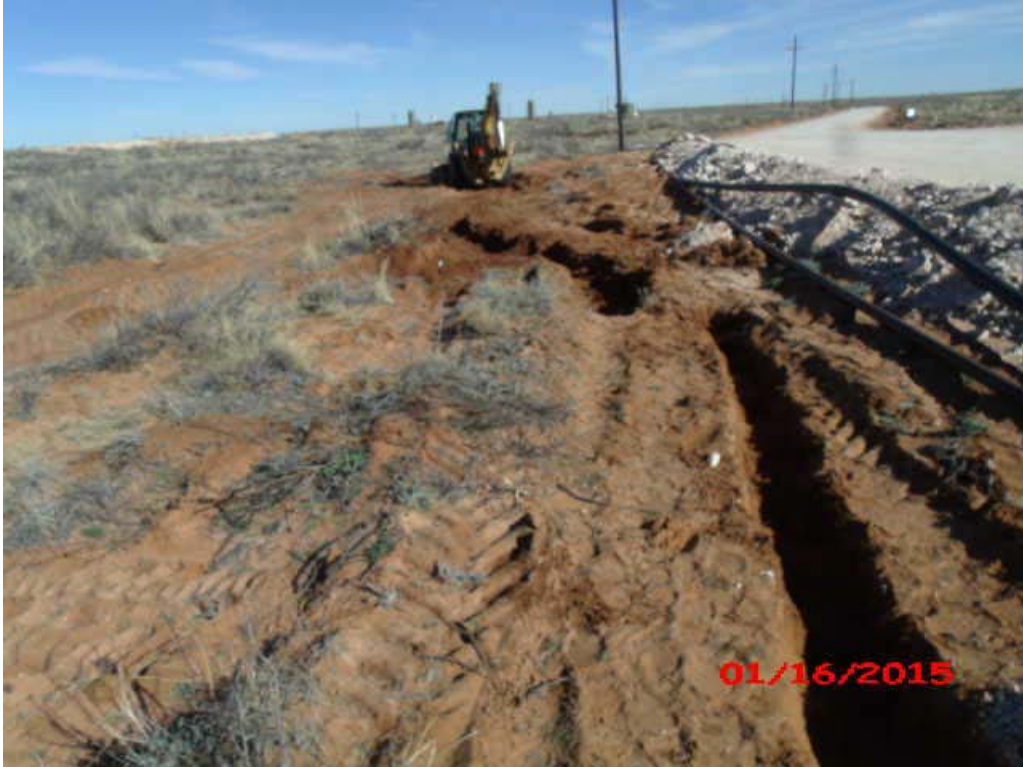
Photograph #7 – Excavated area

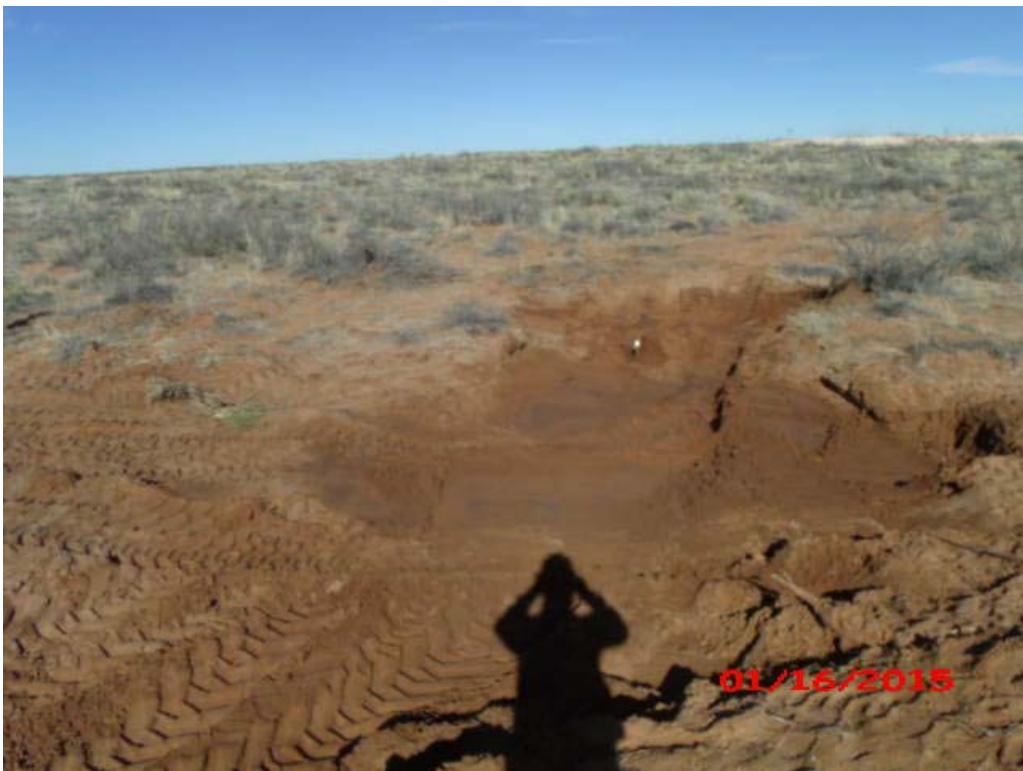
Photograph #8 – Excavated area

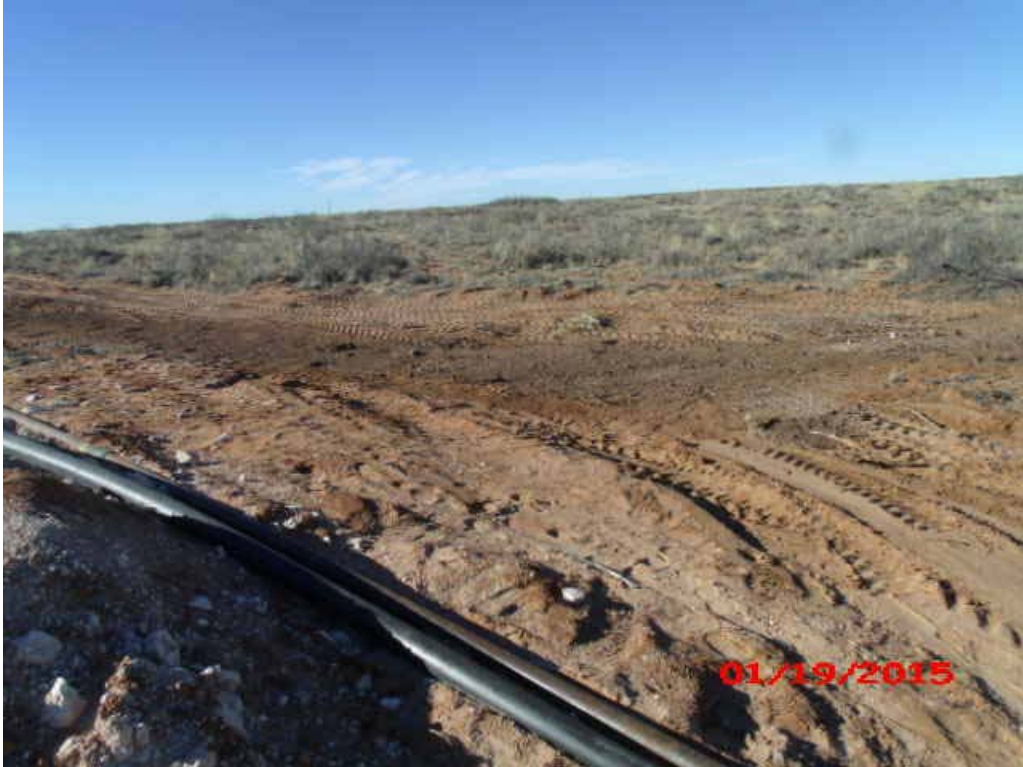
Photograph #9 – Backfilled

Based on laboratory analytical data and NMOCD approval, the excavation was backfilled with approximately 74 tons of clean soil free of rocks, clumps or deleterious material. The entire disturbed area was then contoured to blend with existing area and protected against wind/water erosion.

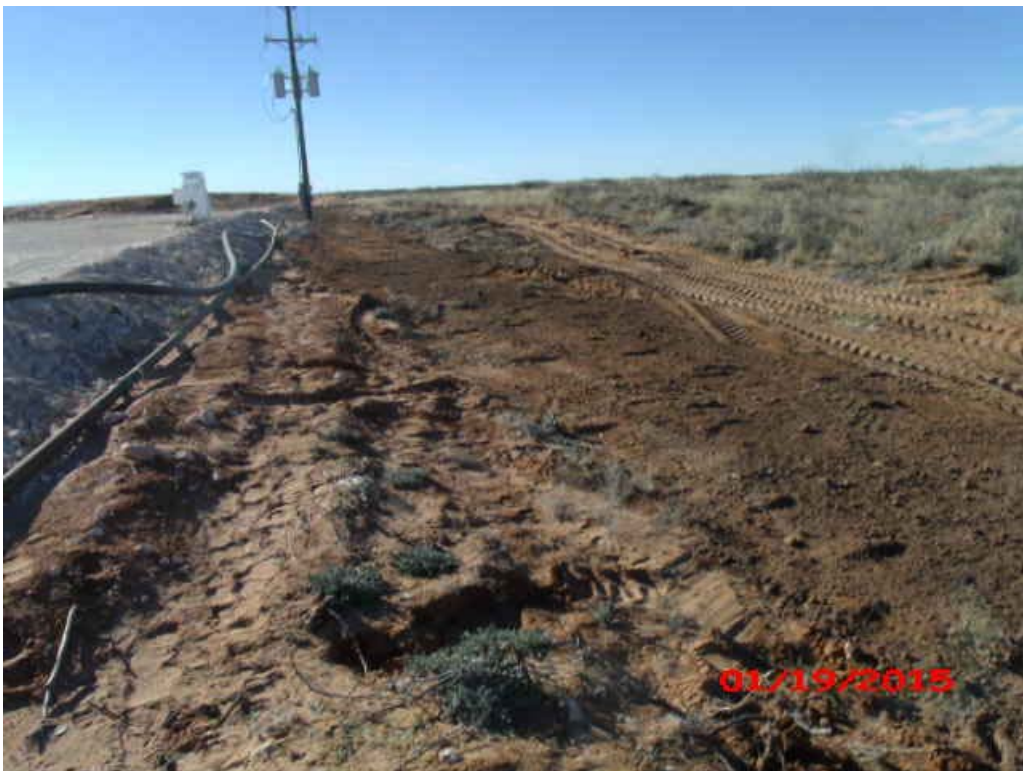
Photograph #10 – Backfilled

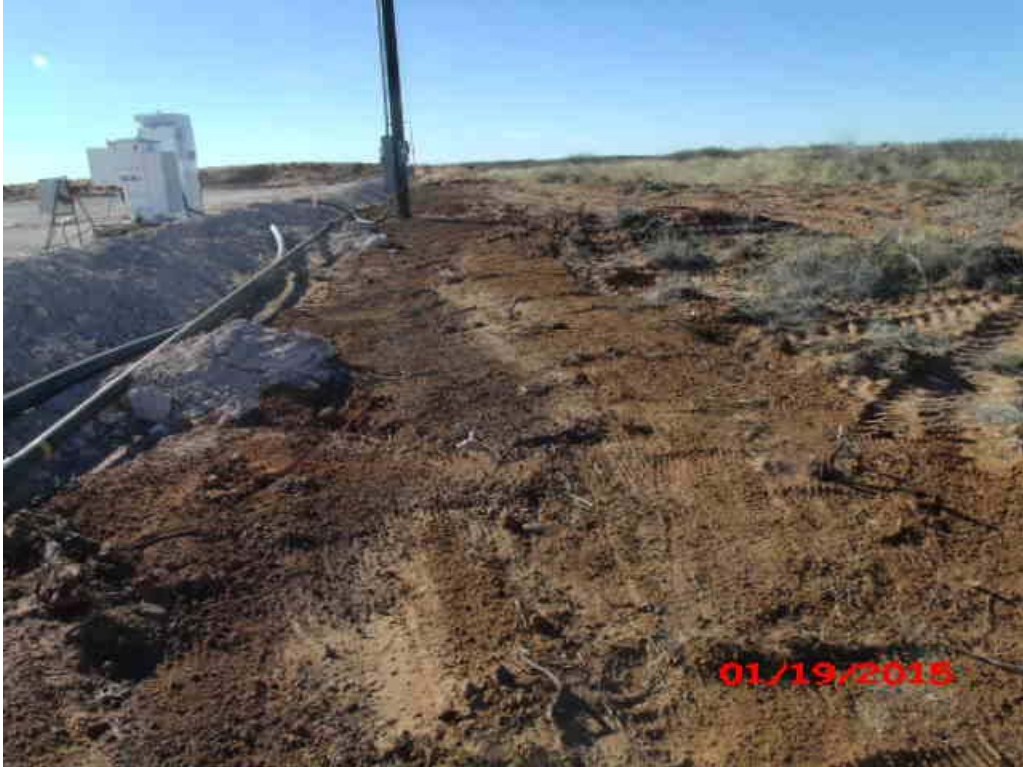
Photograph #11 – Backfilled

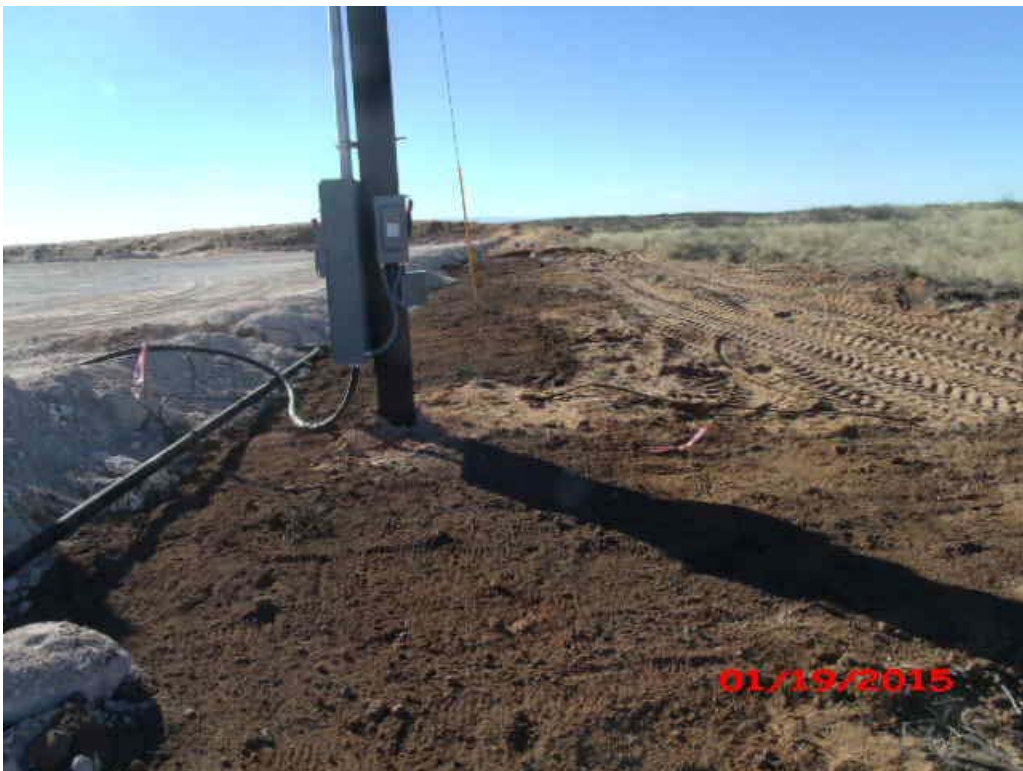
Photograph #12 – Backfilled
