EAU Emulsion Line (2RP-2828)

Termination Request

API No. 30-015-40233

**RE: Termination Request
Apache EAU Emulsion Line (2RP-2828)
UL/J sec. 34 T17S R28E
API No. 30-015-40233**

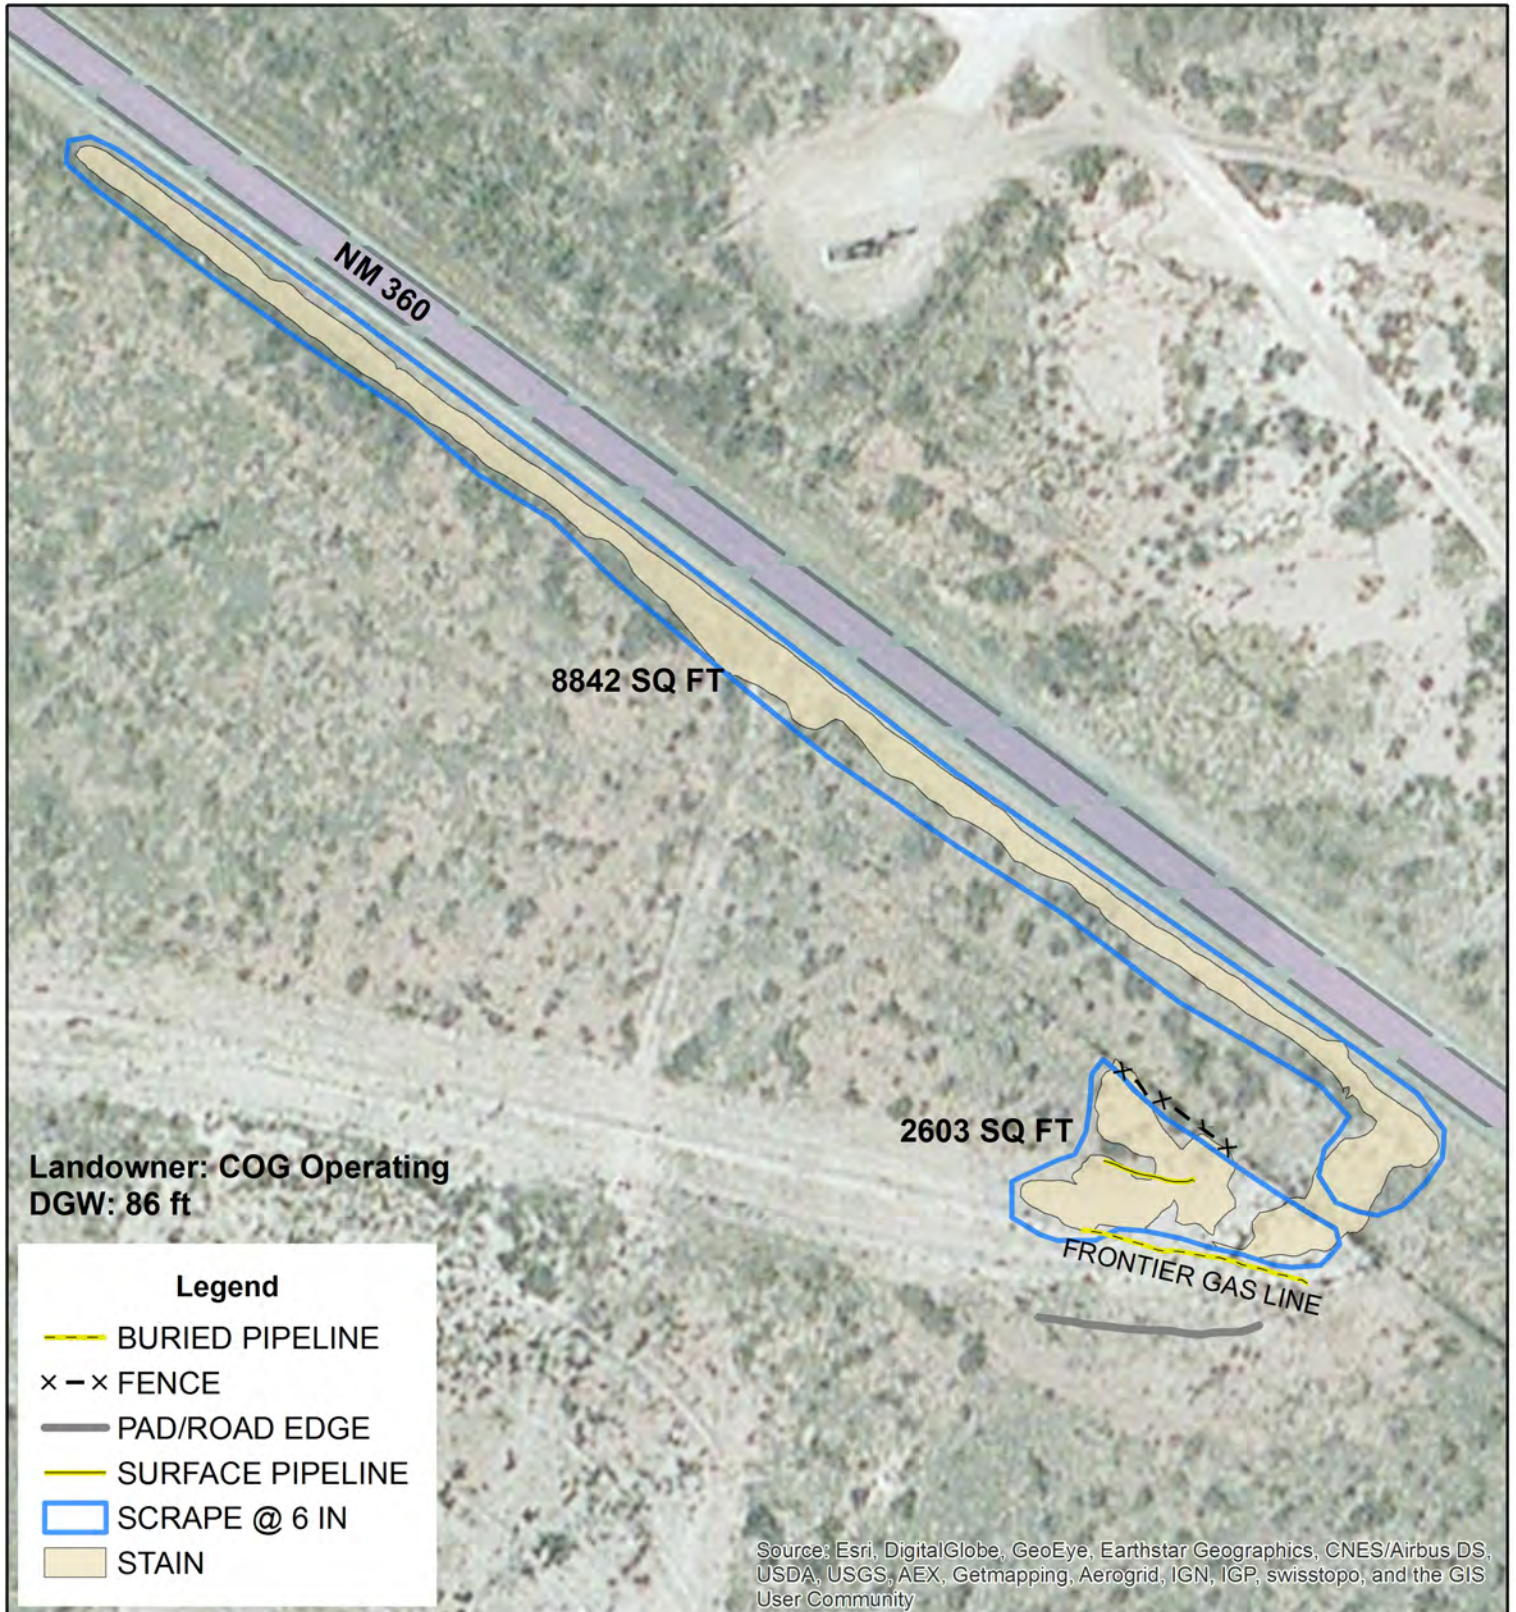
Figure 2

Based on the laboratory data and the approval of the Path Forward from NMOCD, the release area was scraped down 6 inches throughout (Figure 2). The excavated soil was taken to a NMOCD approved facility for disposal. Clean top soil was imported to the site to backfill the scrape and to contour the backfilled scrape to the surrounding area.

Excavation Data

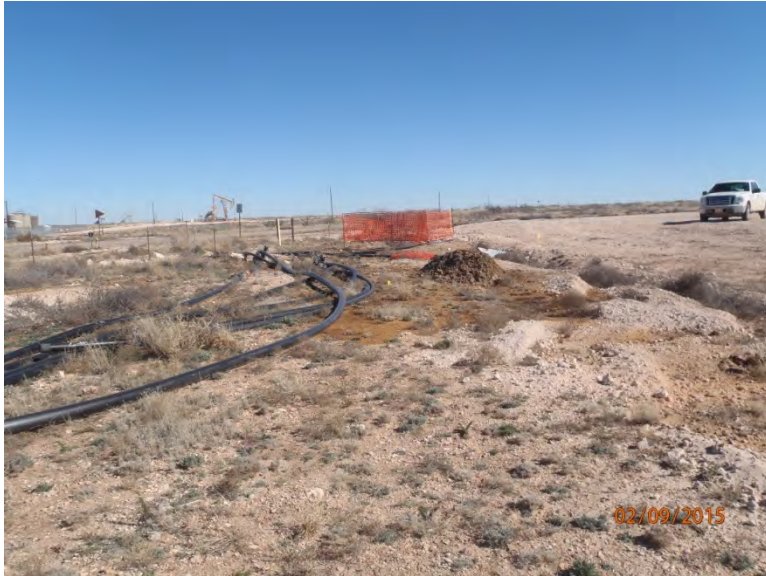
2/9/15

Initial release area, facing southeast

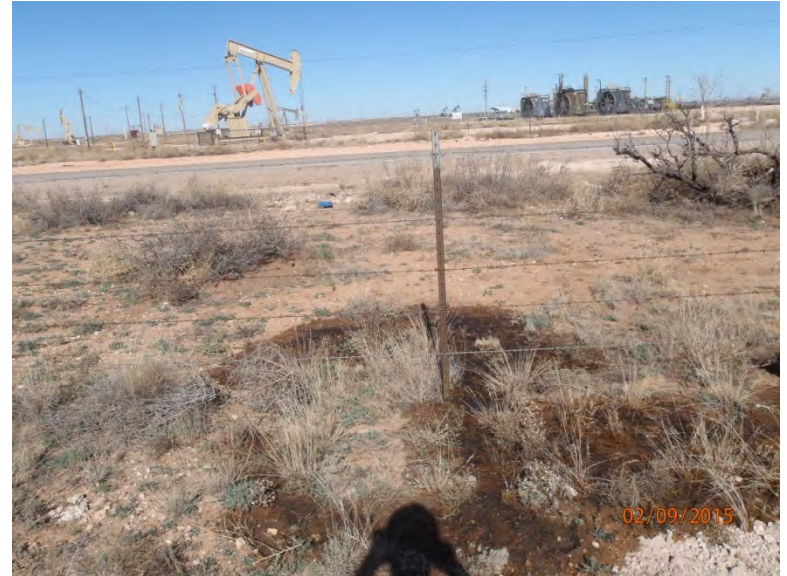
2/9/15

Initial release area, facing east

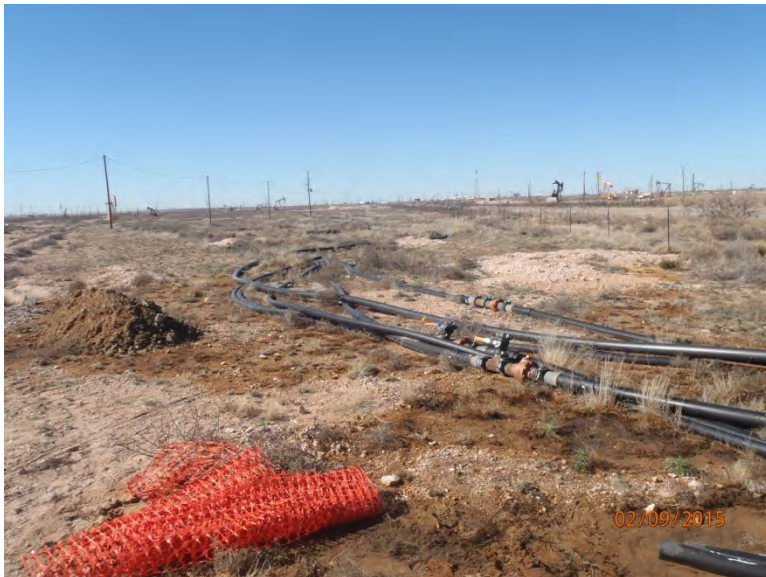
2/9/15

Initial release area, facing north

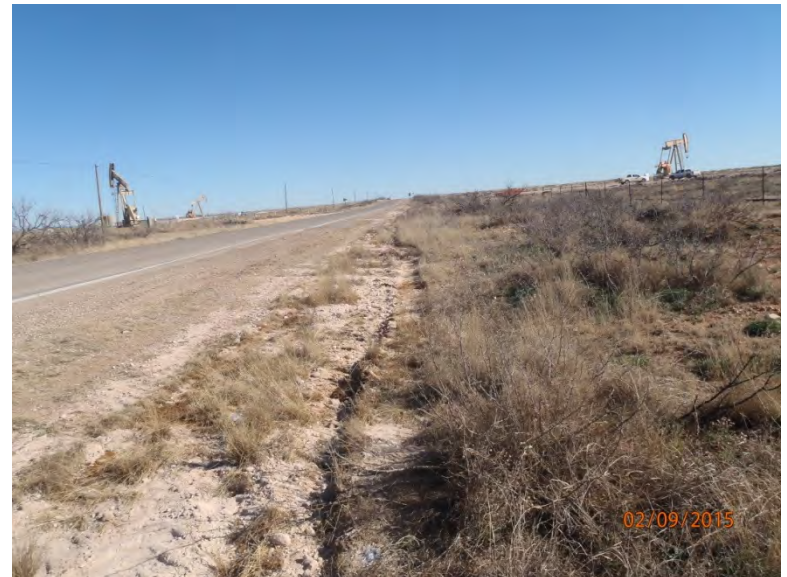
2/9/15

Initial release area, facing south

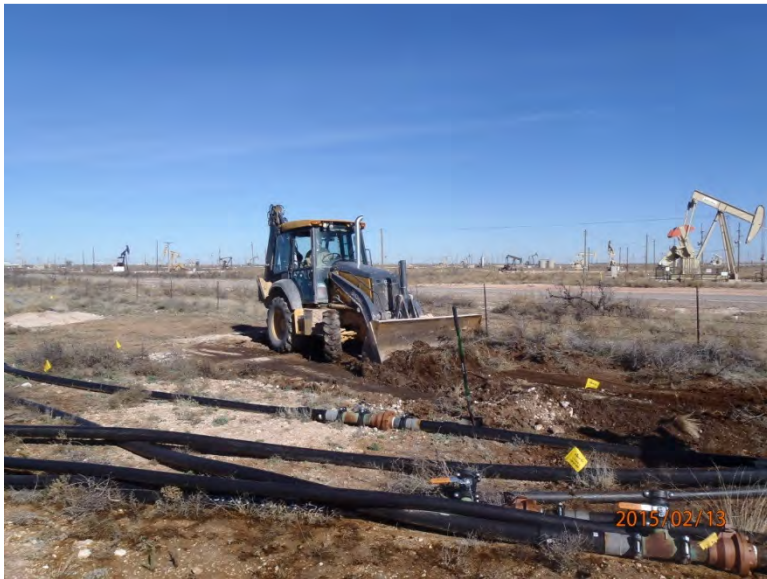
2/13/15

Scraping release area, facing north

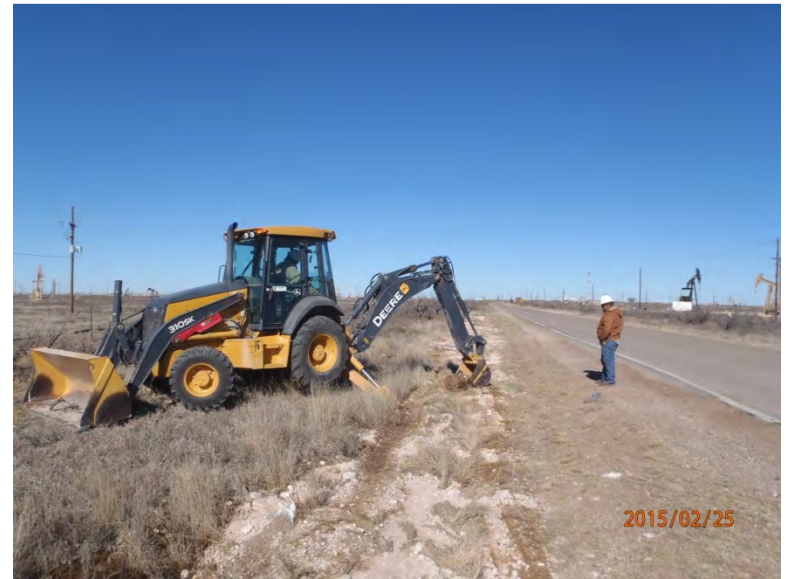
2/25/15

Installing vertical in bar ditch, facing west

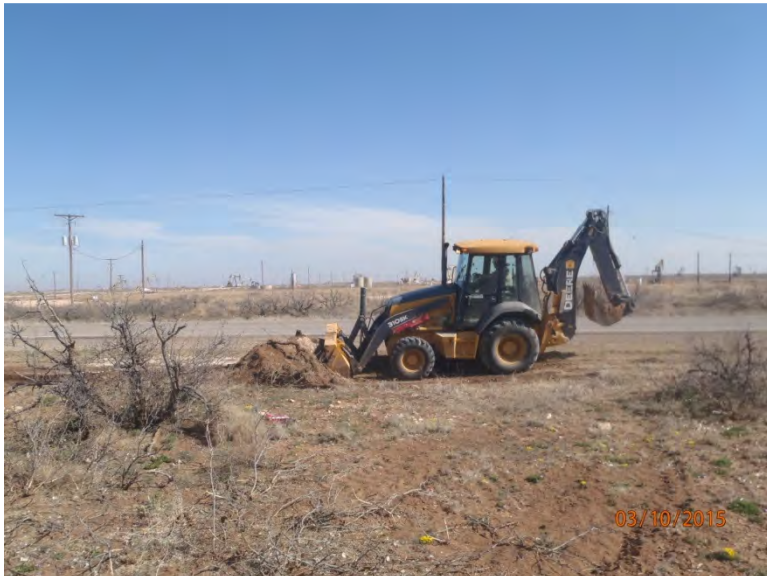
3/10/15

Scraping bar ditch, facing north

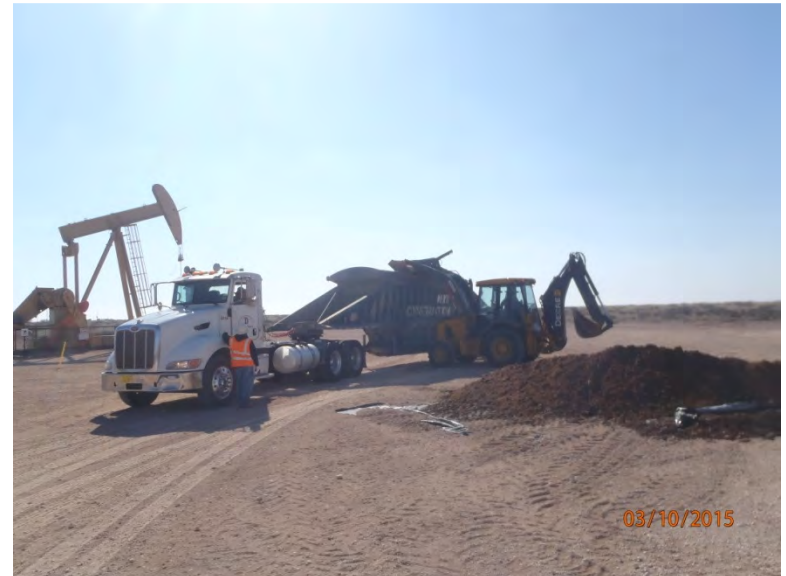
3/10/15

Exporting soil, facing southeast

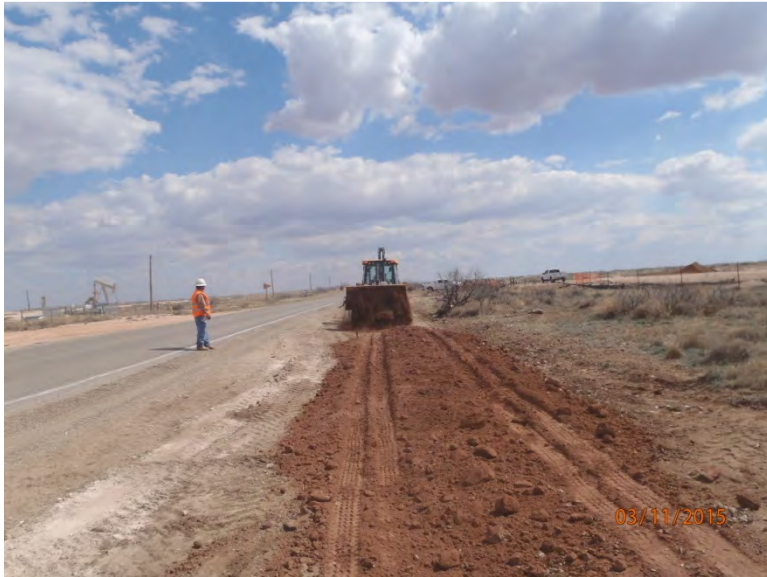
Backfilling release with imported soil, facing east
3/11/15

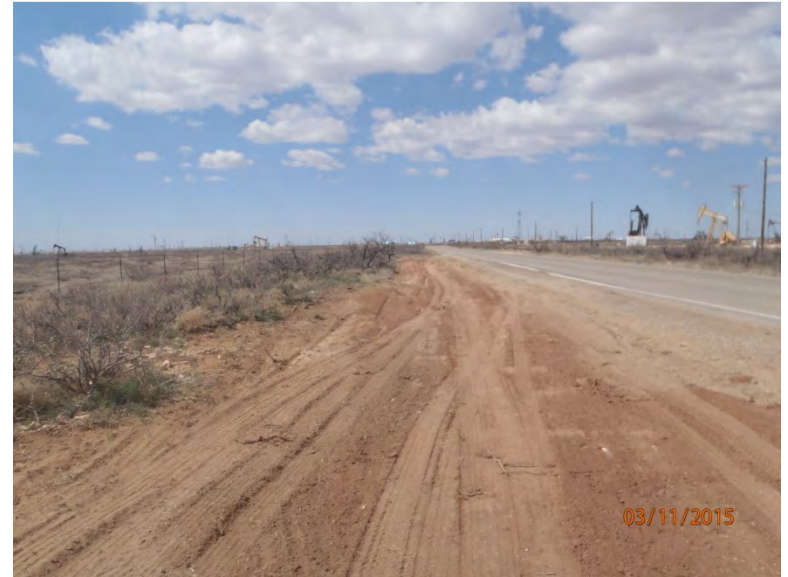
Site backfilled, facing west
3/11/15

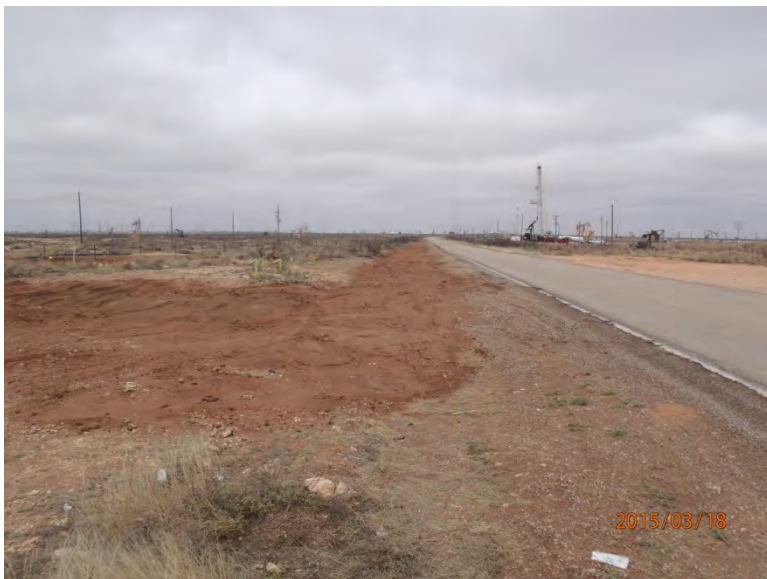
Site completed, facing west
3/18/15

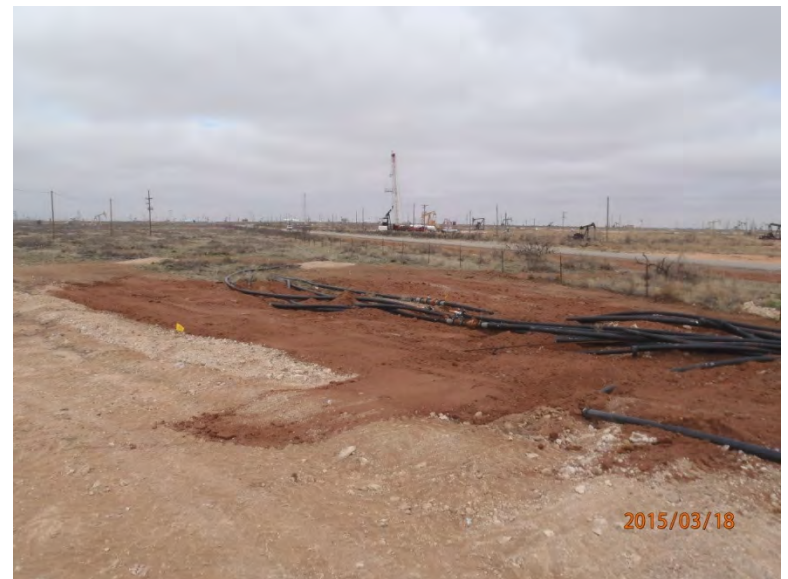
Site completed, facing west
3/18/15
