# Linn Energy Turner B #78

## CLOSURE REPORT

API No. 30-015-05303

Unit J, Section 20, Township 17 South, Range 31 East

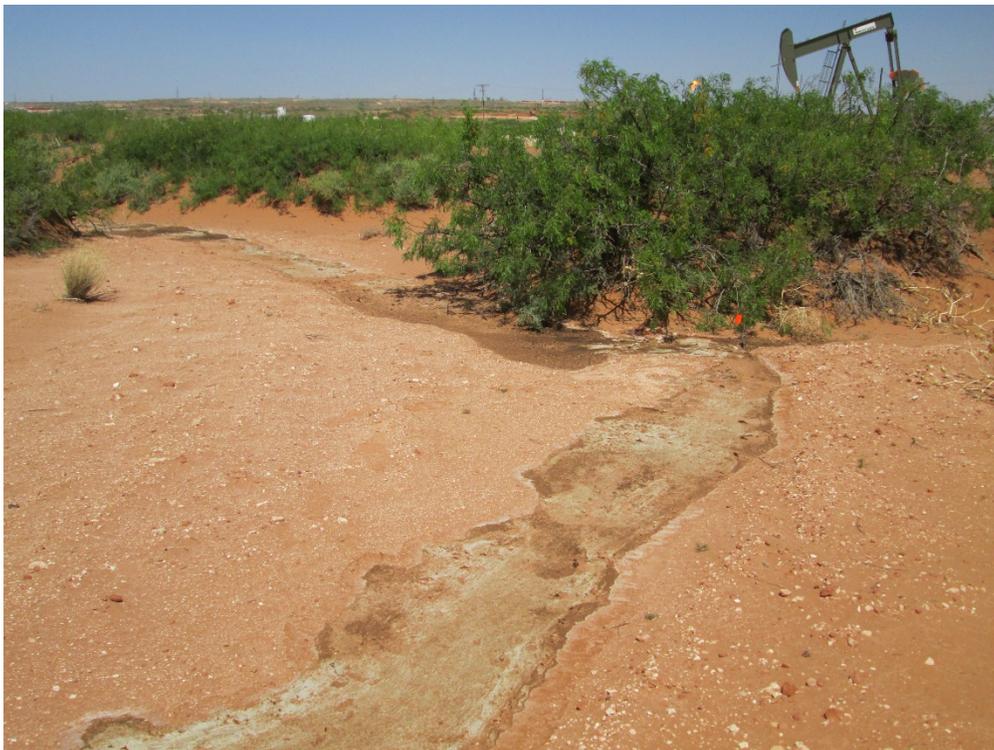
Spill location with sample point

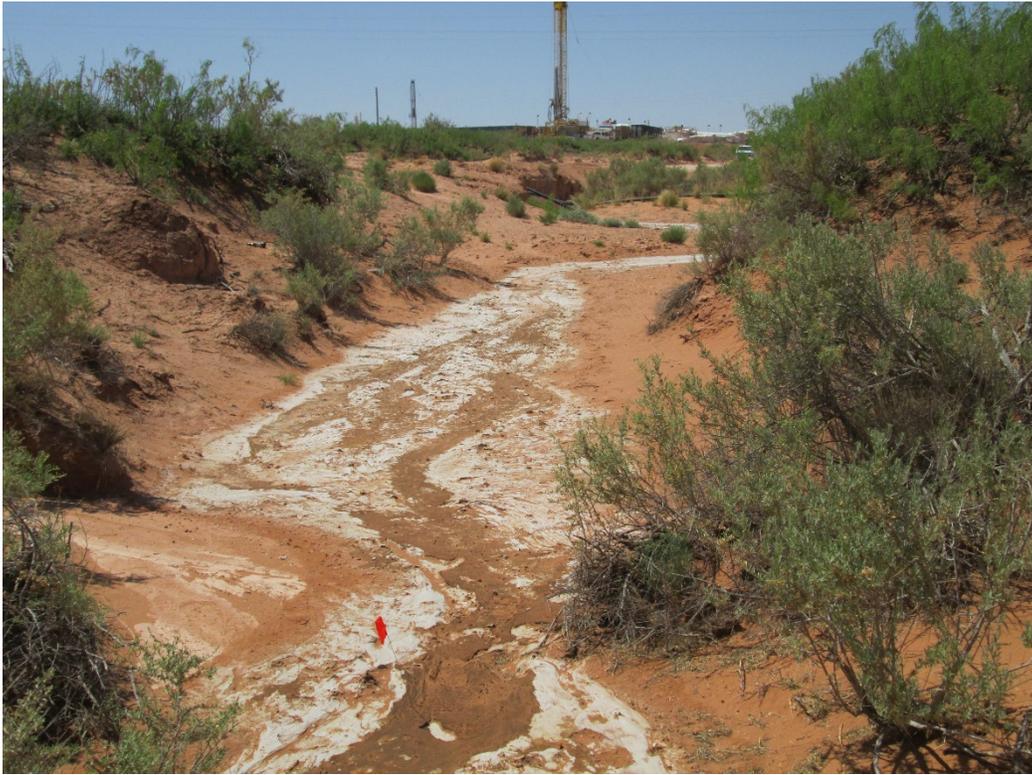
Spill Location with sample point

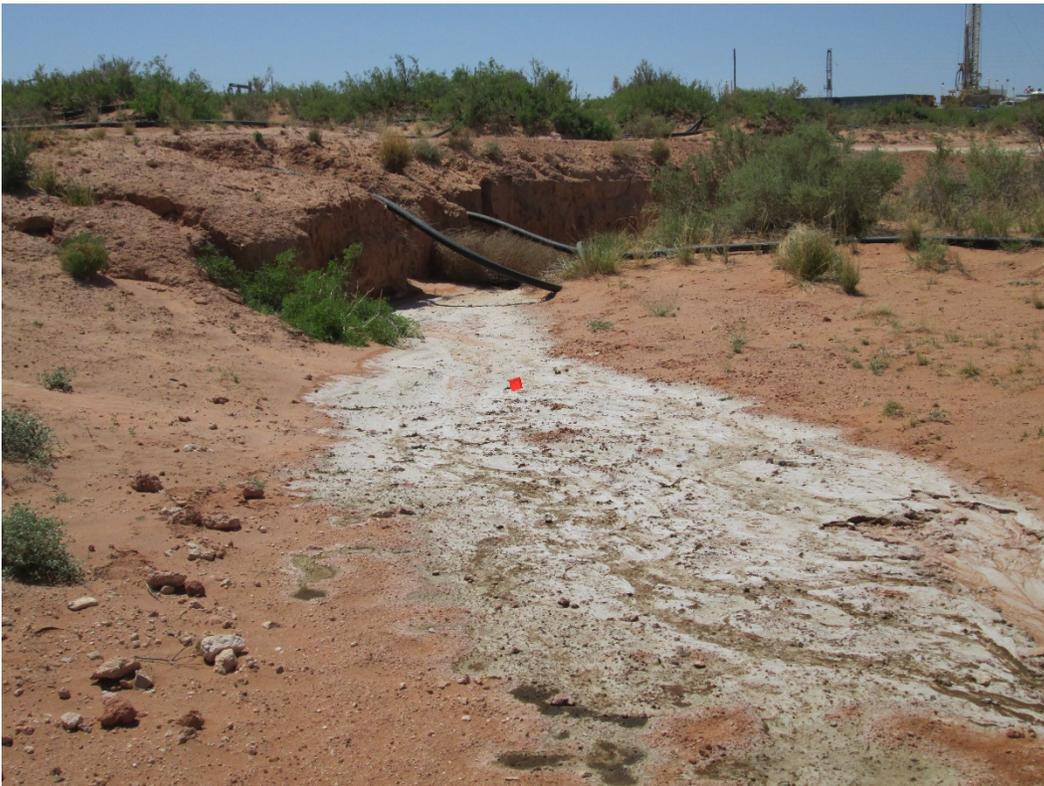
Spill location with sample point

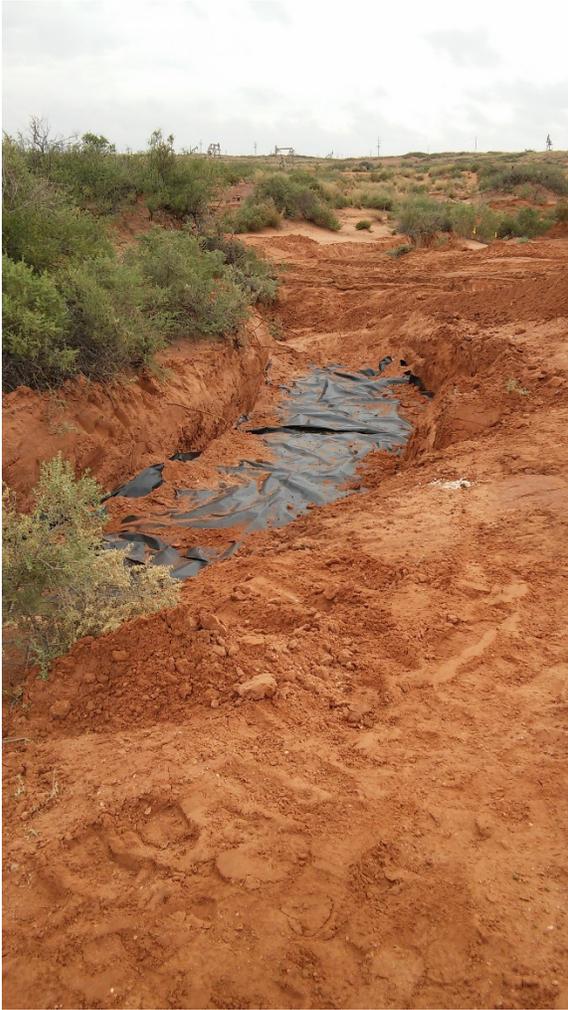
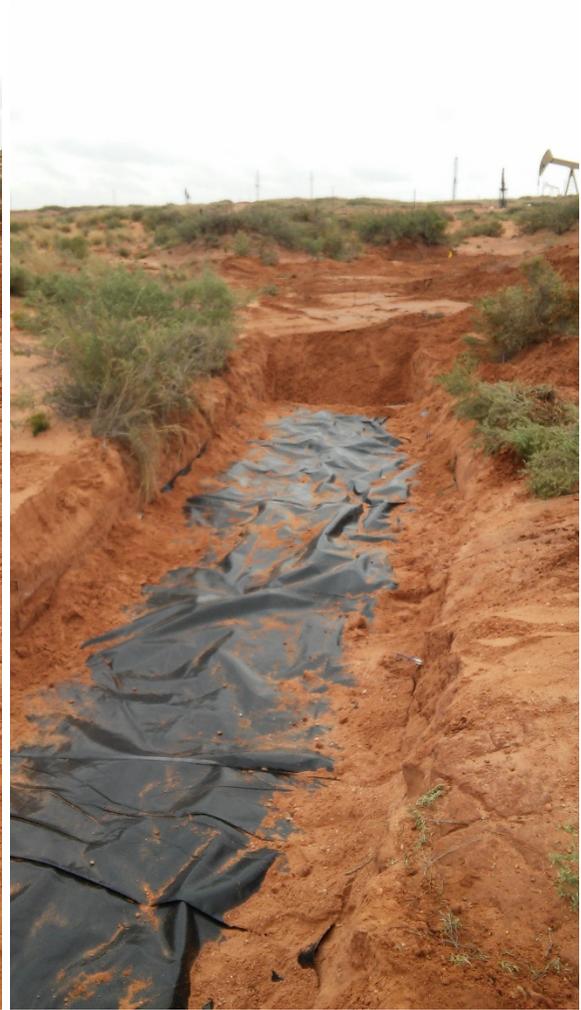
Spill area excavated with liner installation

The contaminated area around SP7 and SP8 was also excavated and lined at 4' with a 20mil liner and the remainder of the clean soil that was excavated for the deep bury area was used as

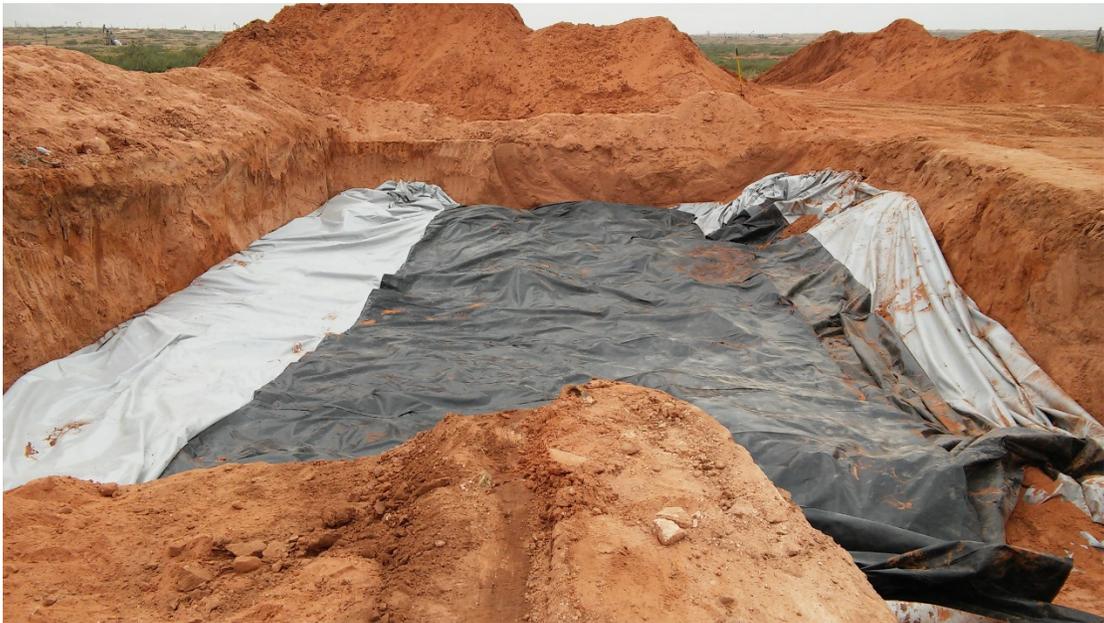
Pit area on Turner B 96 dug out and placed with liner

On October 22, 2014, DFSI employees dug out a 65' x 65' x 8' deep hole on the pad of neighboring well Turner B 96. The bottom of the hole was lined with a 20 mil liner.

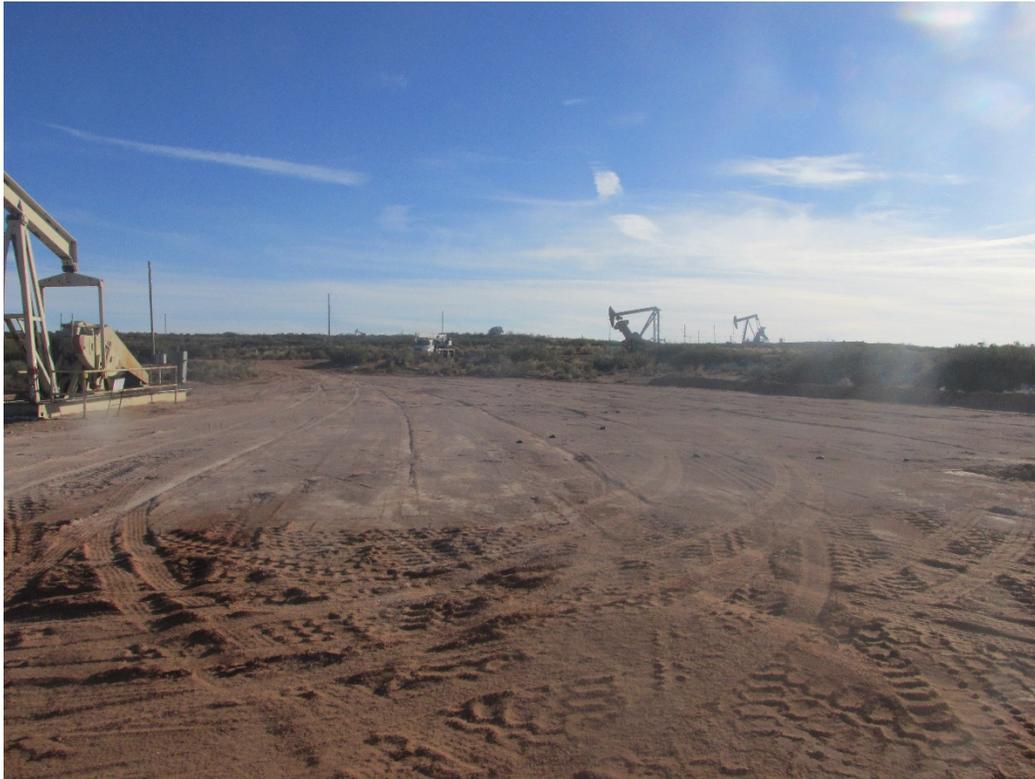
Hole buried on Turner B 96 and backfilled with fresh topsoil/caliche

From October 22, 2014 to November 13, 2015, the entire 7294 sq. ft. area of compacted soil from the Turner B 78 was excavated to 2'bgs. The contaminated soil was then buried in the hole at the Turner B 96. After the contaminated area was completely dug out and transferred to the hole at the Turner B 96, a cap was installed at 4' using a 20 mil liner. The remainder of the dug-out hole was backfilled with clean soil and the area will be reseeded when approved by Linn Energy.

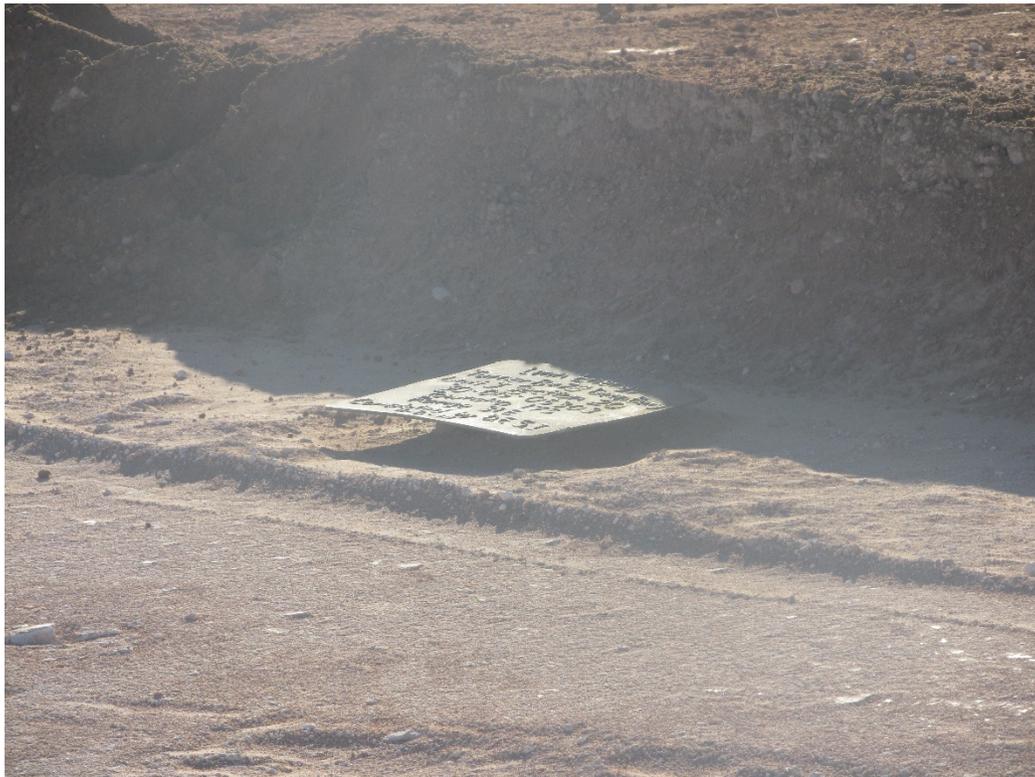
Plate installed for deep bury at Turner B 96

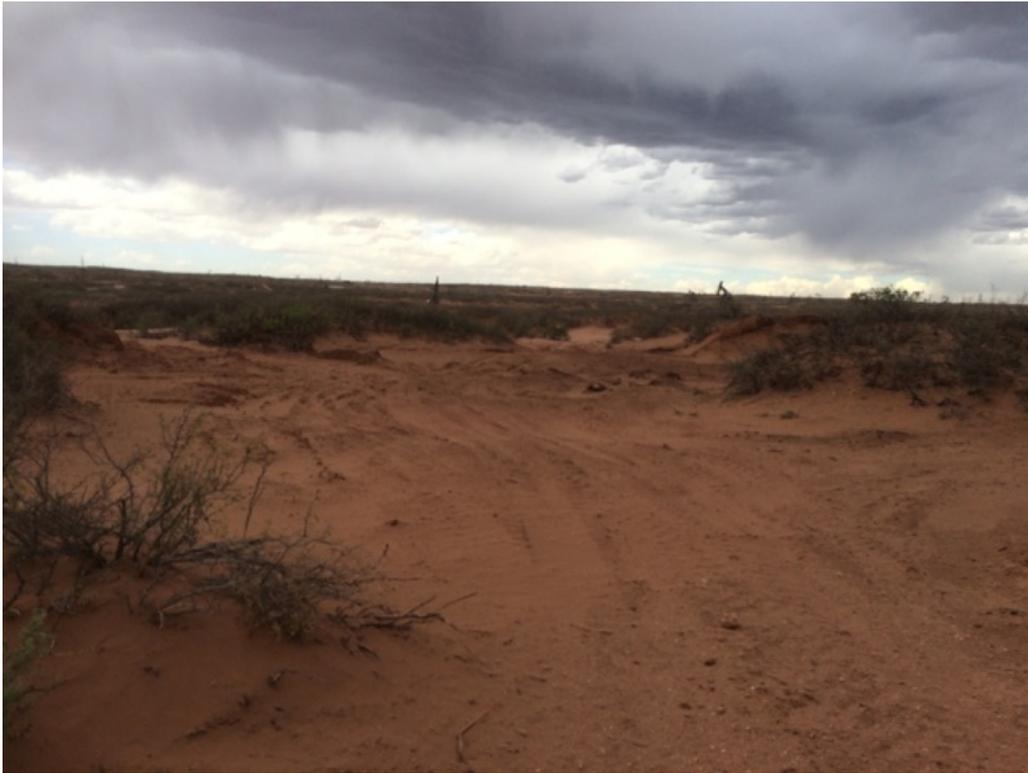
Backfilled spill area, closure pic (Needs seeding)

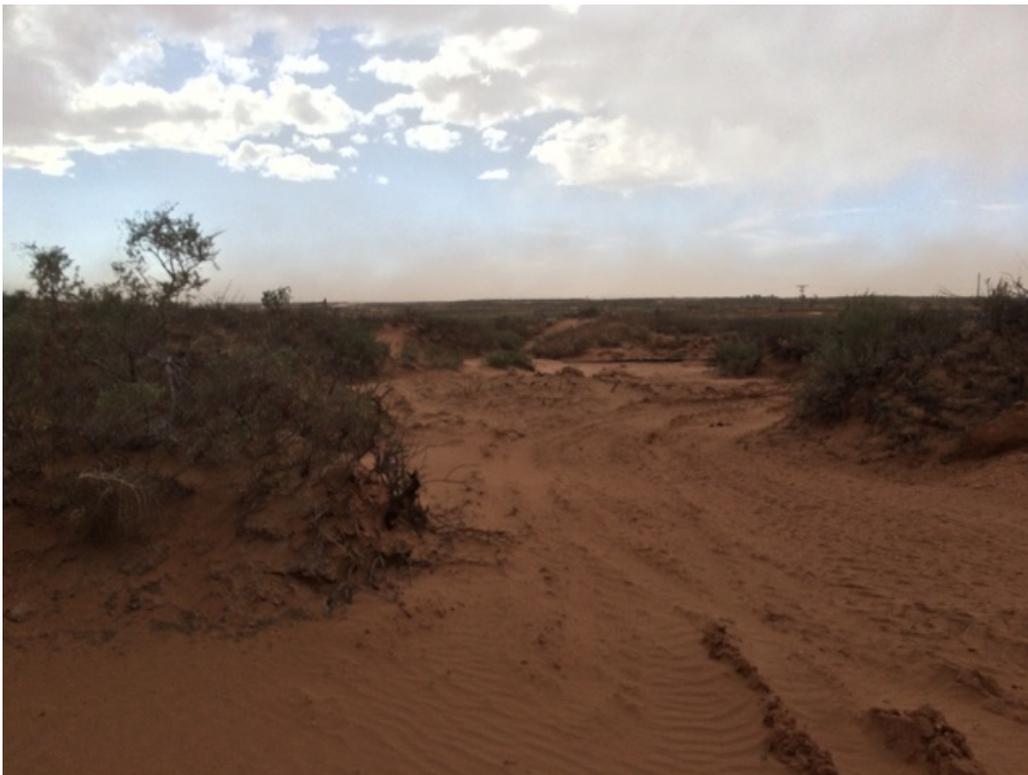
Backfilled area, closure pic (Needs seeding)

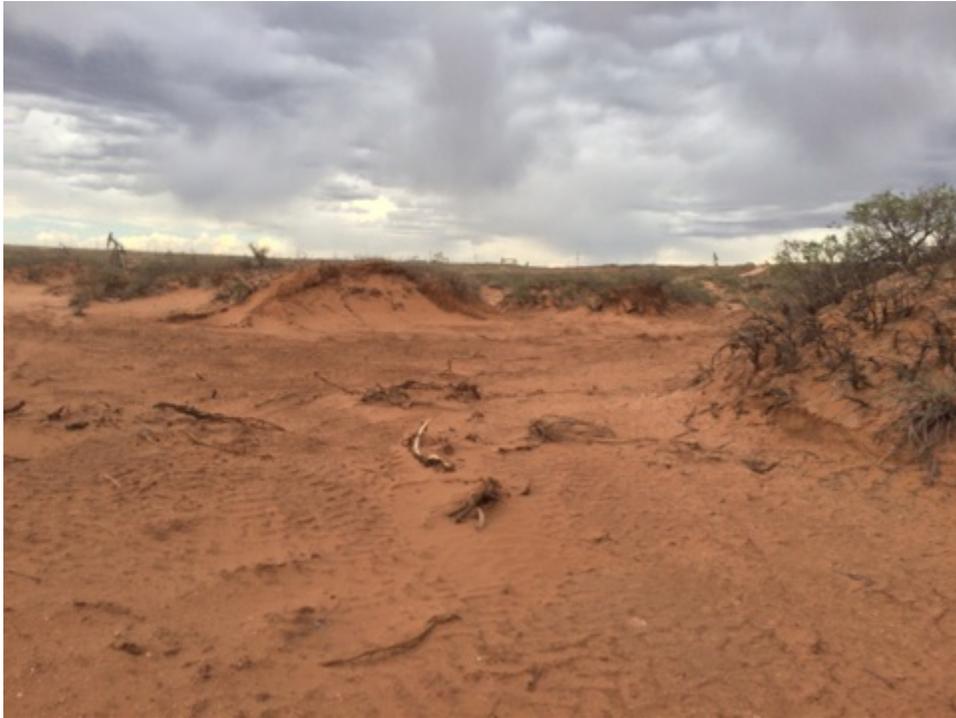
Backfilled spill area, closure pic (Needs seeding)

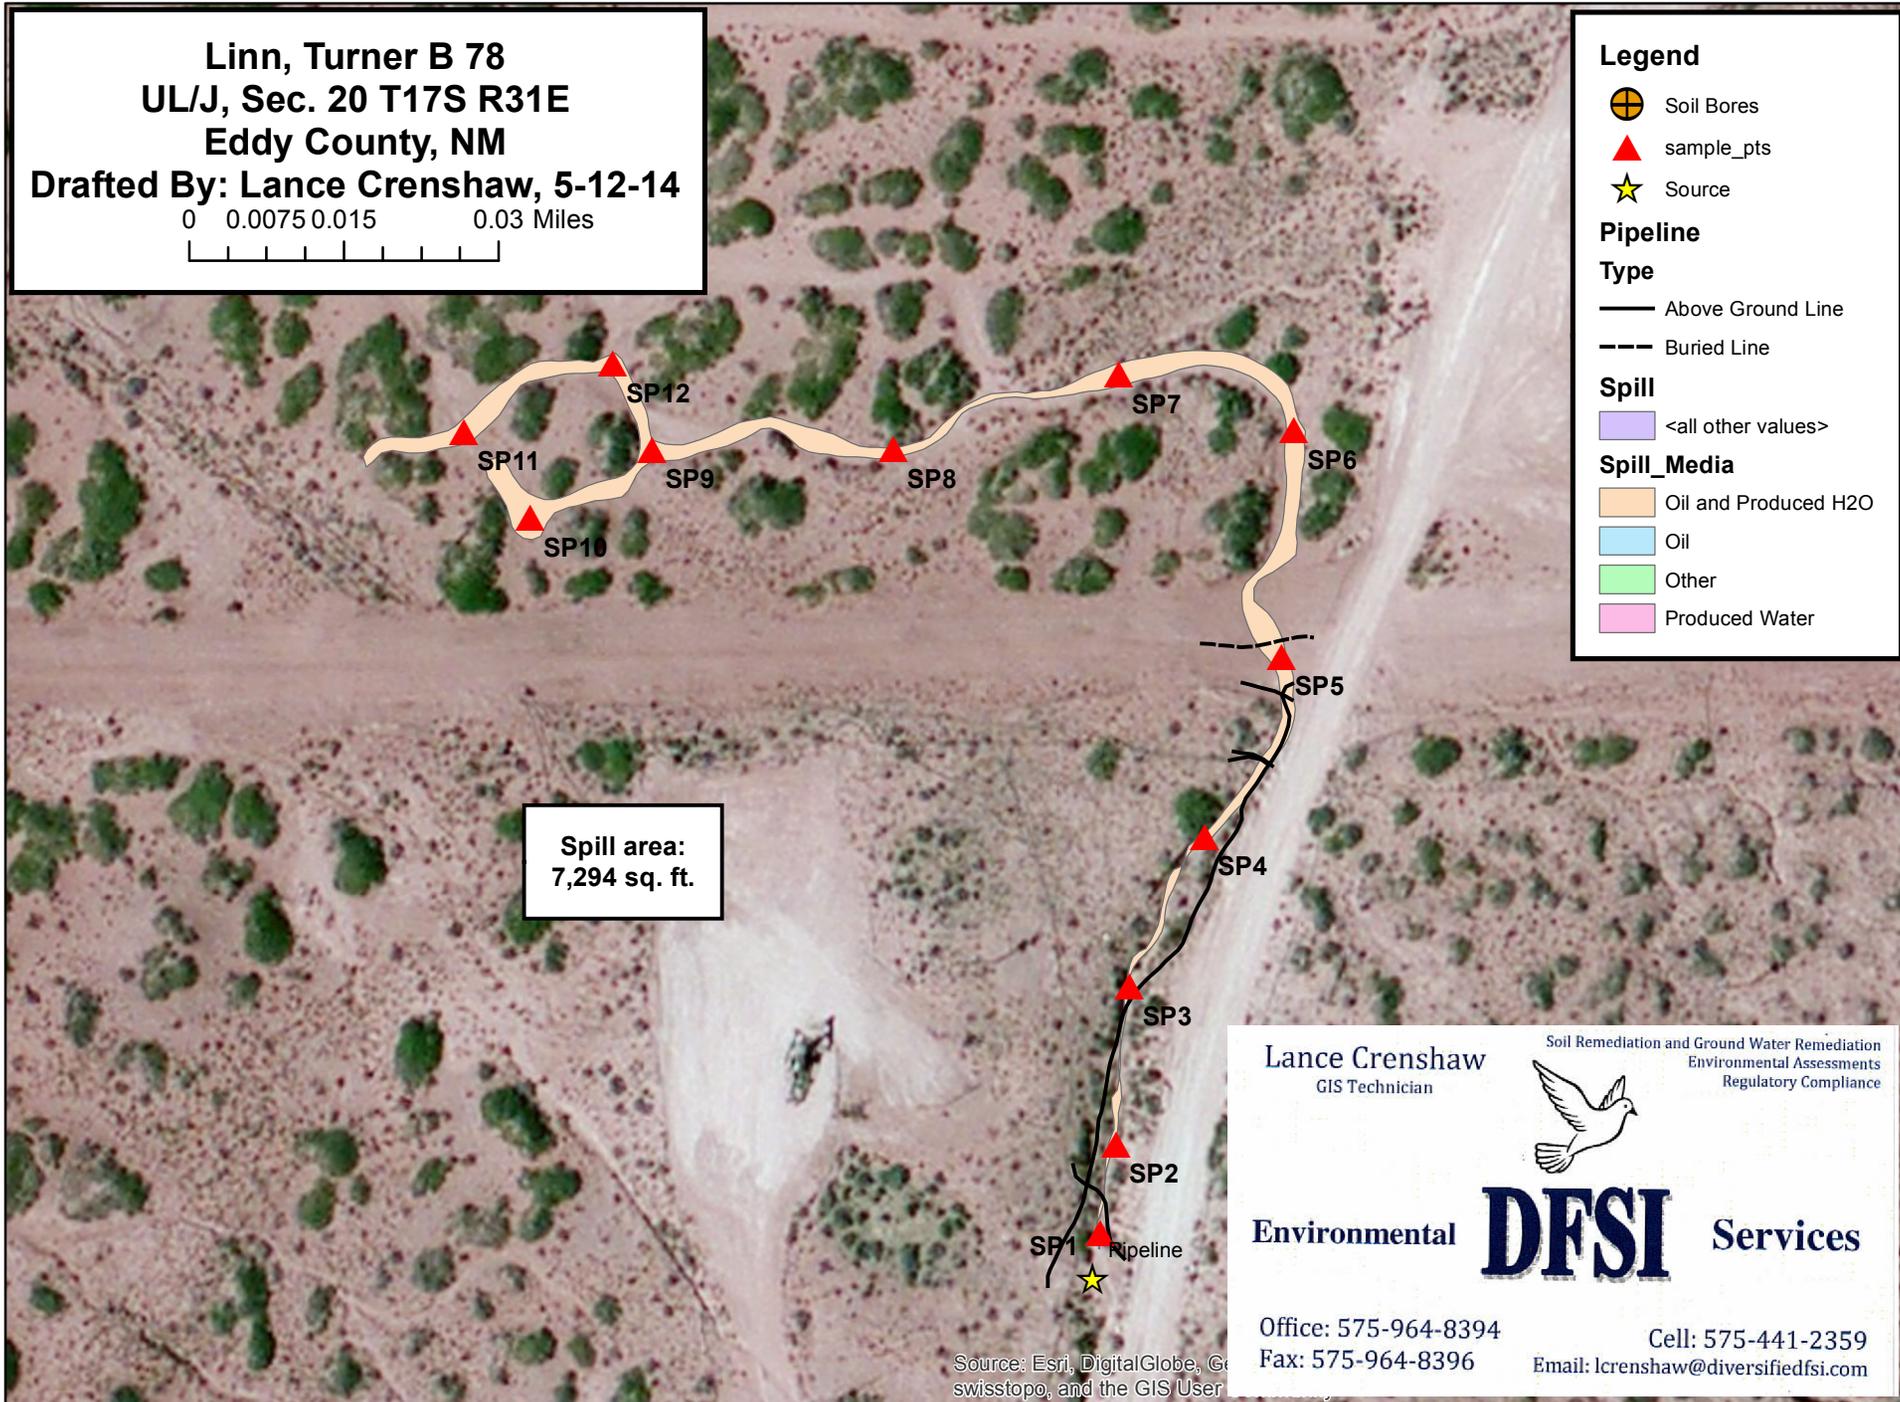
# Site Diagram

Linn, Turner B 78  
 UL/J, Sec. 20 T17S R31E  
 Eddy County, NM  
 Drafted By: Lance Crenshaw, 5-12-14

Spill area:  
7,294 sq. ft.
