CLOSURE REPORT

BOPCO, L.P.
PLU #105
Eddy County, New Mexico
Unit Letter "B", Section 36, Township 24 South, Range 30 East
Latitude 32.179780 North, Longitude 103.832049 West
NMOCD Reference #2RP-2942

RE: Final Closure Report
Bopco – PLU #105
UL-B, Section 26, Township 24 South, Range 30 East
Eddy County, New Mexico
NMOCD Reference # 2RP 2942

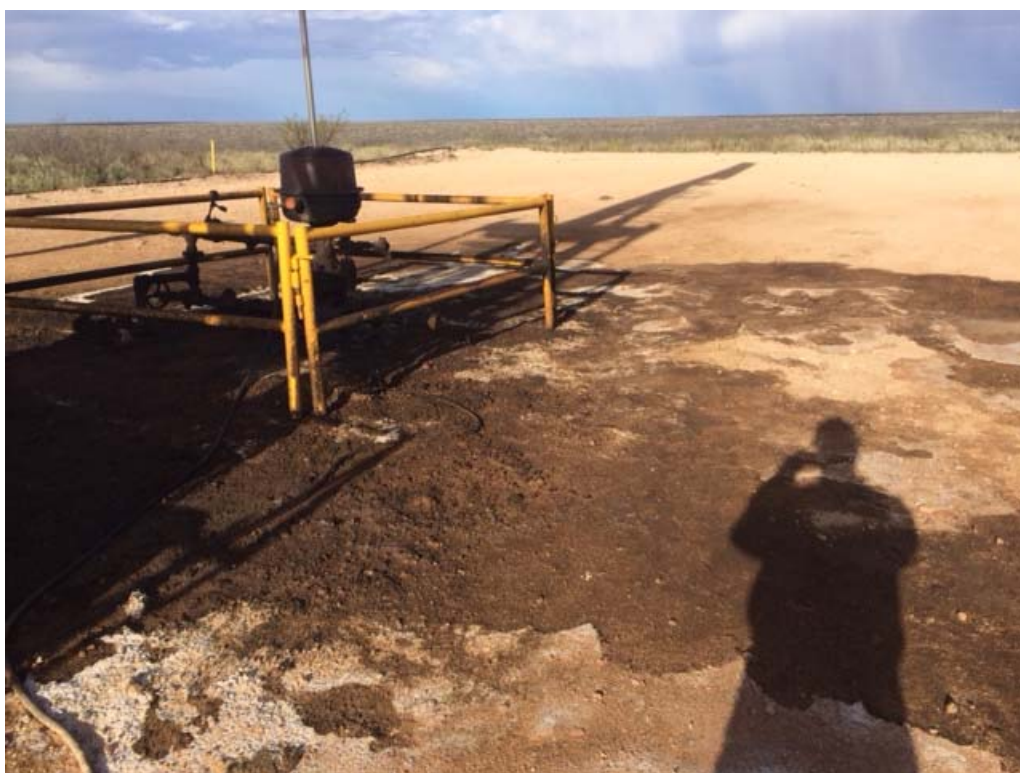
Photograph #2 – Looking across release area

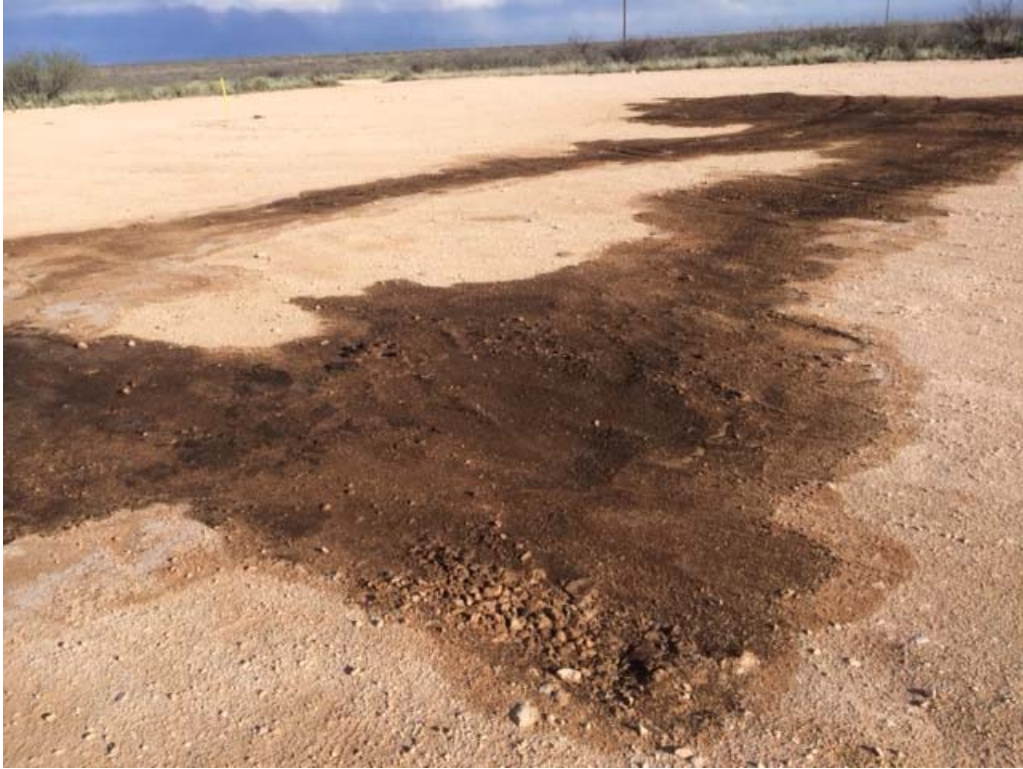
Photograph #3 – Looking across release area

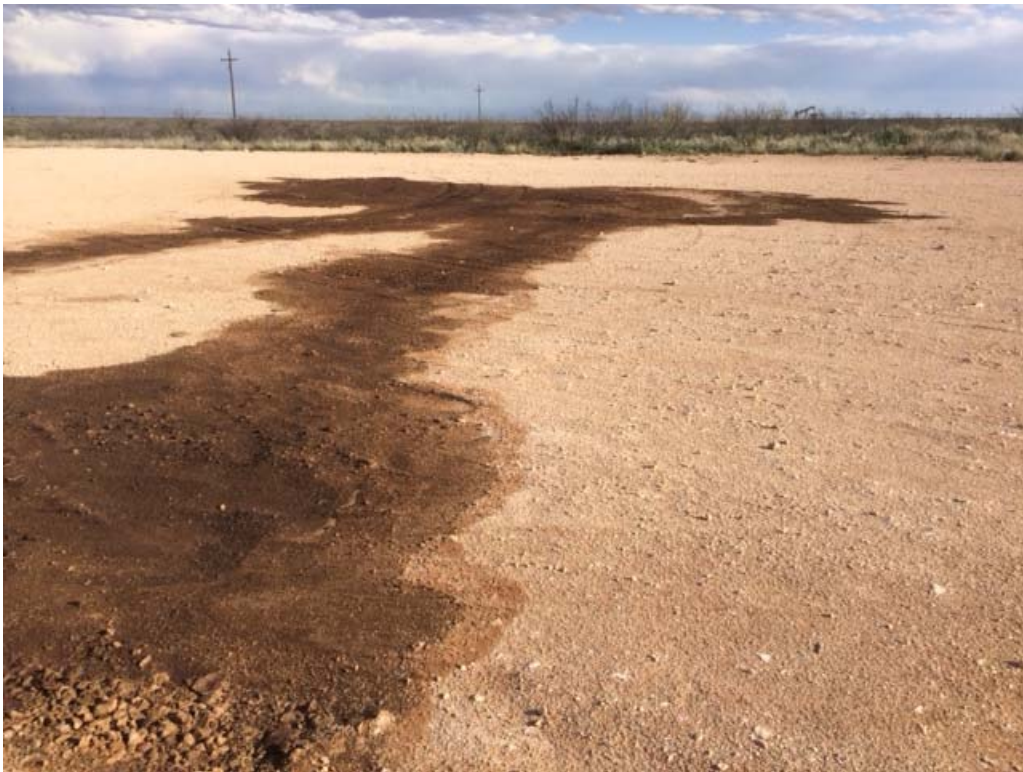
Photograph #4 – Looking across release area

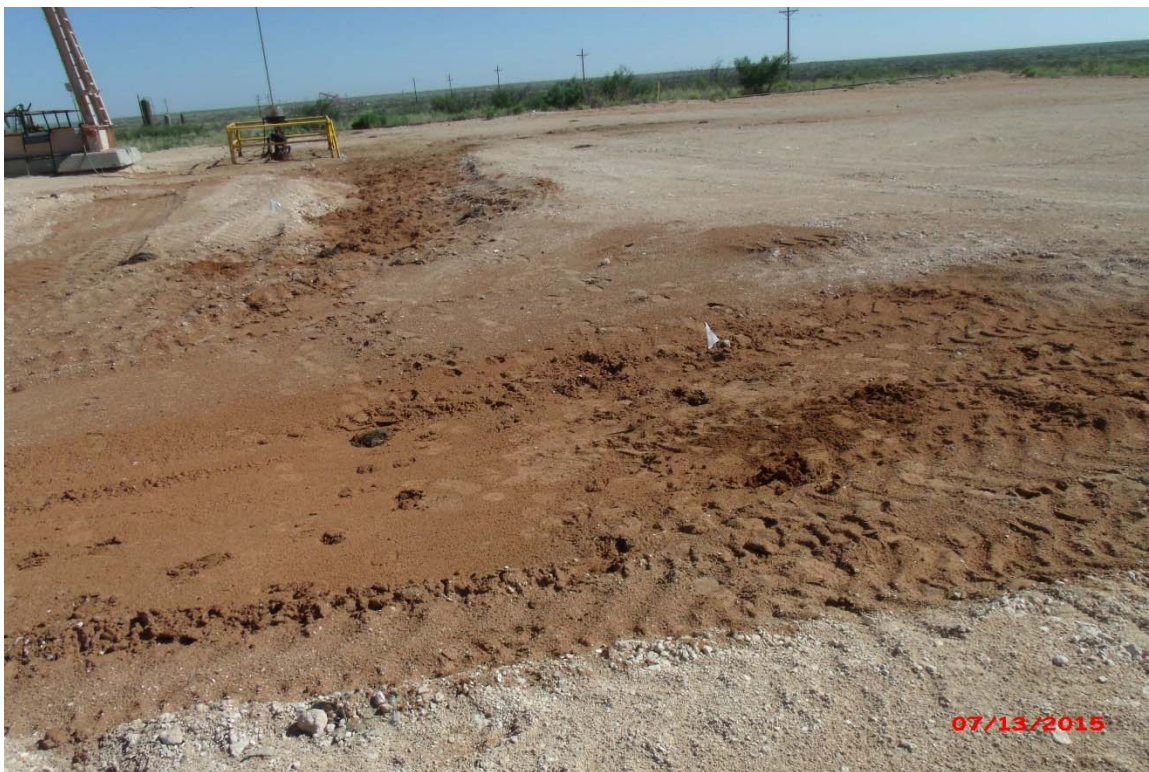
Photograph #5 – Excavated area

The release area was excavated to a depth of approximately six (6) inches bgs. Approximately 88 tons of contaminated soil was excavated and hauled to a state approved facility for disposal.

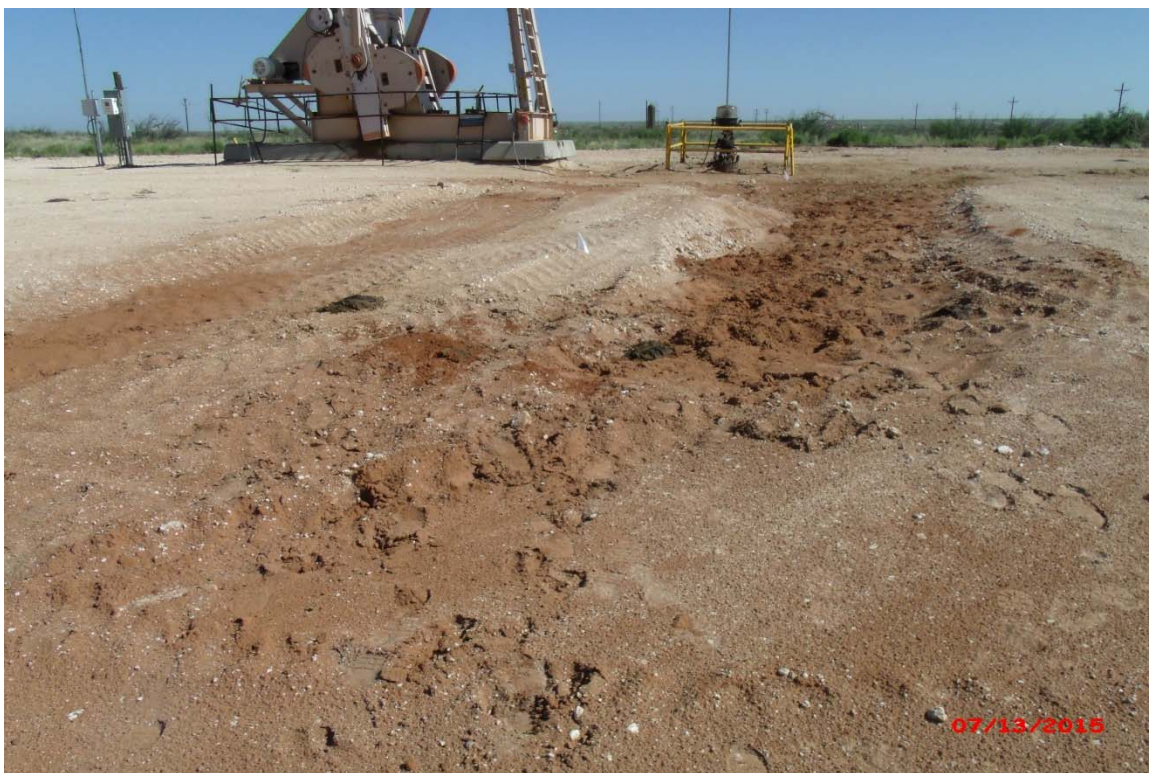
Photograph #6 – Excavated area

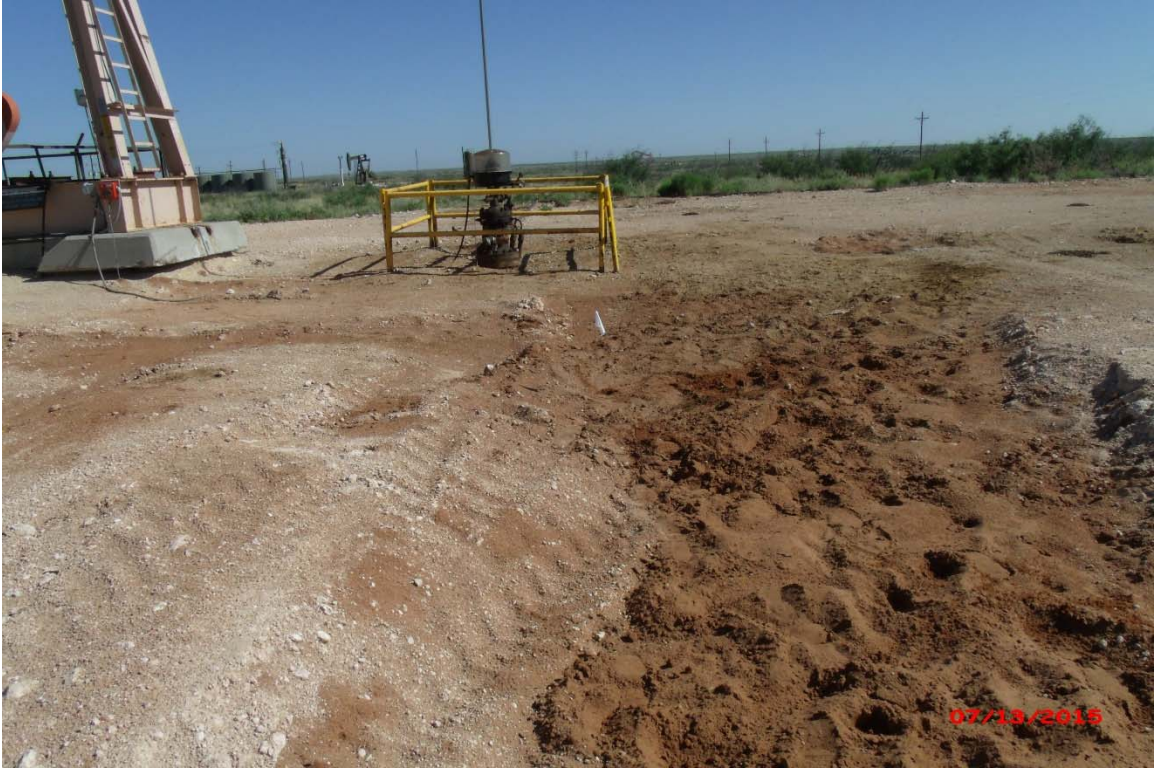
Photograph #7 – Excavated area

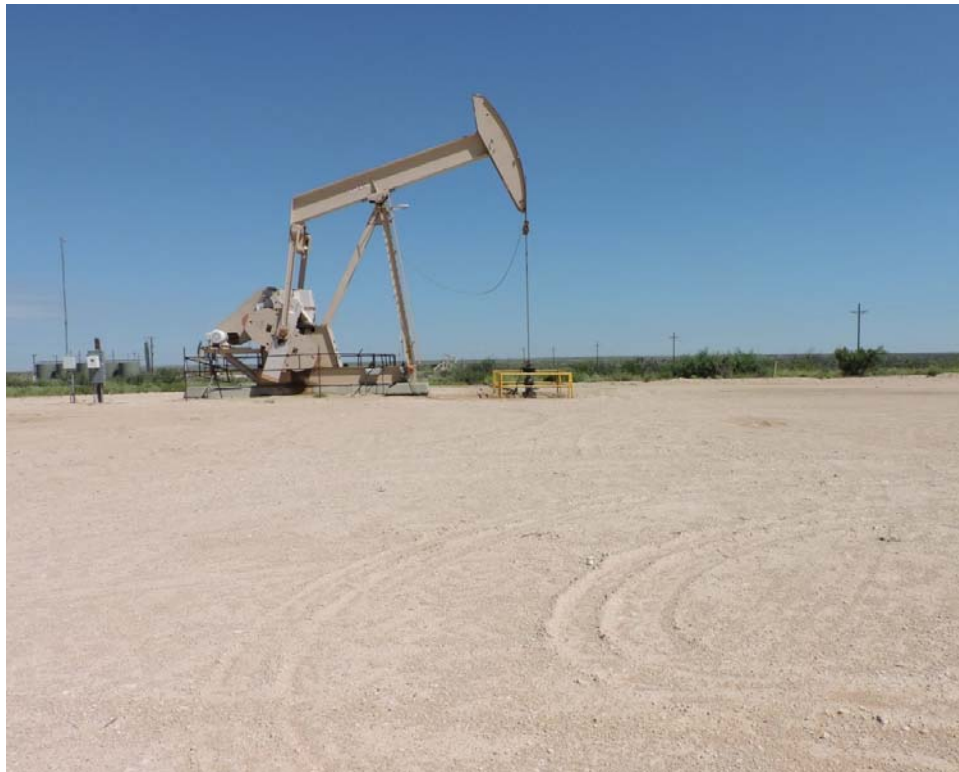
Photograph #8 – Backfilled area

With NMOCD approval the excavation was backfilled with approximately 88 tons of clean soil. All soil was free of rocks, clumps or deleterious material. The entire disturbed area was then contoured to blend with existing pad area and protected against wind/water erosion.

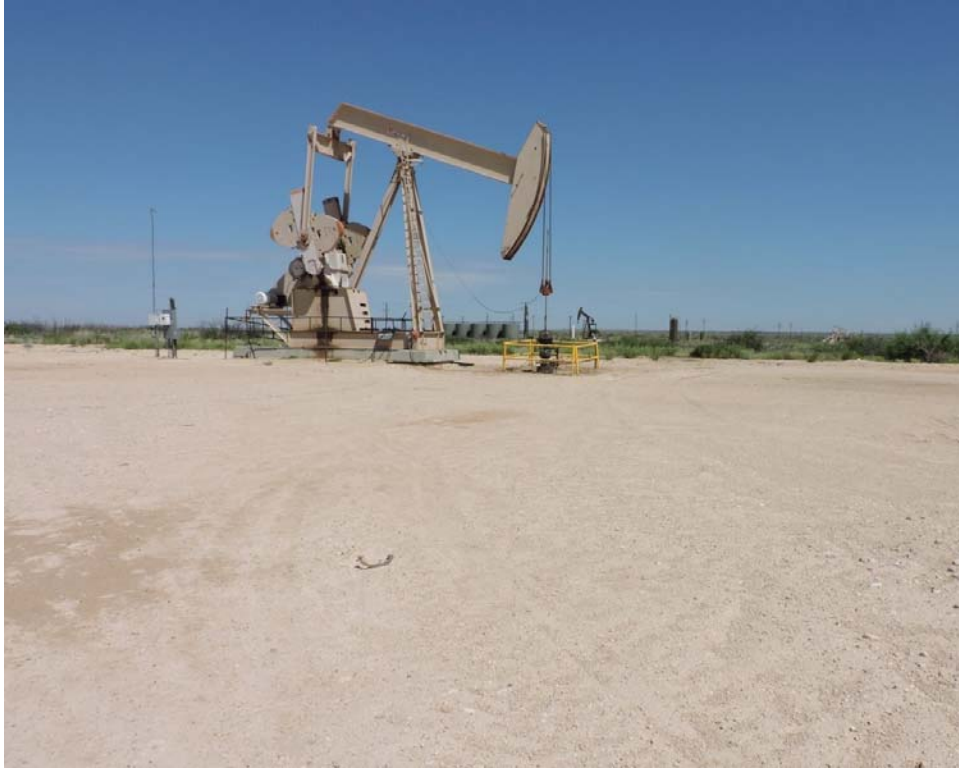
Photograph #9 – Backfilled area

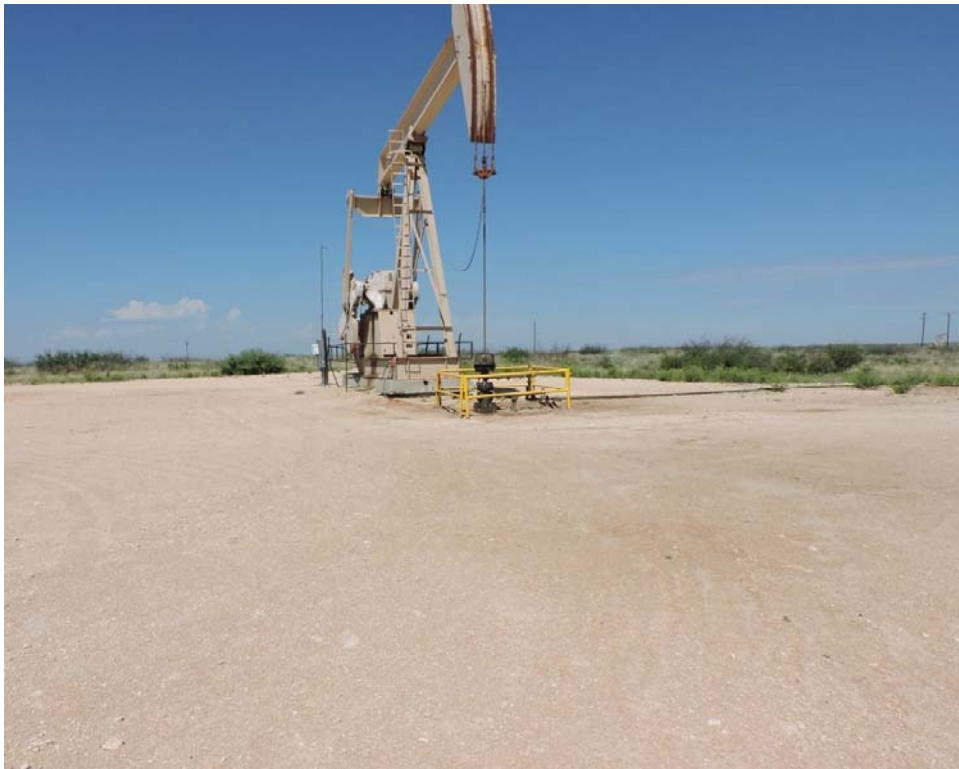
Photograph #10 – Backfilled area
