SUBJECT: FINAL CLOSURE REPORT FOR INCIDENT 2RP-3274 MYOX 32 FEE NO. 002H, EDDY COUNTY, NEW MEXICO

FINAL CLOSURE REPORT FOR INCIDENT 2RP-3274

MYOX 32 FEE No. 002H API# 30-015-41521 SECTION 32, T25S R28E, NMPM EDDY COUNTY, NM

December 4, 2015 SMA Reference 5B24273 BG1

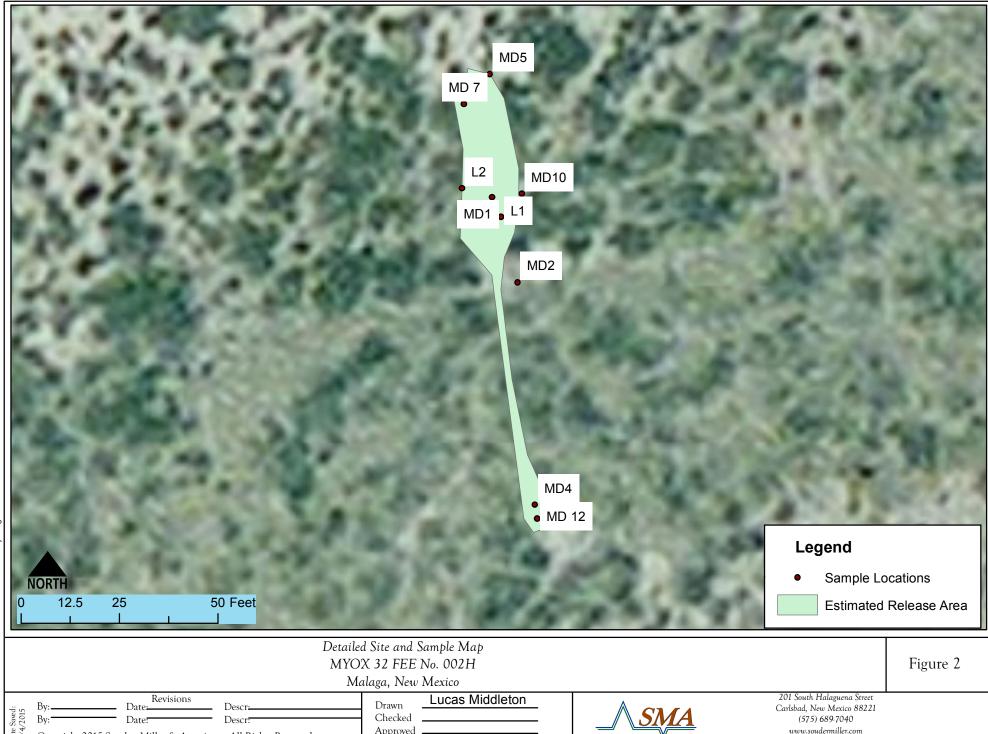
FIGURE 2 SITE DETAILS AND SAMPLE LOCATIONS MAP

The release site is located approximately 4 miles (> 1,000 feet) west of the Pecos River, in an area owned by a private land owner, at an elevation of approximately 2,970 feet above sea level. After evaluation of the site using aerial photography and topographic maps as well as area water well records, depth to groundwater is estimated to be greater than 77 feet below ground surface (bgs). Figure 1 depicts the site vicinity and Figure 2 depicts the site details and sample locations.

Soil contaminant concentrations found during the initial delineation are illustrated in Figure 2. A summary of the laboratory analyses is included in Table 2. Laboratory reports are included in Appendix A.

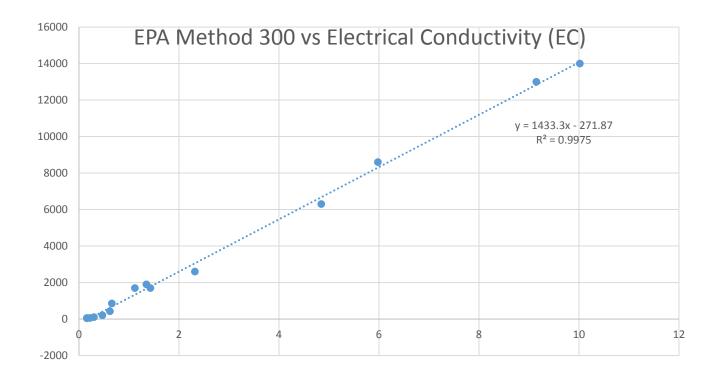
Figure 3: Electrical Conductivity Correlation to EPA Method 300 Graph

FIGURE 3: ELECTRICAL CONDUCTIVITY CORRELATION TO EPA METHOD 300 GRAPH

^{**} Calculated derated reults thought Figure 3
