## **CORRECTIVE ACTION REPORT**

**A-6 Lateral Tank Release  
32.155717, -104.297528  
NW ¼ SE ¼, S4 T25S R26E  
Eddy County, New Mexico  
2RP-3232**

December 2015  
Apex Project No. 7250715079

**Enterprise Field Services, LLC  
PO Box 4324  
Houston, TX 77252  
Attention: Dina Ferguson**

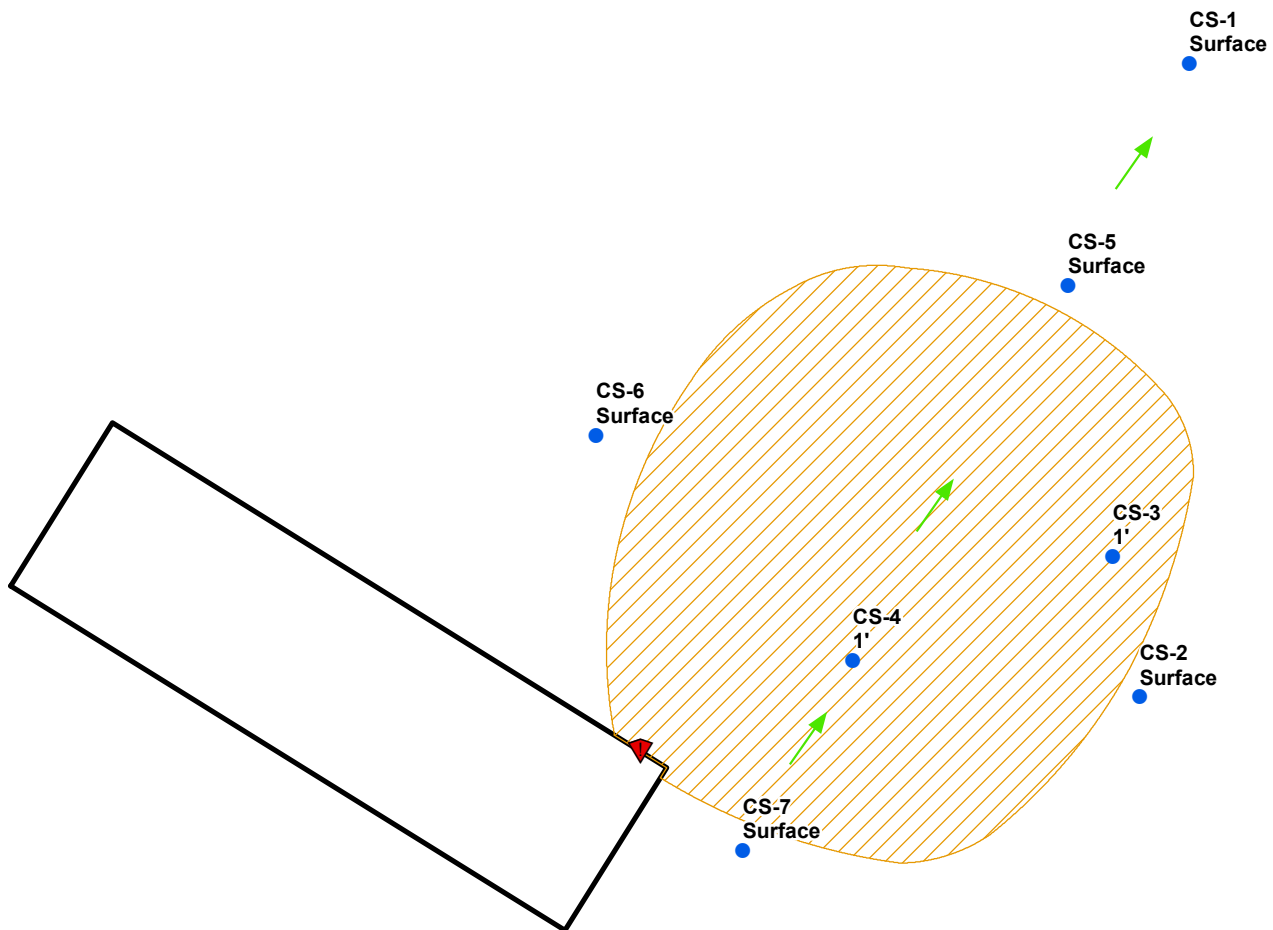
**FIGURE 3**  
**Site Map**

Figure 3 is Site Map that indicates the approximate location of the excavated area in relation to pertinent land features (Appendix A).

The excavation dimensions measured approximately thirty (30) feet long by thirty (30) feet wide, with a total depth of approximately one (1) foot below ground surface (bgs).

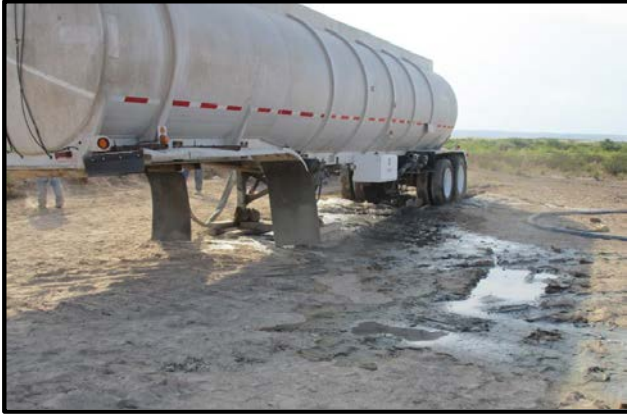
Initial finding of the release point from the bottom of the tanker truck.

On August 17, 2015, Enterprise reported a leak from a tanker truck at the Site. The leak was subsequently identified and repaired. Approximately eight (8) bbls of stagnant water and drilling mud were released from the tanker truck onto the ground surface.

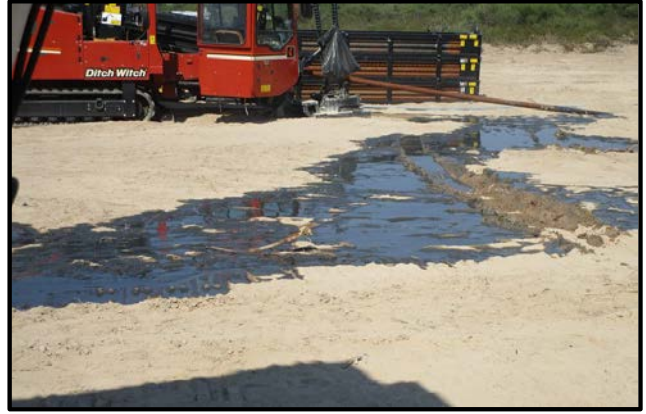
View of initial release in the vicinity of the A-6 lateral pipeline construction.

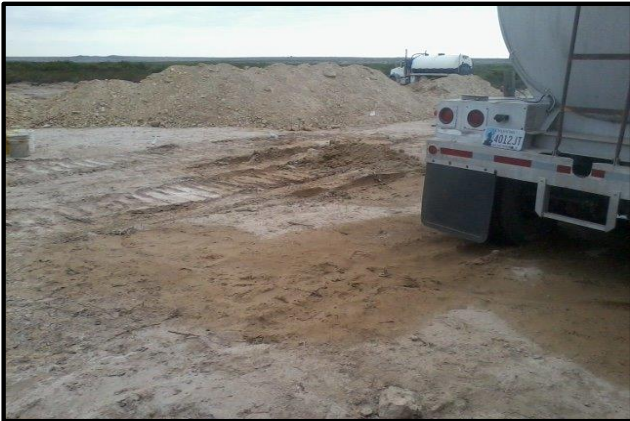
View of release prior to excavation activities.

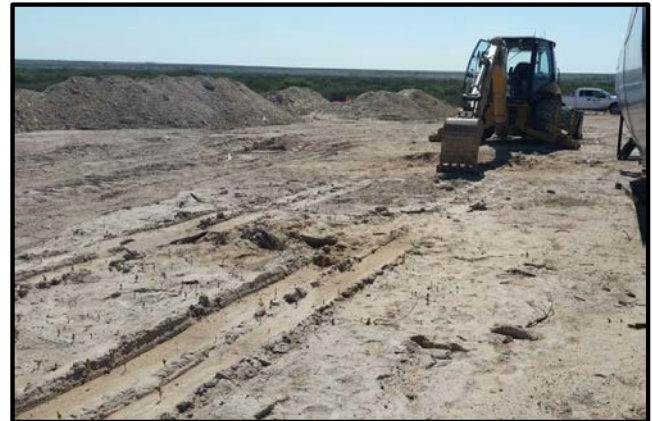
View of initial excavation activities.

The initial excavation was carried out on August 26, 2015. During the corrective action activities, Talon LPE (Talon) provided heavy equipment and labor support. Ms. Georgiana McSwane, an Apex environmental professional, provided environmental support.

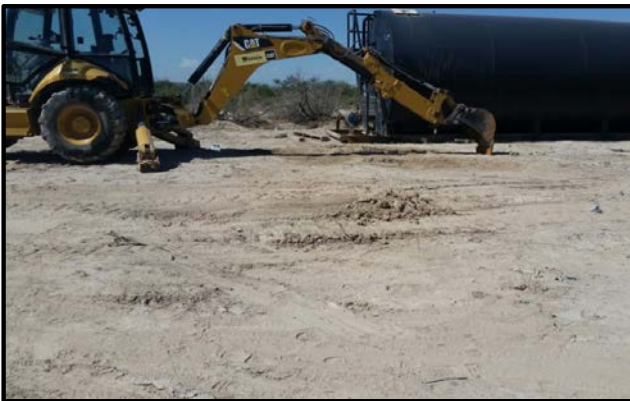
View facing southwest of initial excavation activities.

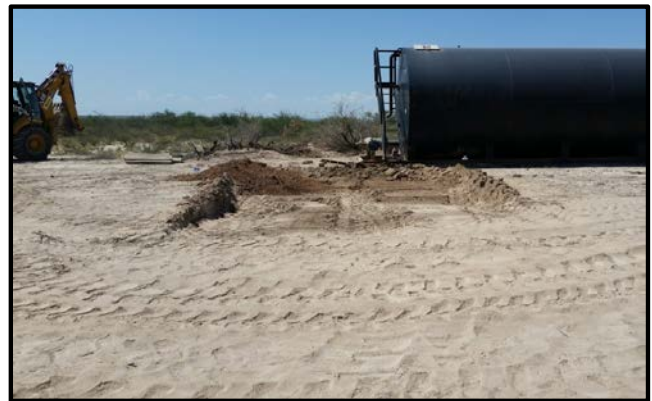
View facing southwest of final excavation.

- The stockpiled material was transported from the excavation to the Lea Land Disposal Facility. The excavation was backfilled with clean imported fill from Lea Land and contoured to surrounding grade. The surface soils at the Site were returned to approximate original grade.
