CLOSURE REPORT

**BOPCO, L.P.
PLU #302H
Eddy County, New Mexico
Unit Letter "G", Section 28, Township 24 South, Range 31 East
Latitude 32.189497 North, Longitude 103.780776 West
NMOCD Reference #2RP-3424**

RE: Final Closure Report
Bopco – PLU #302H
UL-G, Section 28, Township 24 South, Range 31 East
Eddy County, New Mexico
NMOCD Reference # 2RP 3424

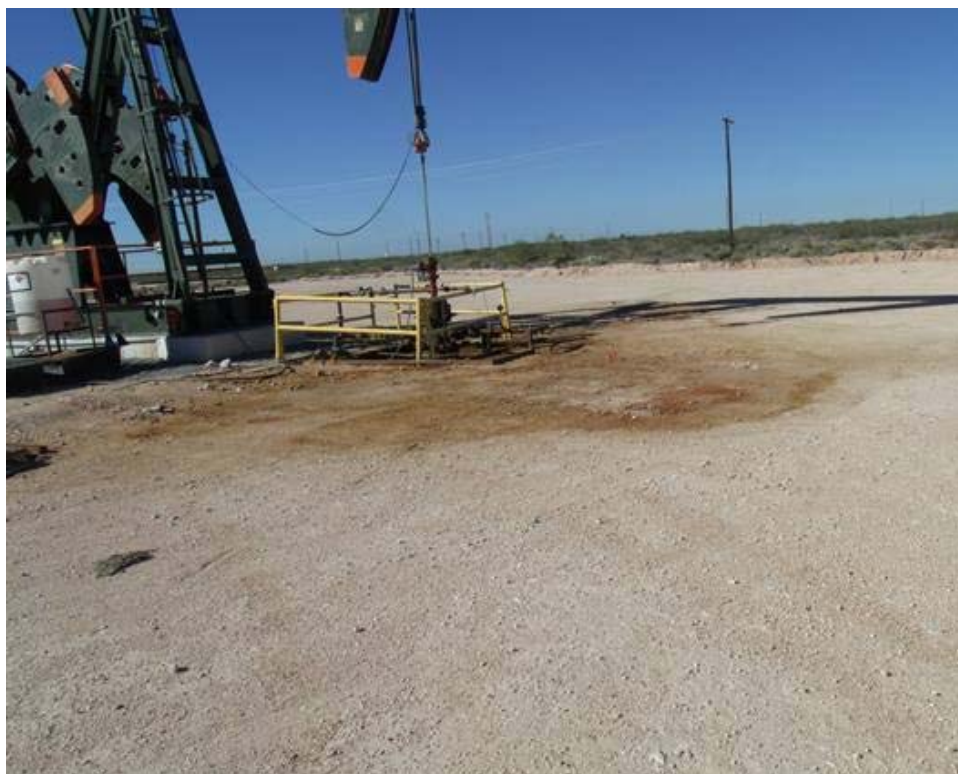
Photograph #1 – Looking across release area

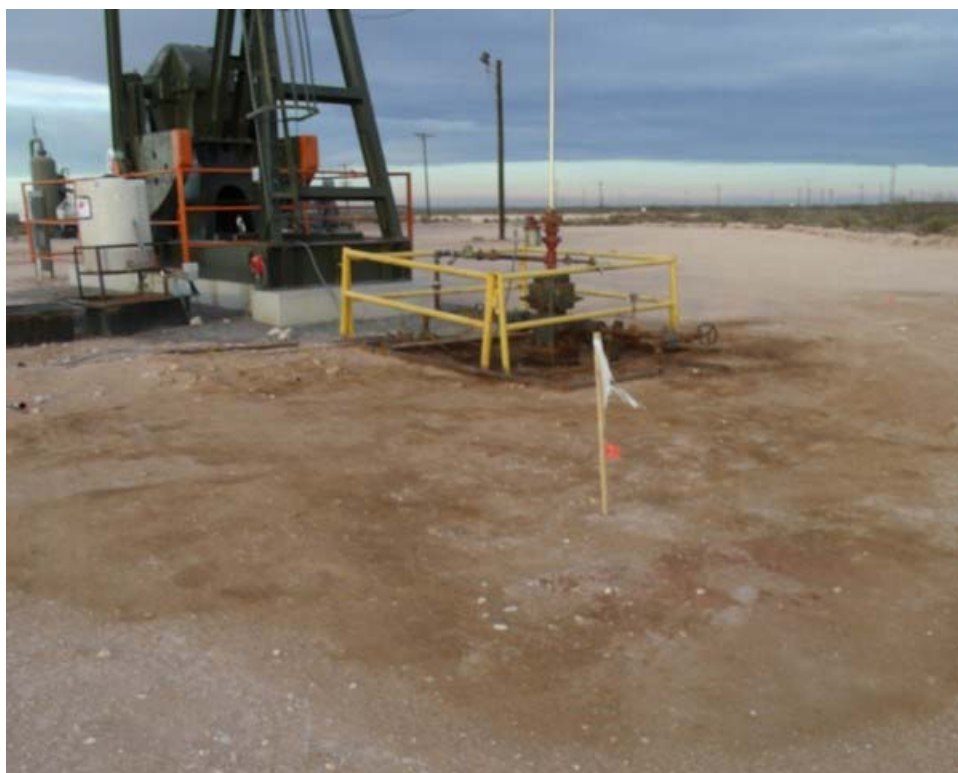
Photograph #2 – Looking across release area

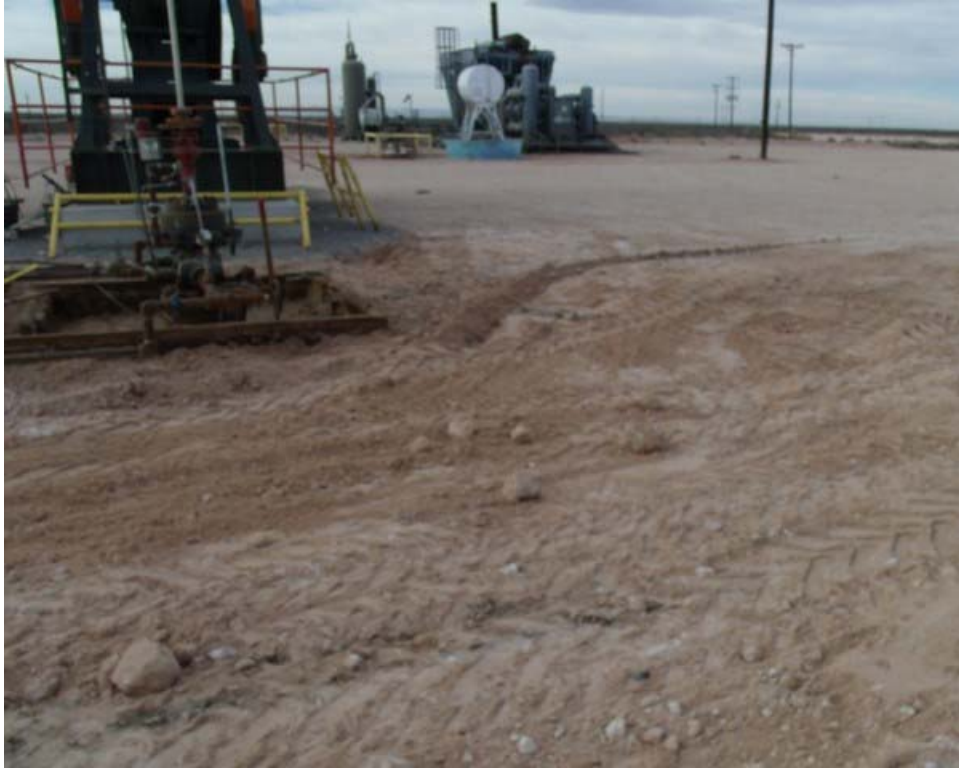
Photograph #3 – Excavated area

The release area was excavated to a depth of approximately six (6) inches bgs. Approximately 11 tons of contaminated soil were excavated and hauled to a state approved facility for disposal.

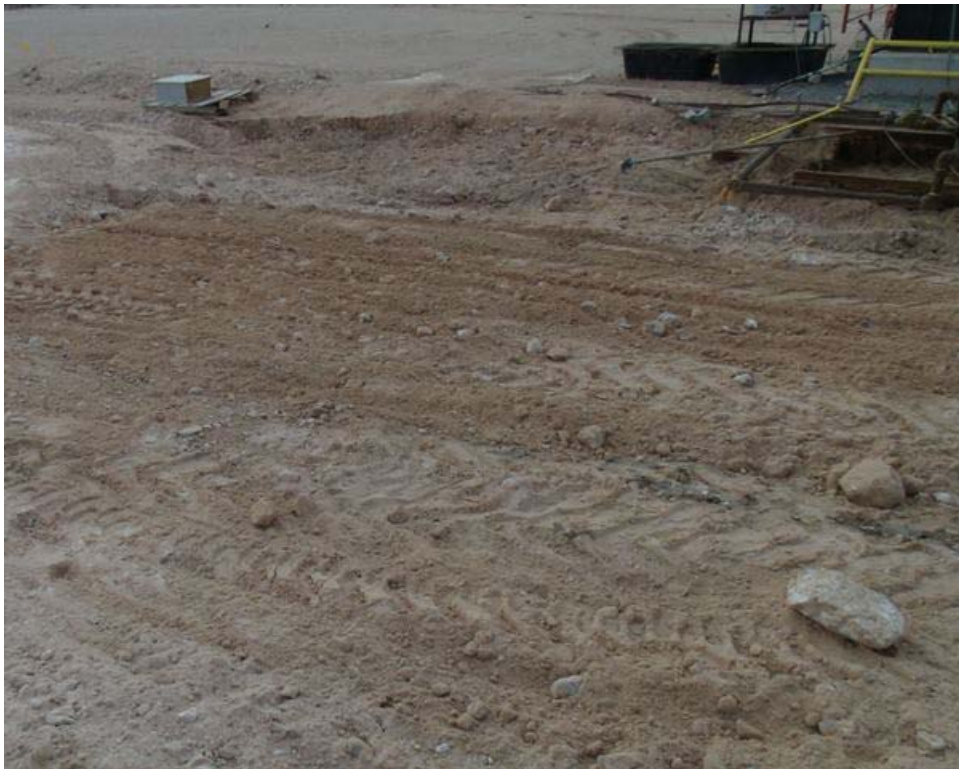
Photograph #4 – Excavated area

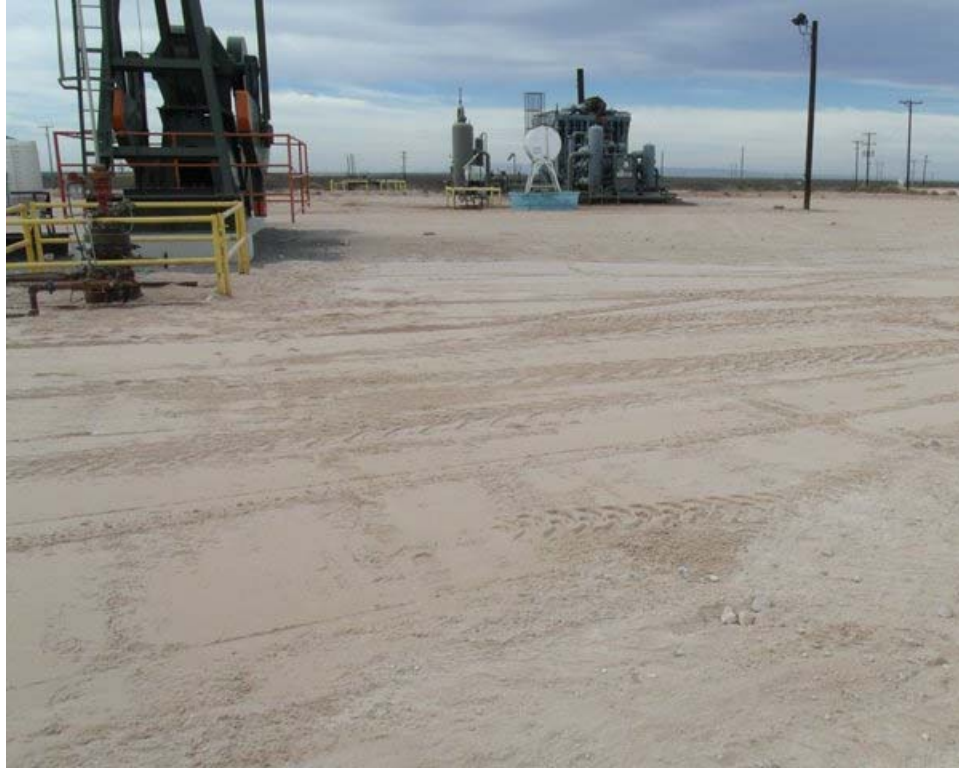
Photograph #5 – Backfilled

Based on laboratory analytical results and NMOCD approval the excavation was backfilled with approximately 11 tons of clean soil. All soil was free of rocks, clumps or deleterious material. The entire disturbed area was then contoured to blend with existing pad area and protected against wind/water erosion.

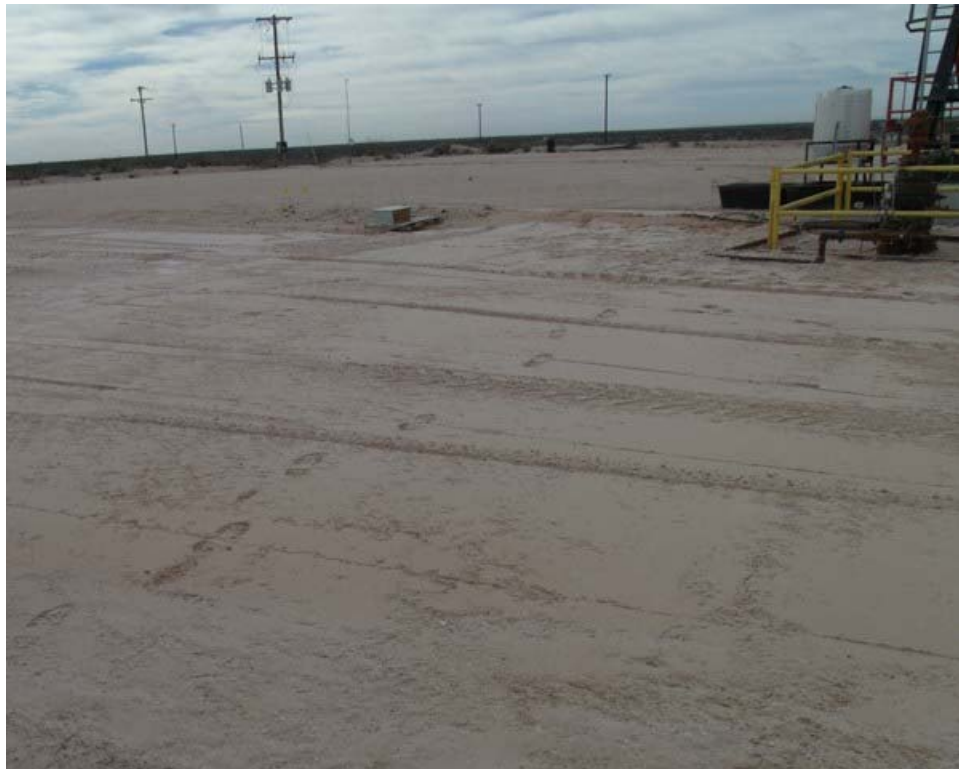
Photograph #6 – Backfilled
