## **CLOSURE REPORT**

**BOPCO, L.P.**  
**PLU CVX JV PC #017**  
**Eddy County, New Mexico**  
**Unit Letter "O", Section 12, Township 24 South, Range 30 East**  
**Latitude 32.213918 North, Longitude 103.920133 West**  
**NMOCD Reference #2RP-3425**

RE: Final Closure Report  
Bopco – PLU CVX JV PC #017  
UL-O, Section 12, Township 24 South, Range 30 East  
Eddy County, New Mexico  
NMOCD Reference # 2RP 3425

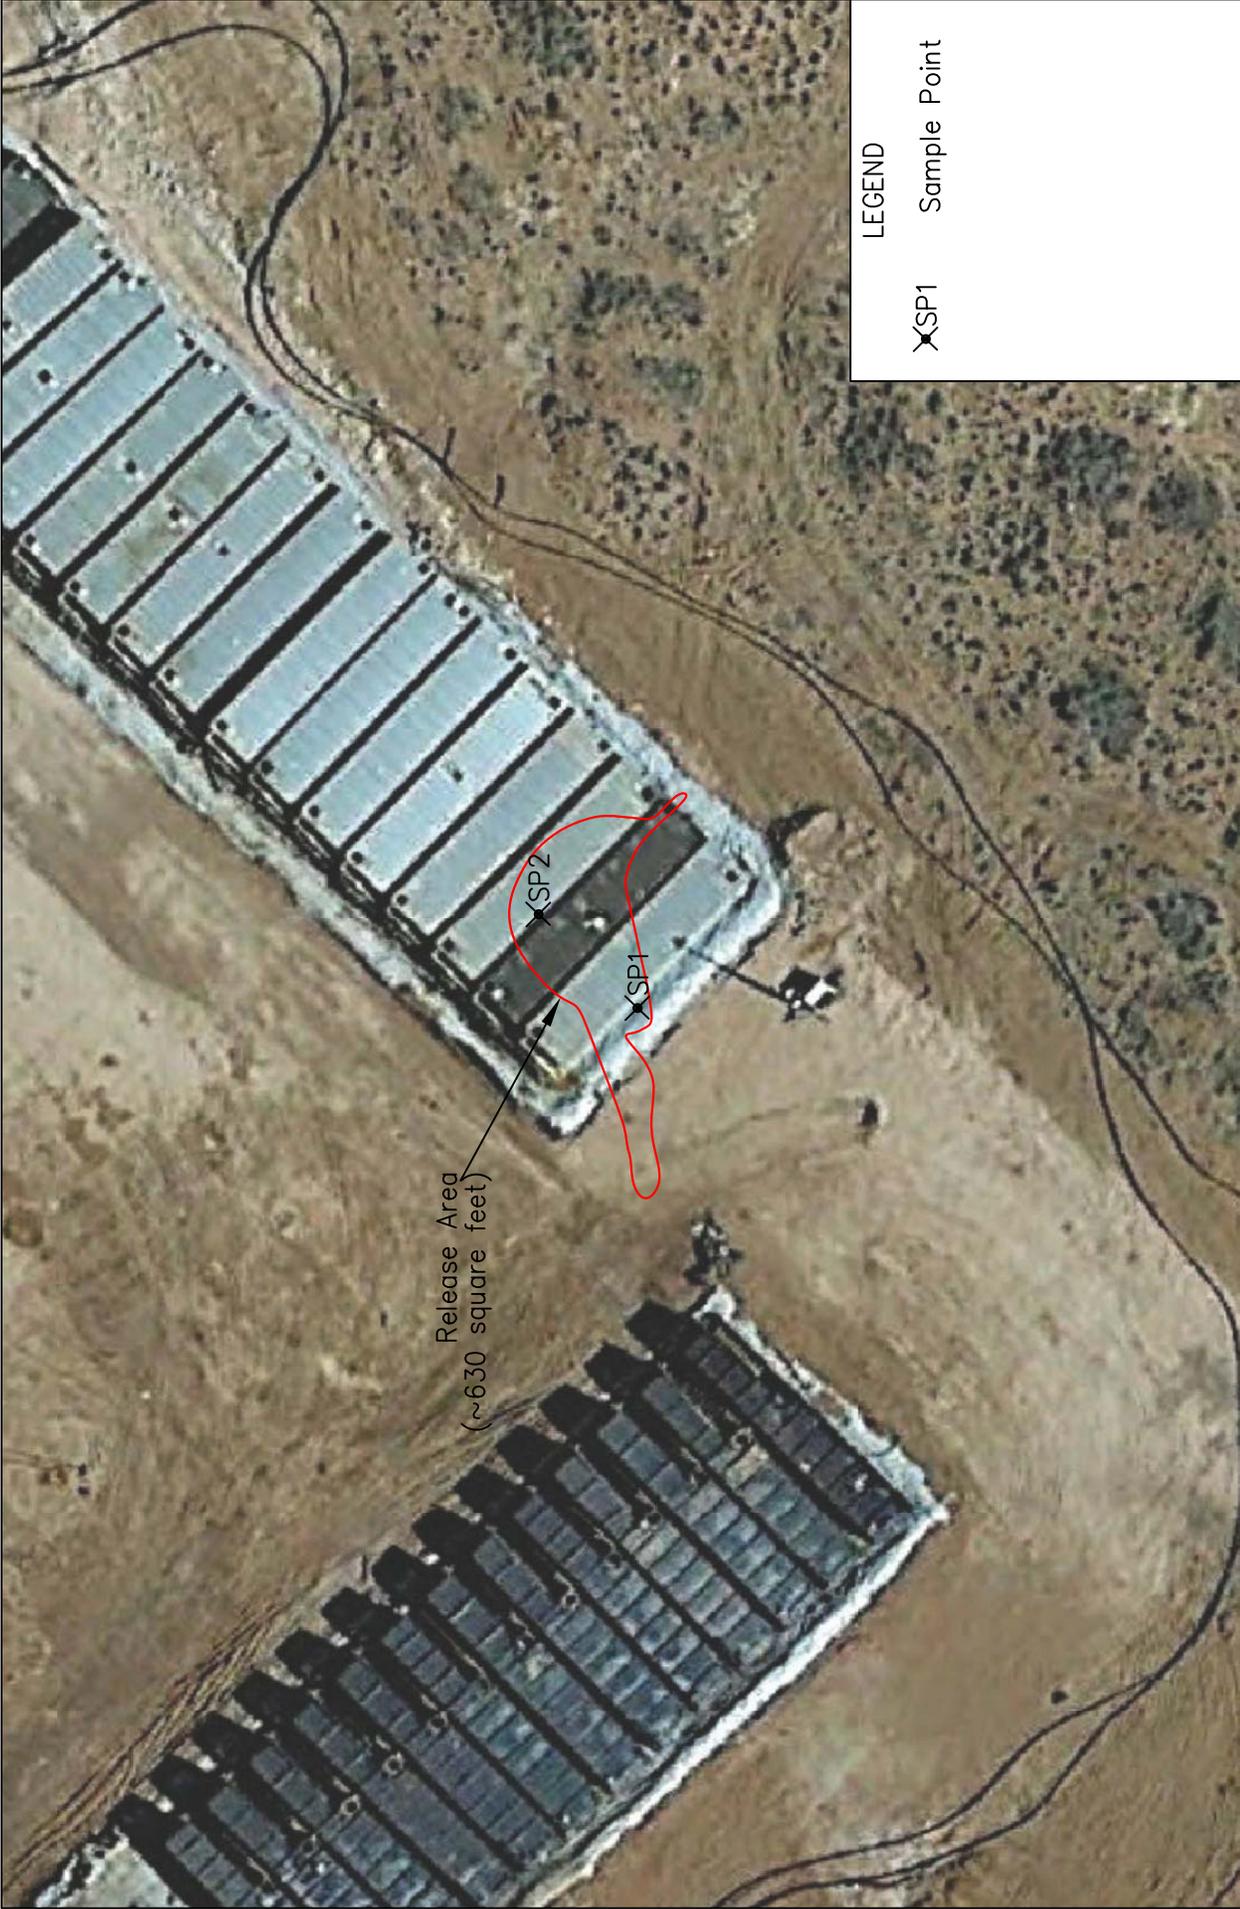
Figure 3  
Site/Sample Map  
Bopco, L.P.  
PLU CVX JV PC #017

Release Area  
(~630 square feet)

XSP2

XSP1

EPI personnel mobilized on the site on December 3, 2015 to collect soil samples to determine the vertical extent of contamination. A total of six (6) soil samples were collected from two (2) sample locations; SP1 and SP2. Four (4) representative samples were sent to Cardinal Labs in Hobbs, New Mexico, for testing. Laboratory analytical results indicate, with the exception of SP1 at surface level, the release area is void of Benzene, BTEX, TPH and Chloride concentrations in excess of NMOCD Recommended Remedial Action Levels (RRALs) of 10 mg/Kg, 50 mg/Kg, 5,000 mg/Kg, and 1,000 mg/Kg, respectively (reference *Figure 3* and *Table 2*).

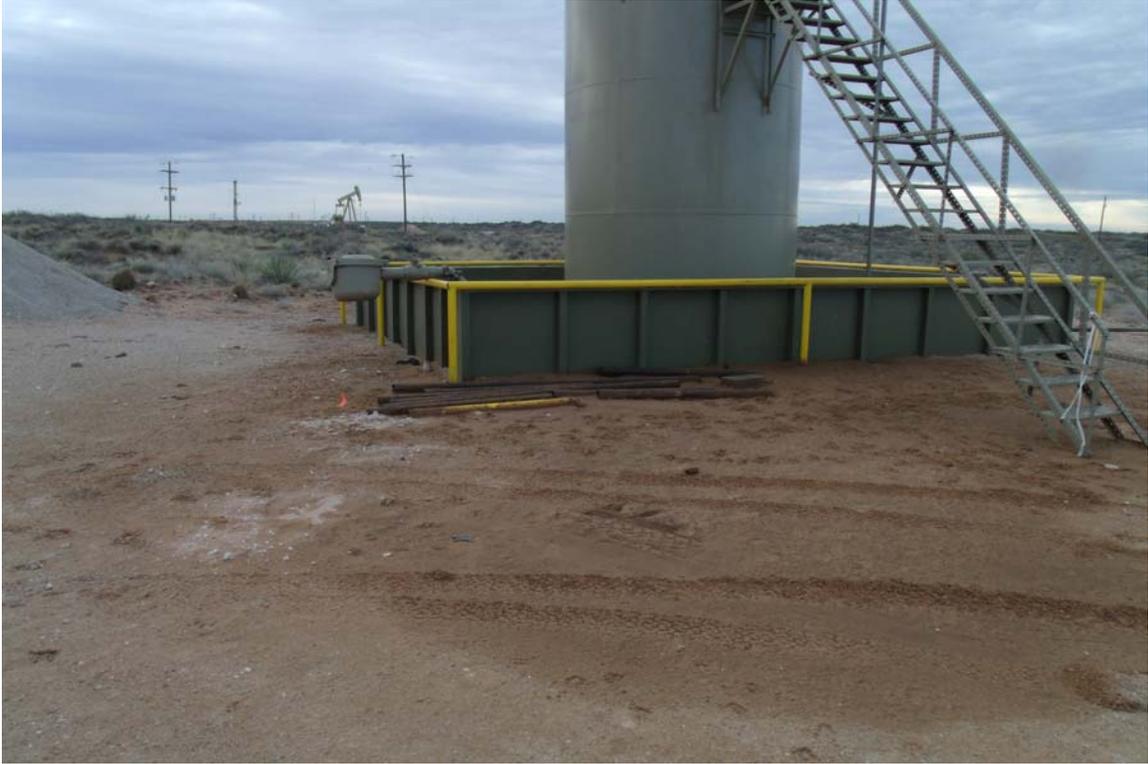
Photograph #1 – Looking across release area

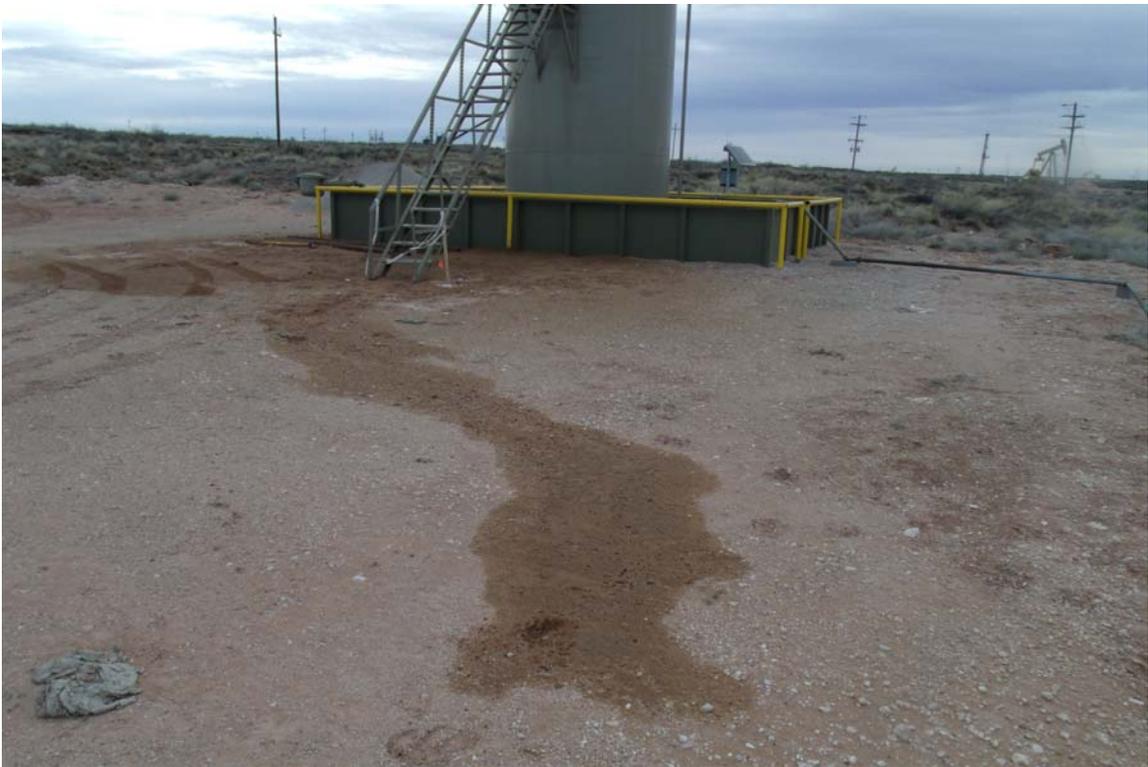
Photograph #2 – Looking across release area

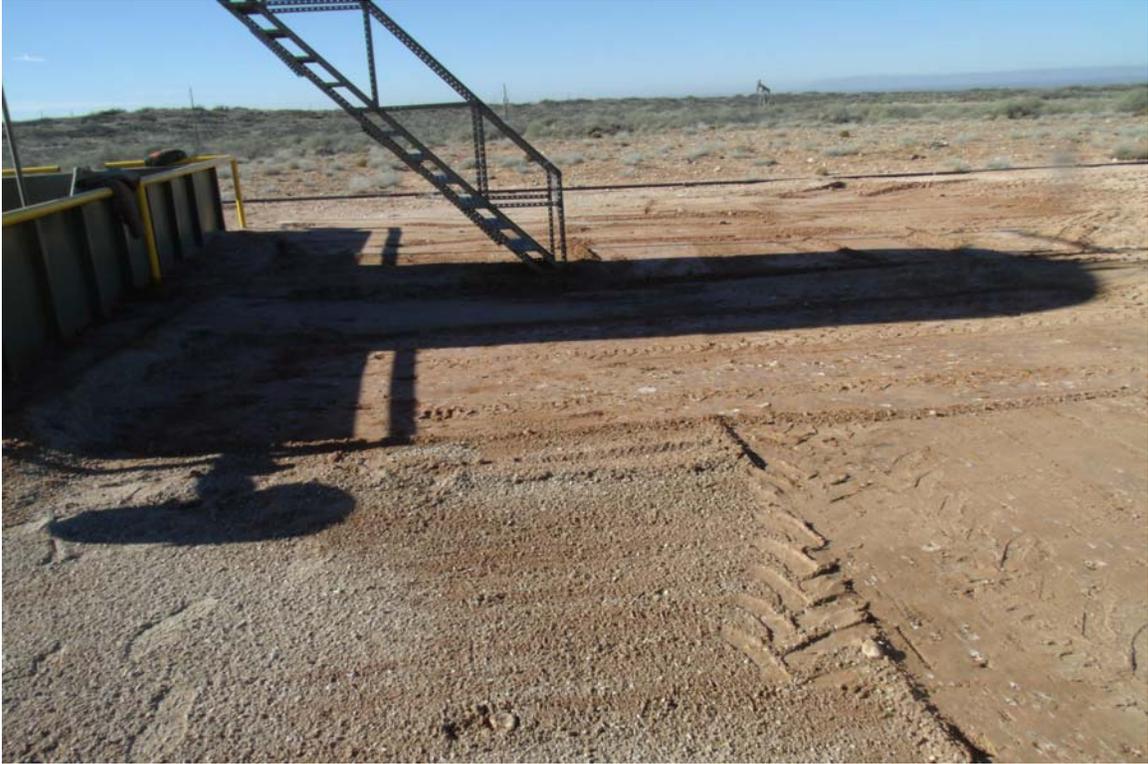
Photograph #3 – Excavated area

The release area was excavated to a depth of approximately six (6) inches bgs. Approximately 12 tons of contaminated soil were excavated and hauled to a state approved facility for disposal.

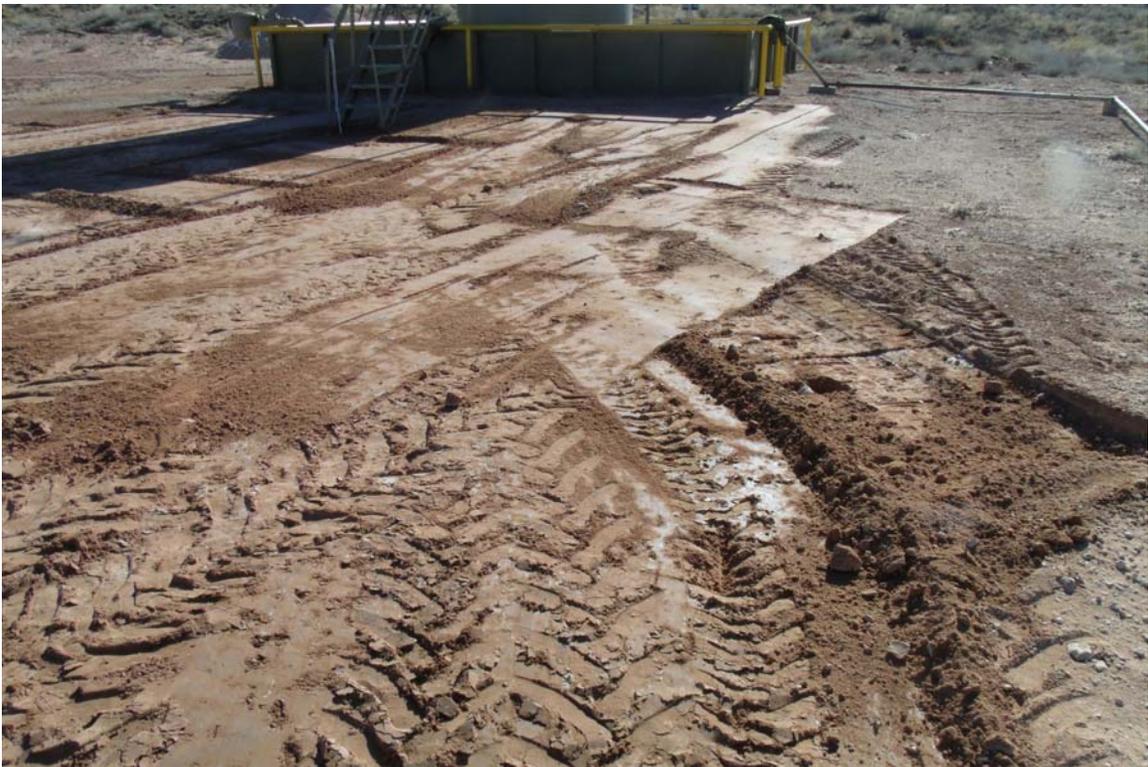
Photograph #4 – Excavated area

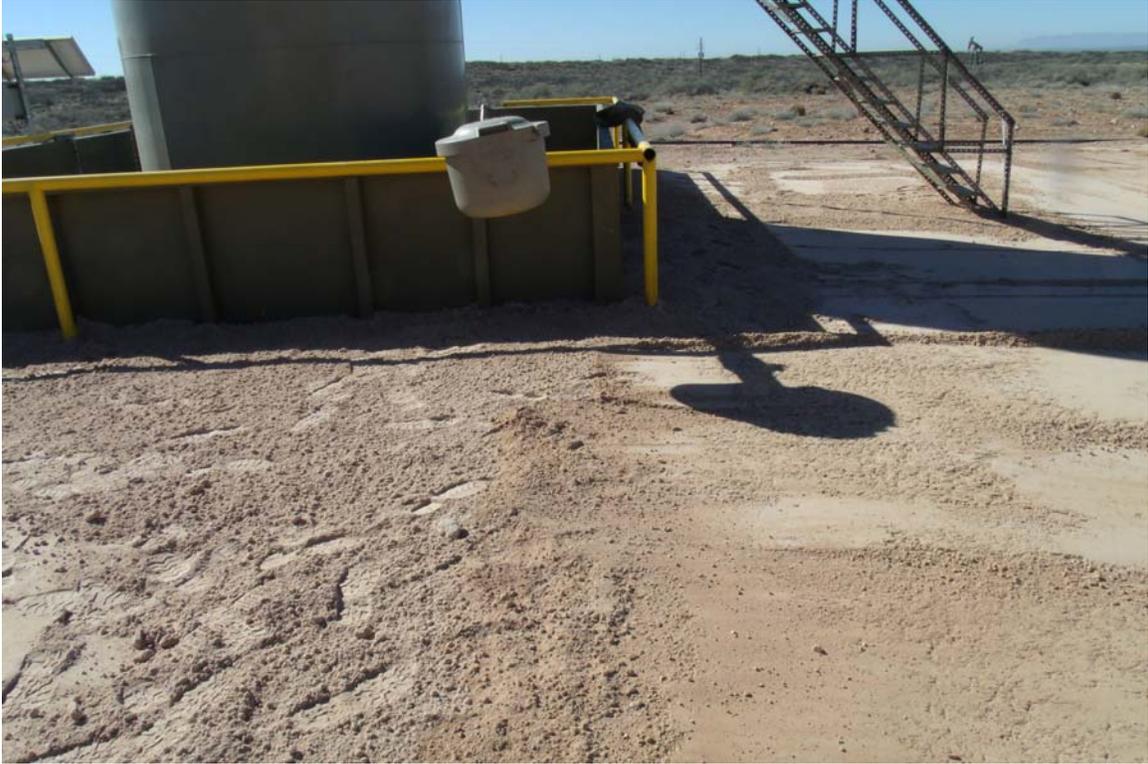
Photograph #5 – Backfilled

Based on laboratory analytical results and with NMOCD approval, the excavation was backfilled with approximately 12 tons of clean soil. All soil was free of rocks, clumps or deleterious material. The entire disturbed area was then contoured to blend with existing well pad area and protected against wind/water erosion.

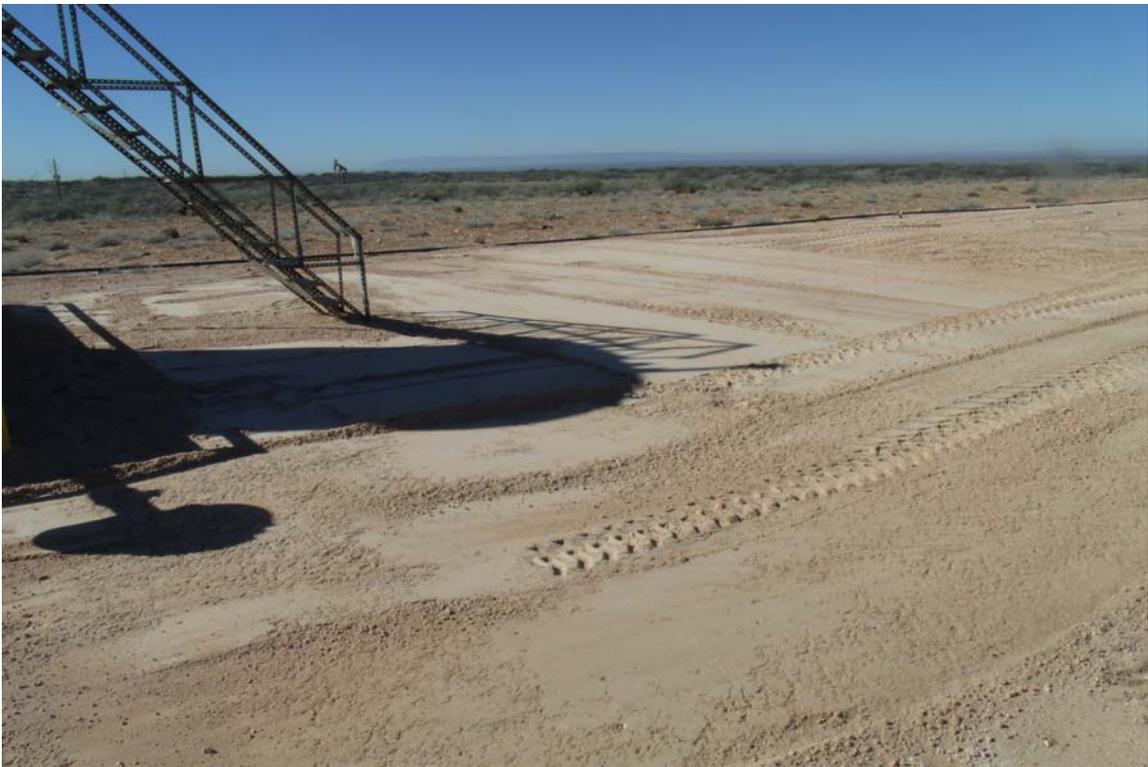
Photograph #6 – Backfilled
