# H E West B #40

## REMEDIATION WORK PLAN

API No. 30-015-26024

**RE: Linn Energy H E West B #40 – Remediation Work Plan**  
UL/D, Section 10, T17S, R31E  
API No. 30-015-26024

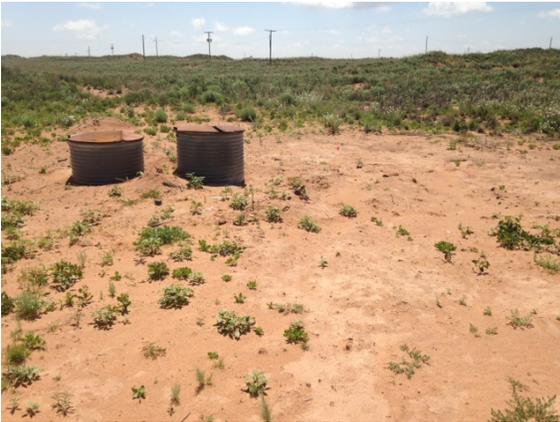
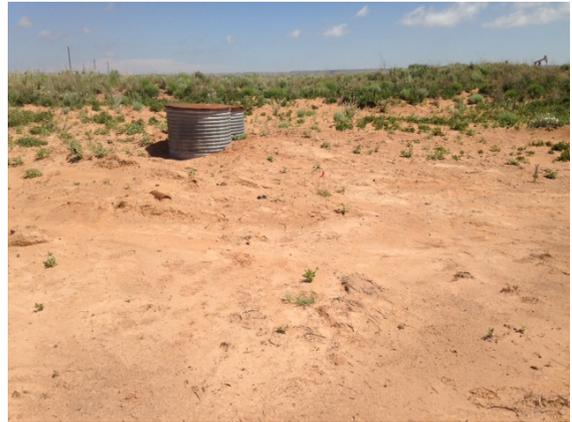
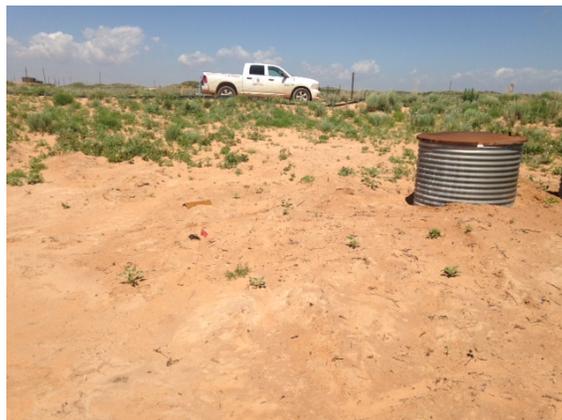
5/18/2015

The site is located northeast of Loco Hills NM, in Eddy County. The leak site resulted from a leak at the tin horn from the truck line. The impacted area is the caliche lease road and north into the pasture. Approximately 22 bbl of produced water was released. Approximately 15 bbls were recovered. On August 18<sup>th</sup>, 2014 another release occurred from the fiberglass under the tin horns. Approximately 9 bbls of produced water was released and 4 bbls recovered. A site map is attached. A C-141 was submitted to the NMOCD on July 21<sup>st</sup>, 2014 for the first release. A C-141 was submitted to the NMOCD on August 19<sup>th</sup>, 2014 for the second release. Both C-141's are attached.

Describe Area Affected and Cleanup Action Taken.\* : Area of water on ground was 22feet long X 21 feet wide by 2in deep. (pictures make the spill looking bigger than area actually was to due rain in area.) At 4:30 P.M. truck on location, went to emptying tinhorn to see if leak was on lateral line or on trunk line. After emptying tinhorn, determined that leak was on lateral line. was able to isolate lateral, to get field back going. Picked up about 7 barrells of water off of ground. Will have to do one call before line can be repaired.  
Directions to site: From Loco Hills N.M. go east on Hwy 82 3.5 miles, turn left on CR221 go 1.4 miles to dirt road on right, turn right go .5 mile, turn right go .6 mile turn left, go .5 mile turn right, go 2.0 miles to West B#40 spill is 25 yds east of location in pasture, at the tinhorns.

Because the surface sample, along with vertical samples down to 2' BGS, came back clean, we propose to re seed the affected area with a BLM, OCD approved seed mix.

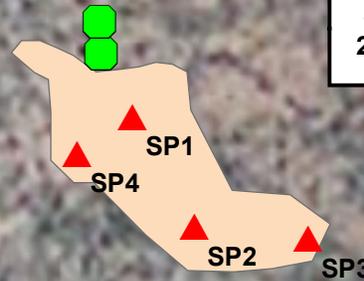
# Site Diagram

**Linn, H.E. West B #40**  
**UL/D, Sec. 10 T17S R31E**  
**Eddy County, NM**  
**Drafted By: Lance Crenshaw, 12-21-15**

**Spill Area:**  
**2,030 sq. ft.**
