**OXY USA, Inc.  
Righthand Canyon 34 Fed Battery  
Closure Report**

**Section 34, T21S, R24E  
Eddy County, New Mexico**

**2RP-2790  
April 1, 2015**

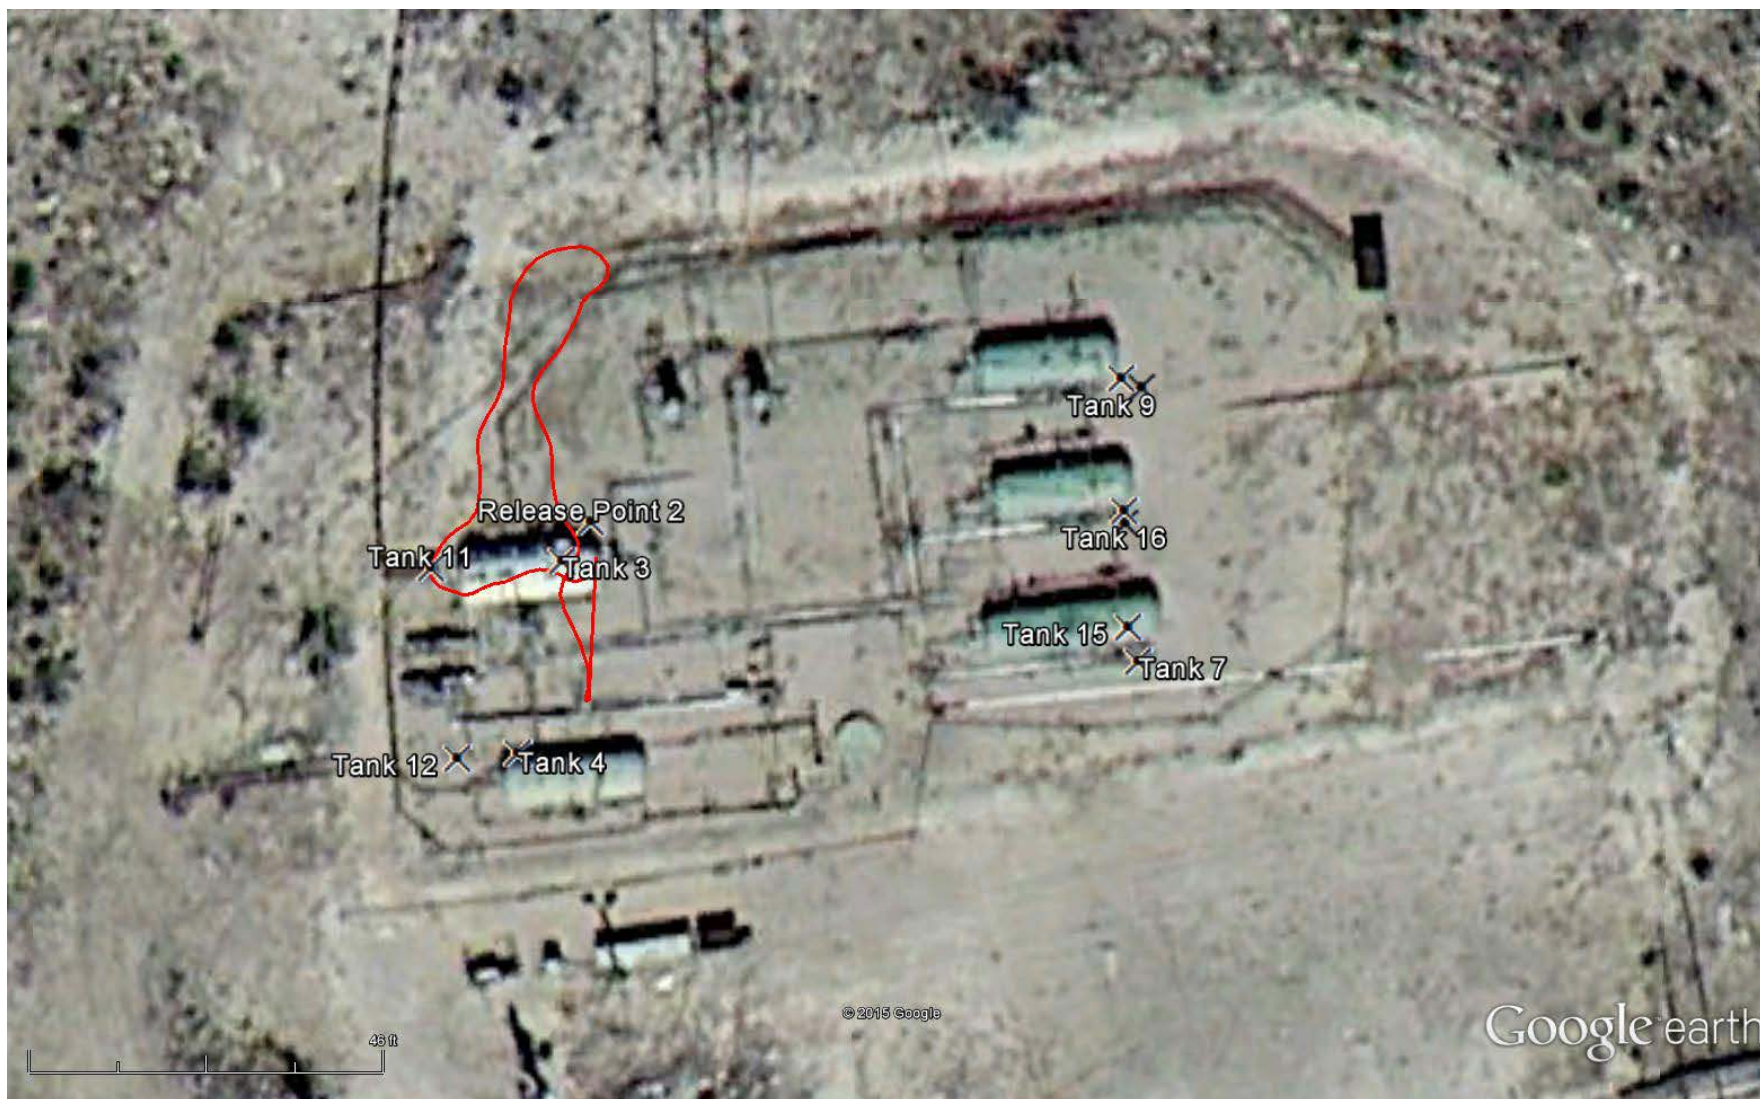
### **Site Plan**

**Righthand Canyon 34 Fed Battery**

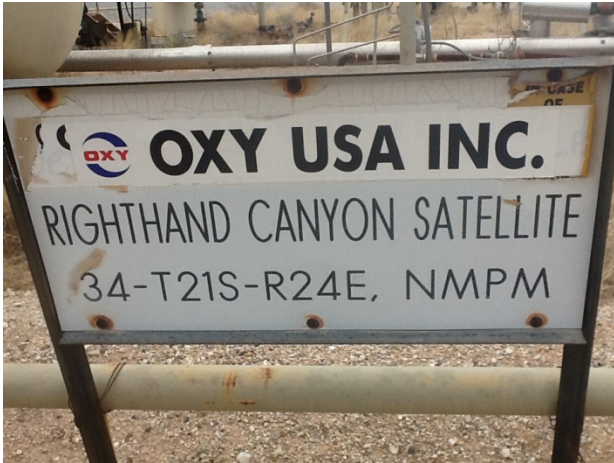
According to the C-141: on January 10, 2015: a 4 inch Victrollic on a water line became detached creating an impacted area of approximately 384 sq. ft. inside battery area.

Location January 2015

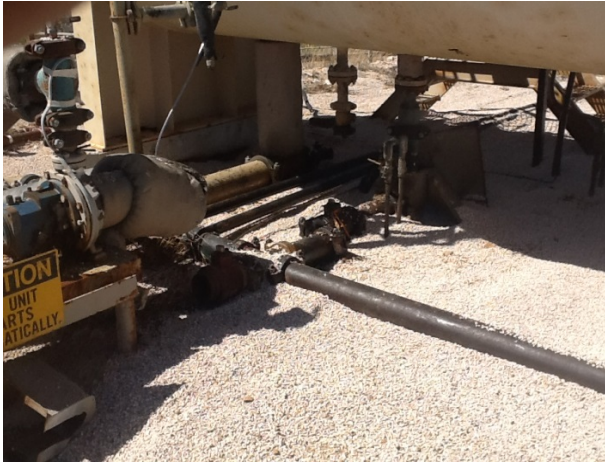
March 2015 Backfill NE

Due to the number of lines in the area, as well as the presence of hard shale the above laboratory analyses sufficed for acceptable levels of BTEX, TPH and Chloride levels. No further action was deemed prudent and the excavation was backfilled with 3/8" pea gravel, esthetically restoring the battery area. Therefore, Safety and Environmental Solutions, Inc. respectfully requests closure of the regulatory file related to this incident on the aforementioned site.

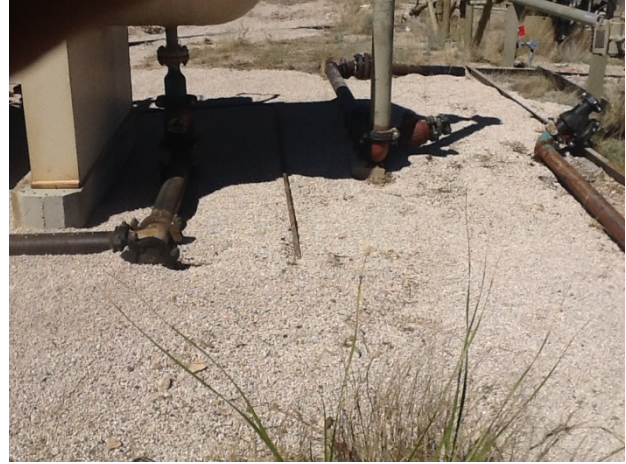
March 2015 Backfill North

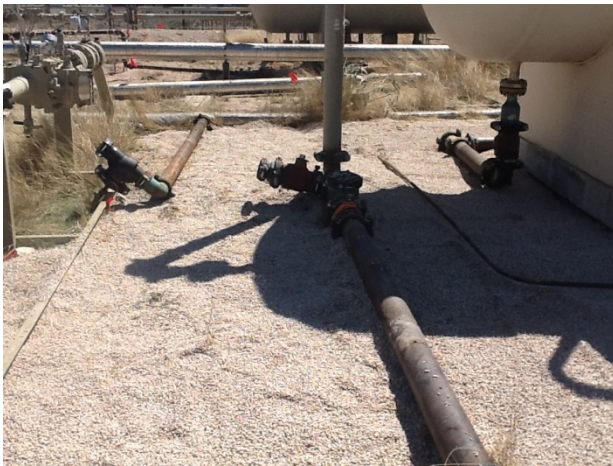
March 2015 Backfill South

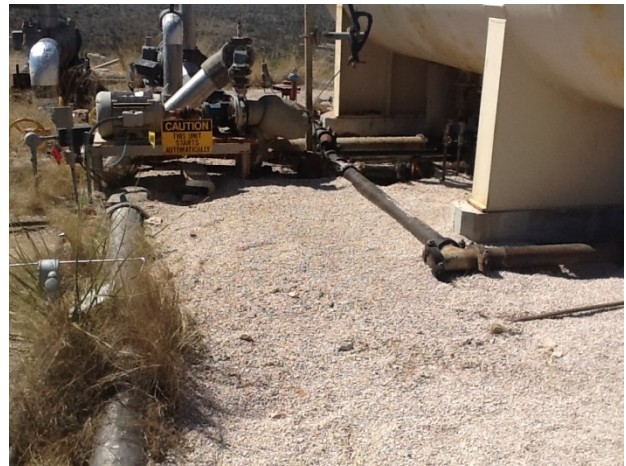
March 2015 Backfill West
