## **CLOSURE REPORT**

**BOPCO, L.P.  
PLU #345H  
Eddy County, New Mexico  
Unit Letter "F", Section 35, Township 24 South, Range 30 East  
Latitude 32.177937 North, Longitude 103.855171 West  
NMOCD Reference #2RP-3508**

RE: Final Closure Report  
Bopco, L.P. – PLU #345H  
UL-F, Section 35, Township 24 South, Range 30 East  
Eddy County, New Mexico  
NMOCD Reference #'s 2RP 3508

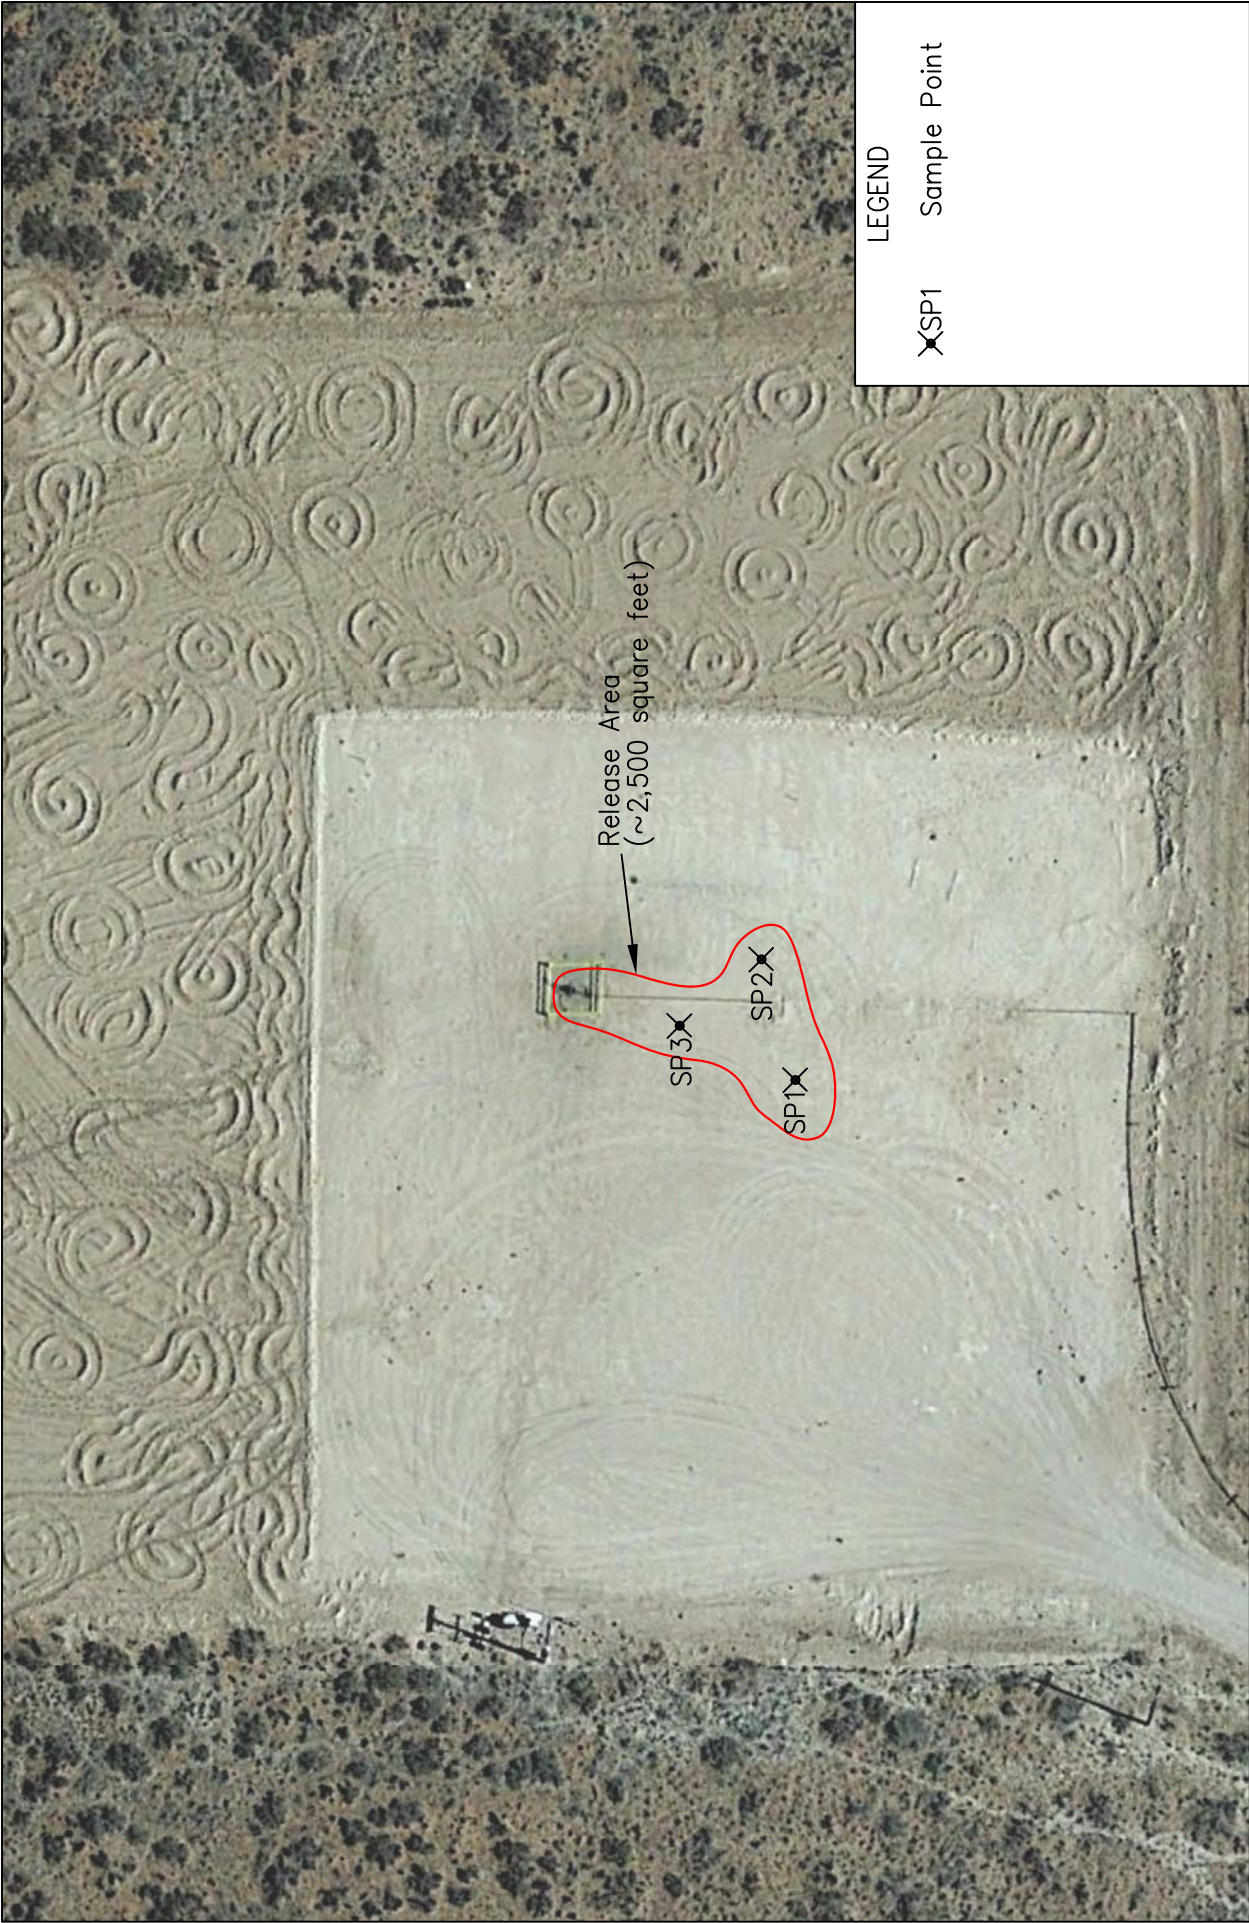
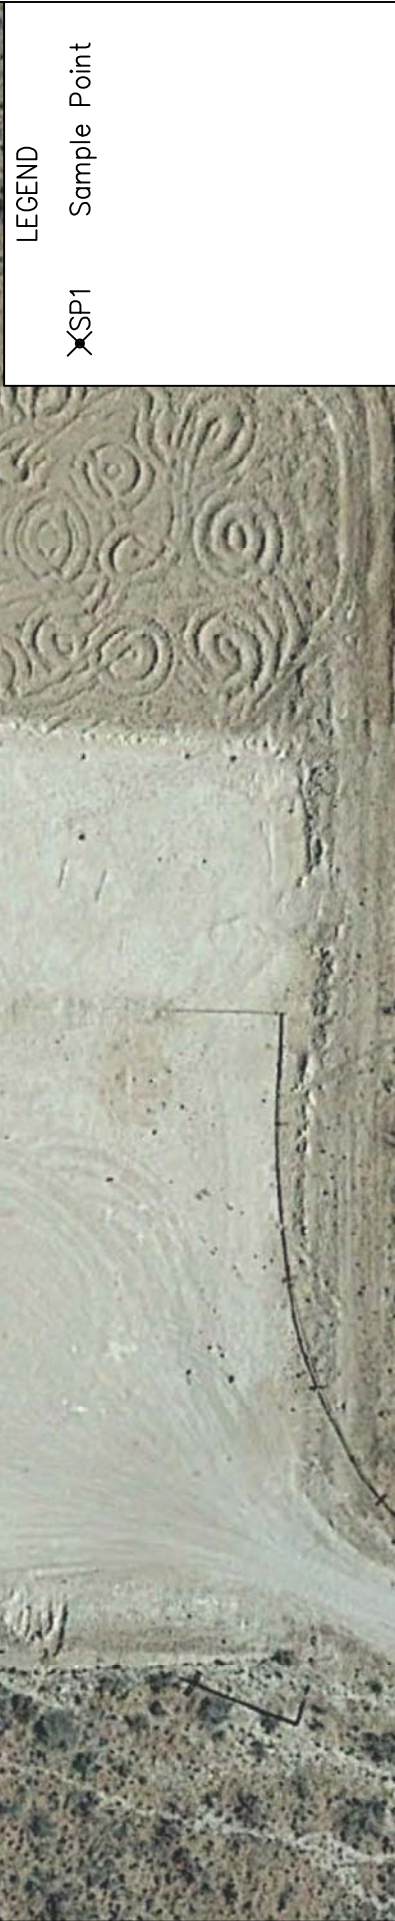
Figure 3 Site/Sample Map Bopco, L.P. PLU #345H		Eddy County, New Mexico SE 1/4 of NW 1/4, Sec. 35, T24S, R30E N 32° 10' 40.52" W 103° 51' 18.88" Elevation: 3,361 feet amsl		DWG By: D Dominguez March 2016	REVISED:

EPI personnel mobilized on the site on January 21, 2016 to collect soil samples to determine the vertical extent of contamination. A total of thirteen (13) soil samples were collected from three (3) sample locations; SP1 – SP3. Three (3) representative samples were sent to Cardinal Labs in Hobbs, New Mexico, for testing. Laboratory analytical results indicate the release area to be void of Benzene, BTEX, TPH, and Chloride concentrations in excess of NMOCD Recommended Remedial Action Levels (RRALs) of 10 mg/Kg, 50 mg/Kg, 5,000 mg/Kg, and 1,000 mg/Kg, respectively (reference *Figure 3* and *Table 2*).

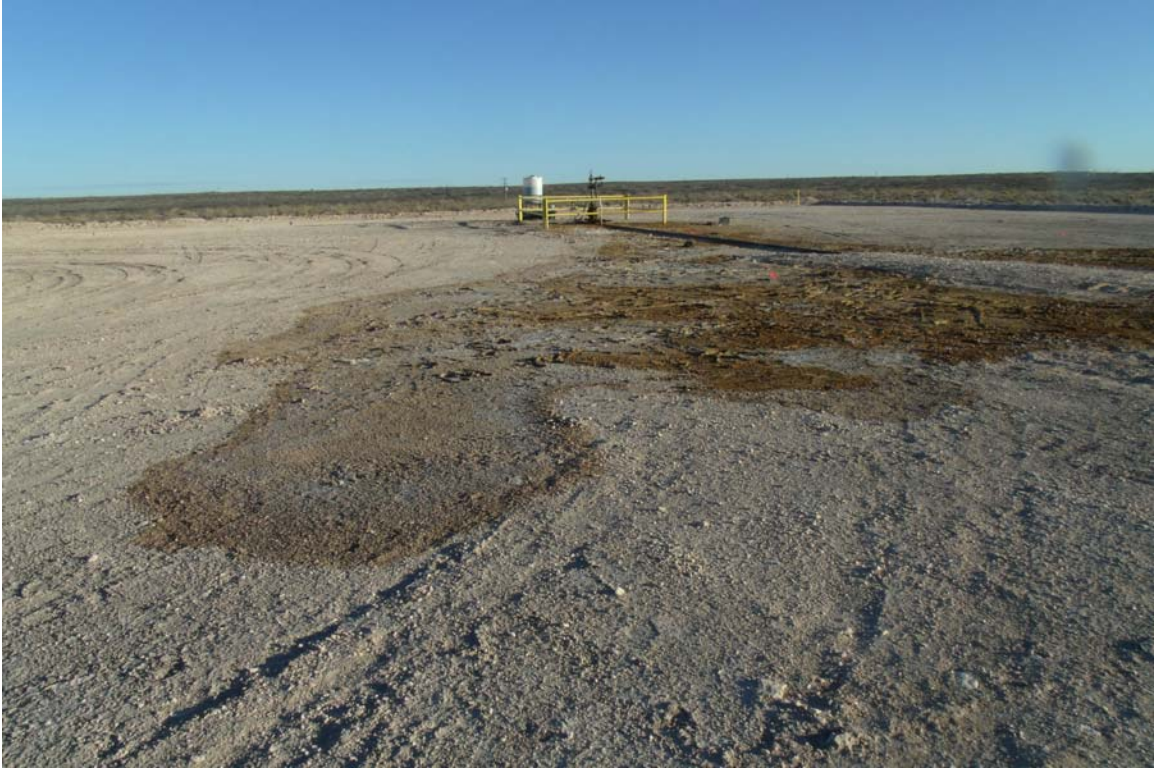
A pressure gauge failed on the wellhead resulting in the release of oil and produced water to the well pad. A vacuum truck was called to the location and was able to recover 10 barrels of fluid. The release of oil and produced water remained on the well pad.

Photograph #1 – Northern view across release area

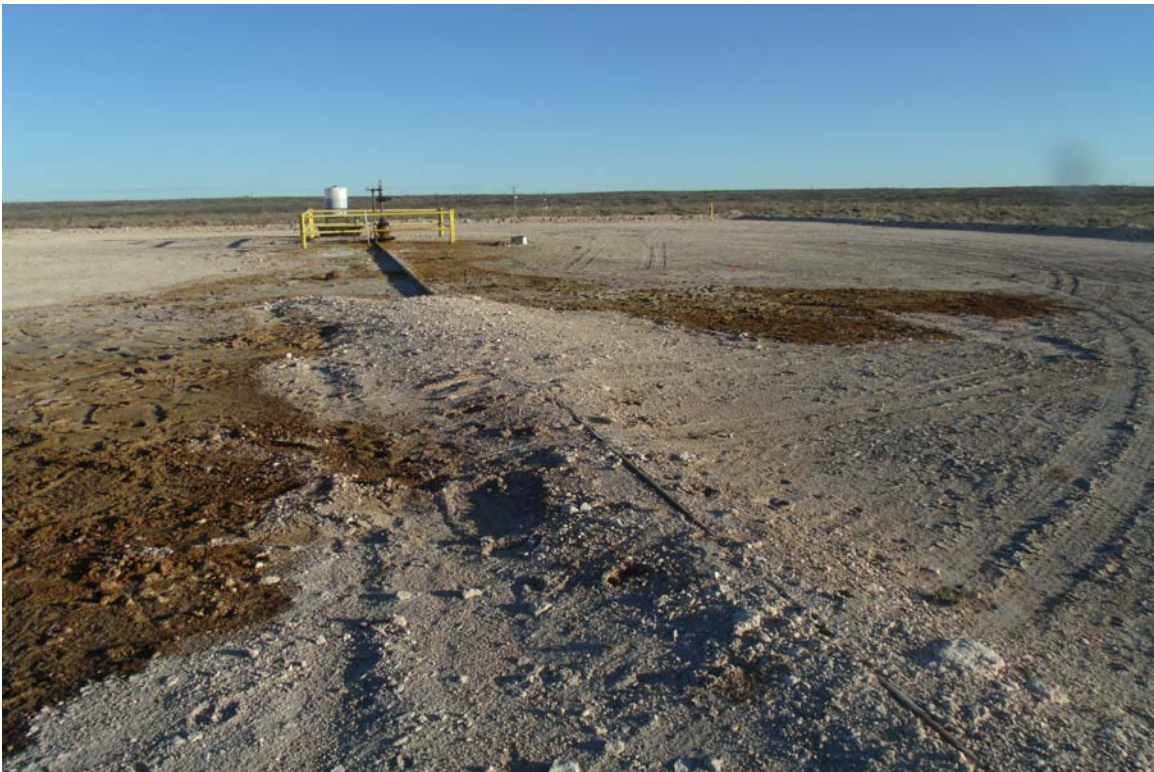
Photograph #2 – Northern view across release area

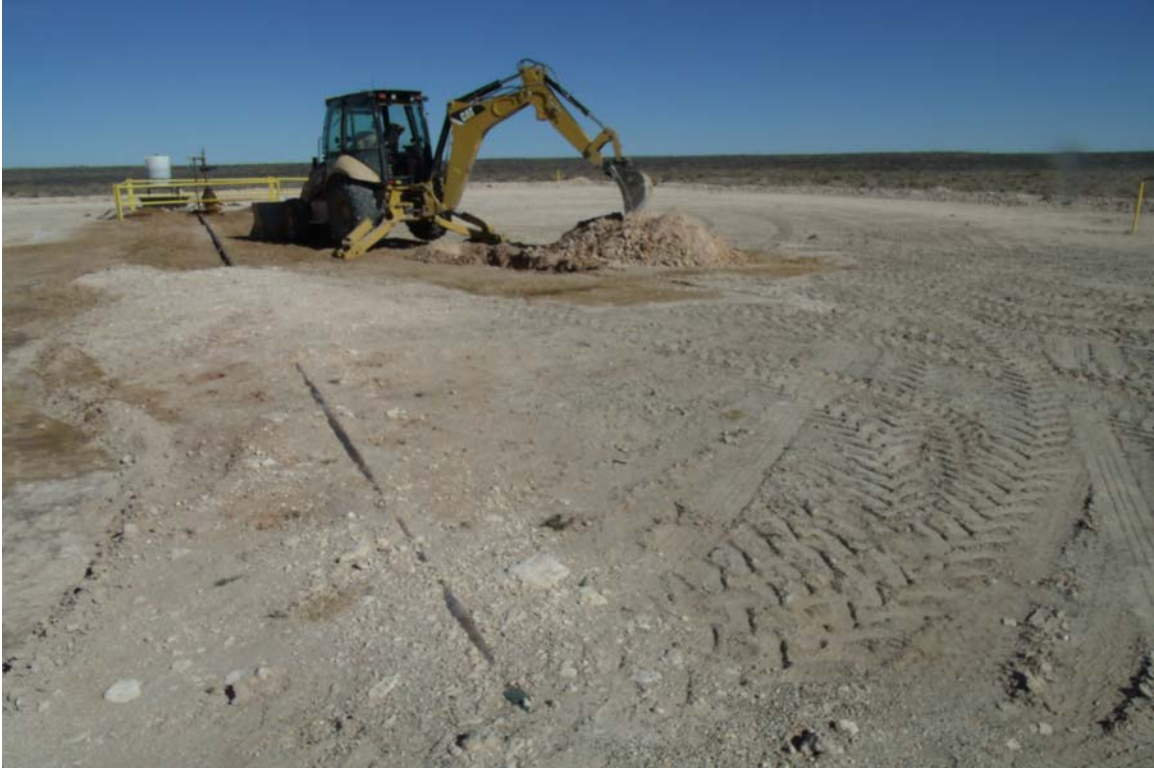
Photograph #3 – Surface scraped and samples collected

The release area was surface scraped approximately three (3) – four (4) inches deep. Approximately 28 yards of contaminated soil was excavated and hauled to a state approved facility for disposal.

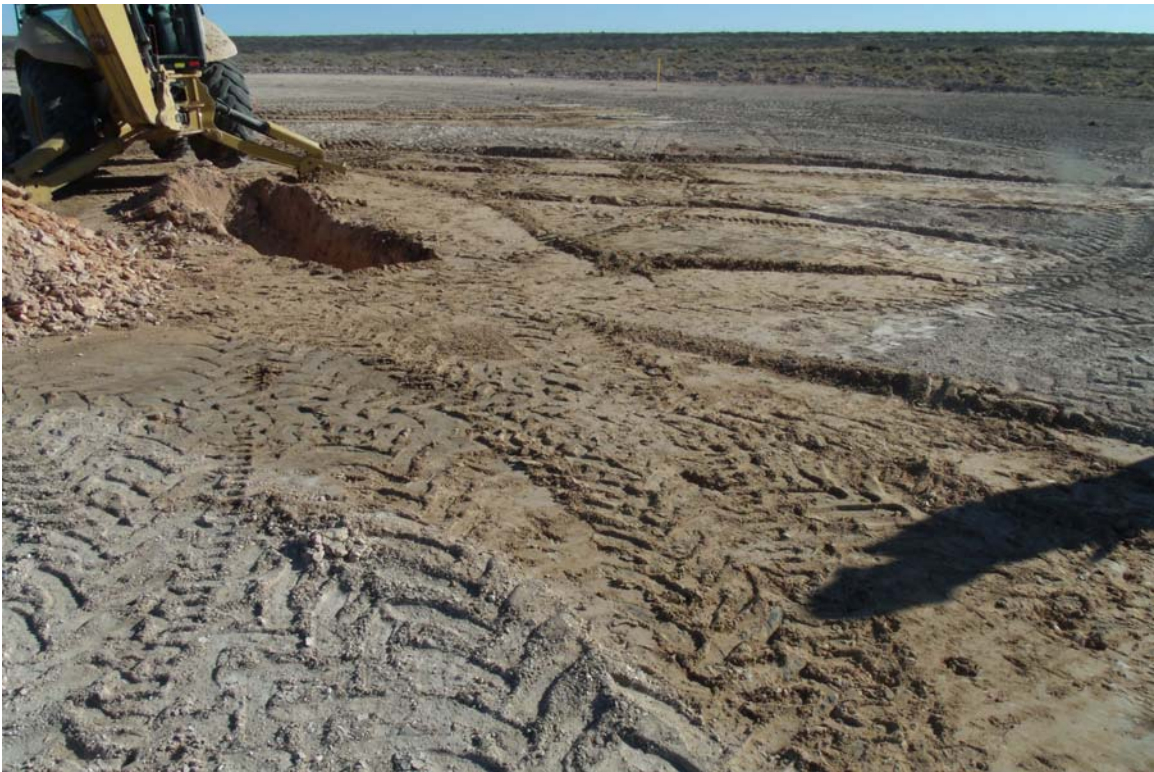
Photograph #4 – Surface scraped and samples collected

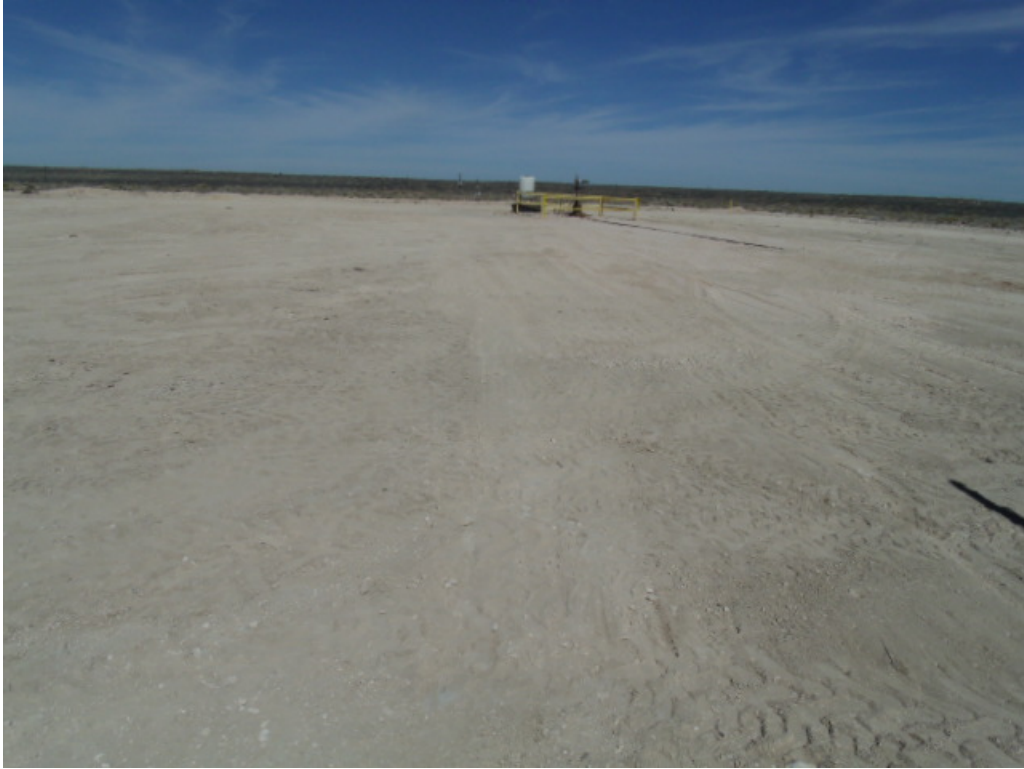
Photograph #5 – Backfilled

Based on laboratory analytical data and NMOCD approval, the excavation was backfilled with approximately 28 yards of clean soil. The entire disturbed area was then contoured to blend with existing pad area and protected against wind/water erosion.

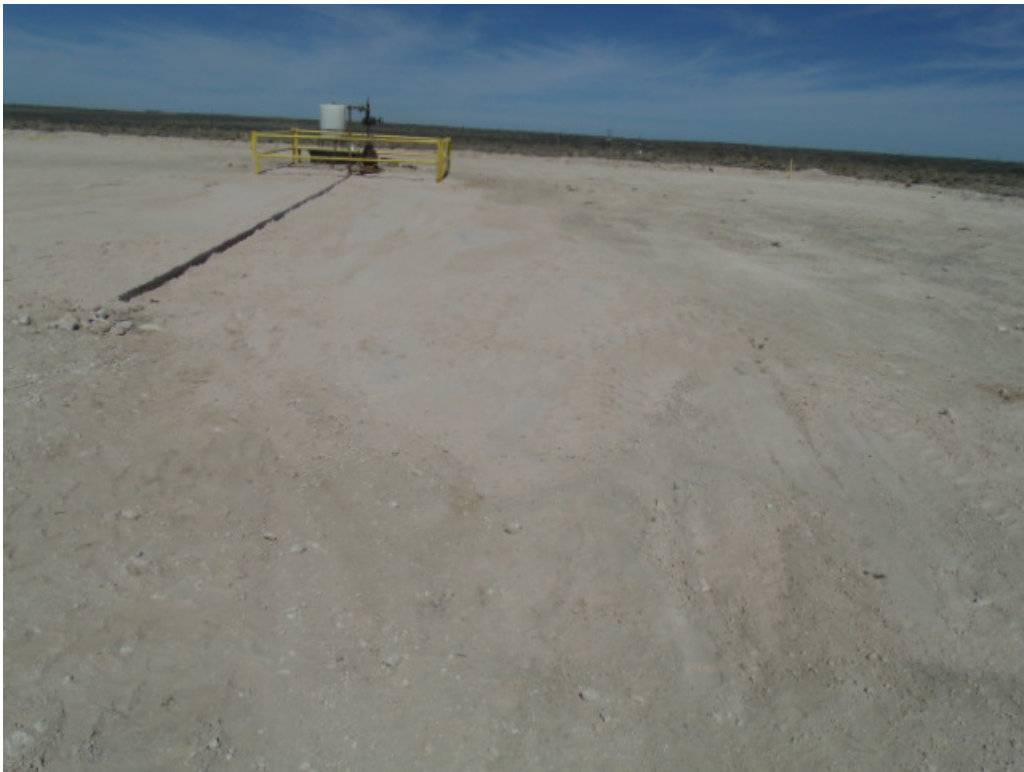
Photograph #6 – Backfilled
