**Tamano 10 Fed Com #7H**

**API: 30-015-39685**

**NMOCD Case #: 2R-3142**

## **Closure Report**

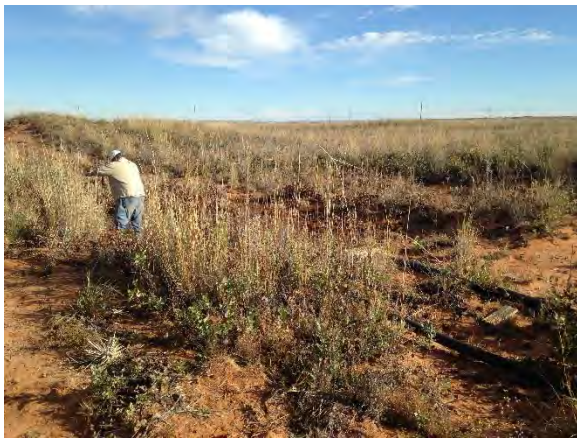
Collecting auger samples, facing northeast  
10/30/2015

On October 30, 2015, DFSI personnel were on site to obtain samples within the leak area (Appendix II). Three samples were obtained and field sampled for chloride levels, as well as BTEX. The BTEX samples were performed using a Mini Rae Photoionization Detector (PID). Auger refusal was encountered at all three sample points at depths of 5', 8' and 12' bgs, respectively. Due to the safety concerns of the presence of two high-pressure lines operating through the middle of the spill area, attaining confirmation clean samples for this spill was not possible. Samples that were attained before auger refusal were submitted for laboratory analysis at Cardinal Laboratories of Hobbs, NM (Appendix III).

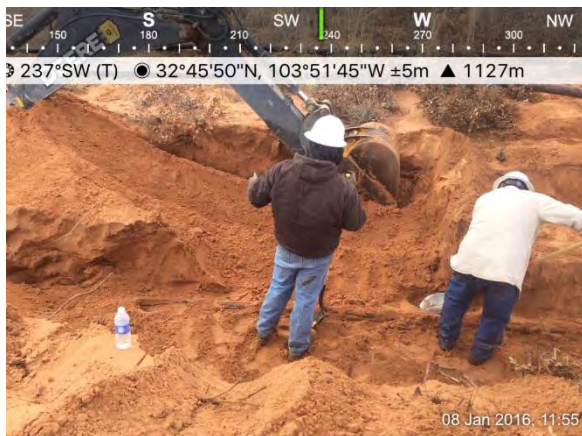
Excavating site  
1/8/2016

A revised work plan was submitted to NMOCD and BLM on December 18, 2015. Beginning January 8, 2016, DFSI personnel were on site to excavate the area to 4' bgs (Appendix V). The excavation was backfilled with clean, imported topsoil to ground surface and contoured to the surrounding area. Contaminated soil was properly disposed of at an NMOCD approved facility. An approximate area of 1 acre was seeded with LPC mix (Appendix VI).

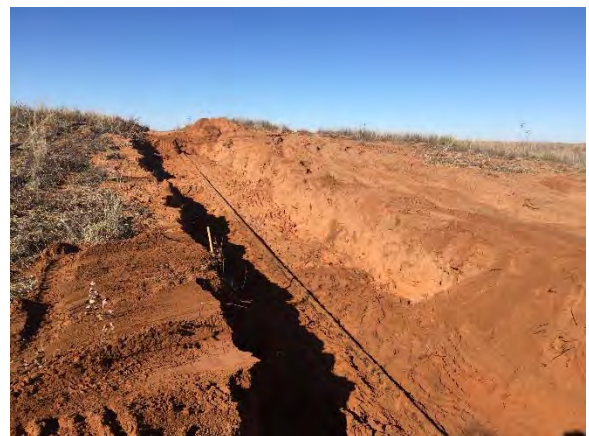
Completed excavating  
1/12/2016

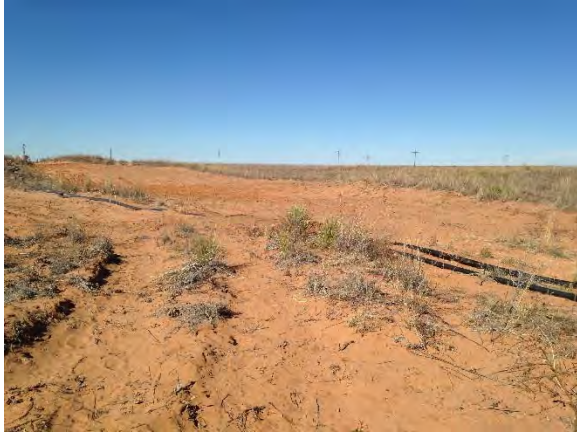
Site completed, facing northeast 3/11/2016

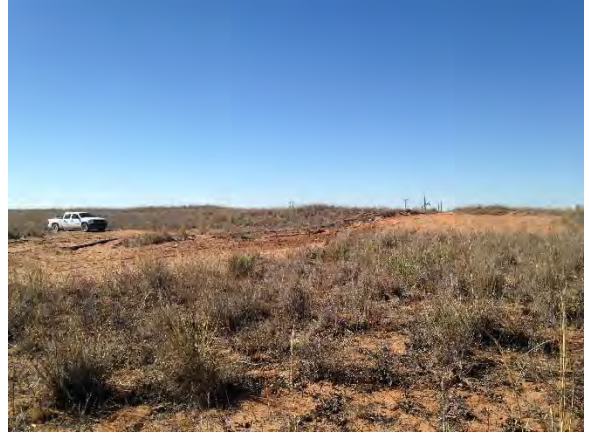
Site completed, facing northwest 3/11/2016

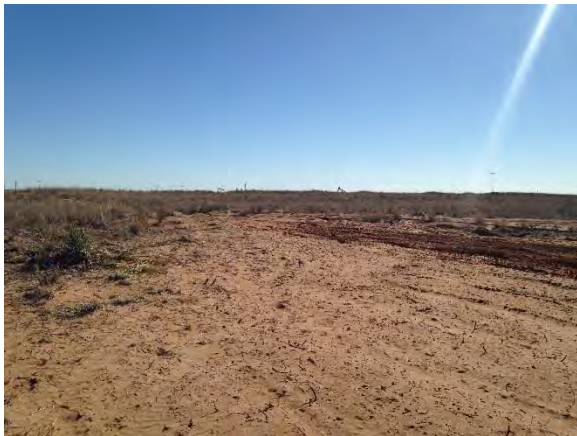
Site completed, facing southwest 3/11/2016

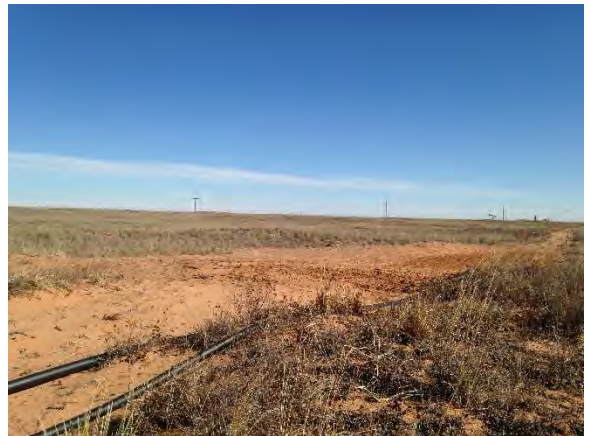
Site completed, facing southeast 3/11/2016
