Hornsby 35 Fed 2-3 Battery

CLOSURE REPORT

UL/E Sec 35, T26 south, R27 east, Eddy county NM

API # 30-015-42208

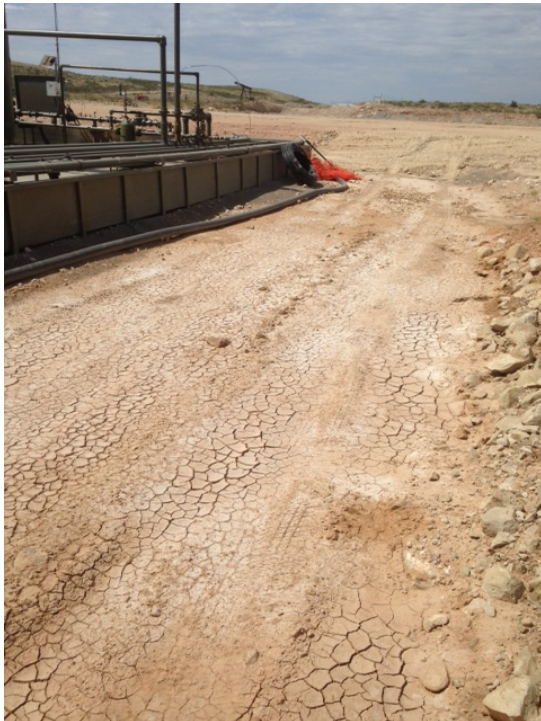
Spill area behind tank battery

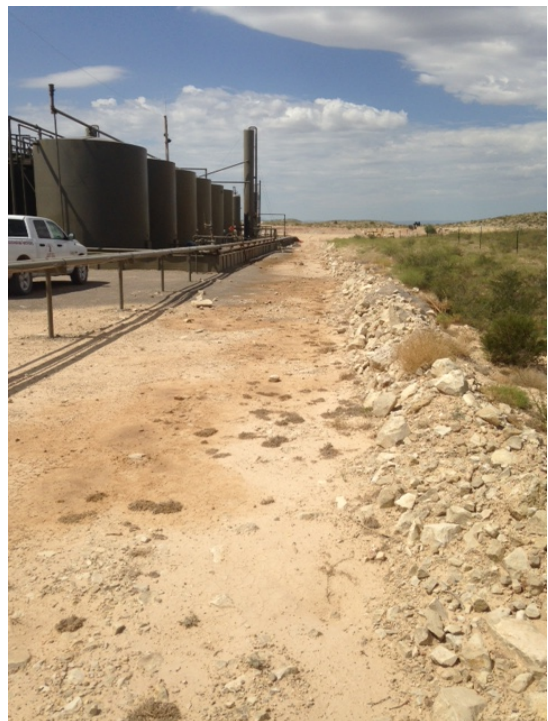
Spill area behind tank battery

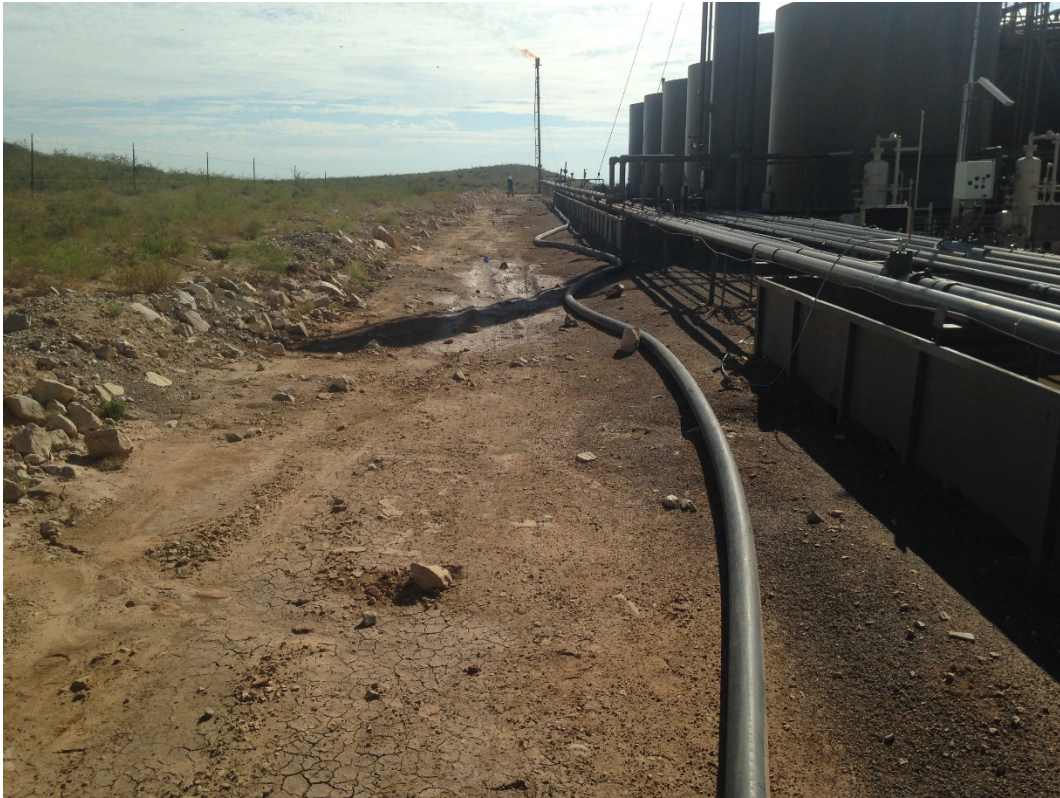
Spill area with sample point

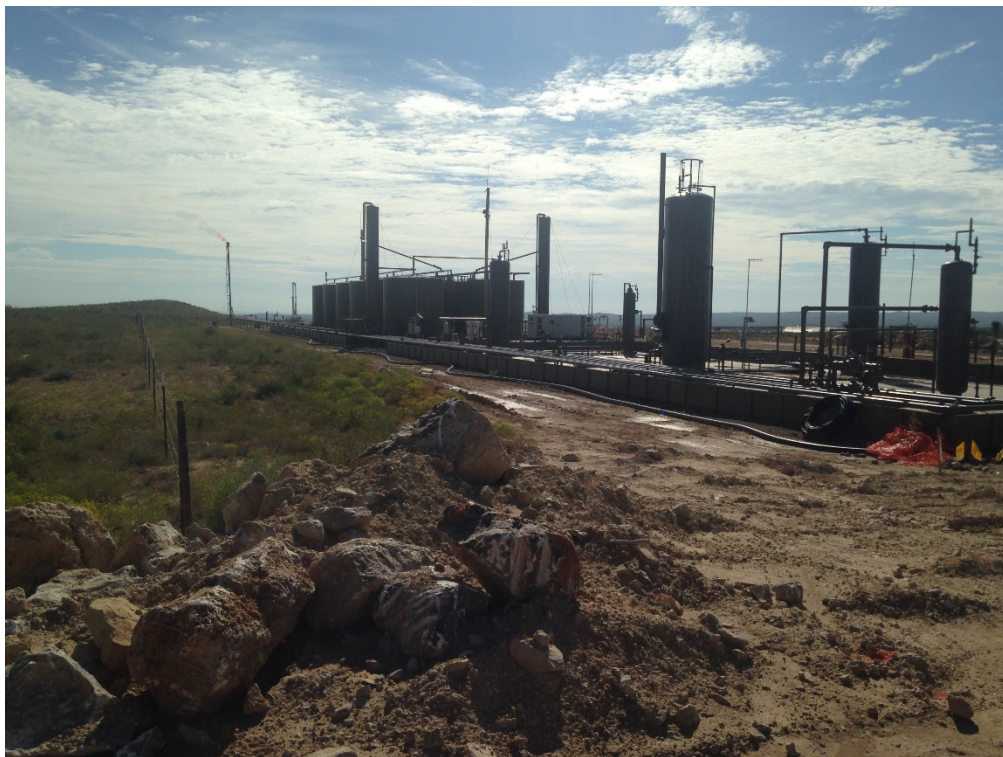
Spill area behind battery

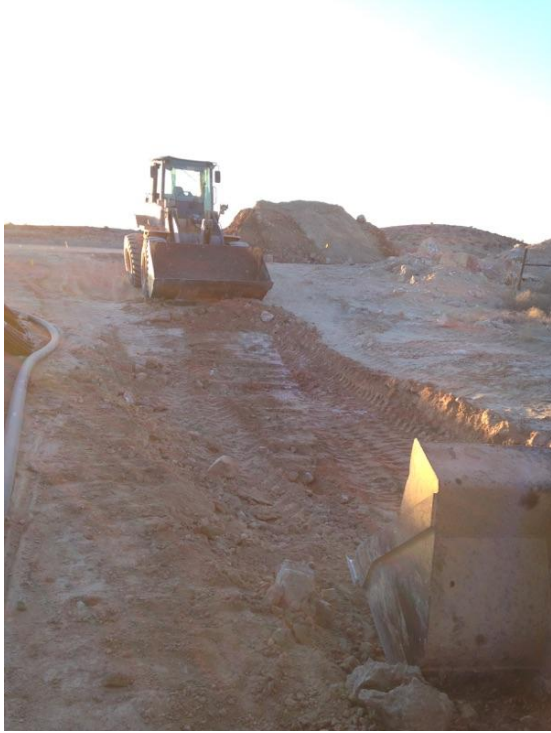
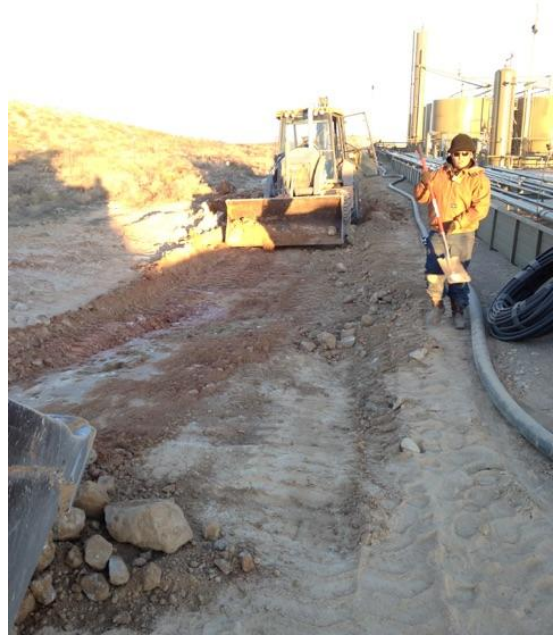
Excavating spill area behind battery

DFSI personnel returned to the location on February 2, 2016, to begin excavation. In the areas of SP1-SP3, 2' of contaminated soil was removed. In the areas of SP4-SP6, 1' of contaminated soil was removed. All contaminated material was hauled to an approved NM state disposal. Fresh caliche was then brought in for backfill, and the location was returned to its previous state. Photos of the work being done can be viewed in Appendix II.

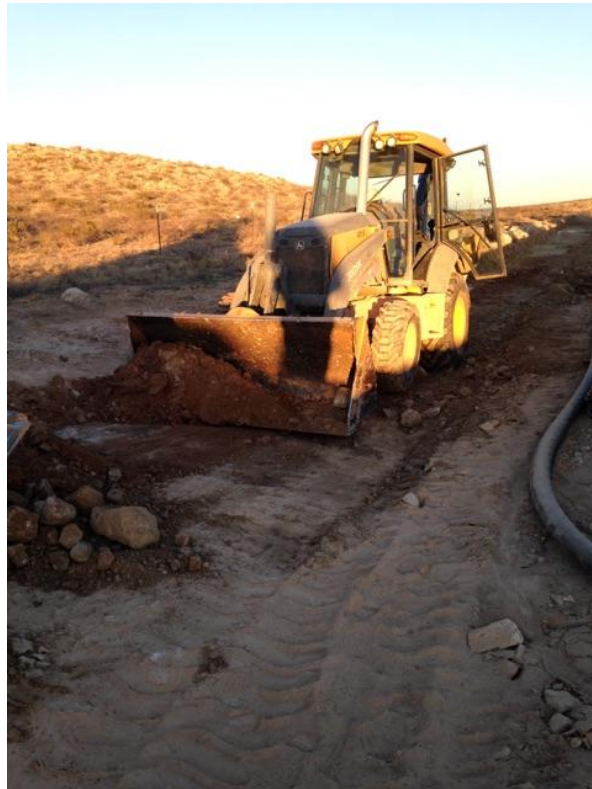
Excavating spill area behind battery

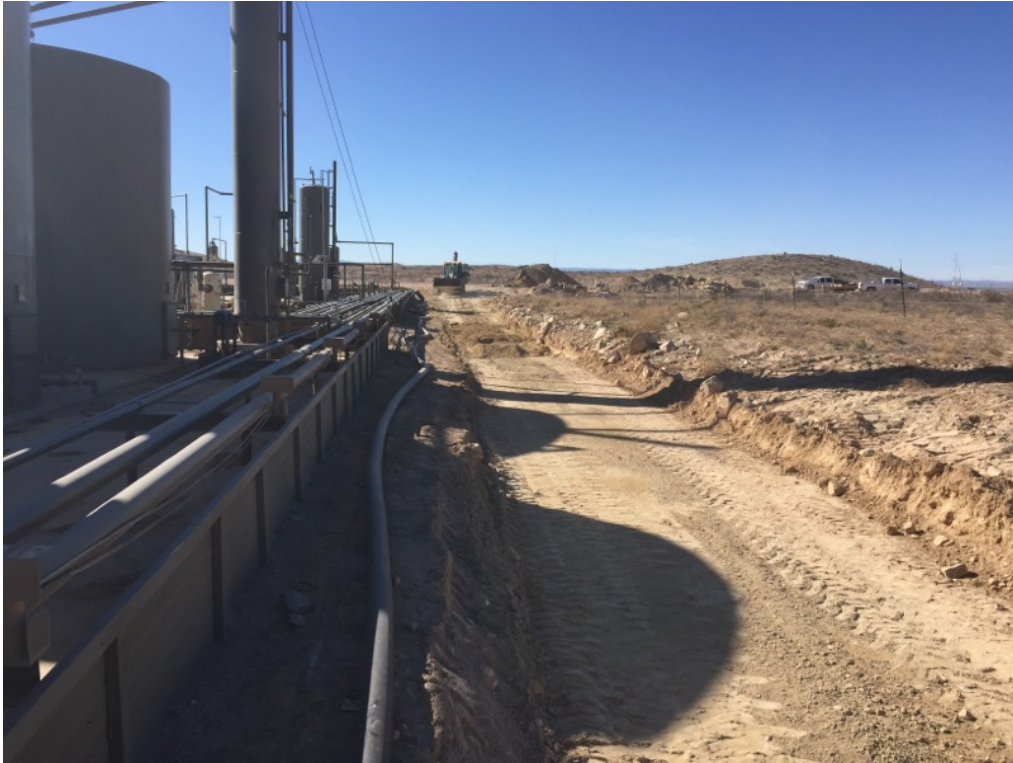
Spill area fully excavated

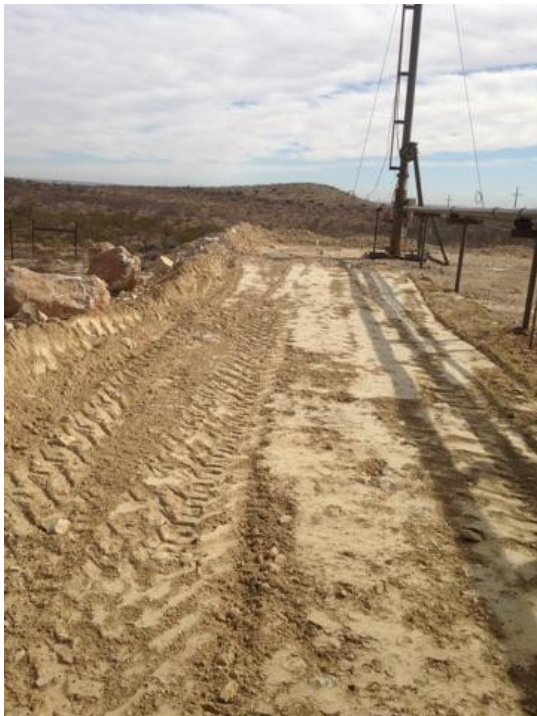
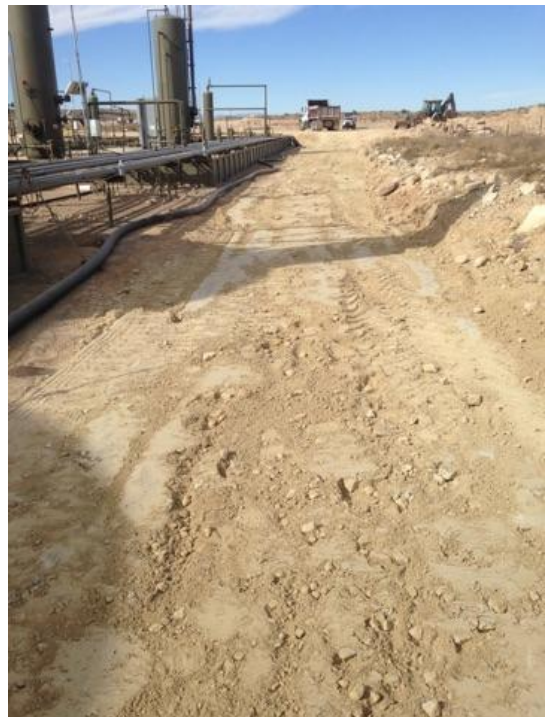
Spill area fully excavated and backfilled with fresh caliche, site completed
