## **CLOSURE REPORT**

**BOPCO, L.P.  
PLU #332H  
Eddy County, New Mexico  
Unit Letter "D", Section 3, Township 24 South, Range 30 East  
Latitude 32.250927 North, Longitude 103.876671 West  
NMOCD Reference #2RP-3686**

RE: Final Closure Report  
Bopco – PLU #332H  
UL-D, Section 3, Township 24 South, Range 30 East  
Eddy County, New Mexico  
NMOCD Reference # 2RP 3686

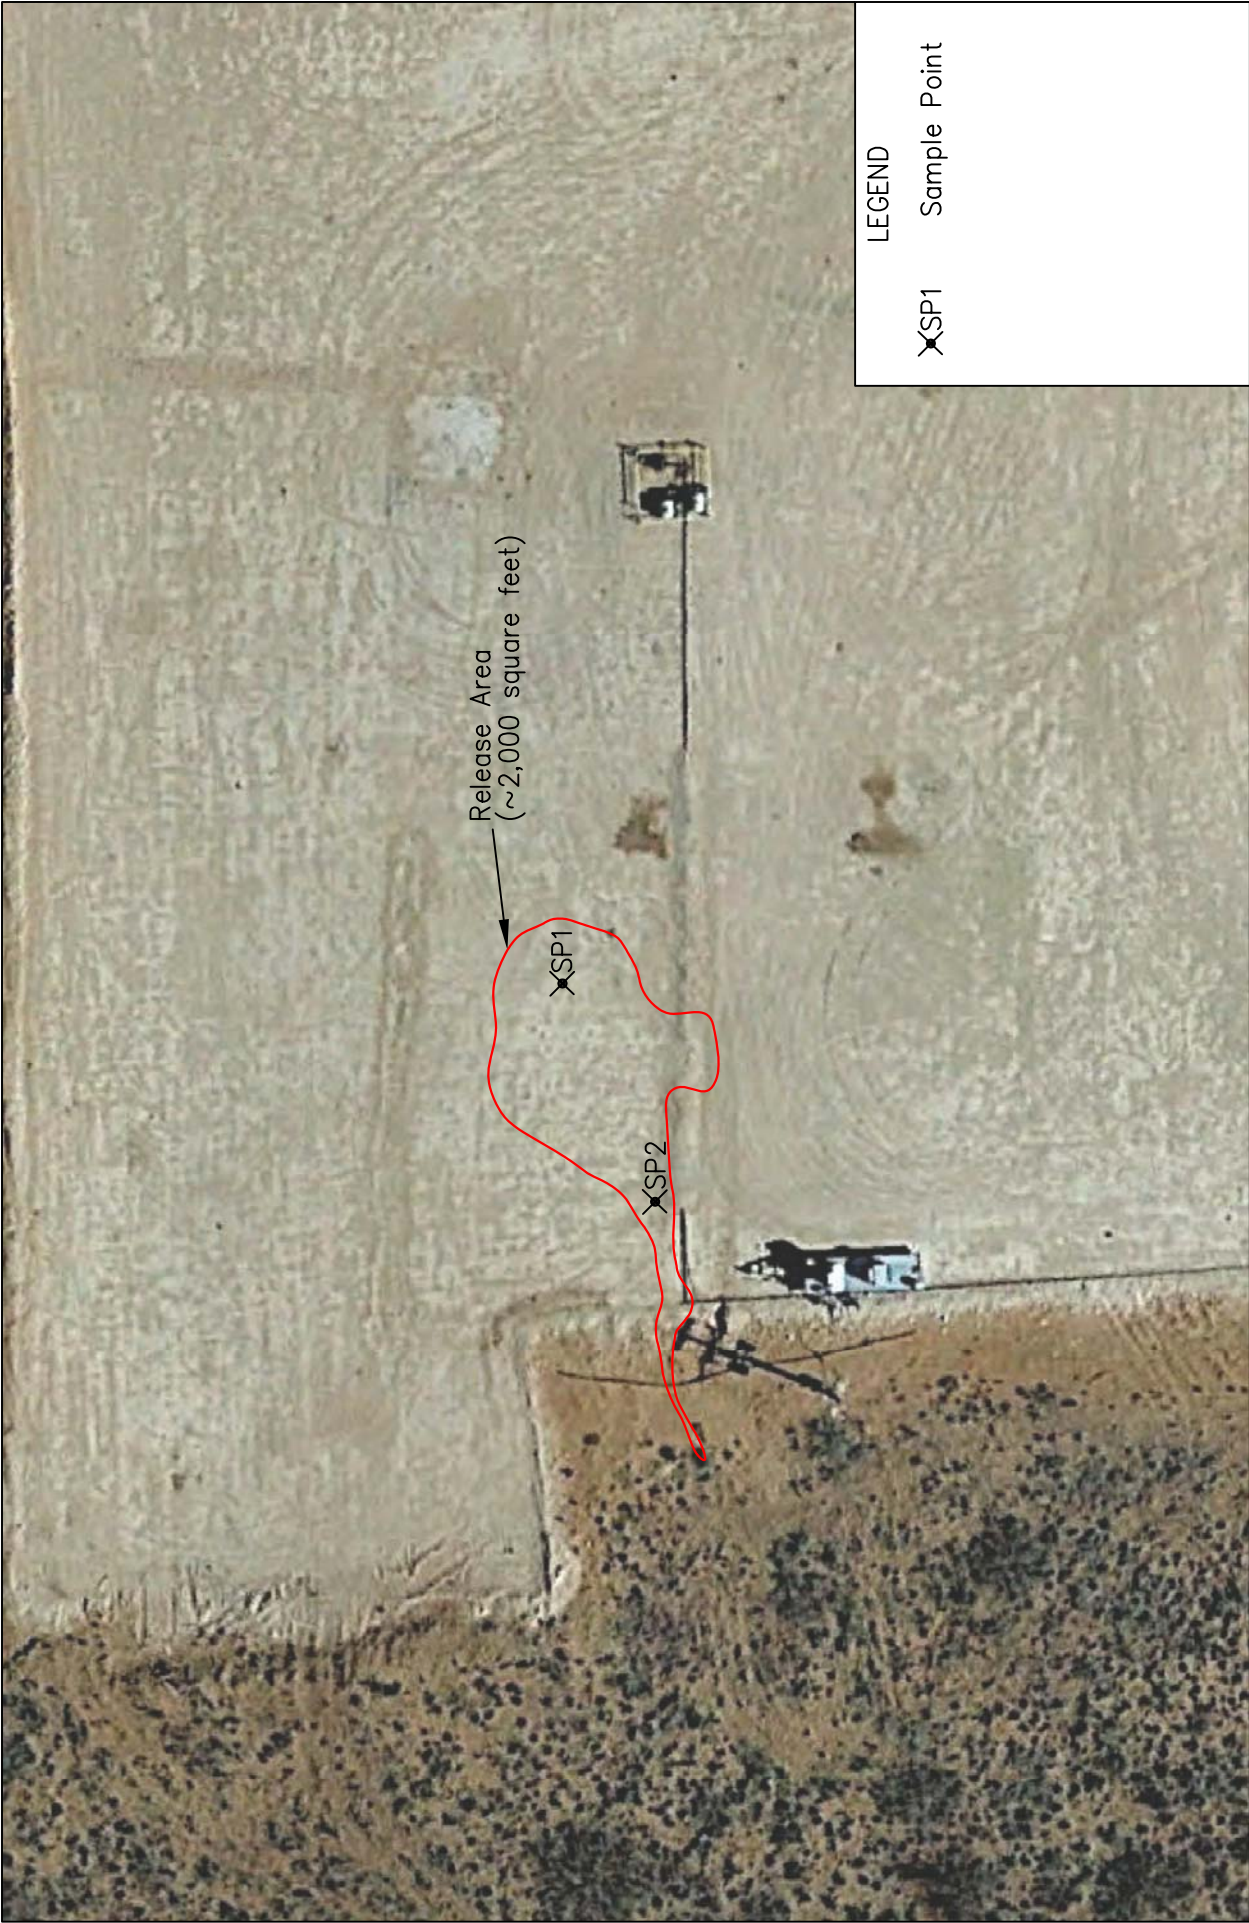
Figure 3 Site/Sample Map Bopco, L.P. PLU #332H	Eddy County, New Mexico NW 1/4 of NW 1/4, Sec. 3, T24S, R30E N 32° 15' 3.25" W 103° 52' 35.90" Elevation: 3,439 feet amsl	DWG By: D Dominguez July 2016	REVISED:	 
		  Feet	SHEET 1 of 1

EPI personnel mobilized on the site on May 5, 2016 to collect soil samples to determine the vertical extent of contamination. A total of eight (8) soil samples were collected from two (2) sample locations; SP1 and SP2. Five (5) representative samples were sent to Cardinal Labs in Hobbs, New Mexico, for testing. Laboratory analytical results indicate, with exception of the surface area, the release area is void of Benzene, BTEX, TPH and Chloride concentrations in excess of NMOCD Recommended Remedial Action Levels (RRALs) of 10 mg/Kg, 50 mg/Kg, 5,000 mg/Kg, and 1,000 mg/Kg, respectively (reference *Figure 3* and *Table 2*).

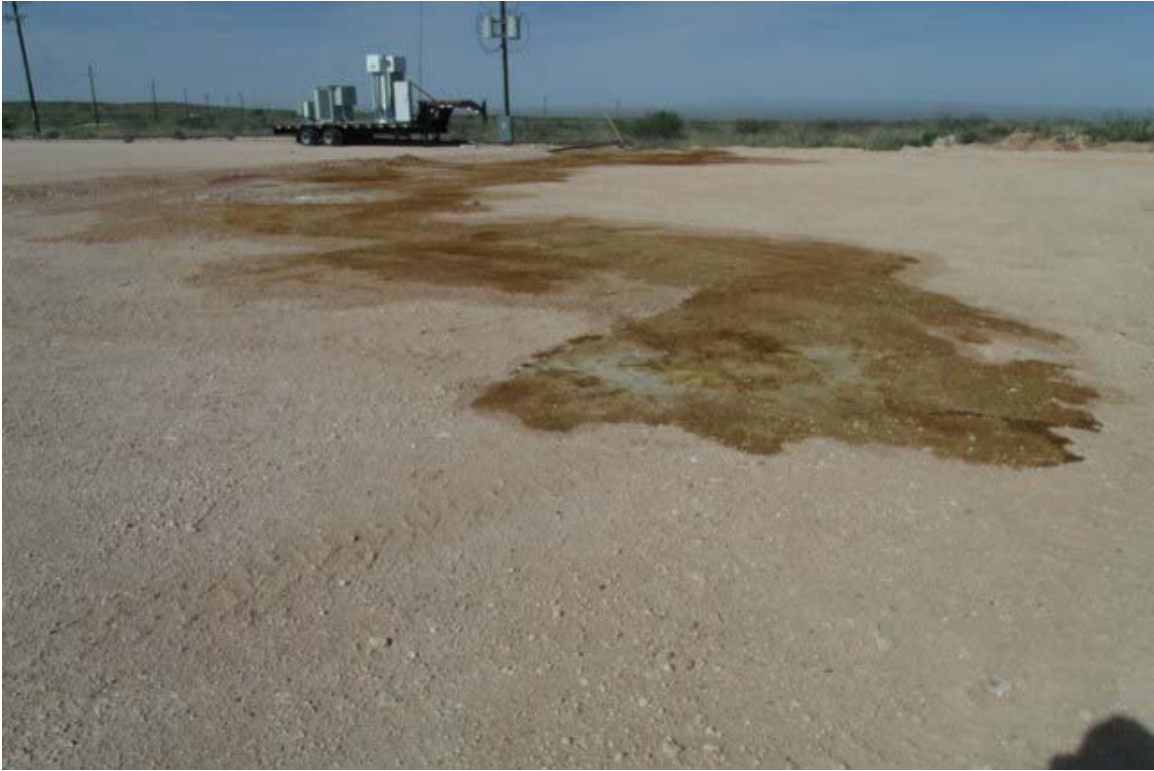
The lease operator reported a release due to flowline failure caused by external corrosion. The above-ground flowline had been buried and covered with caliche without being wrapped or coated. Majority of release was concentrated to pad but some fluid entered pasture. A vacuum truck was called to the location to recover standing fluid. A response crew was sent to the location and conducted an initial scrape of the heavy saturated soils.

Photograph #1 – Looking across release area

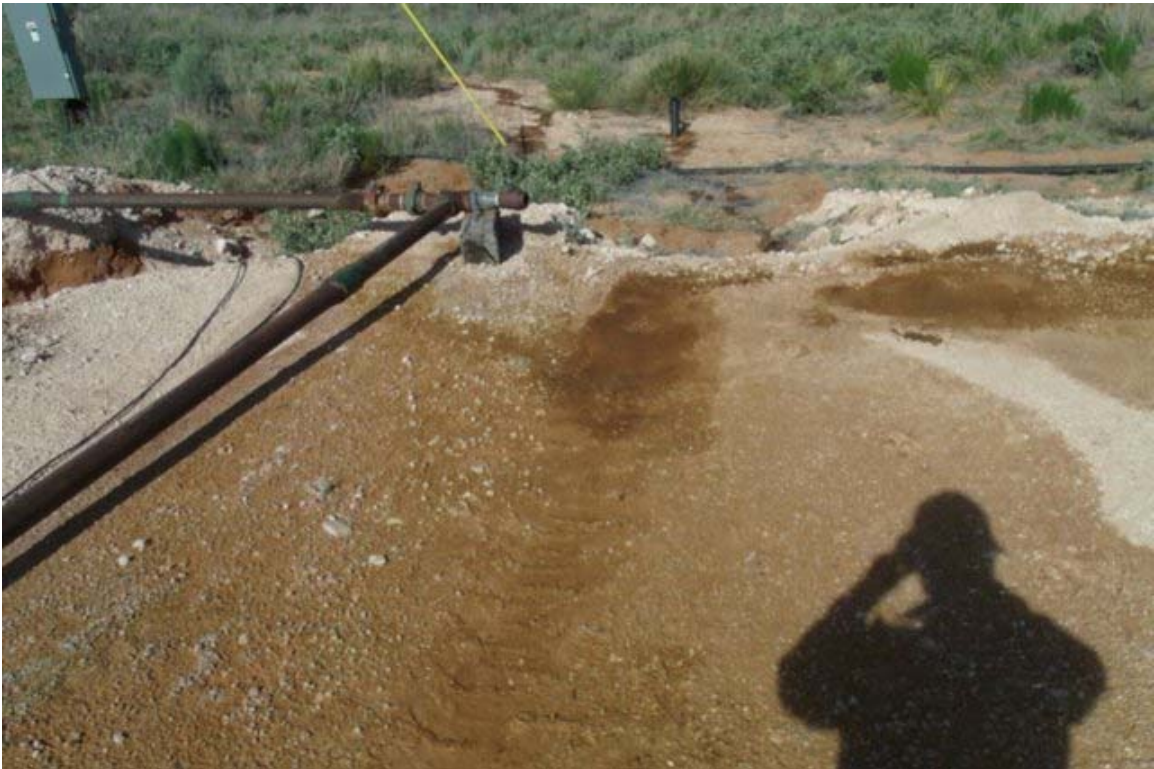
Photograph #2 – Looking across release area

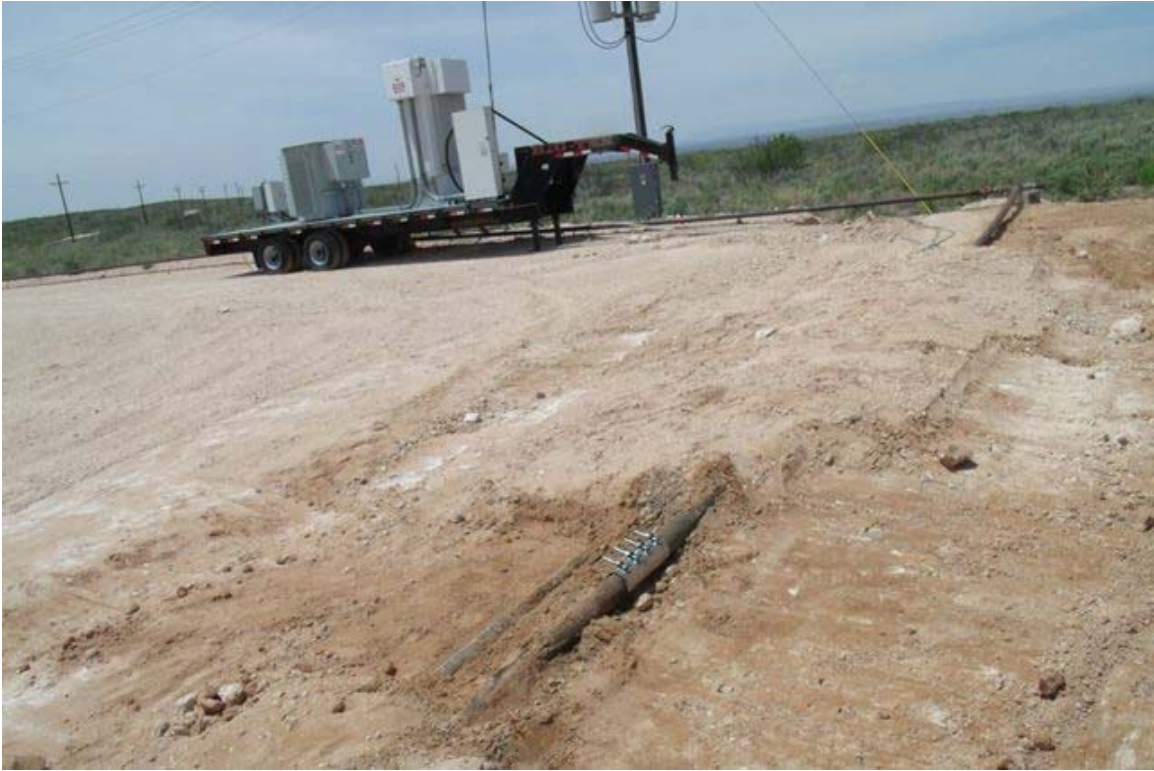
Photograph #3 – Excavated

The release area was excavated to a depth of approximately six (6) inches bgs. Approximately 14 tons of contaminated soil were excavated and hauled to a state approved facility for disposal.

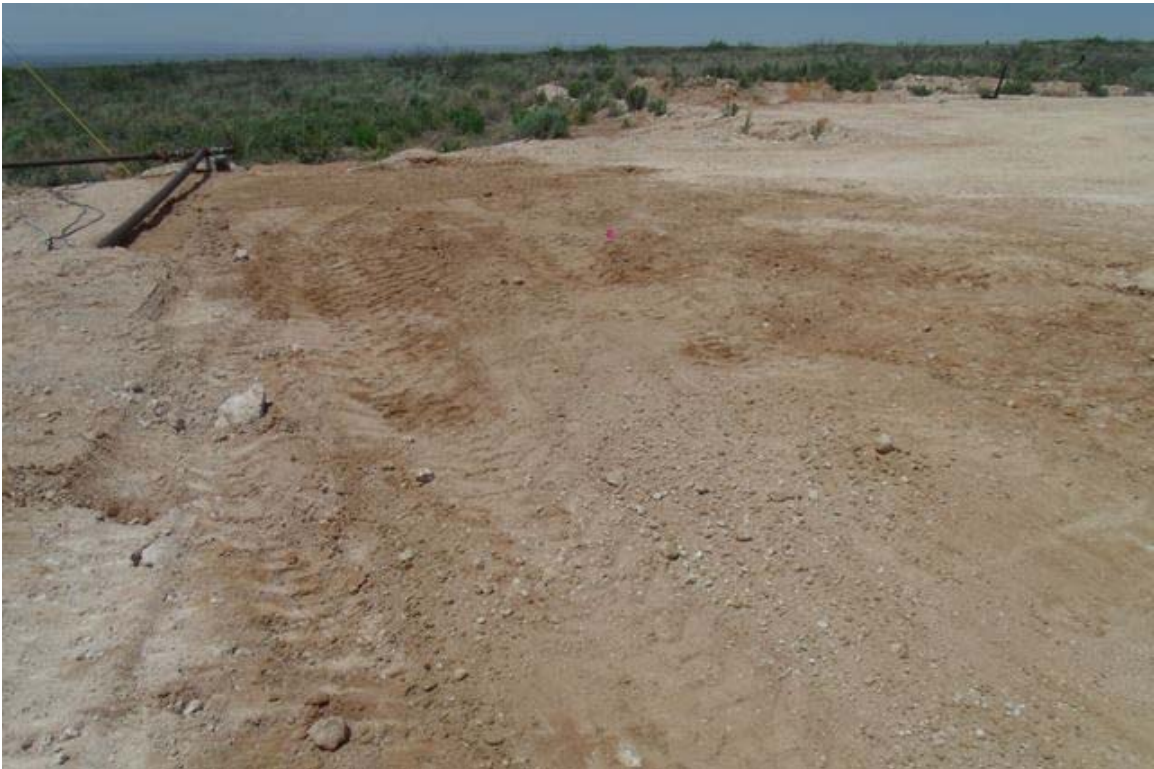
Photograph #4 – Excavated

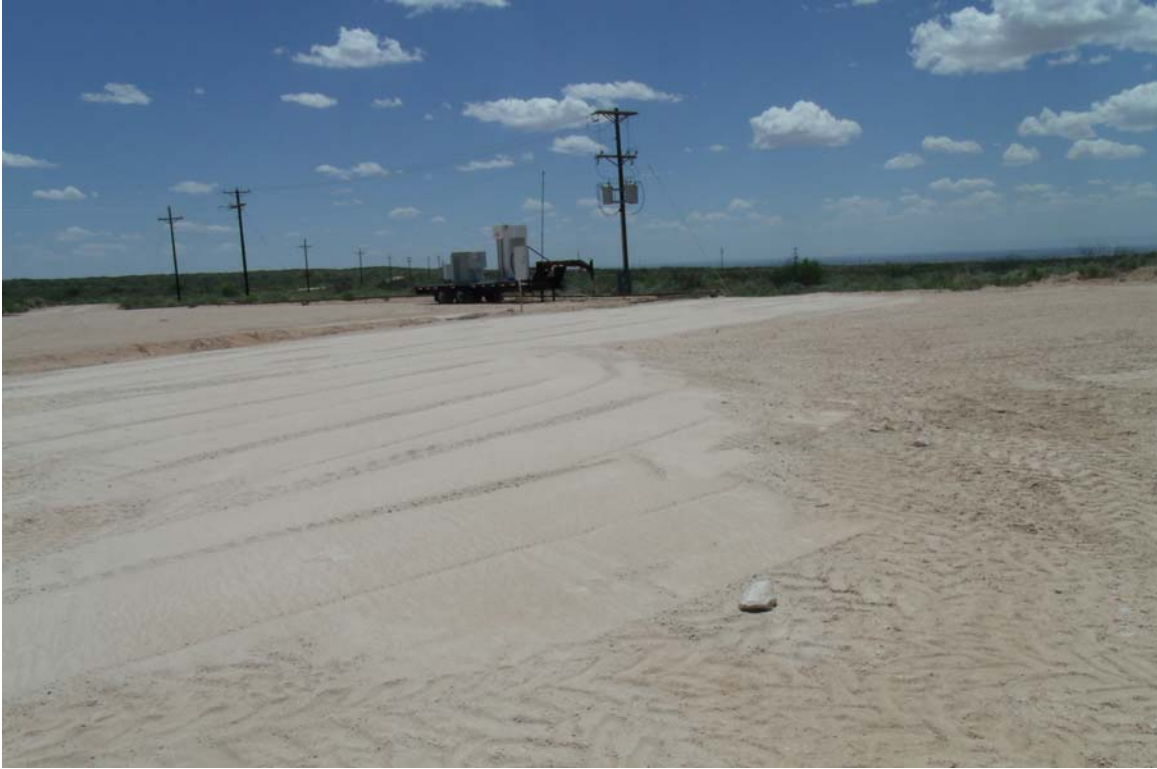
Photograph #5 – Backfilled

Based on laboratory analytical results and with NMOCD approval the excavation was backfilled with approximately 14 tons of clean soil. All soil was free of rocks, clumps or deleterious material. The entire disturbed area was then contoured to blend with existing well pad area and protected against wind/water erosion.

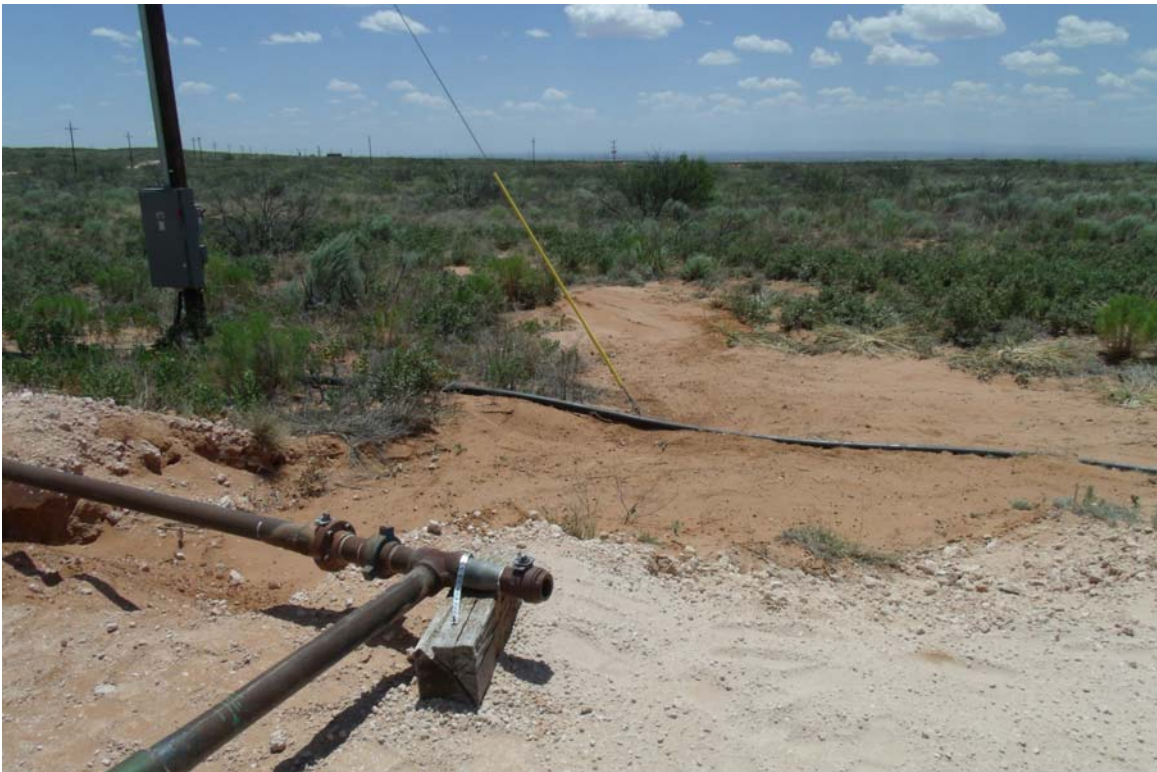
Photograph #6 – Backfilled
