CORRECTIVE ACTION REPORT

**Chinaberry Leak
32.330720, - 104.310416
NE ¼ SE ¼, S5 T23S R26E
Eddy County, New Mexico
2RP-3295**

August 2016

Apex Project No. 7250715089

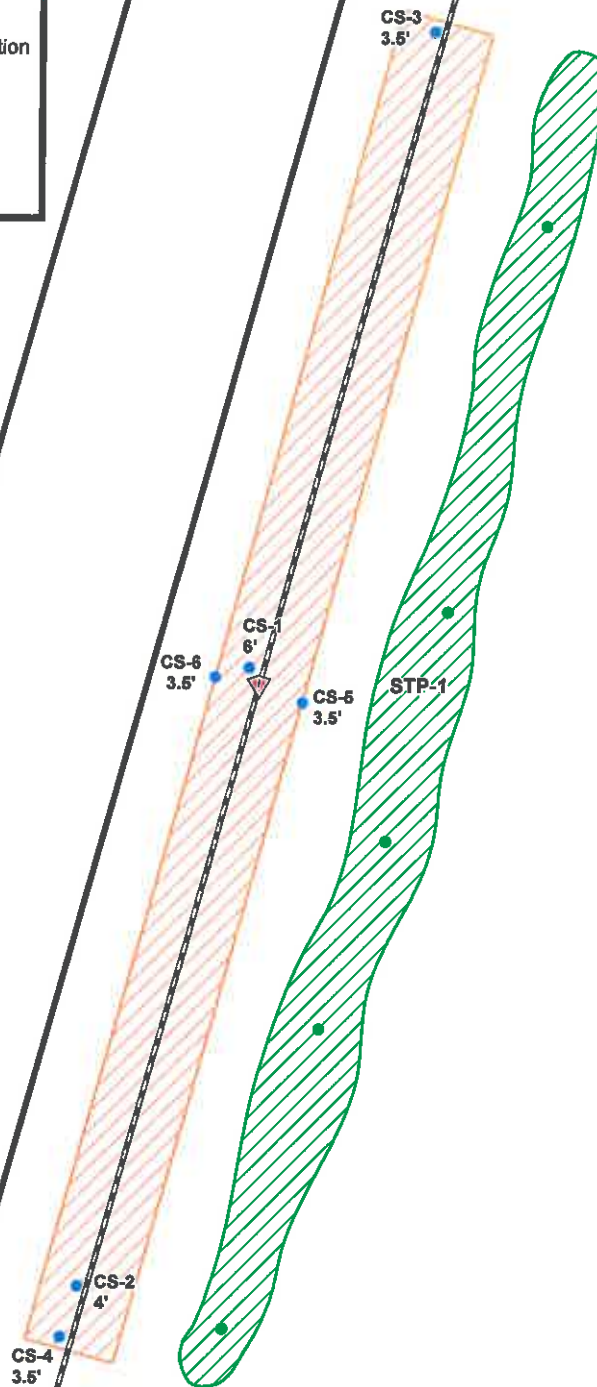
FIGURE 3
Site Map

Figure 3 is a Site Map that indicates the approximate location of the confirmation soil samples in relation to pertinent land features and general Site boundaries (Appendix A).

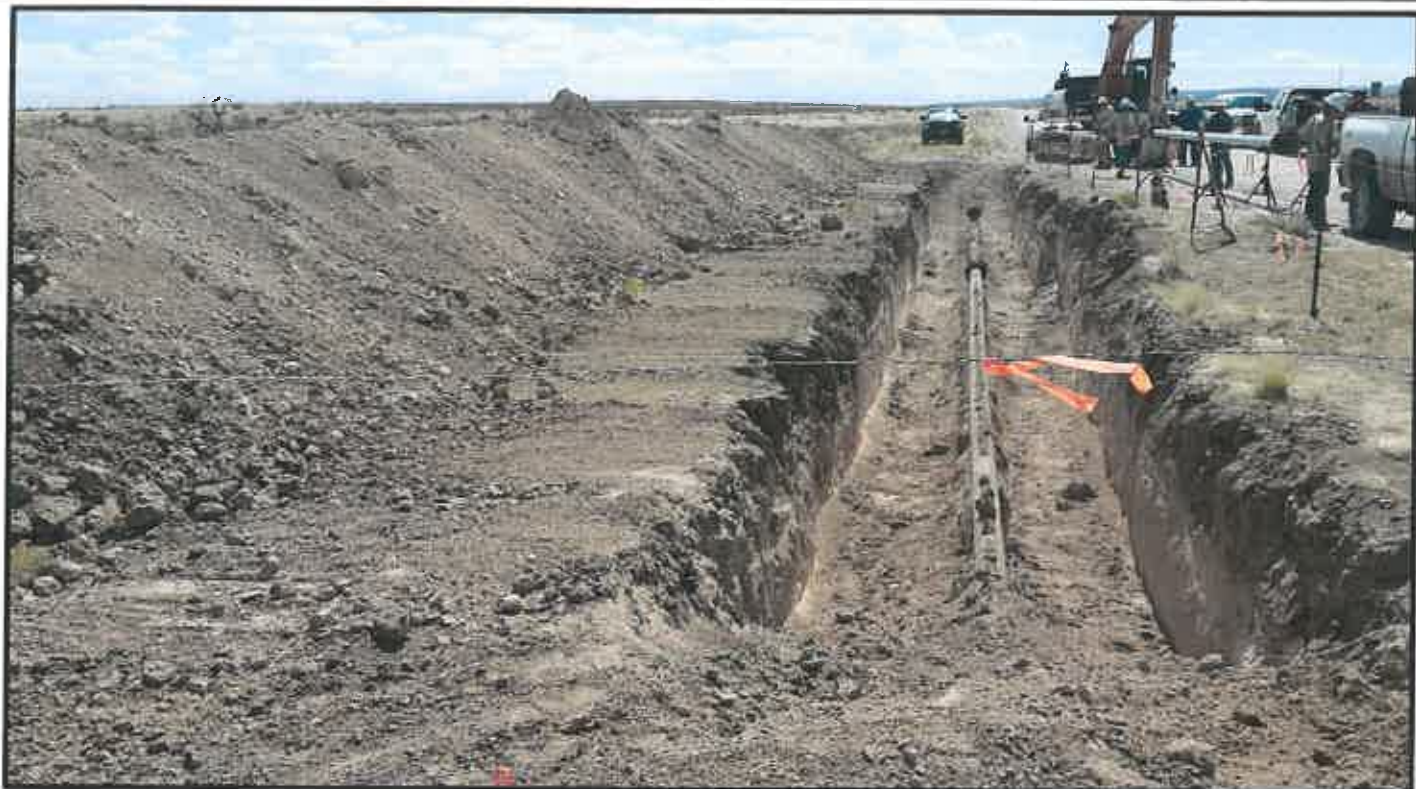
The excavation was carried out on September 10, 2015. Impacted soil was removed from below and surrounding the release point on the pipeline. The excavation dimensions measured approximately one-hundred and twenty feet (120) feet long by eight (8) feet wide, with total depth ranging to approximately six (6) feet below ground surface (bgs). Impacted soil was removed and collected into one (1) stockpile on Site.

View of pipeline leak excavation facing south.

As noted by Enterprise, the backfill of the excavation was completed between September 11, 2015 through October 16, 2015. The stockpiled material from the excavation was transported off-Site to Lea Land, LLC (Lea Land) disposal facility in Carlsbad, New Mexico during the completion of backfill activities. The excavation was backfilled with clean caliche fill material, compacted utilizing heavy equipment and the area was contoured to approximate original surface grade. Copies of the waste disposal manifests are included as an attachment in Appendix F.

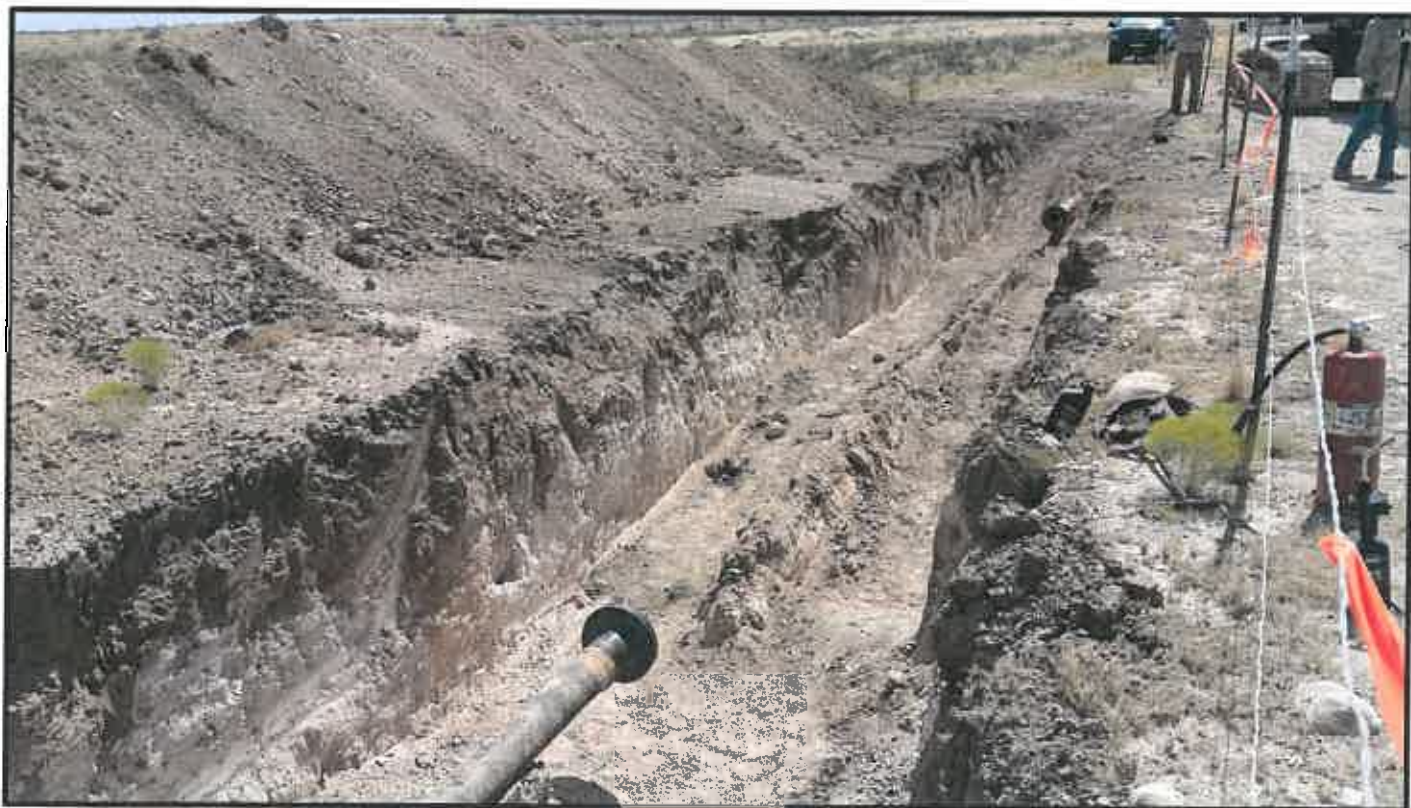
On September 4, 2015, Enterprise was informed of a pipeline leak detected by an Enterprise technician on the Chinaberry line. Approximately five (5) bbls of natural gas pipeline liquids was released from the leaking portion of the pipeline and onto the ground surface within the pipeline ROW. Enterprise isolated the leaking portion and the pipeline section was blown down to carry out repair activities.

Close up view of release point facing south.

Pipeline leak was discovered by Enterprise operations. Pipeline segment was isolated, blown down and clamped; leaking portion was repaired following standard One-Call.
