**RE: LETTER REPORT SUMMARIZING THE PIPELINE LEAK AT THE SALT DRAW
PIPELINE ROW 1003, EDDY COUNTY, NEW MEXICO;
ECIRTS# 30310, NMOCD 2RP-3867**

**ENTERPRISE FIELD SERVICES, LLC
SALT DRAW PIPELINE RELEASE
EDDY COUNTY, NEW MEXICO**

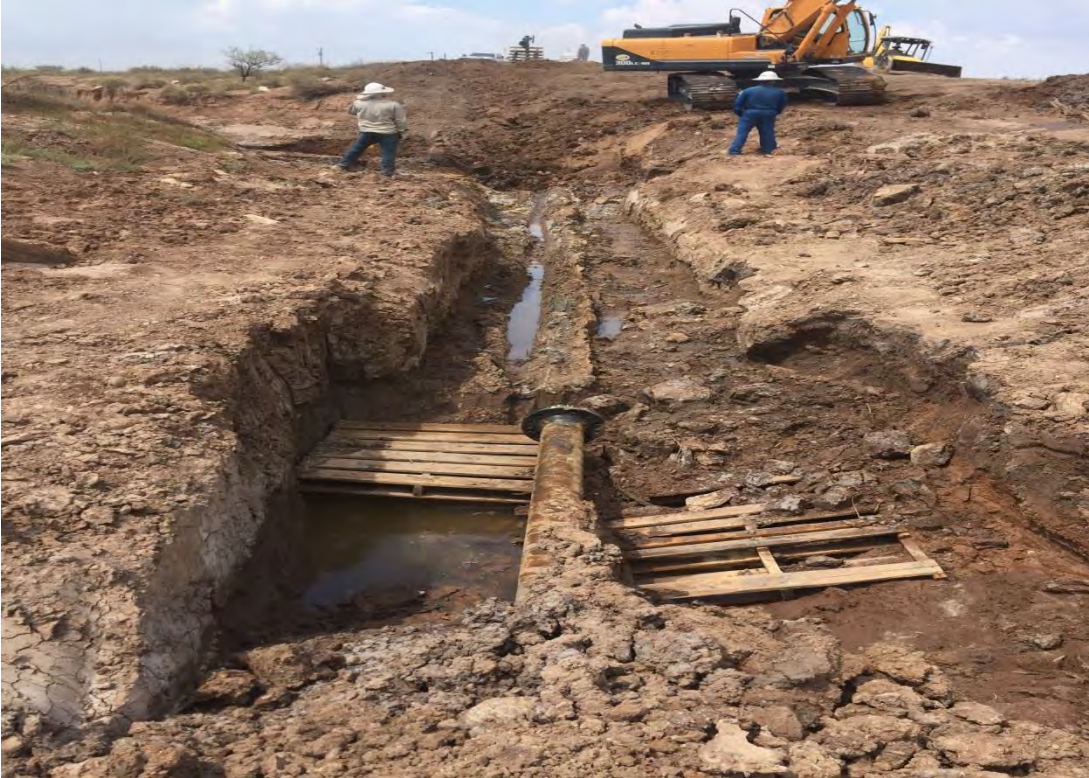
Photo 7

Looking at excavation of affected soil Salt Draw at ROW 1003 7/28/16 photo by SMA

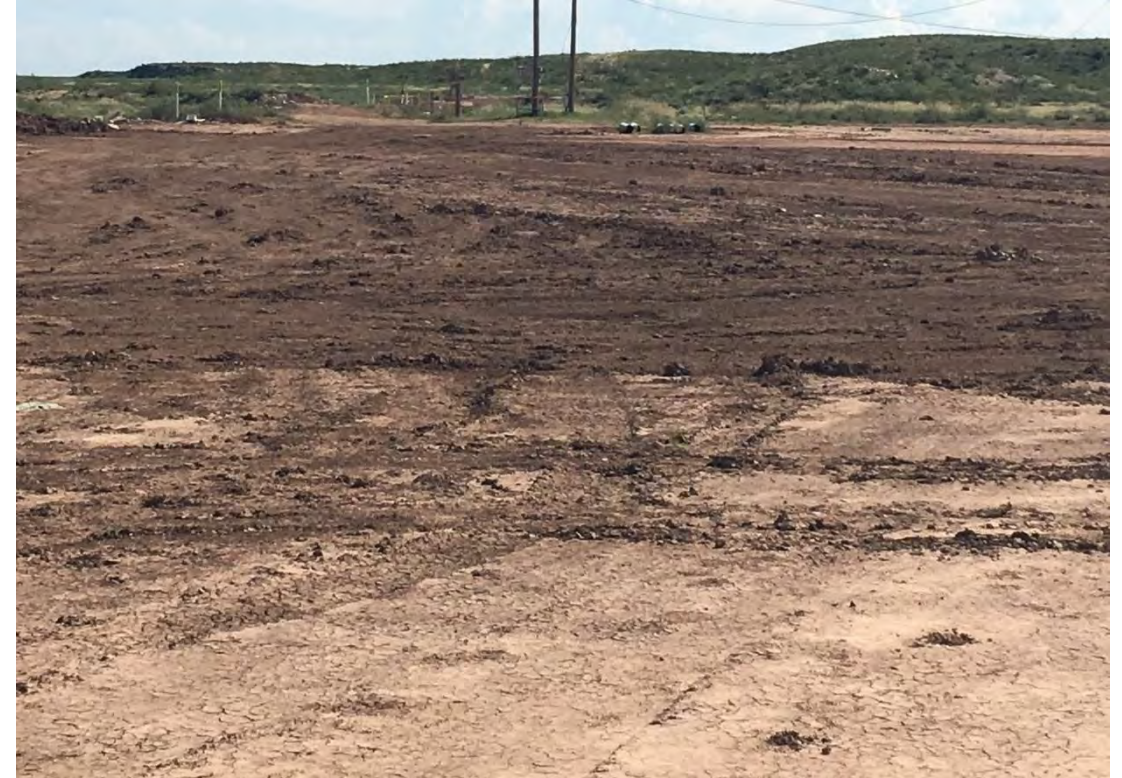
Photo 8

Looking at Spill pile area after removal of affected soil Salt Draw at ROW 1003 9/19/16 photo by SMA

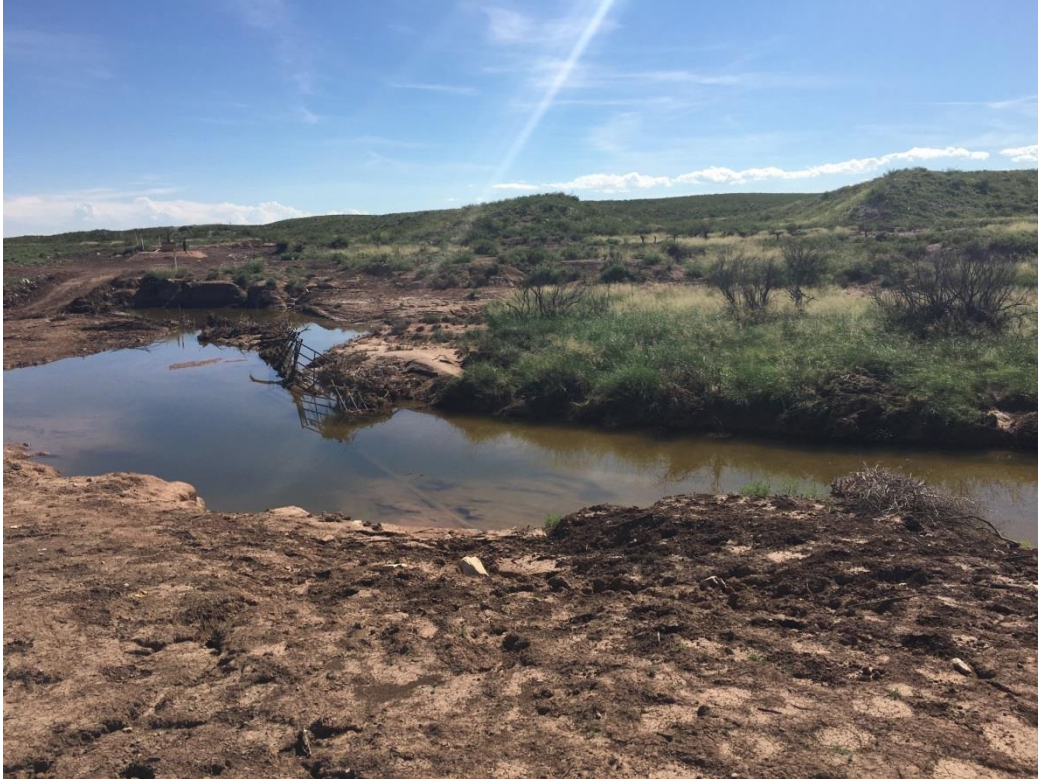
Photo 11

Looking South down ROW 1003 at
excavation in Salt Draw 9/19/16
photo by SMA

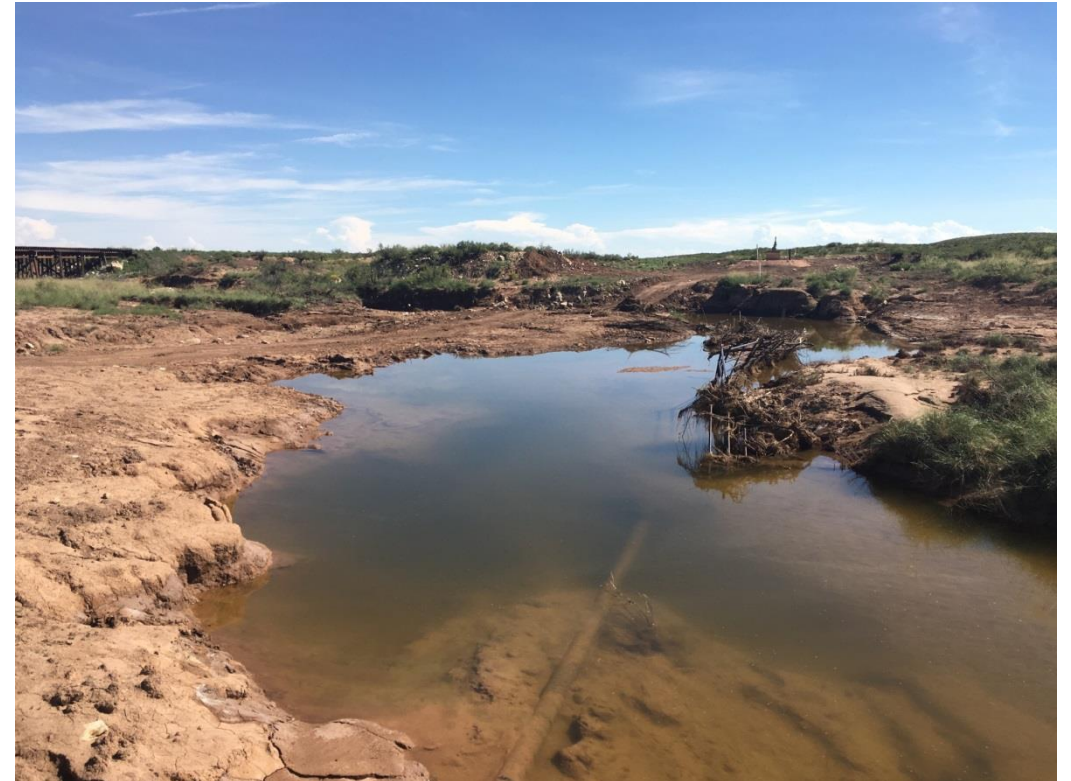
Photo 12

Looking South down ROW 1003 at excavation in Salt
Draw 9/19/16 photo by SMA
