SUBJECT: WORK PLAN FOR INCIDENT 2RP-3902, Charlie Sweeney 201H
UNIT M SECTION 30-T23S-R28E NMPM, API# 30-015-43695, EDDY COUNTY, NEW MEXICO

SOIL REMEDIATION WORK PLAN FOR INCIDENT 2RP-3902

MATADOR RESOURCES COMPANY

CHARLIE SWEENEY 201H
UL M, SECTION 30, T23S R28E, NMPM
API #30-015-43695
EDDY COUNTY, NM

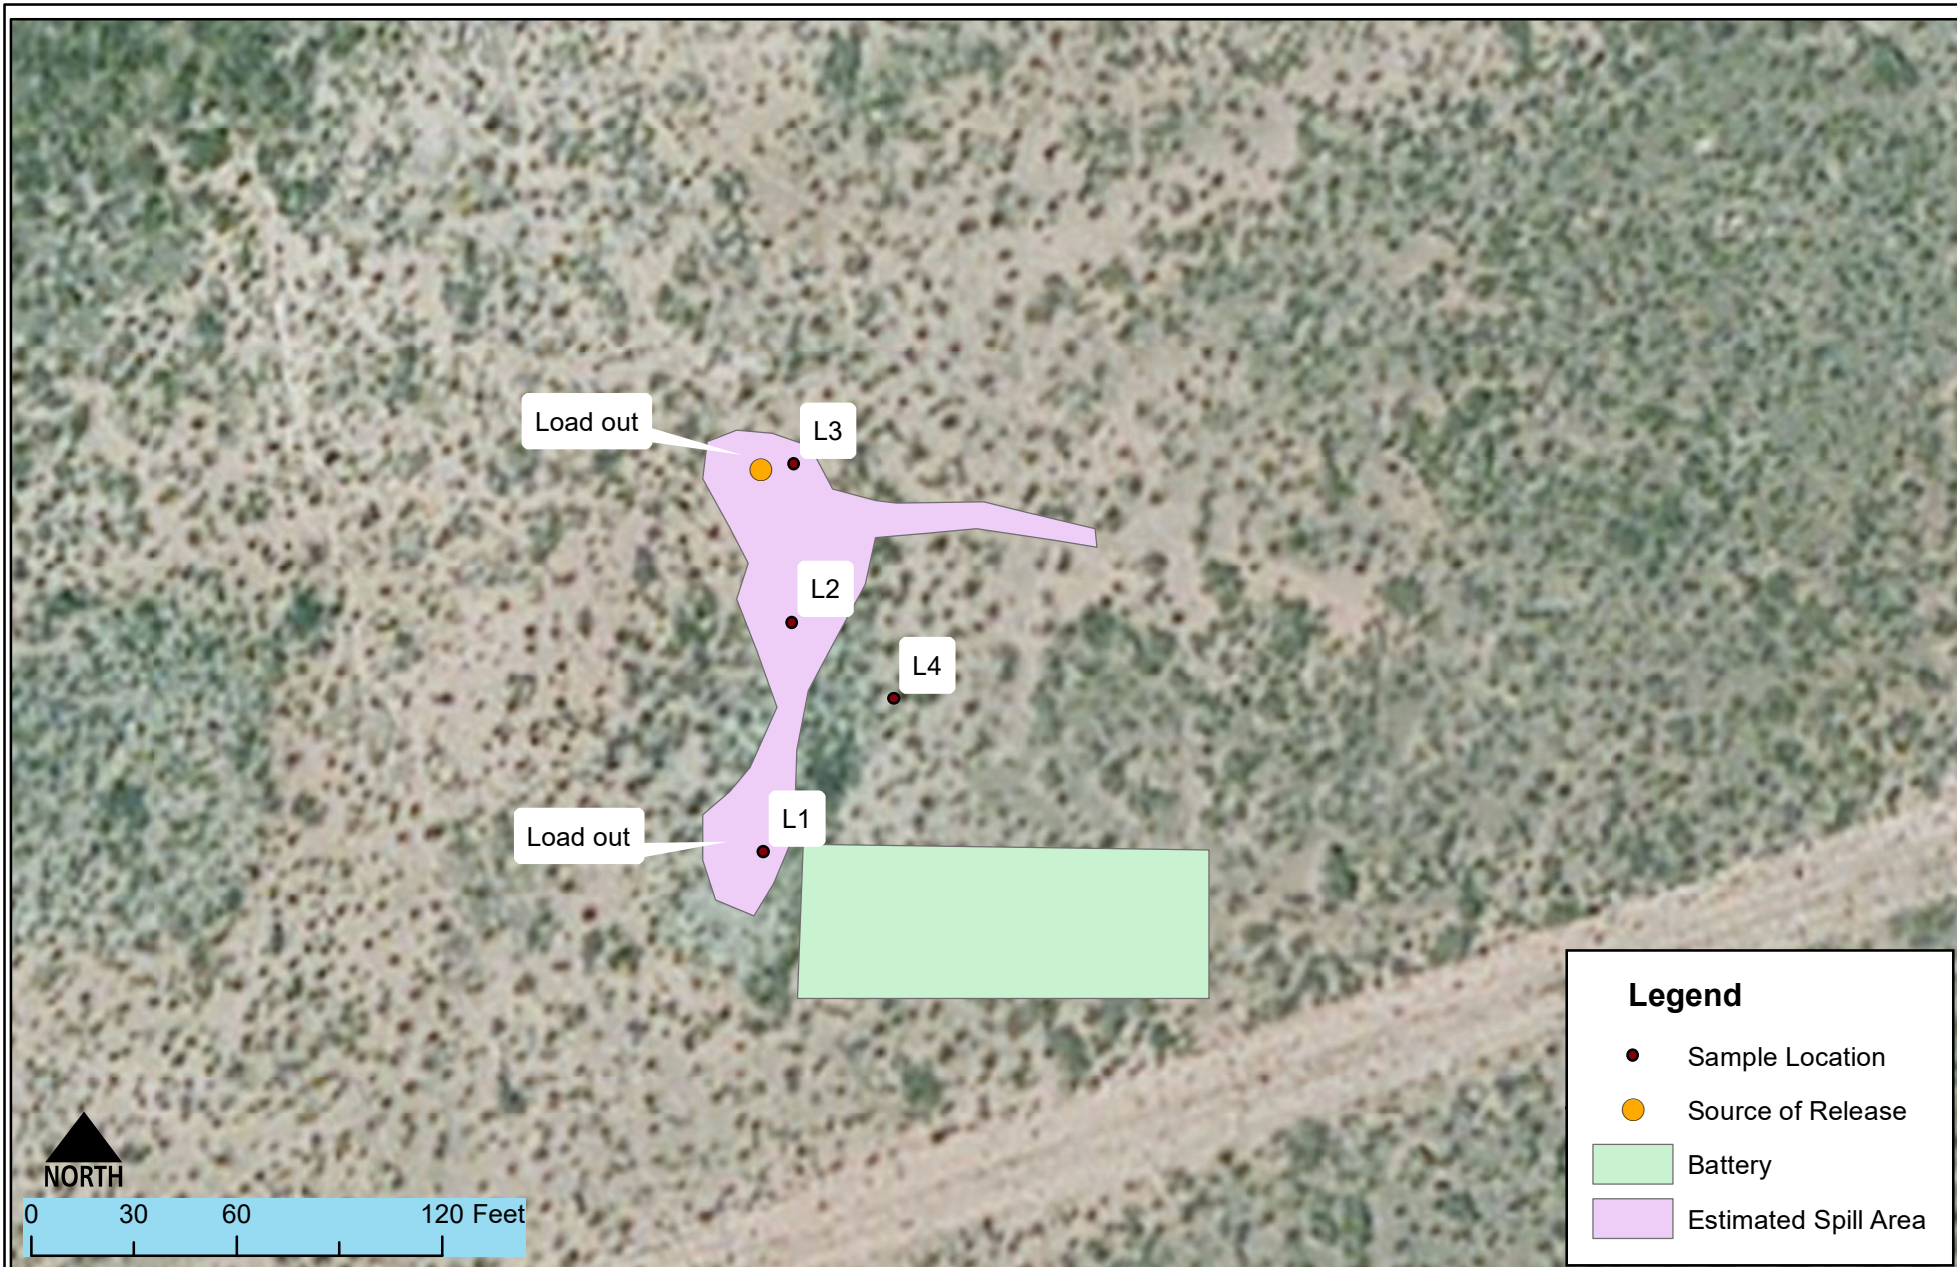
FIGURE 2

DETAILED SITE AND SAMPLE MAP

Detailed Site and Sample Map
Matador- Charlie Sweeney
Malaga, New Mexico

| Analytical Report- 1610672 | Sample Number on Figure 2 Map | Sample Date | Depth | BTEX ppm | Benzene mg/Kg | GRO mg/Kg | DRO mg/Kg | Cl- mg/Kg |
| 1610672-001 | L1 | 10/4/2016 | 1.5' | <0.095 | <0.024 | N/A | N/A | <30 |
| 1610672-002 | L2 | 10/4/2016 | 1' | N/A | N/A | <4.8 | <10 | <30 |
| 1610672-003 | L3 | 10/4/2016 | 1' | N/A | N/A | N/A | N/A | <30 |
| 1610672-004 | L4 | 10/4/2016 | 1' | N/A | N/A | N/A | N/A | <30 |
