SUBJECT: WORK PLAN FOR INCIDENT 2RP-4081, Ford State #2, UNIT F SECTION 2-T22S-R28E NMPM, API# 30-015-22714, EDDY COUNTY, NEW MEXICO

SOIL REMEDIATION WORK PLAN FOR INCIDENT 2RP-4081

JUDAH OIL LLC

FORD STATE # 002

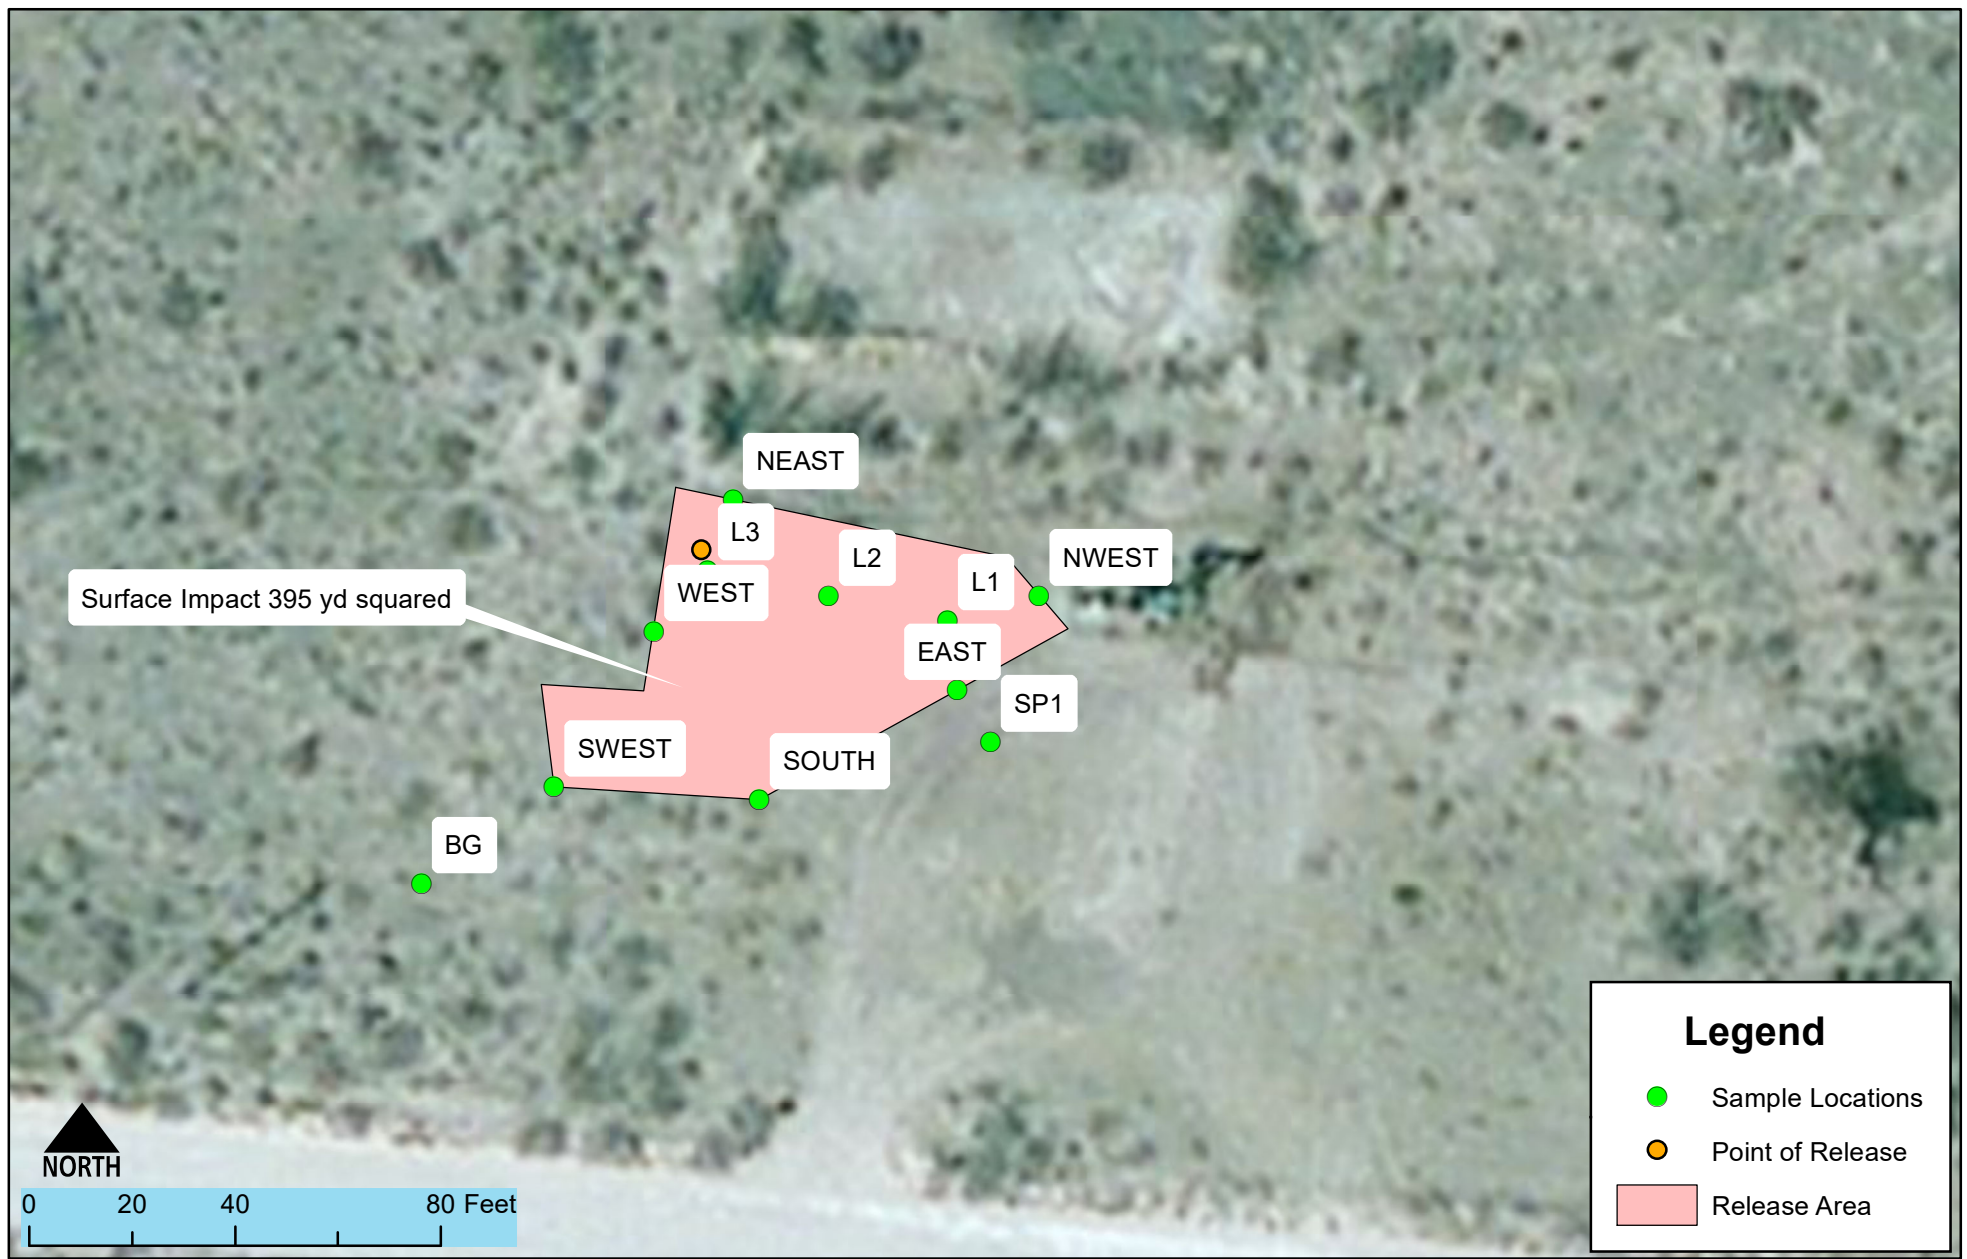
FIGURE 2

Soil contaminant concentrations found during the initial delineation are illustrated in Figure 2. A summary of the laboratory analyses is included in Table 2. Laboratory reports are included in Appendix A.

DETAILED SITE AND SAMPLE MAP

SMA will continue to vertically delineate the location to satisfy NMOCD requirements. With approval from area utilities owners via 811 and NMOCD, SMA will conduct an in-situ remediation of the hydrocarbons using high nitrogen fertilizer to reach RRAL's for a site ranking of 10. Once bioremediation is complete, SMA will resample all three sample locations. In the event RRAL's cannot be met within 180 days of the remediation approval, soils with elevated hydrocarbons will be excavated and hauled to an NMOCD permitted facility.
