Site Investigation Report & Corrective Action Plan

Onsurez #2

Eddy County, New Mexico

Project: 17-389

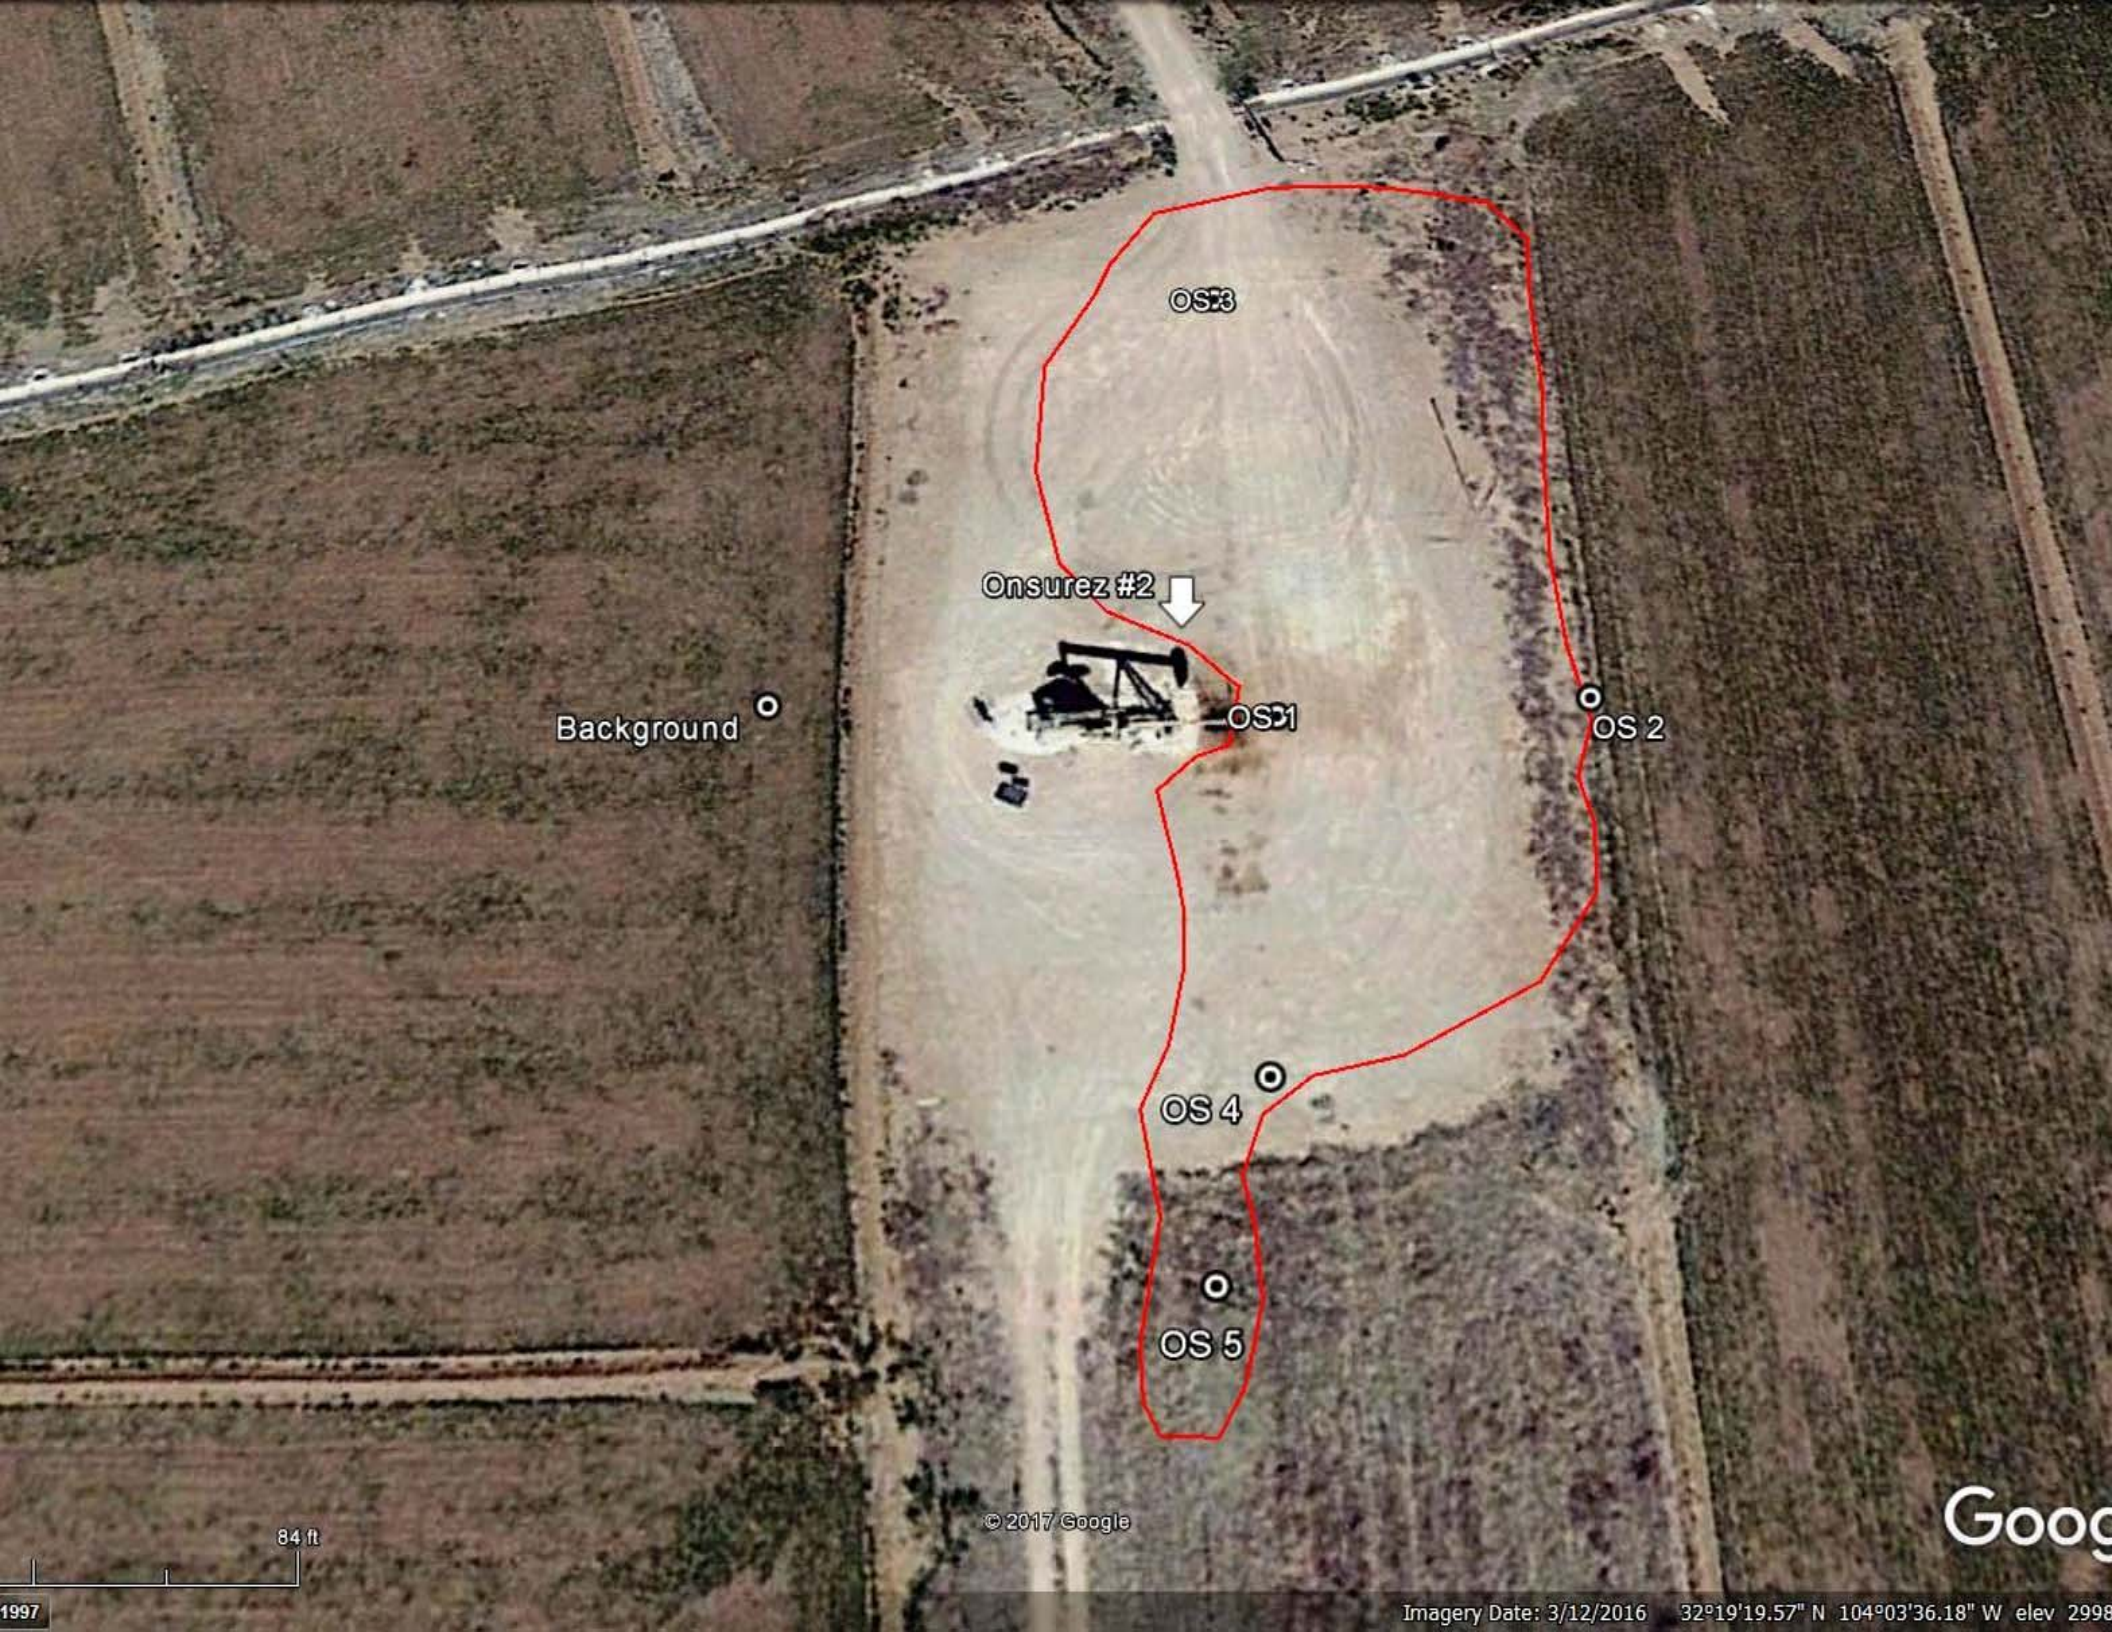
FIGURE 1

On June 3rd, 2017 approximately 1 barrel of crude oil and produced water were released as a result of a leaking stuffing box. The release occurred during a rain event and impacted the area surrounding the well (**Figure 1**). Approximately 1 barrel was recovered. The impacted area was estimated to be about 17,955 square feet (**Appendix A**). A copy of the C-141 is provided as (**Figure 2**).

3. Kane personnel identified and collected five (5) samples (Sample OS1, OS2, OS3, OS4 and OS5) that were taken in each cardinal direction of the impacted area (**Figure 1**). Soils were collected at depths of 1 ft, 3 ft, and 5 ft (bgs). The samples were placed in sealable plastic bags, allowed to reach temperature equilibrium and then screened for hydrocarbons using a MiniRae 2000 photoionization detector (PID). The samples were also screened for chlorides using a Spectrum Field Scout electrical conductivity (EC) meter. The results are provided in (**Table 1**) along with a description of the soils encountered. A composite background sample was also collected from the surface to a depth of 3 ft (bgs) from an area that based on historical aerial photographs has not been impacted (**Figure 1**). This soil was also screened using the PID and EC meter and the results are provided in (**Table 1**).

Impacted Area

- The soils around the wellhead and sample OS1 should be excavated to a depth of 5 ft (bgs) (approximately 125 cubic yards yd³). Then the area backfilled with clean soil.
- The soil in the area of sample OS2 will be excavated to a depth of 5 ft (bgs), then backfilled with clean soil (approximately 95 yd³).
- The soil in the area of sample OS3 will be excavated to a depth of 1 ft (bgs), then backfilled with clean soil (approximately 45 yd³).
- The soil in the area of sample OS4 will be excavated to a depth of 1 ft (bgs), then backfilled with clean soil (approximately 55 yd³).
- The soils around the wellhead and sample OS5 should be excavated to a depth of 5 ft (bgs). Then the area backfilled with clean soil (approximately 155 yd³).

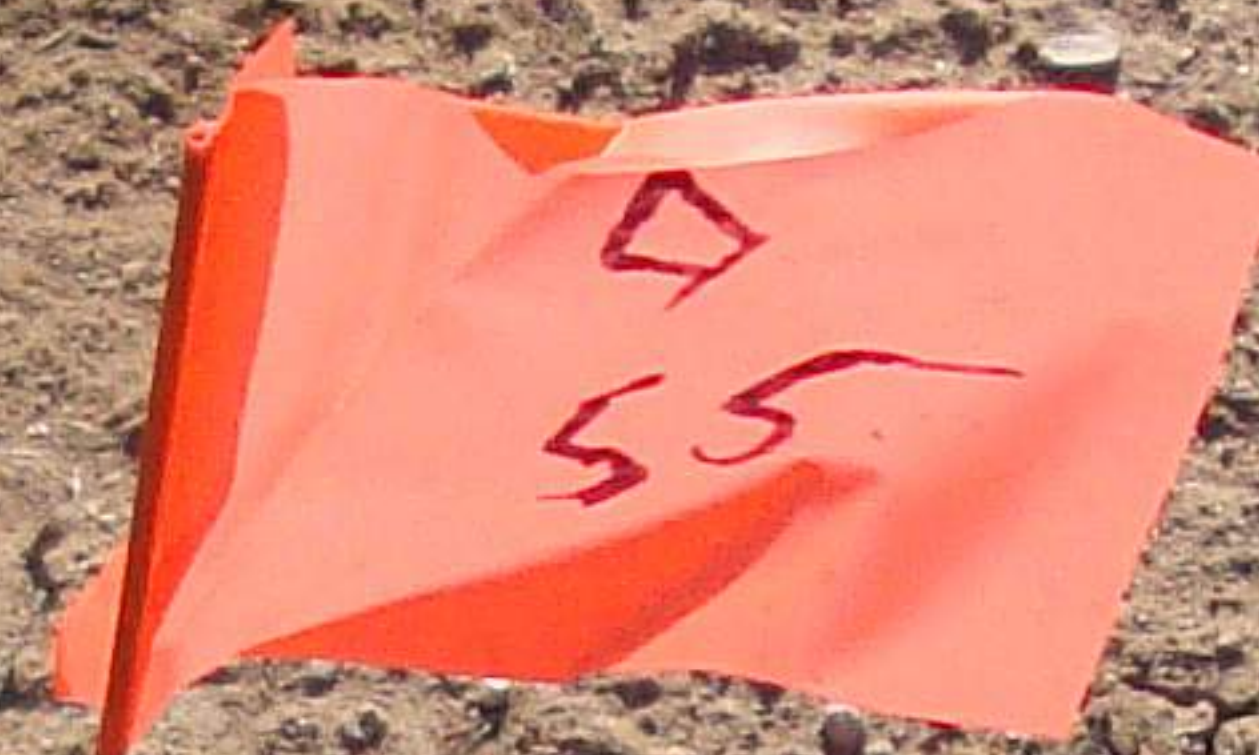
Impacted Area Photographs

2. Kane personnel, Chris Elrod and Alan Kane, P.E. began the site investigation at 8:15am on June 29th, 2017 (**Appendix D**). Photographs were taken of the well and impacted areas (**Appendix A**).
