Report Type: Closure Report 2RP-3927

Site:	Blue Thunder 4 Federal #1					
Company:	COG Operating LLC					
Section, Township and Range	Unit M	Sec. 04	T 19S	R 31E		
Lease Number:	API No. 30-015-34125					
County:	Eddy County					
GPS:	32.684022° N			103.881225° W		
Surface Owner:	Federal					
Mineral Owner:						
Directions:	From the intersection of 126A (Maljamar Rd) and Lusk Plant Rd. in rural Eddy County, turn west on Lusk Rd for approximately 6.20 mi, turn west onto lease road for 0.4 miles, turn south for 0.6 mi to location.

Re: Closure Report for the COG Operating LLC., Blue Thunder 4 Federal #1, Unit M, Section 04, Township 19 South, Range 31 East, Eddy County, New Mexico. 2RP-3927

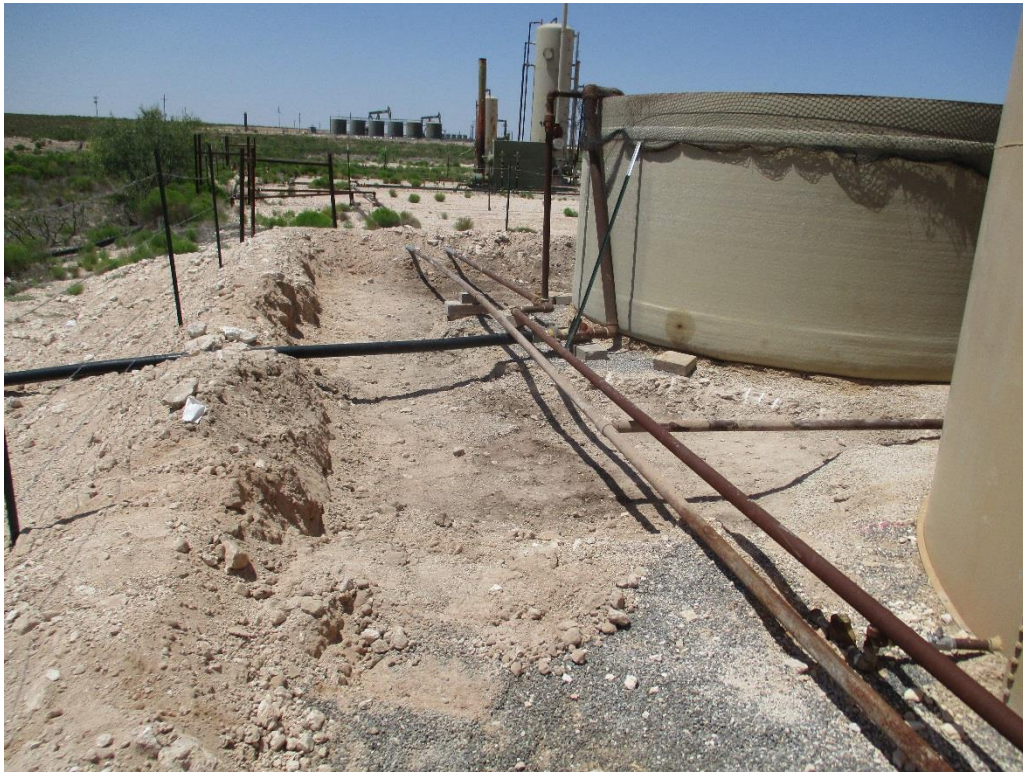
View North – Excavated Area of T-1

On June 28-29, 2017, Tetra Tech personnel were onsite to supervise the excavation and remediation activities. The excavated areas and depths are shown on Figure 4 and highlighted (green) in Table 1. The area of trench (T-1) was excavated to 1.0' below surface. A total of three (3) sidewall samples (South Sidewall, West Sidewall, and North Sidewall) were collected to ensure the proper removal of the impacted material. A sample was not collected along the east sidewall, due to the equipment in the area. Selected samples were analyzed for TPH by EPA method 8015 modified. Copies of the laboratory analysis and chain-of-custody documentation are included in Appendix C. The sampling results are summarized in Table 1. The sidewall sample locations are shown on Figure 4.

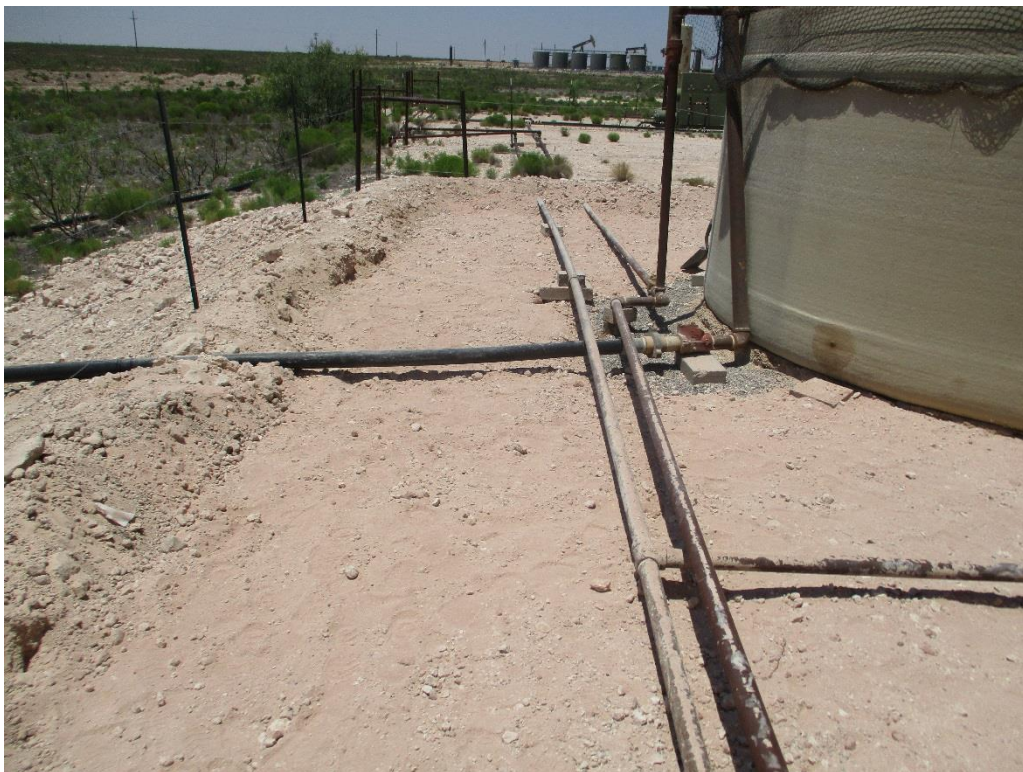
View North – Backfilled Area of T-1

Referring to Table 1, none of the sidewall samples collected showed TPH concentrations above the 5,000 mg/kg RRAL. The TPH concentrations detected ranged from 39.0 mg/kg to 3,840 mg/kg. Once the excavation was completed, the area of trench (T-1) was backfilled with clean material to surface grade. Approximately 20 cubic yards of excavated material was transported offsite for proper disposal.
