Report Type: Closure Report 2RP-4073

Site:	Puckett 13 Federal Tank Battery					
Company:	COG Operating LLC					
Section, Township and Range	Unit P	Sec. 12	T 17S	R 31E		
Lease Number:	API No. 30-015-40737					
County:	Eddy County					
GPS:	32.842045° N			103.816429° W		
Surface Owner:	Federal					
Mineral Owner:						
Directions:	From the intersection of NM 529 & HWY 82 in rural Eddy County, Travel east on HWY 82 for approximatey 3.9 miles, turn north onto a lease road for approximately 0.10 mi, turn northeast onto lease road for 0.20 mi to location on south side of the lease road.

Re: Closure Report for the COG Operating LLC., Puckett 13 Federal Tank Battery, Unit P, Section 12, Township 17 South, Range 31 East, Eddy County, New Mexico. 2RP-4073

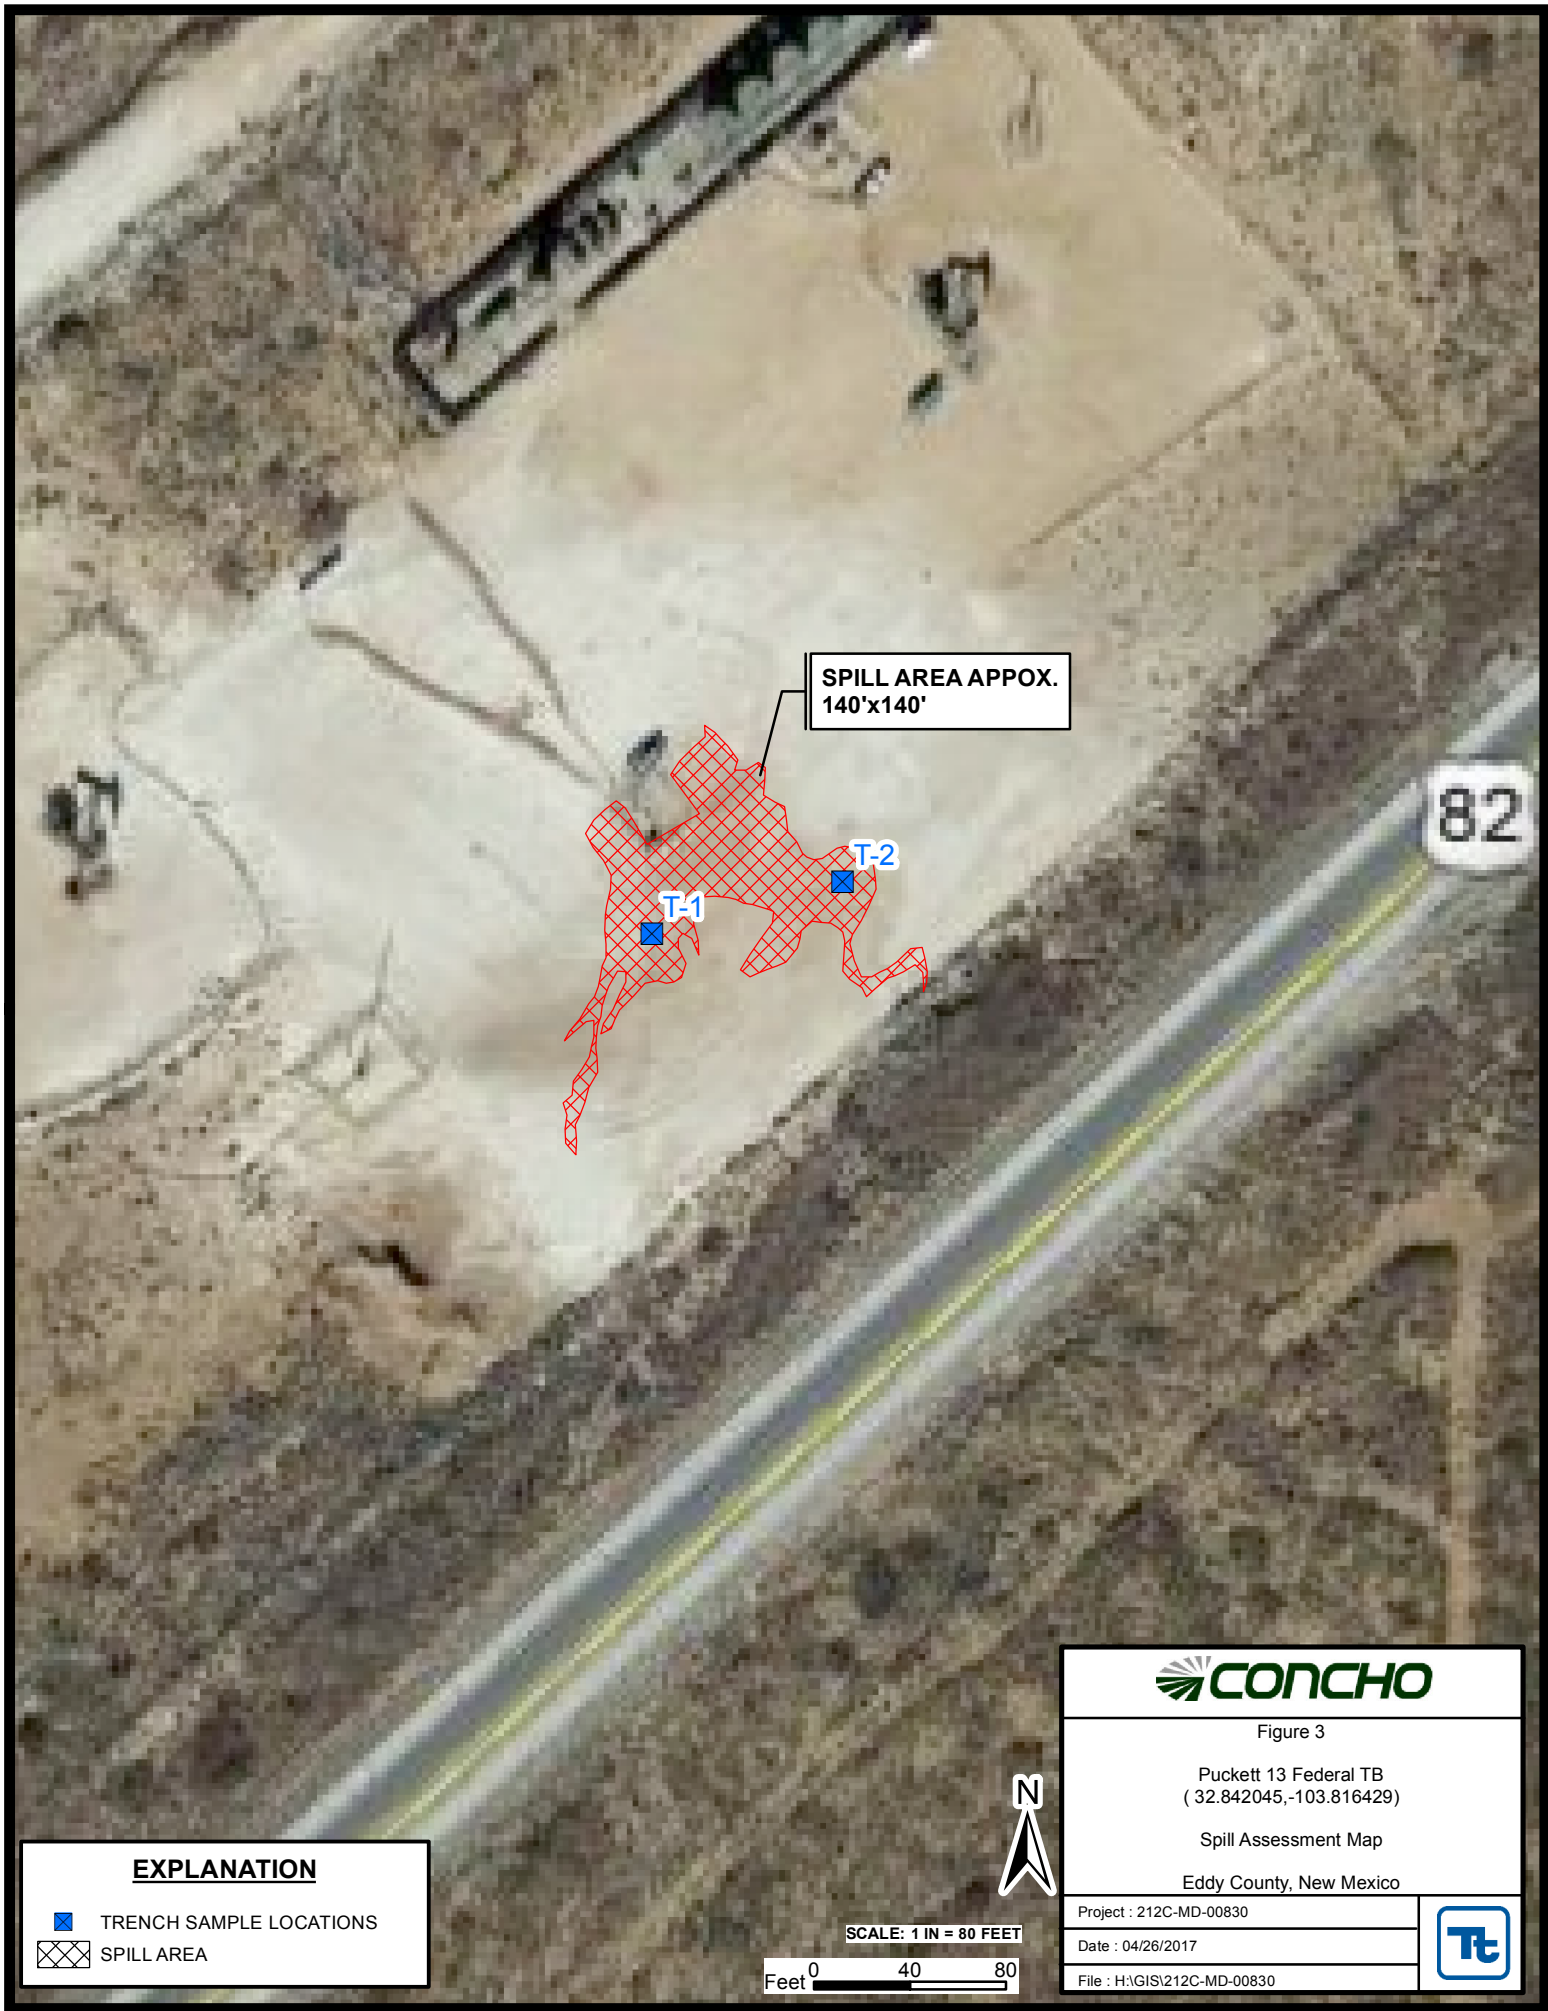
Figure 3

SPILL AREA APPROX.
140'x140'

T-1

T-2

Spill Assessment Map

On February 7, 2017, COG personnel were onsite to evaluate and sample the release area. Using a backhoe, two (2) trenches (T-1 and T-2) were installed to a total depths of 4.0' below surface. Selected samples were analyzed for TPH analysis by EPA method 8015 modified, BTEX by EPA Method 8021B, and chloride by EPA method 300.0. Copies of the laboratory analysis and chain-of-custody documentation are included in Appendix C. The results of the sampling are summarized in Table 1. The trench locations are shown in Figure 3.

Referring to Table 1, none of the samples collected in the areas of trenches (T-1 and T-2) showed TPH, benzene, or total BTEX concentrations above the laboratory reporting limits or the RRAL's. However, the area of trench (T-1) showed elevated chloride concentrations in the shallow soils of 6,240 mg/kg (surface) and 1,020 mg/kg (1.0'). The chloride concentrations then declined with depth at 2.0' to 32.0 mg/kg with a bottom trench concentration of <16.0 mg/kg at 4.0' below surface. The area of trench (T-2) did not show a significant chloride impact to the soils with a chloride high of 368 mg/kg at surface, which declined with depth to 16.0 mg/kg at 2.0' below surface.

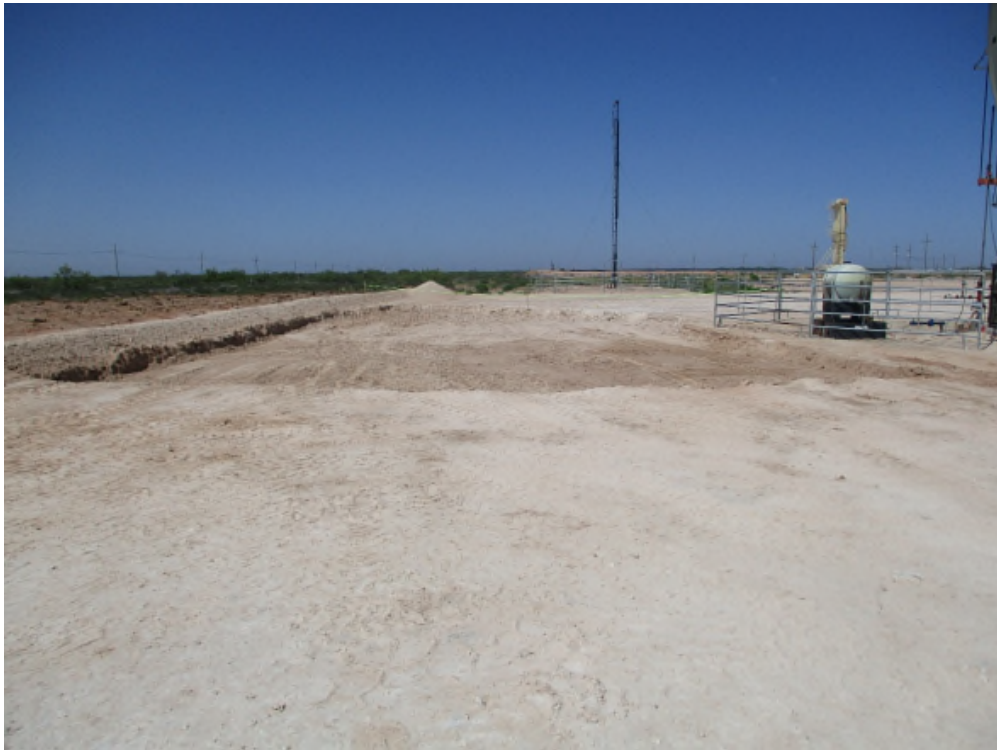
View West – Excavated Area of T-1

After the initial release was assessed, the southern portion of the pad area was reclaimed and approximately 1.0' of the pad material was removed from the area. Additionally, a berm was placed along the south edge of the pad. On June 14-15, 2017, Tetra Tech personnel were onsite to supervise the excavation and remediation activities. The excavated areas and depths are shown on Figure 4 and highlighted (green) in Table 1. The area of trench (T-1) was excavated to 1.0' below surface and expanded horizontally to properly remove the impacted soils.

Once the excavation was completed, the area of trench (T-1) was backfilled with clean material to surface grade. Approximately 140 cubic yards of excavated material was transported offsite for proper disposal.

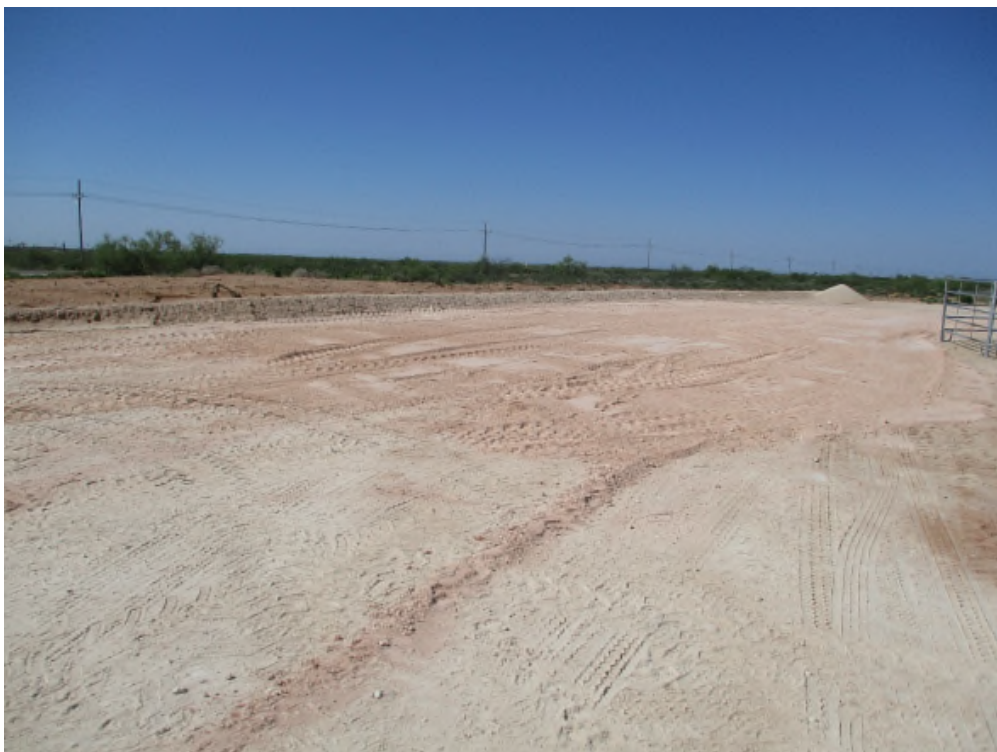
View Southwest – Backfilled Area of T-1
