CEDAR LAKE CA335 Remediation Proposal 2RP-3658 OGRID 873

Eddy County, New Mexico

May 31, 2017

Remediation Proposal

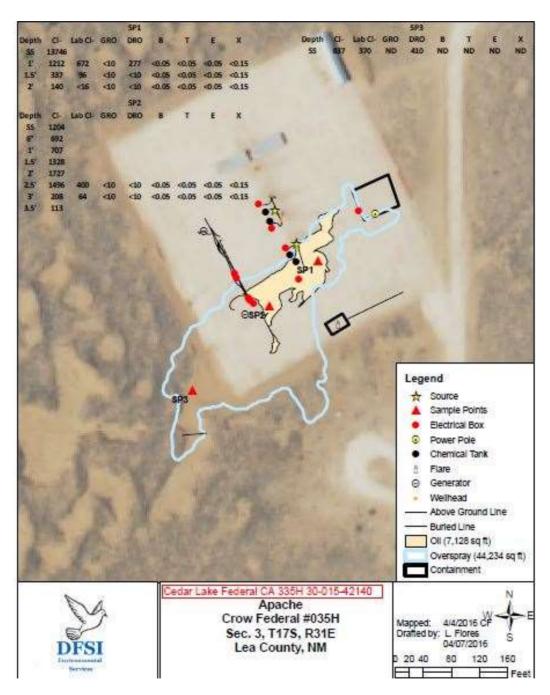
Figure 1: Sample Point Locations and Results

Soil sampling results are shown in the Figure 1.

The Figure 1 was from a March 12, 2016 aerial view on google and Figure 2 is from a February 1, 2017 updated aerial view on google. There are no changes to the vegetation except where previous excavation took place. The well pad is bermed on all sides, which will prevent any storm water runoff from the well pad.

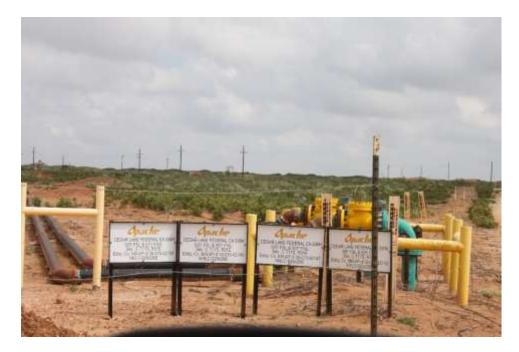
Photograph: 1

Description:Site vegetation

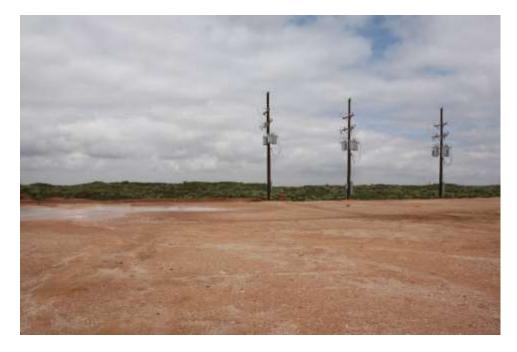
Photograph: 2

Description: Site vegetation

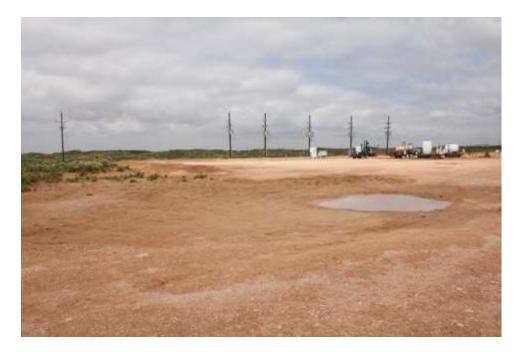
Photograph: 3

Description:Site vegetation

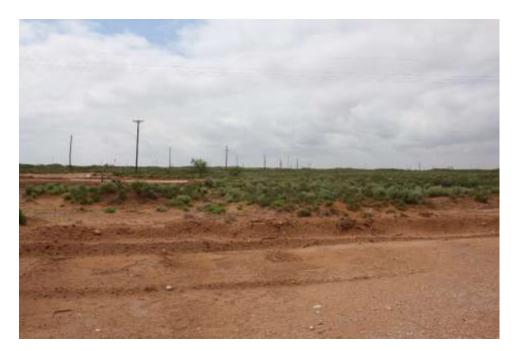
Photograph: 4

Description: Site vegetation

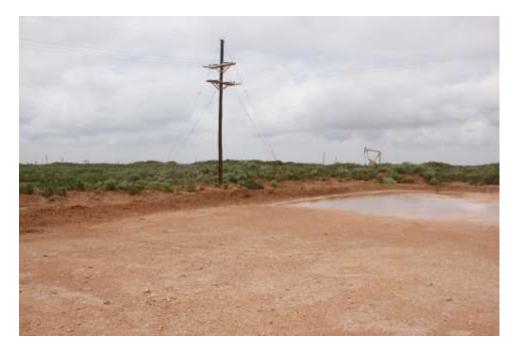
Photograph: 5

Description:Site vegetation
