Re: Dayton Water Line (Gushwa DX #1)
30-015-21703
Section 21, T18S-R26E
Eddy County, New Mexico
2RP-2824

Dayton Water Line (Gushwa DX #1)
Remediation Work Plan
2RP-2824

Dayton Water Line (Gushwa DX #1) Work Plan

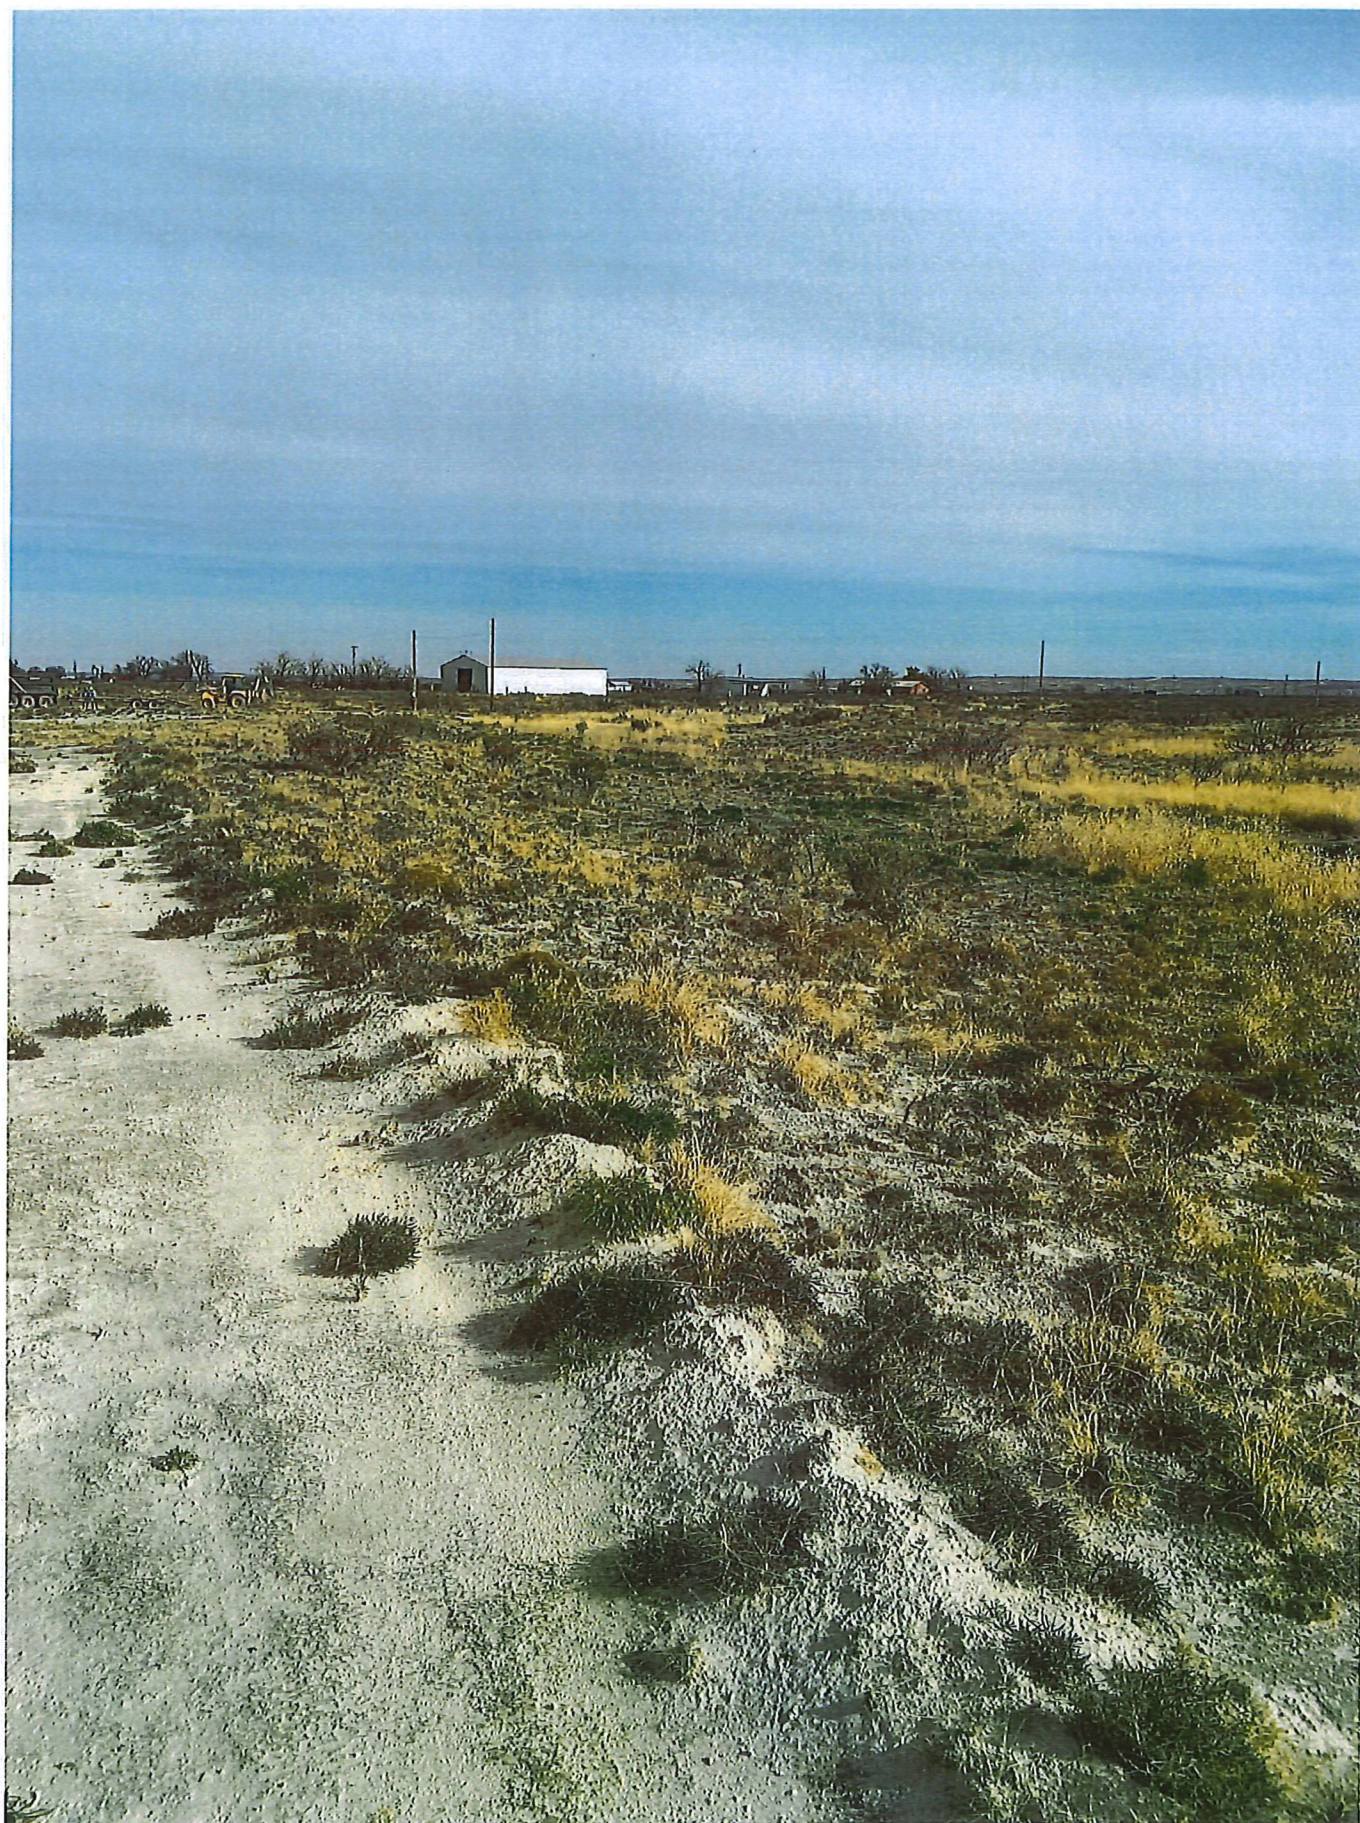
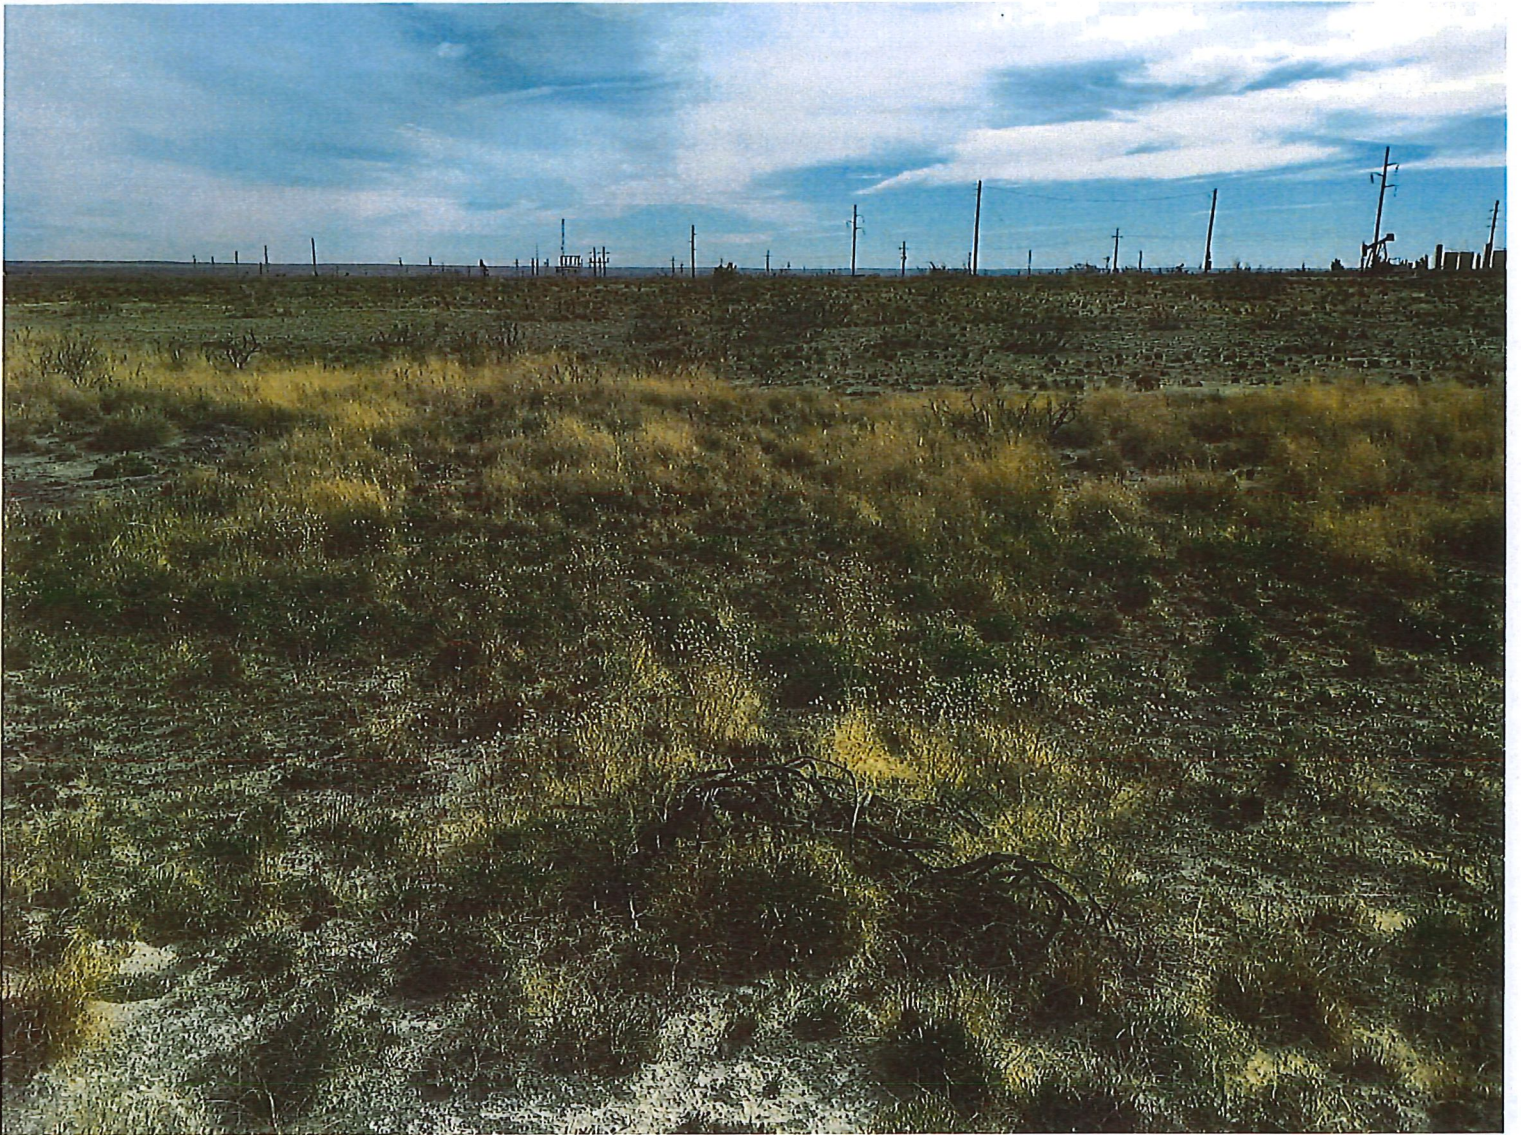
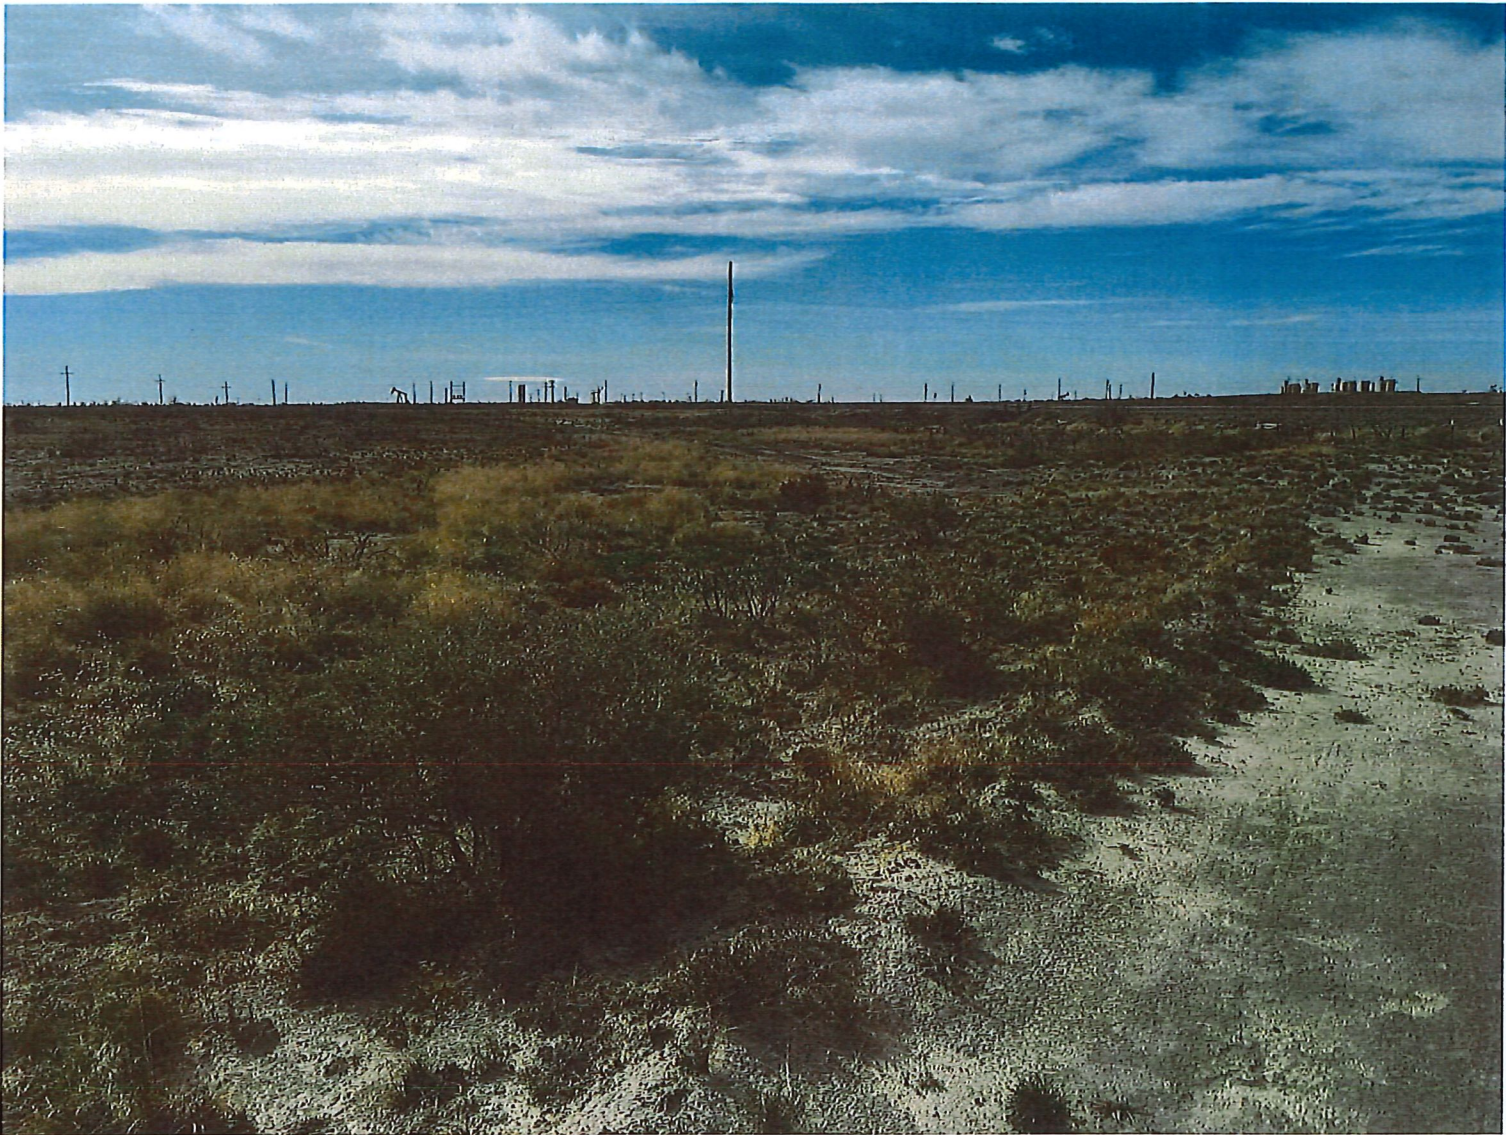
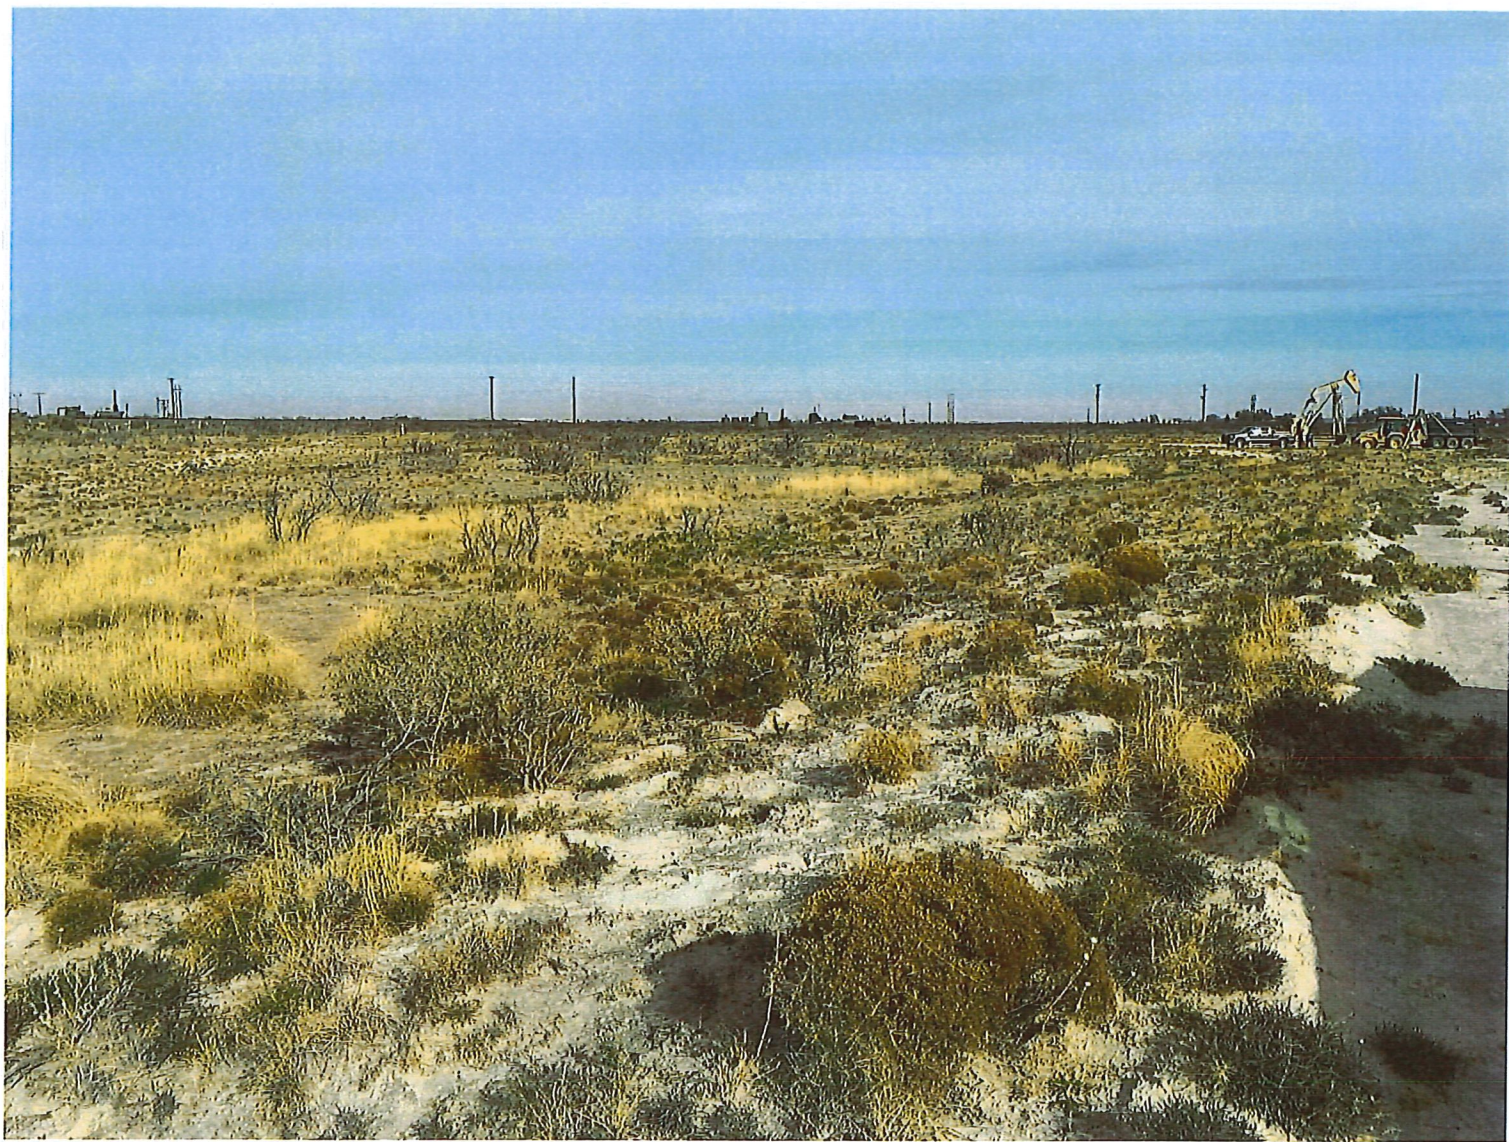
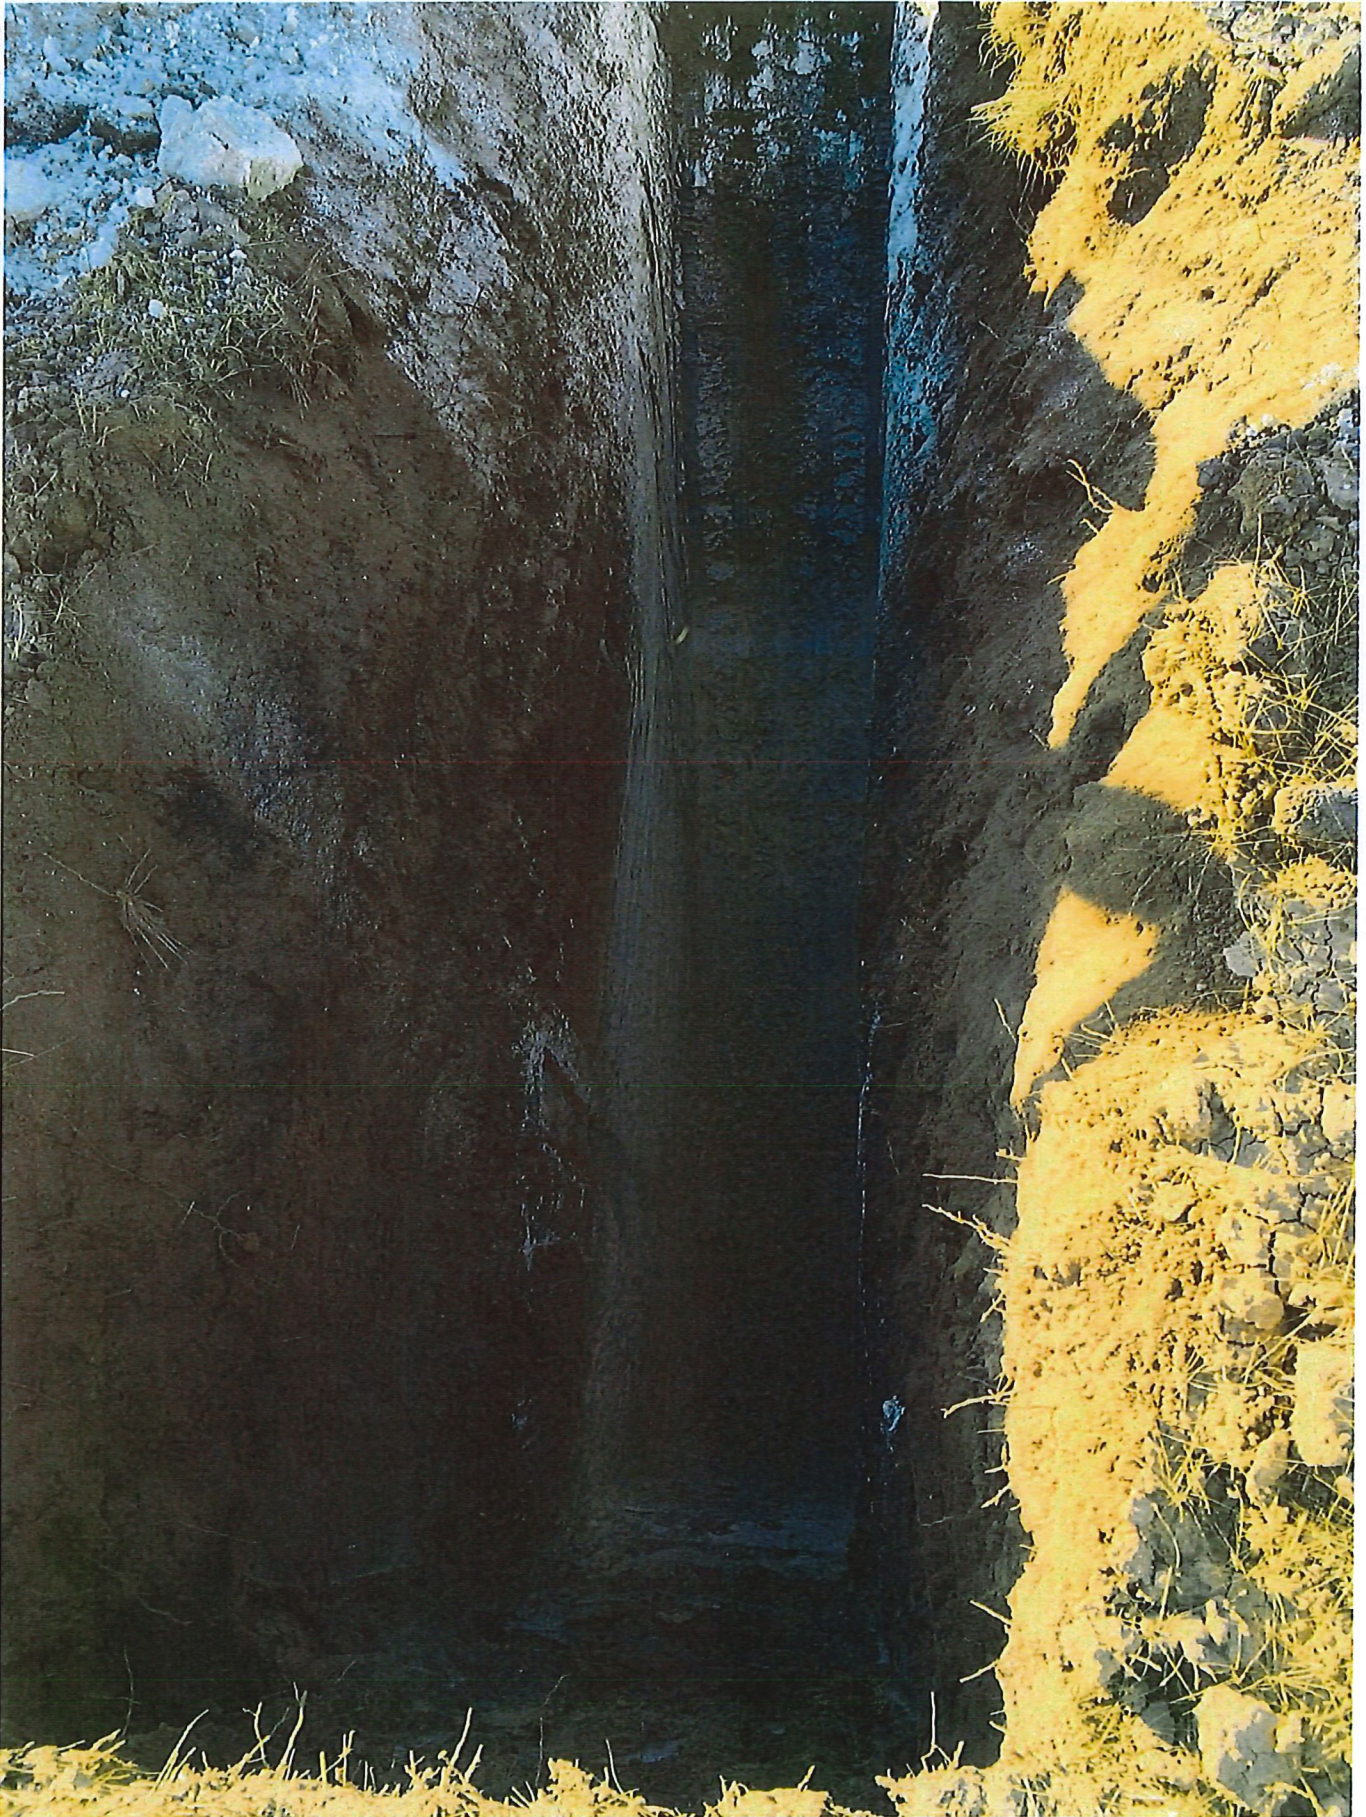
Photos

S3 & S4 Area

Due to the vegetative growth in the S3 and S4 sample areas, no work will be conducted. This area has recovered in regards to vegetation (see S2 Pictures section) and has a tremendous population of native grass that is thriving compared to the surrounding area. Due to the amount of vegetation growth and the clay soils encountered while sampling, it would be more beneficial to let the clay and evapotranspiration provide the groundwater protection rather than destroying that vegetation to install a liner at four (4) feet bgs when the same soil will be placed back on top of the liner since it does not contain or show the effects of chloride impaction.

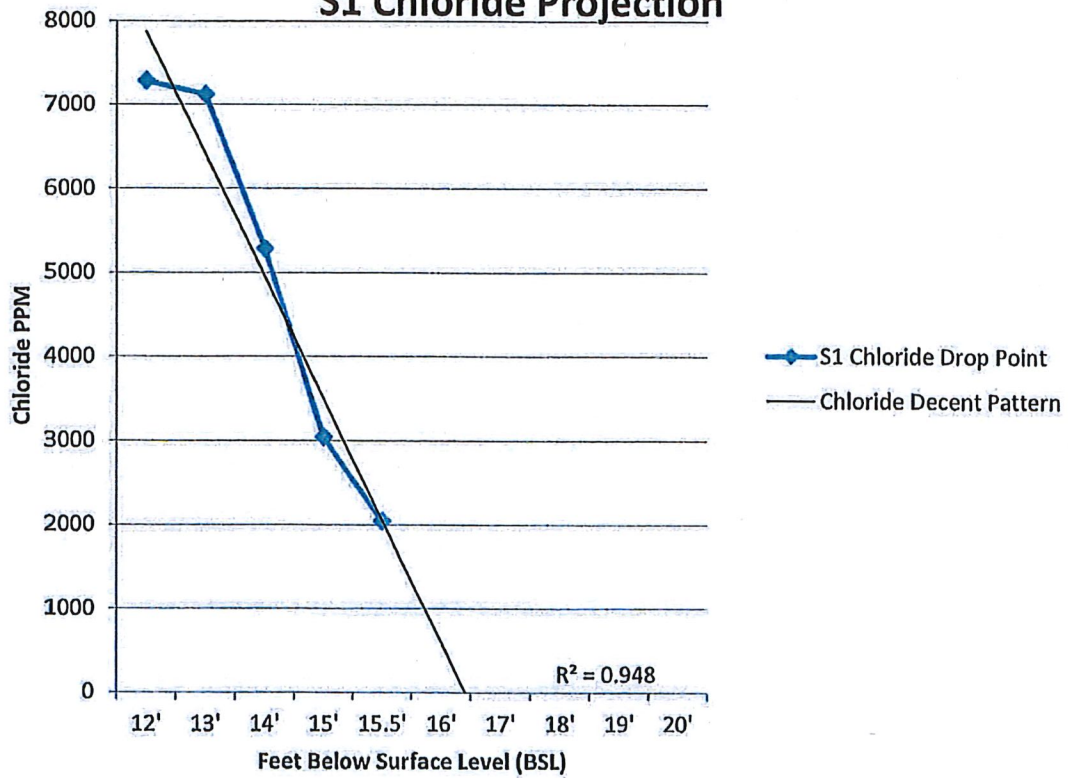
S1 Chloride Projection
