## **Closure Report**

Emerald PWU 20 #001H

|30-015-38338|2RP-4109|

Subject:       **Closure Report**  
                  Emerald PWU 20 #001H  
                  |30-015-38338| 2RP-4109|

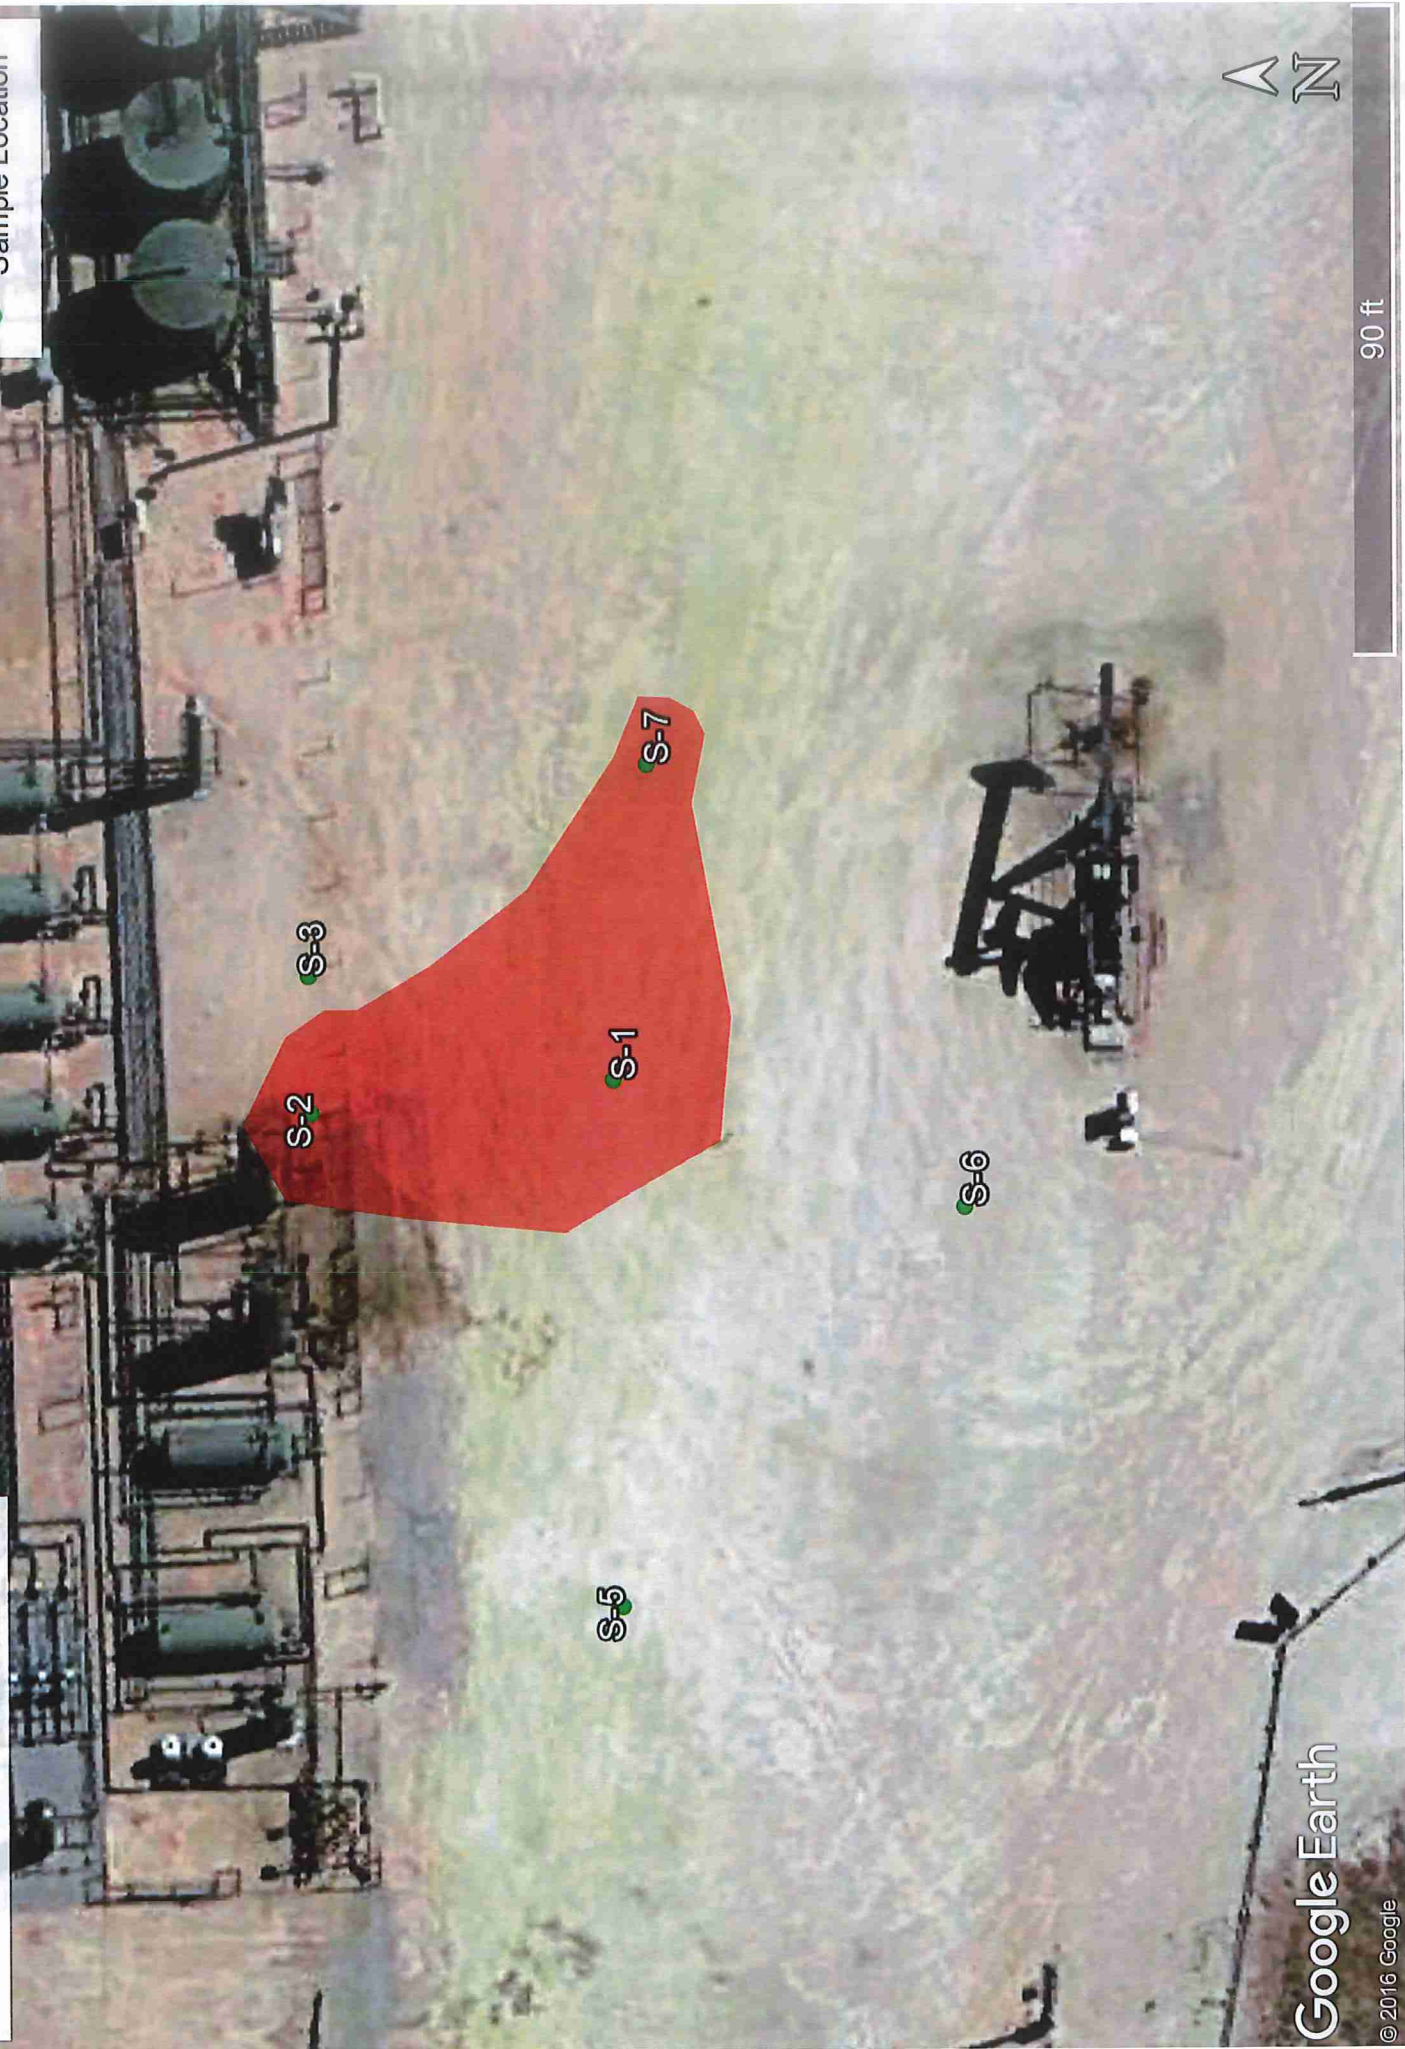
## SITE PLAN

# Emerald PWU 20 #1H

- Impacted Area
- Sample Location

- The impacted area in the vicinity of sample location S-1 was excavated to a depth of 0.5-feet BGS.
- The impacted area in the vicinity of sample location S-2 was hand excavated to a depth of 1-foot BGS.

- The impacted area in the vicinity of sample location S-7 was excavated utilizing field chloride titrations to guide the vertical extent of the excavation. At a depth of 0.5-feet field chloride titrations indicated that the soil chloride concentration was below 250 mg/kg. Per the approved work plan, a confirmation soil sample was taken from the bottom of the excavation and analyzed for total chlorides.
