**RE: Closure Request  
Remuda North 25 State 101H  
Remediation Permit Numbers 2RP-5139 and 2RP-5181  
Eddy County, New Mexico**

LT Environmental, Inc. (LTE), on behalf of XTO Energy, Inc. (XTO), presents the following report detailing excavation of impacted soil and confirmation soil sampling activities at the Remuda North 25 State 101H (Site) located in Unit L, Section 25, Township 23 South, Range 29 East, in Eddy County, New Mexico (Figure 1). The purpose of the soil sampling and excavation activities was to address impact to soil after two separate events caused the release of crude oil into the lined temporary tank containment during flowback operations.

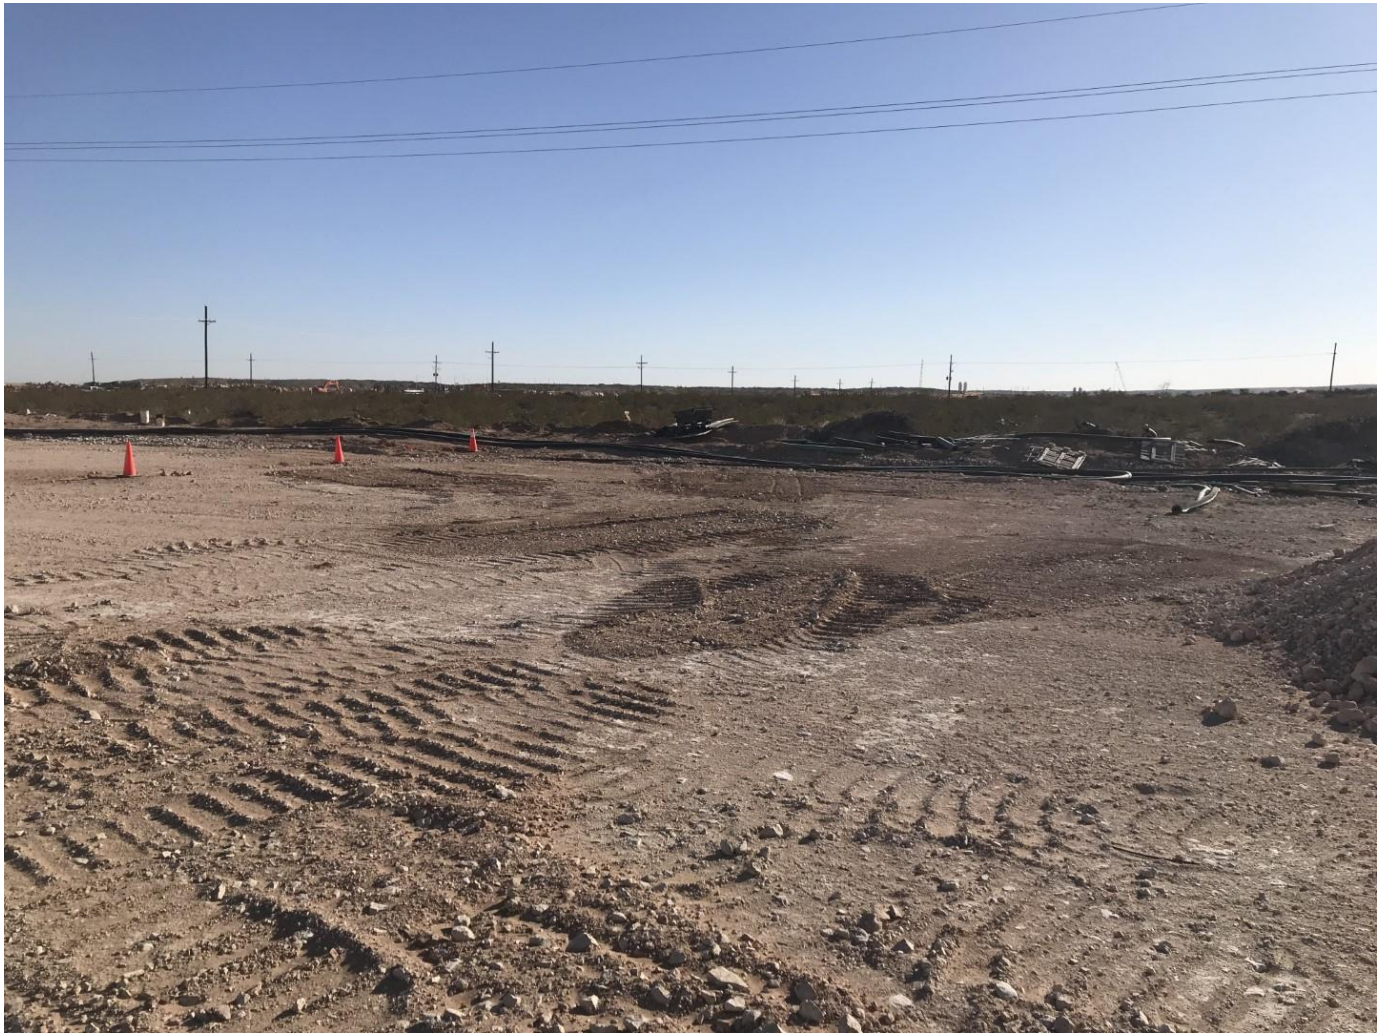
**Southeastern view of the contaminated area on the caliche well pad at the commencement of excavation activities.**

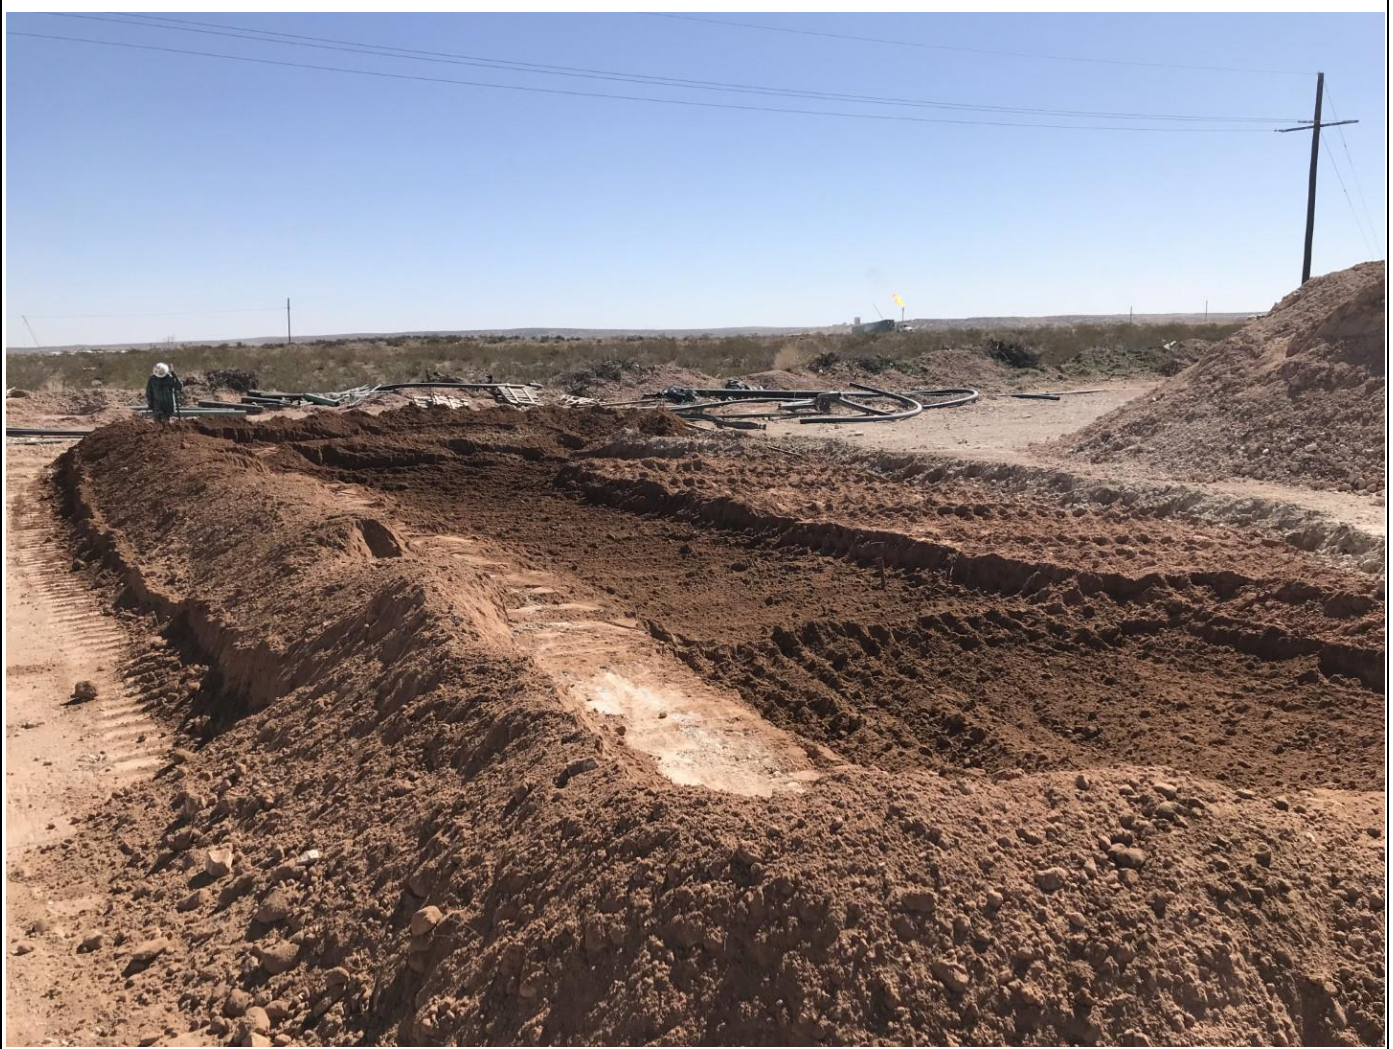
**View of the excavation area southern boundary.**

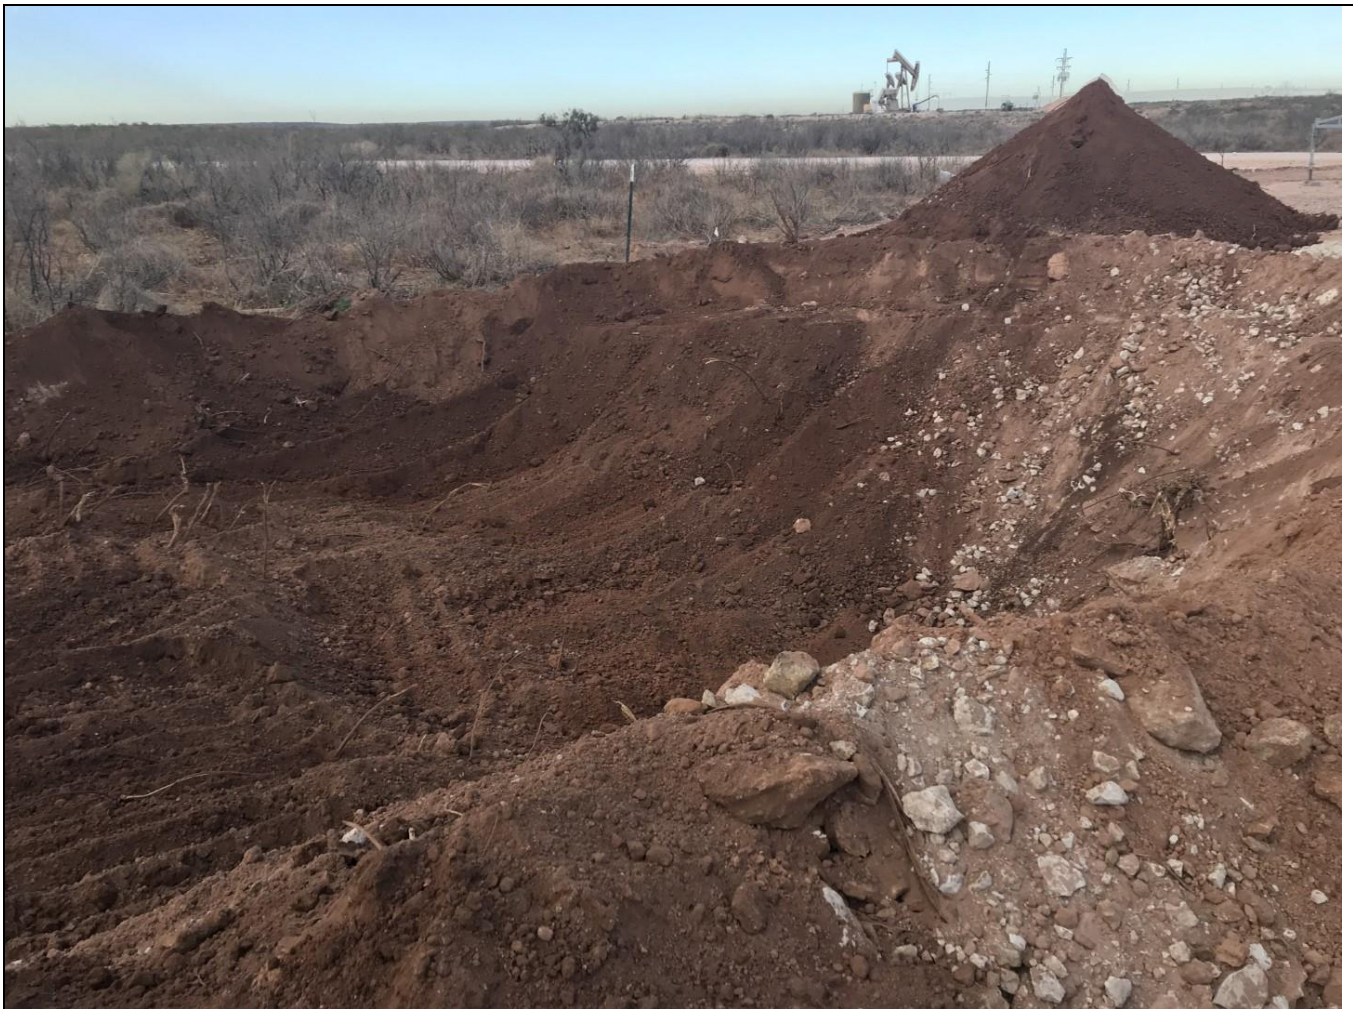
**View of excavation facing southwest.**
