Remediation Plan

Re: A State 40 Battery
API# 30-015-41130
Case # 2RP-5045

On 11/07/2019 a release occurred due to a failure on a poly pipe transition. An initial C-141 was sent to NMOCD and approved on 11/13/2019. The release (GPS 32.80258 -104.14958) is located east of Artesia New Mexico in unit letter K section 26 township 17S range 28E. A groundwater survey of 2000 meters for wells in the area was conducted utilizing the NMOSE and USGS web sites. The only well in that radius shows groundwater to be a depth of 257 feet below ground surface. There is a significant water course noted on the topographic map located 630 feet north of the release location. According to the BLM Karst Map shows that the release is not in an area of Karst. To date the site has been sampled to a depth of 1 foot which could not be extended vertically due to the hardness of the soil below 1 foot. This indicates that the root zone in the area is 1 foot deep. All samples that were collected were submitted to a commercial laboratory for analysis of chlorides, total hydrocarbons, and BTEX. Laboratory results were below table one standards for sites above 100 feet to groundwater.

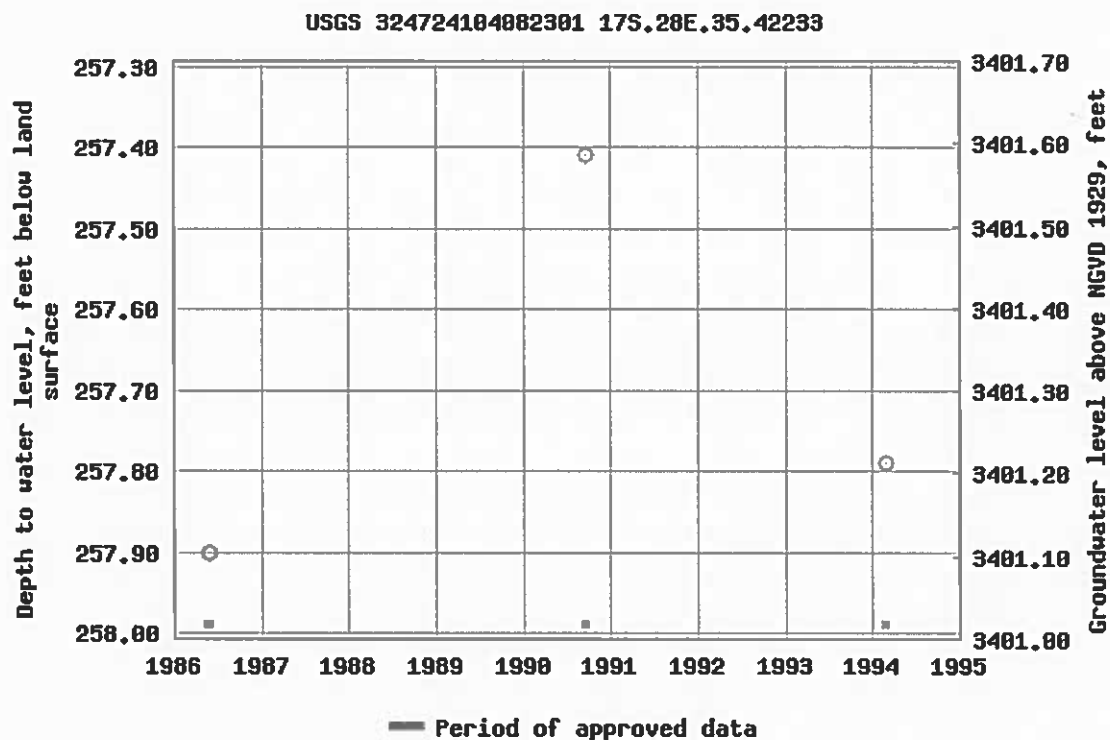
USGS 324724104082301 17S.28E.35.42233

The depth of the well is 280.00 feet below land surface.

This well is completed in the Rustler Formation (312RSLR) local aquifer.

Breaks in the plot represent a gap of at least one year between field measurements.

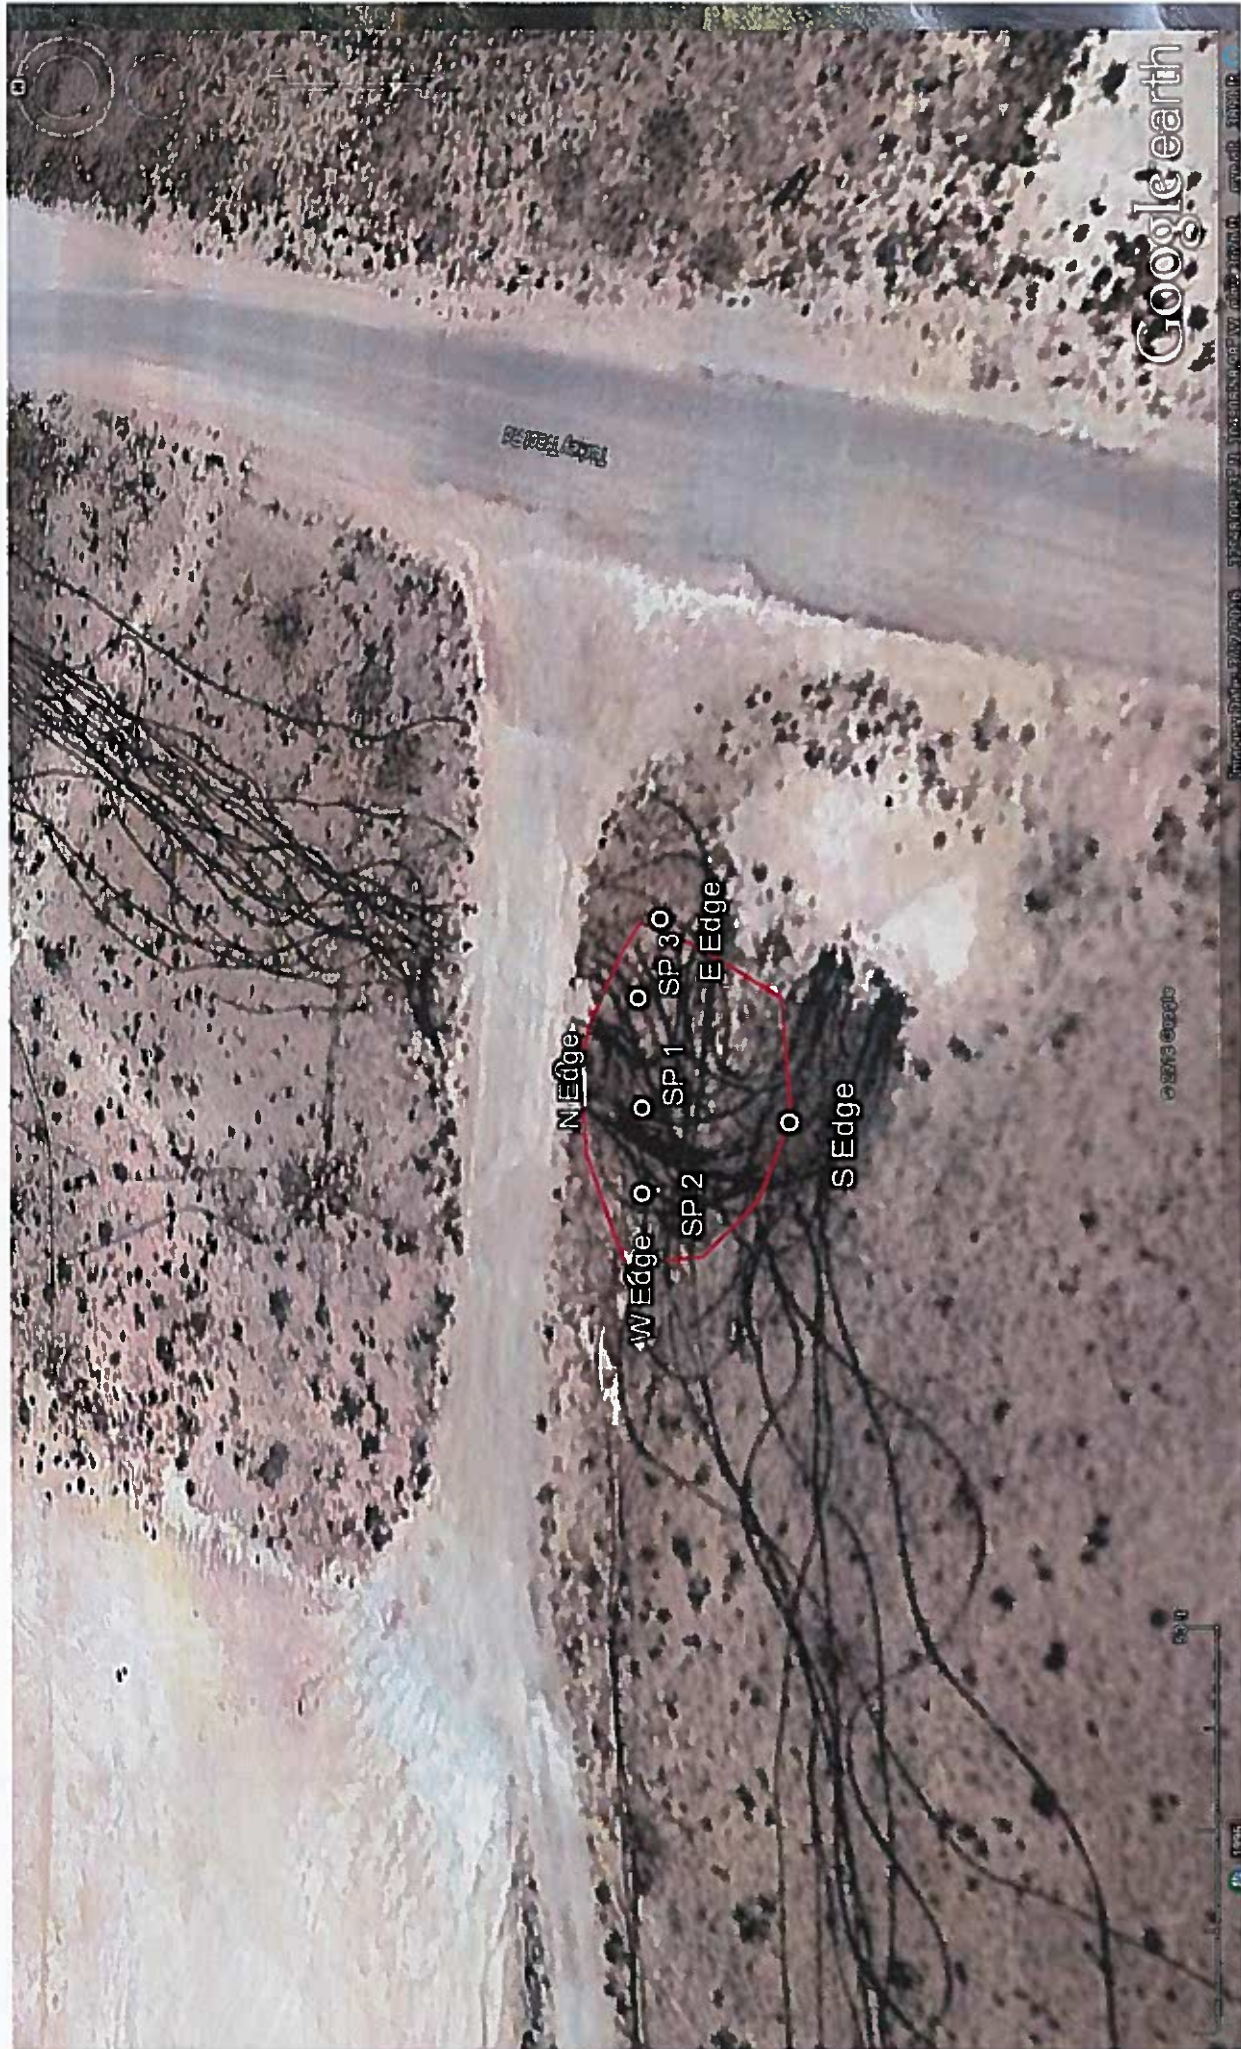
A State 40 Battery Release

SP 1										
Depth	Field Cl-	Lab Cl-	Benzene	Toluene	Ethybenzene	Total Xylenes	Total BTEX	GRO	DRO	EXT DRO
Surface	6,272	5840	<0.050	<0.050	<0.050	<0.150	<0.300	<10.0	191	52.6
1'	3,884	6240	<0.050	<0.050	<0.050	<0.150	<0.300	<10.0	<10.0	<10.0
SP 2										
Depth	Field Cl-	Lab Cl-	Benzene	Toluene	Ethybenzene	Total Xylenes	Total BTEX	GRO	DRO	EXT DRO
Surface	8,367	13800	<0.050	<0.050	<0.050	<0.150	<0.300	<10.0	<10.0	<10.0
1'	5752	9400	<0.050	<0.050	<0.050	<0.150	<0.300	<10.0	<10.0	<10.0
SP 3										
Depth	Field Cl-	Lab Cl-	Benzene	Toluene	Ethybenzene	Total Xylenes	Total BTEX	GRO	DRO	EXT DRO
Surface	12,416	16400	<0.050	<0.050	<0.050	<0.150	<0.300	<10.0	<10.0	<10.0
1'	2065	6720	<0.050	<0.050	<0.050	<0.150	<0.300	<10.0	<10.0	<10.0
N EDGE										
Depth	Field Cl-	Lab Cl-	Benzene	Toluene	Ethybenzene	Total Xylenes	Total BTEX	GRO	DRO	EXT DRO
Surface	272	16	<0.050	<0.050	<0.050	<0.150	<0.300	<10.0	<10.0	<10.0

W EDGE										
Depth	Field Cl-	Lab Cl-	Benzene	Toluene	Ethybenzene	Total Xylenes	Total BTEX	GRO	DRO	EXT DRO
Surface	407	6400	<0.050	<0.050	<0.050	<0.150	<0.300	<10.0	<10.0	<10.0
E EDGE										
Depth	Field Cl-	Lab Cl-	Benzene	Toluene	Ethybenzene	Total Xylenes	Total BTEX	GRO	DRO	EXT DRO
Surface	134	<16	<0.050	<0.050	<0.050	<0.150	<0.300	<10.0	<10.0	<10.0
S EDGE										
Depth	Field Cl-	Lab Cl-	Benzene	Toluene	Ethybenzene	Total Xylenes	Total BTEX	GRO	DRO	EXT DRO
Surface	266	<16	<0.050	<0.050	<0.050	<0.150	<0.300	<10.0	<10.0	<10.0

Apache Corporation purposes that since the release area is under multiple poly flow lines and is below the table one standards that no action be required and reclamation be performed to restore the vegetation at a time when the poly lines are removed from service.
