SUBJECT: Remediation Closure Report for the Wolfman 5/4 WOLI Fed Com #1H Release (2RP-5250), Eddy County, New Mexico

Site and Sample location Map  
Mewbourne-Wolfman 5/4 WOLI Fed Com #1H  
Unit L, Sec. 5, T23S, R27E, Eddy County

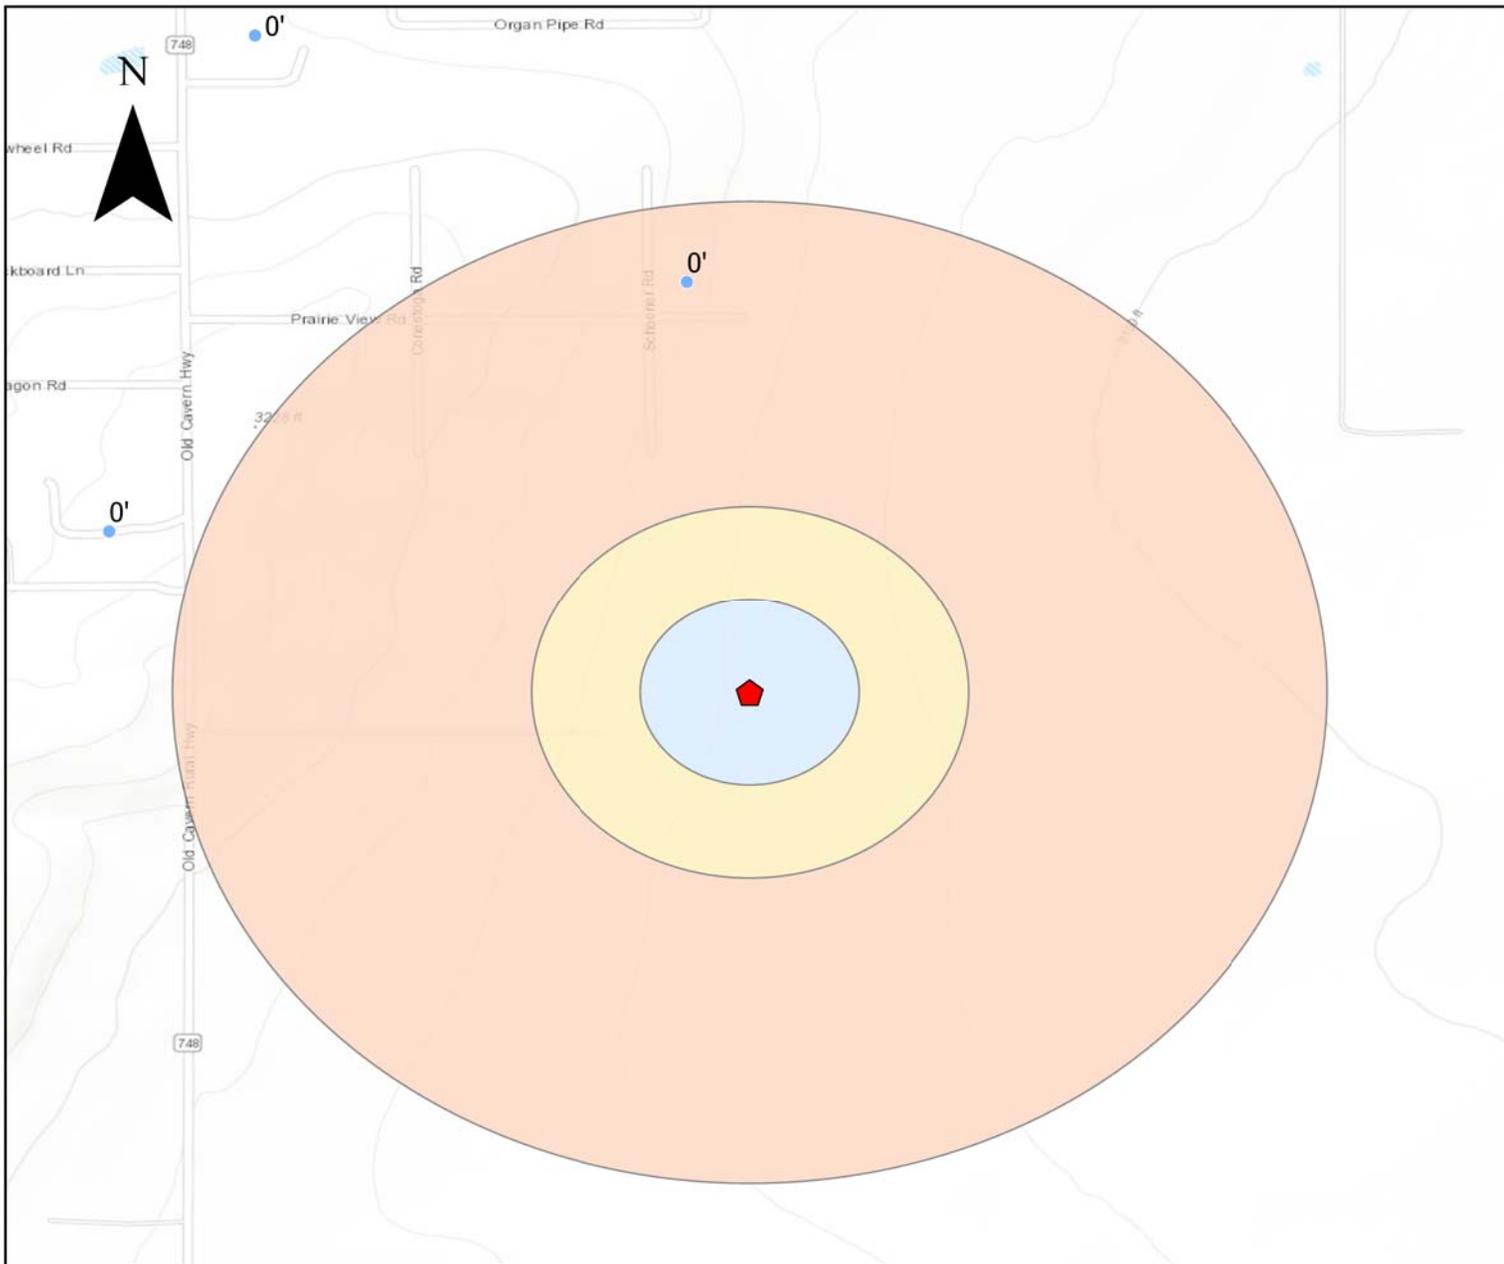
Figure 1

Regional Vicinity & Wellhead Protection Map  
 Wolfman 54 WOLI Fed Com #1H-Mewbourne

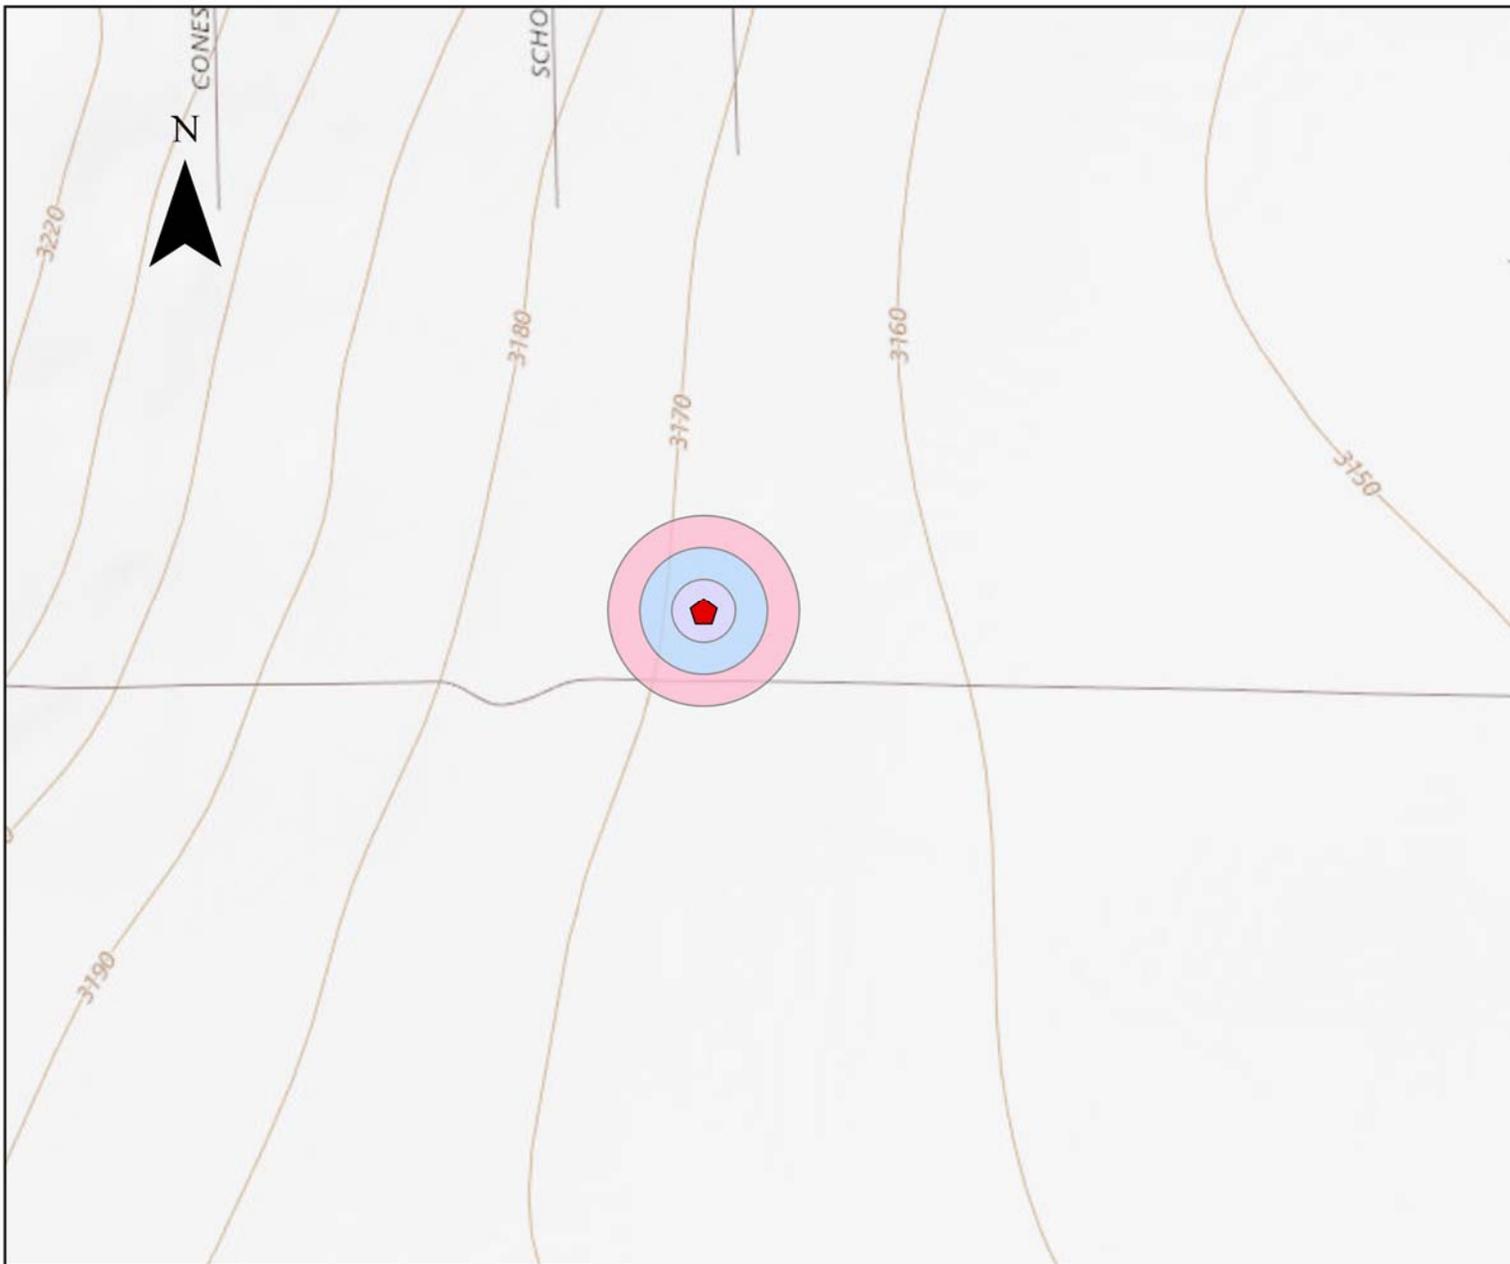
Figure 2

Surface Water Protection Map  
 Wolfman 54 WOLI Fed Com #1H-Mewbourne  
 Eddy County, NM

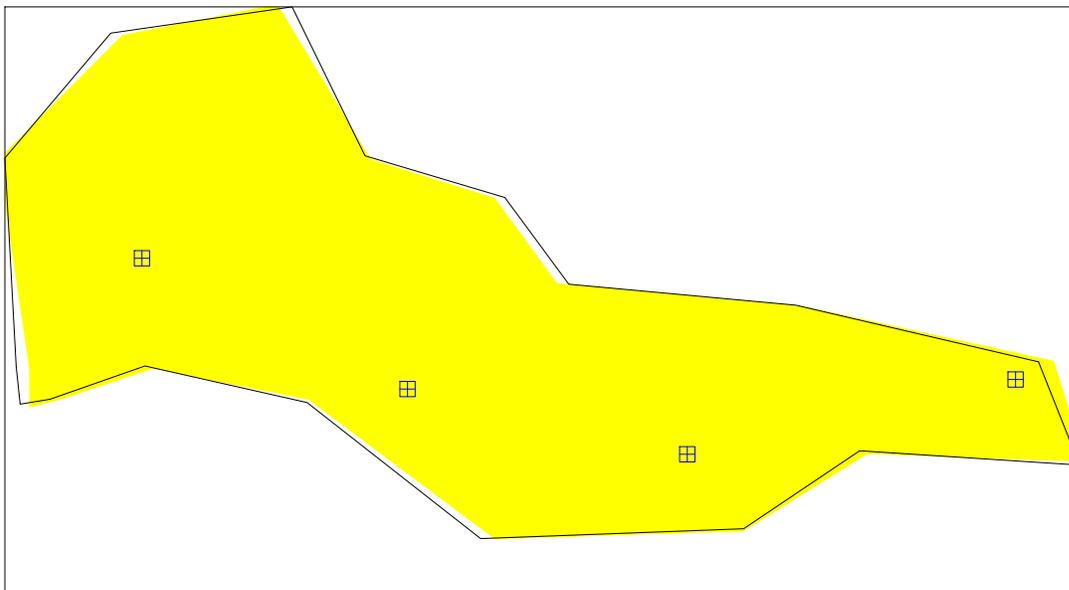
The following table summarizes the proportion stratified sampling design developed. A figure that shows sampling locations in the field and a table that lists sampling location coordinates are also provided below.

Area: Area 1
