Remediation Plan

*Re: Cedar Lake Federal CA 737H
API# 30-015-40901
Case # 2RP-4972*

On 9/16/2018 a release occurred due to a 2 inch tee on the well head failed. An initial C-141 was sent to NMOCD and approved by NMOCD on 9/18/2018. The Cedar Lake Federal CA 737H is located east of Loco Hills in unit letter A section 7 township 17S range 31E (GPS Coordinates: 32.85432 -103.90390). A groundwater study was conducted utilizing the NMOSE and USGS sites to search for groundwater wells in the vicinity of the release site. According to the USGS and NMOSE there are no wells in township 17S range 31E. It is common knowledge that there is no groundwater in township 17S and range 31E. The village of Loco Hills water source is the double eagle water pipeline which source of water is on top of the cap-rock located east of the township and range.

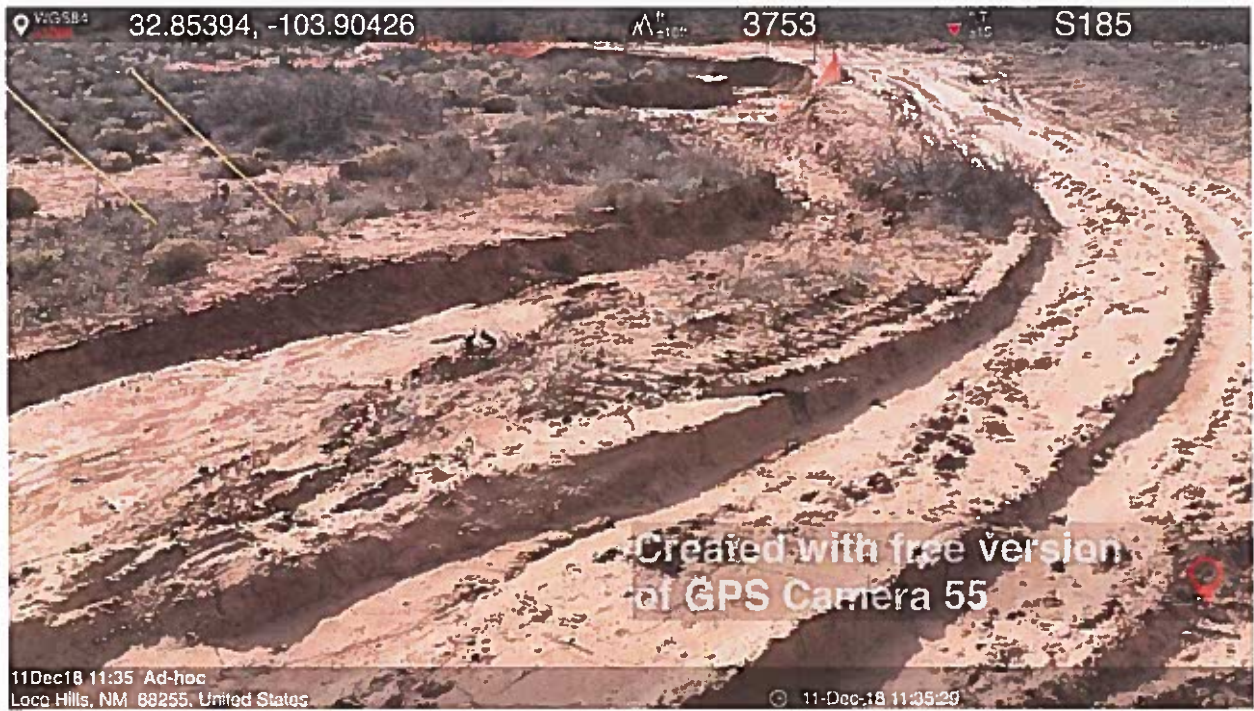
Photo of Pasture Excavation

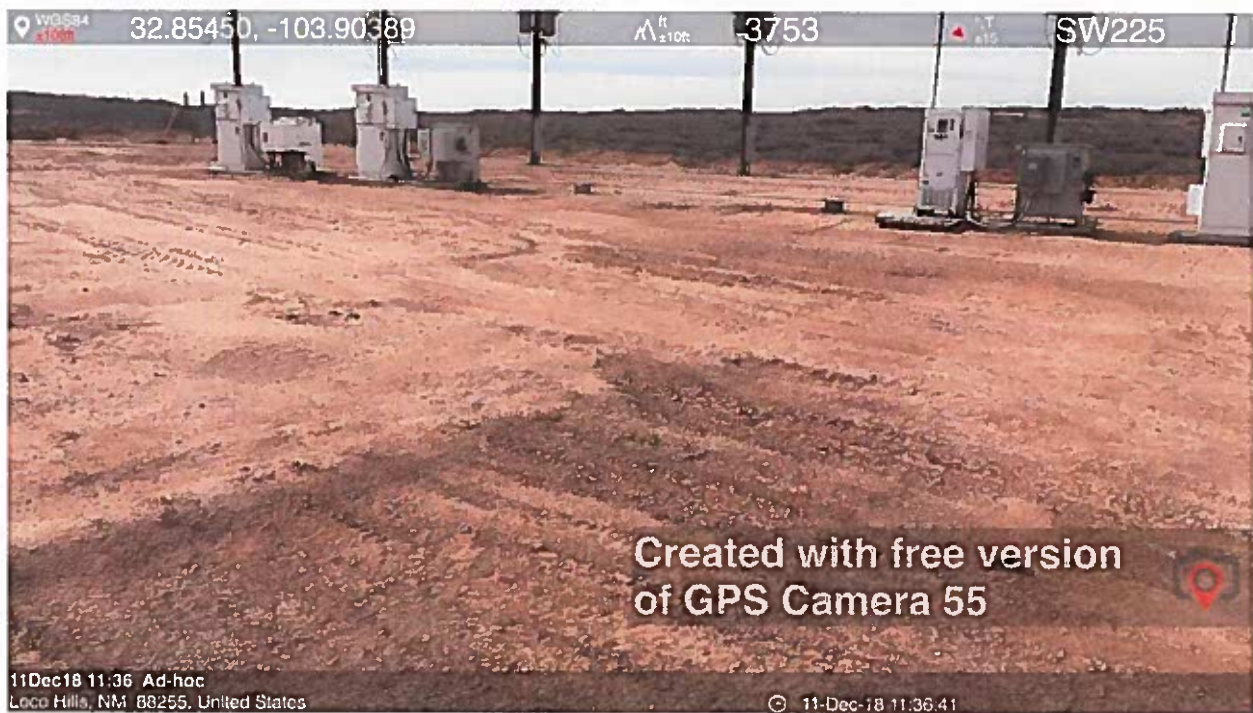
Photo of Pad Scrape
