May 30, 2019

Vertex Project #: 19E-00614-003

Spill Closure Report: Fiddle Fee 24 28 23 TB #2H (Section 23, Township 24 South, Range 28 East)
API: 30-015-44540
County: Eddy
Incident Report: 2RP-5322

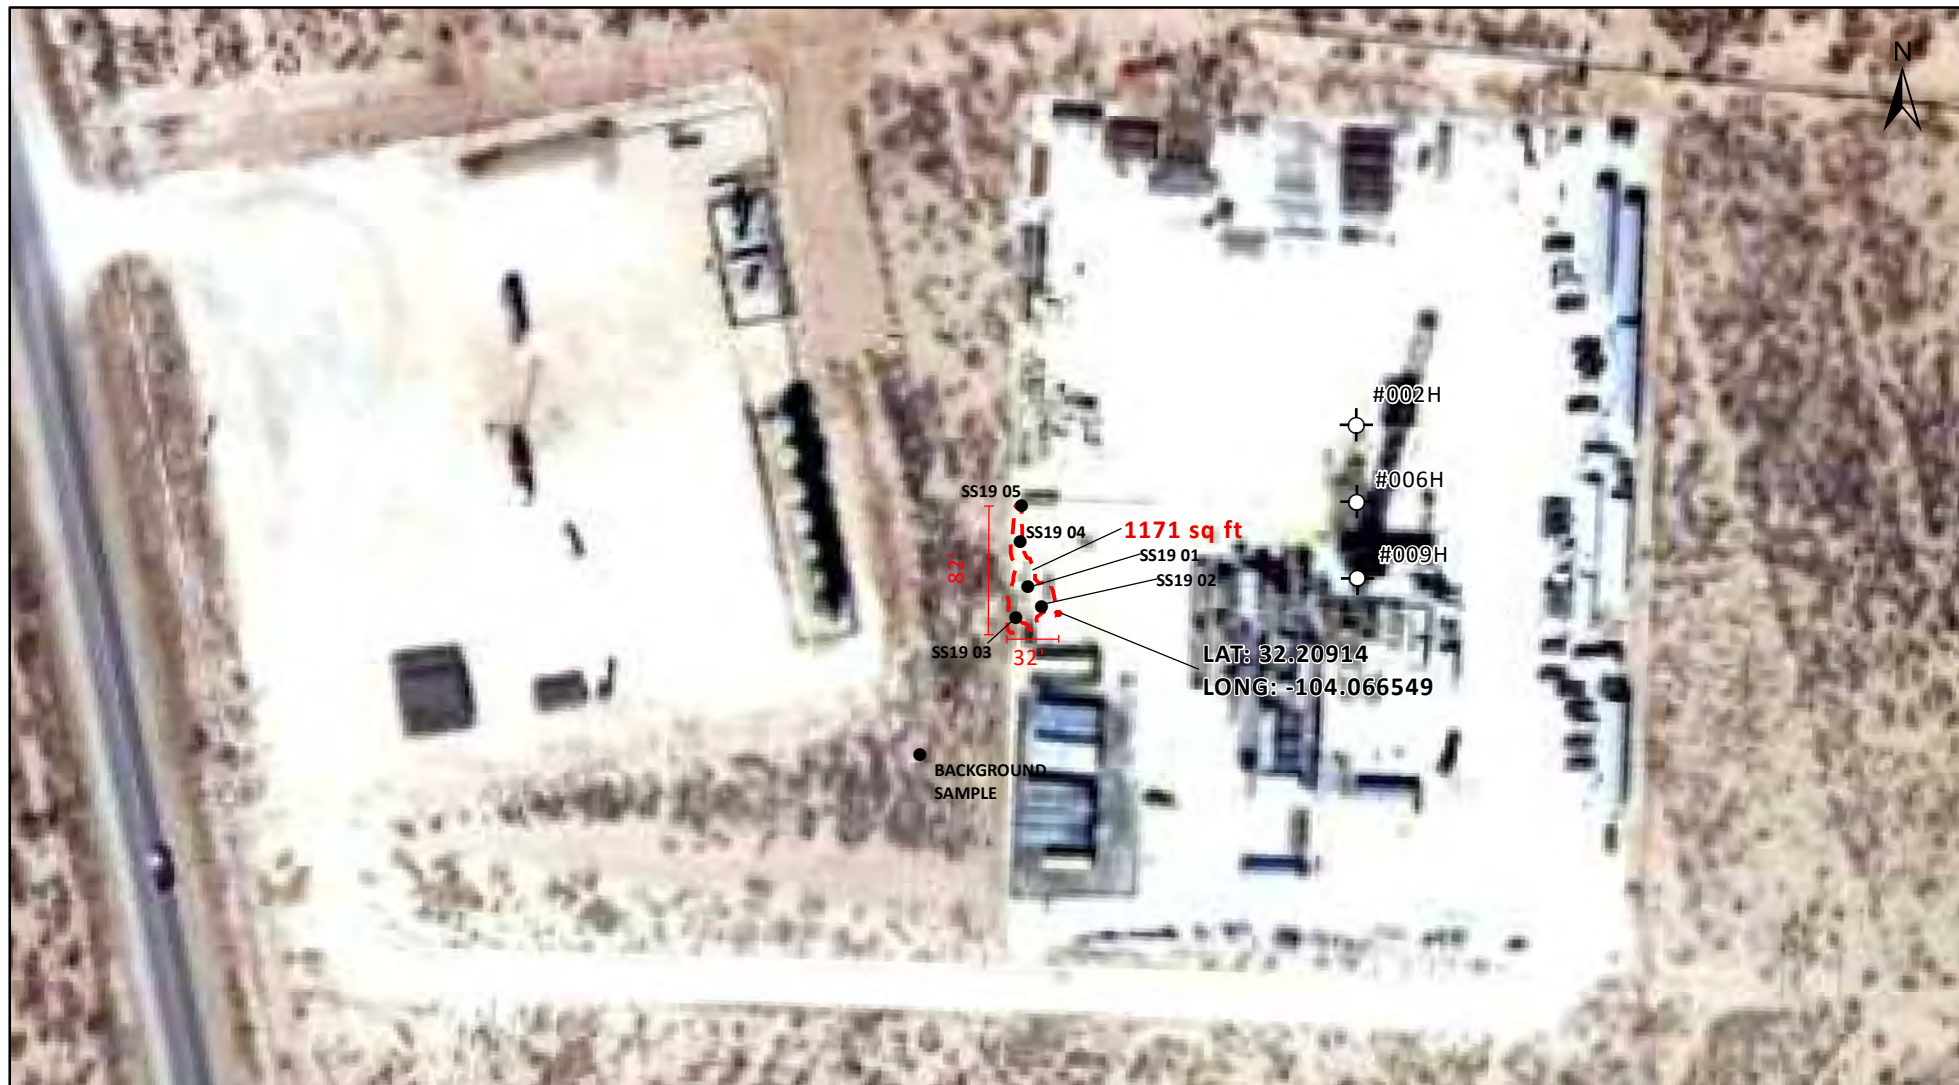
1

- SOIL SAMPLE
- ⊕ WELL
- ▭ SPILL

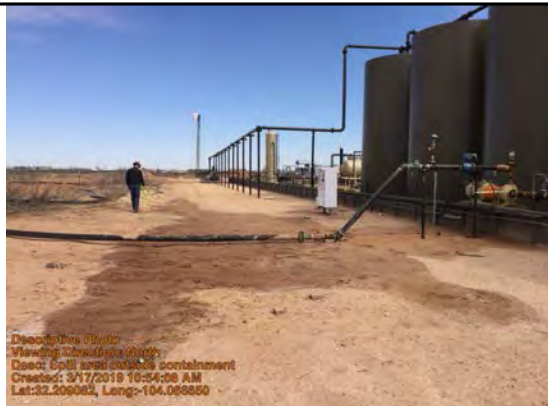
Viewing Direction: North

Spill area outside containment

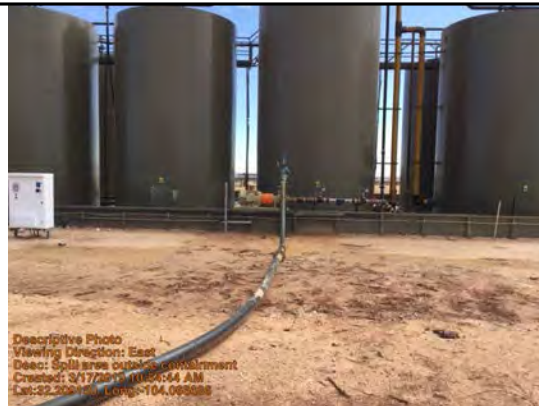
Viewing Direction: East

Spill area outside containment

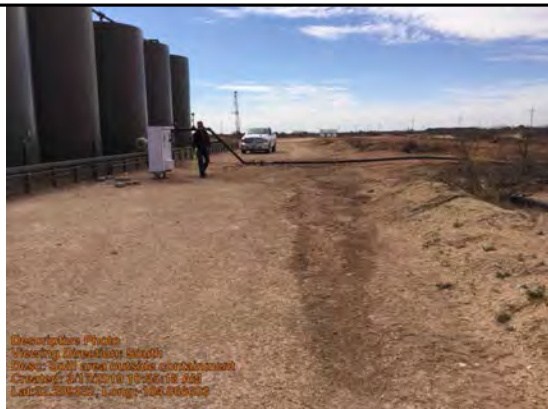
Viewing Direction: South

Spill area outside containment

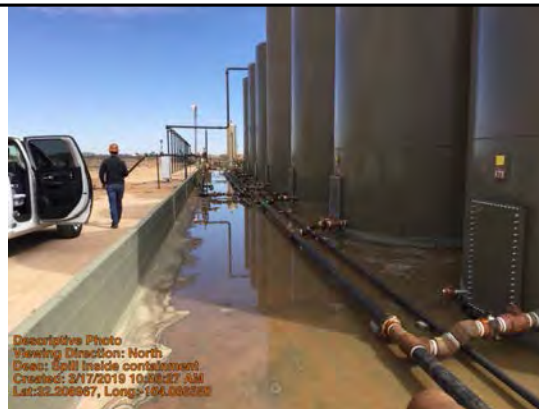
Viewing Direction: North

Spill inside containment

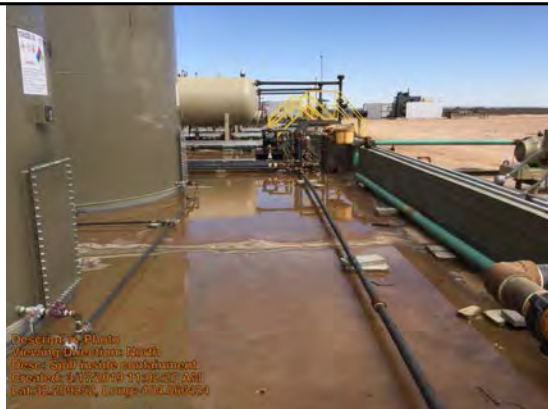
Viewing Direction: North

Spill inside containment

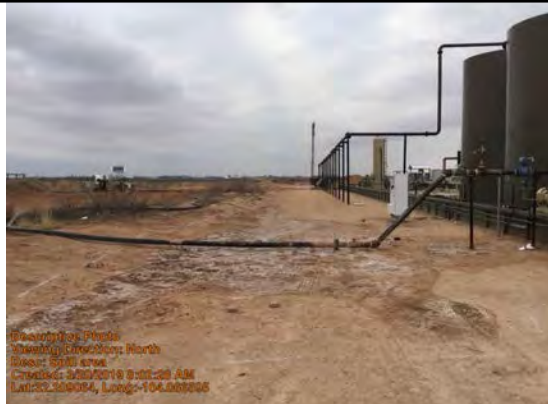
Viewing Direction: North

Spill area

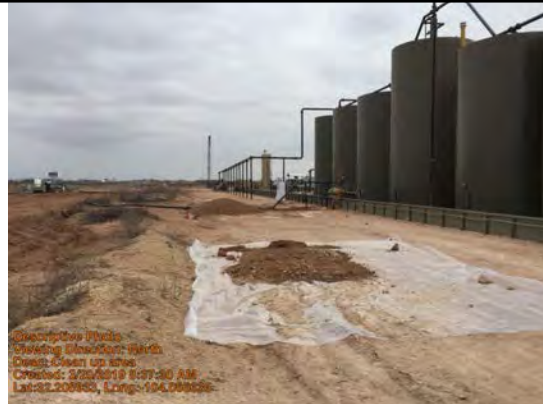
Viewing Direction: North

Clean up area

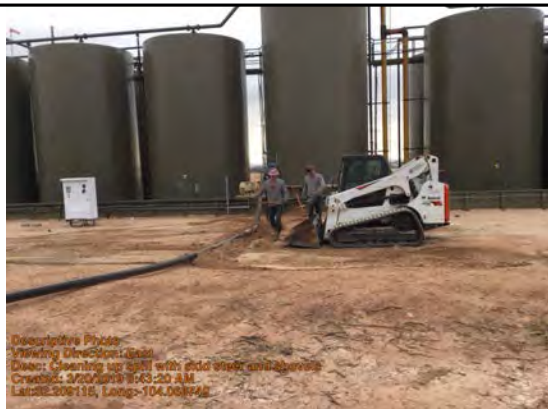
Viewing Direction: East

Cleaning up spill with skid steer and shovels

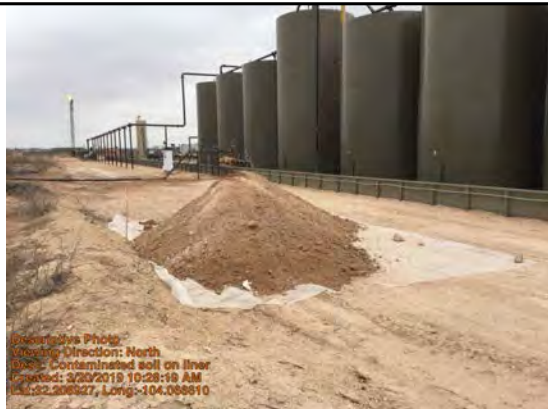
Viewing Direction: North

Contaminated soil on liner

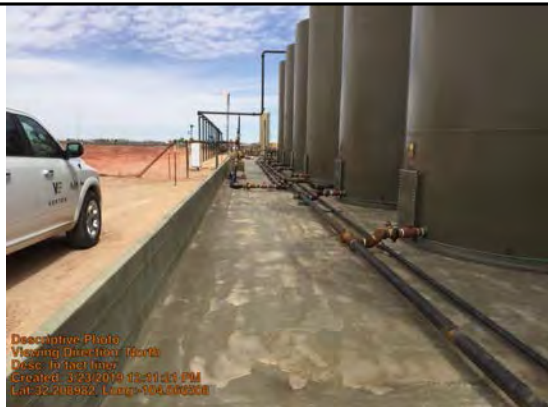
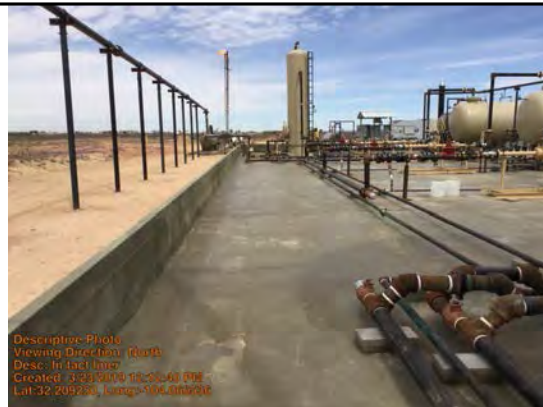
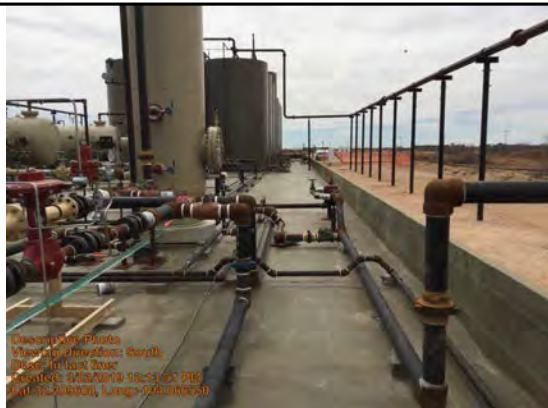
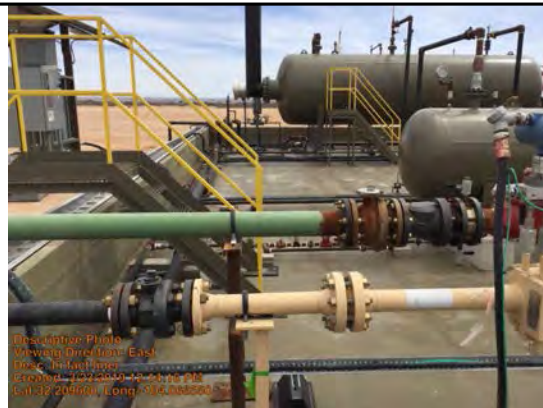
In tact liner

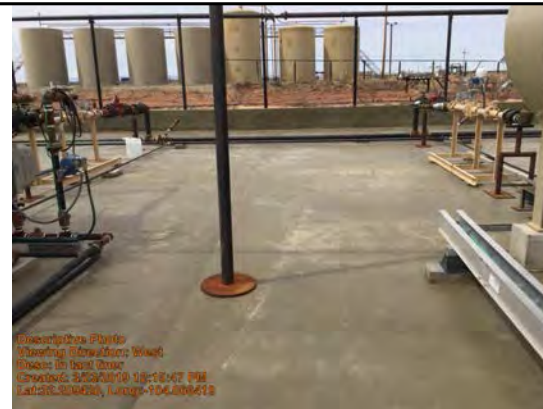
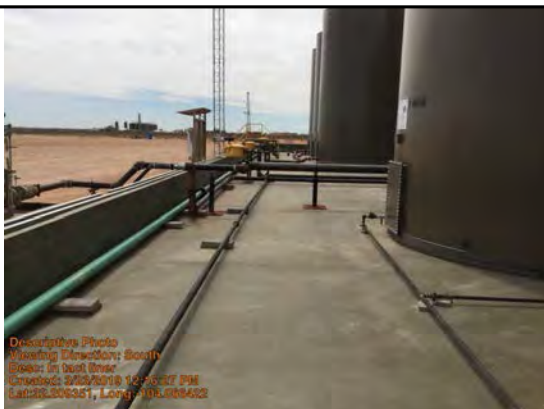
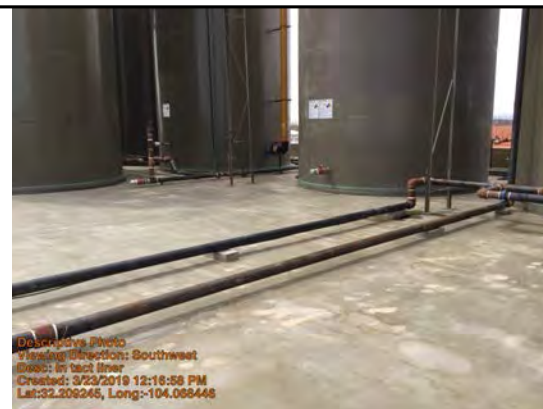
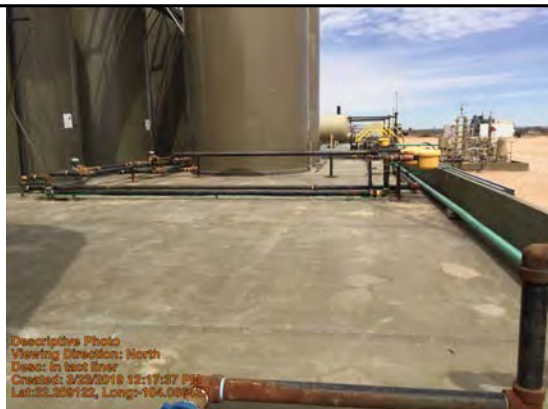
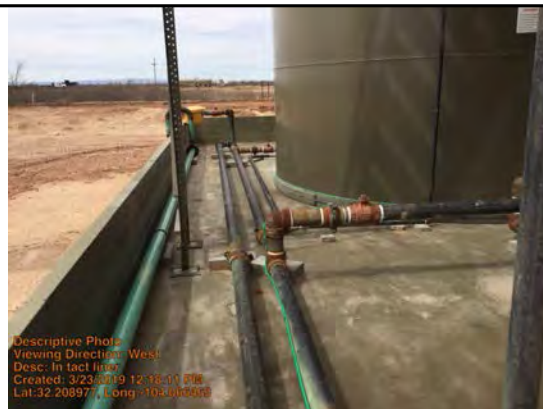
In tact liner

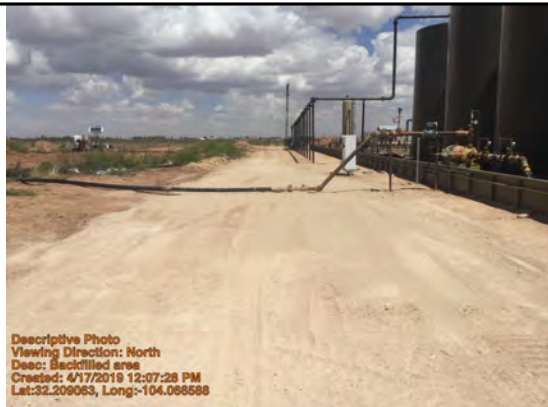
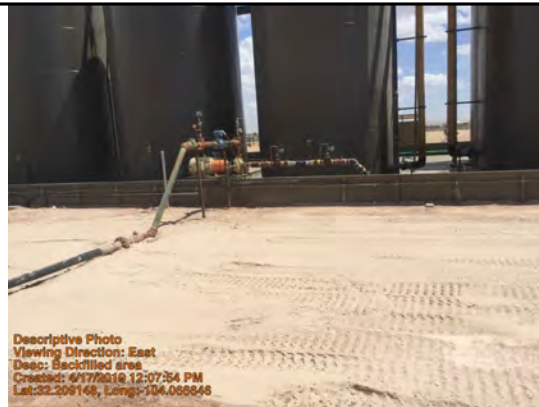
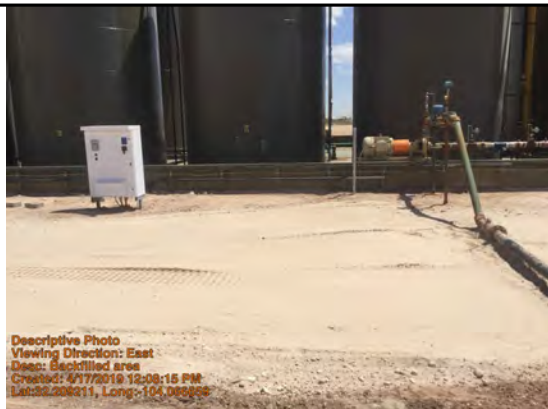
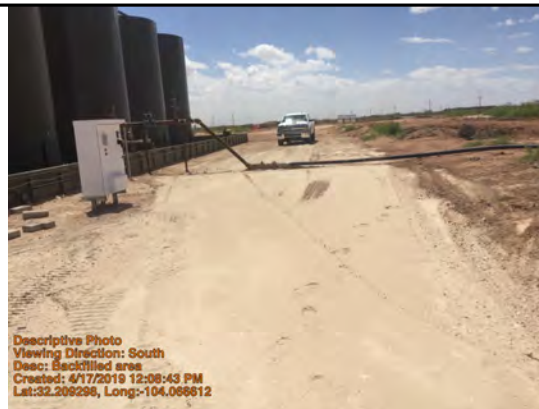
Backfilled area

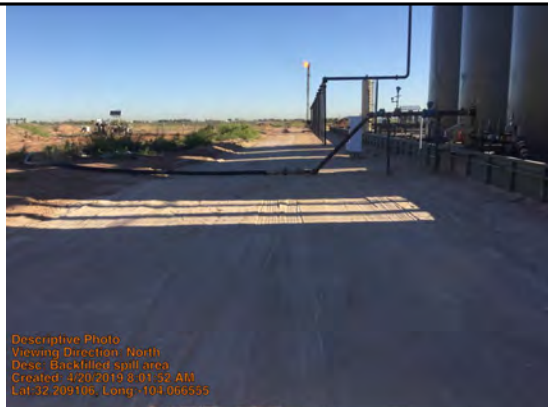
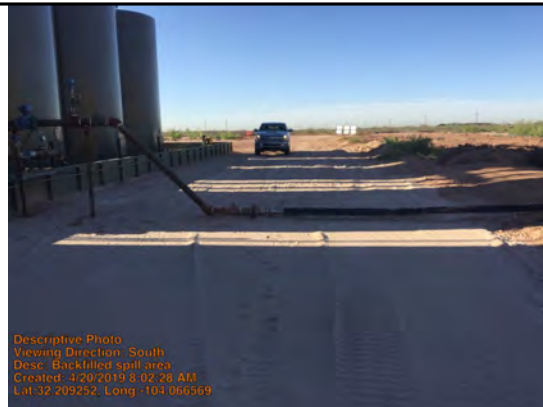
Backfilled spill area

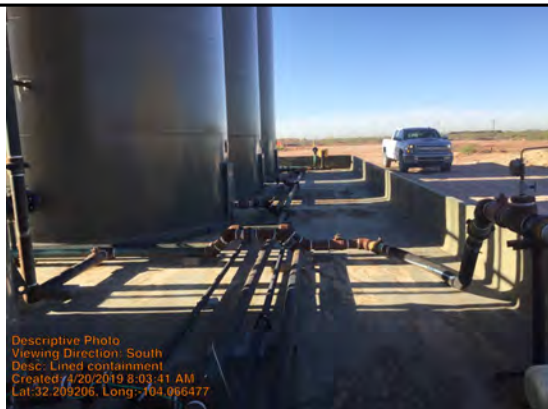
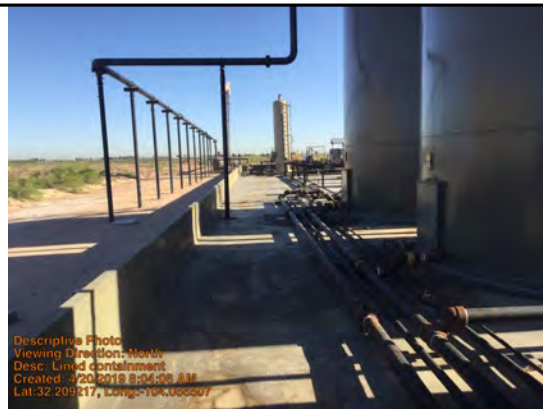
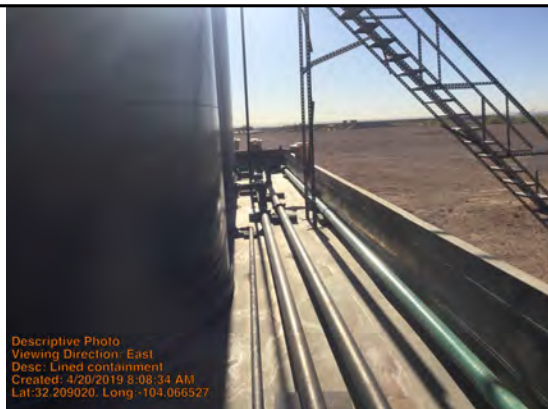
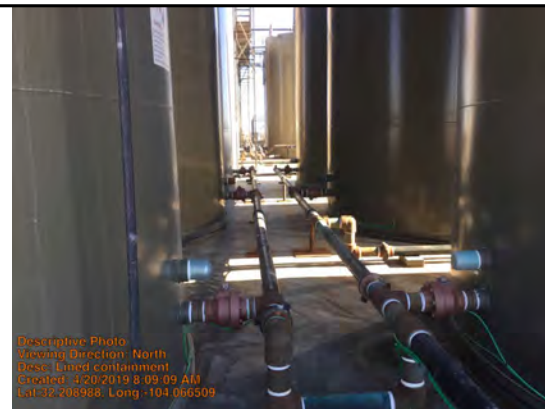
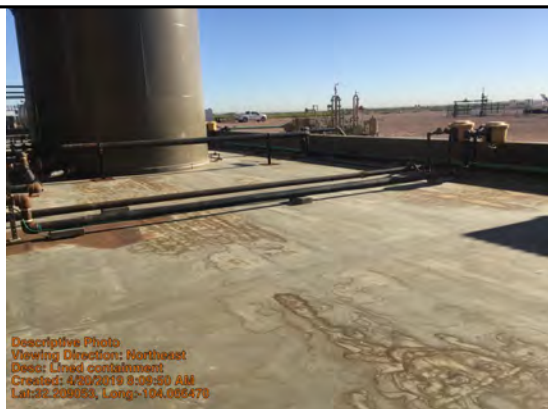
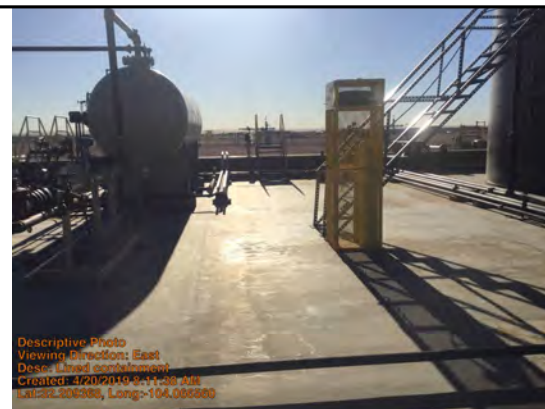
Lined containment
