**RE: BTA Oil Producers  
Site Activities**

**1RP-5289**

**Mesa 8105 JV-P 13/18 Compressor  
UL-P, Sec. 1 T26S - R32E  
Lea County, NM**

Mesa 13/18 Compressor Slop Tank Release - November 24, 2018; February 8, 2019; and February 9, 2019  
 OCD Tracking #: 1RP-5289 and 1RP-5383

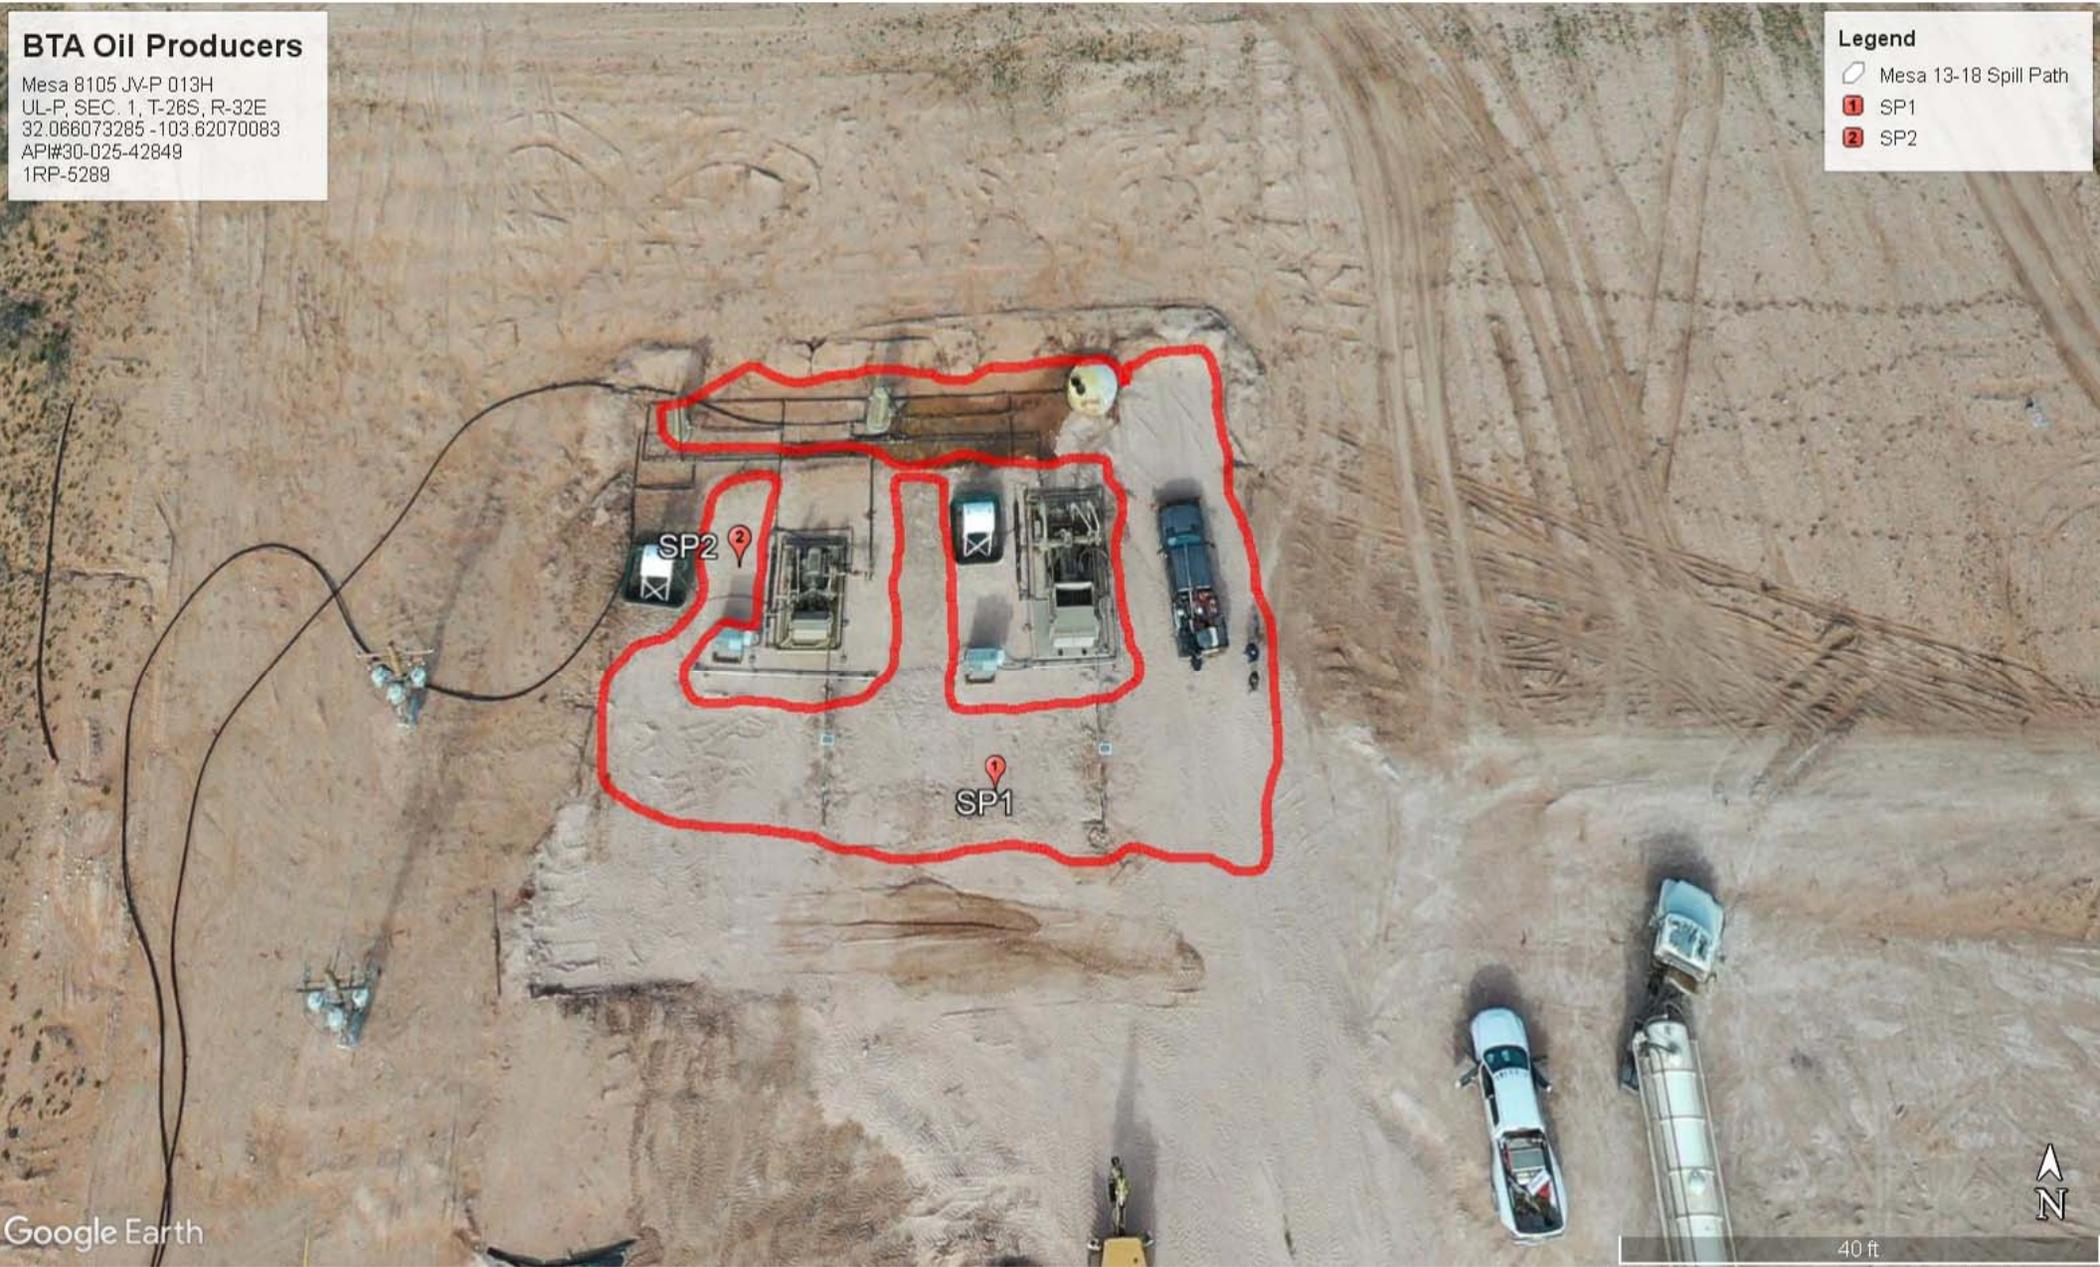
**Legend**

- Mesa 13-18 Spill Path
- 1 SP1
- 2 SP2

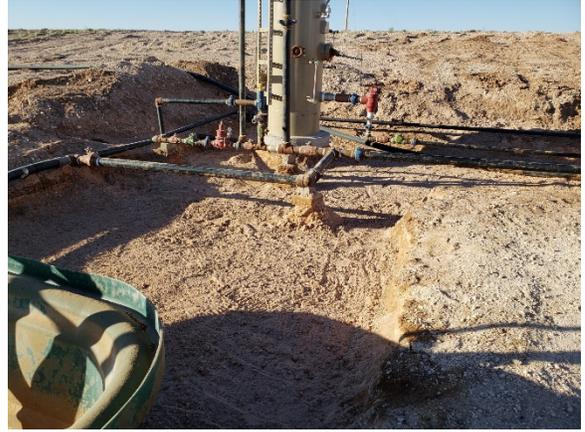
Spill Excavated

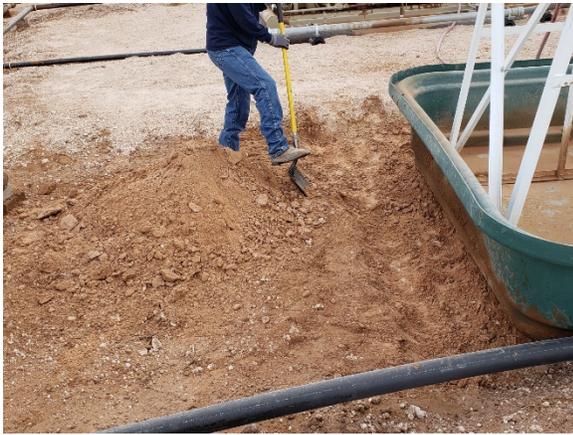
Digging up release

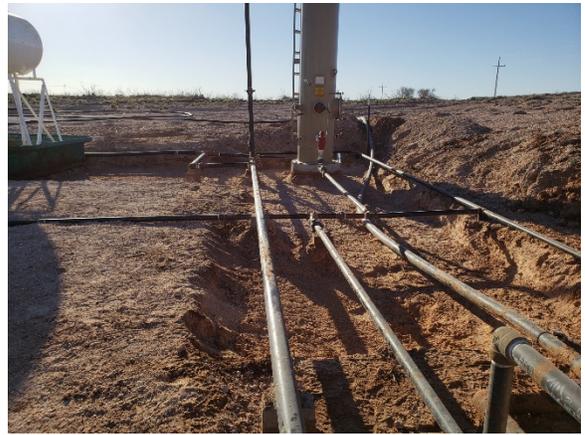
Spill Excavated

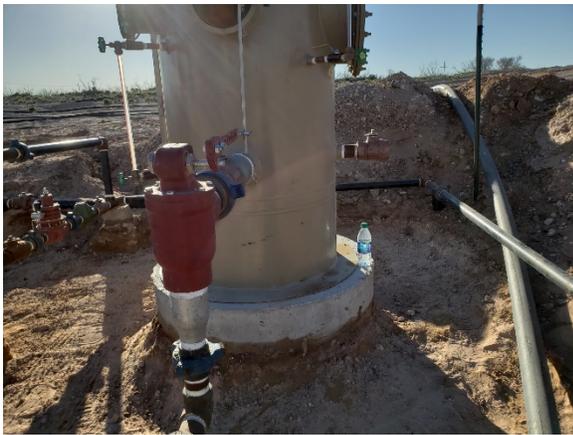
Spill excavated

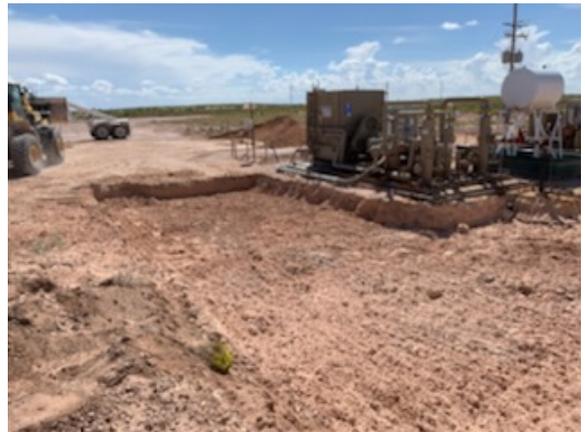
Spill Area Facing South
