## DELINEATION/REMEDATION WORKPLAN

### OXY – CEDAR CANYON 28-2 WT PUMP (Leak Date: 1/17/19)

#### RP # 2RP-5224

# Oxy, Cedar Canyon 28-2 WT Pump

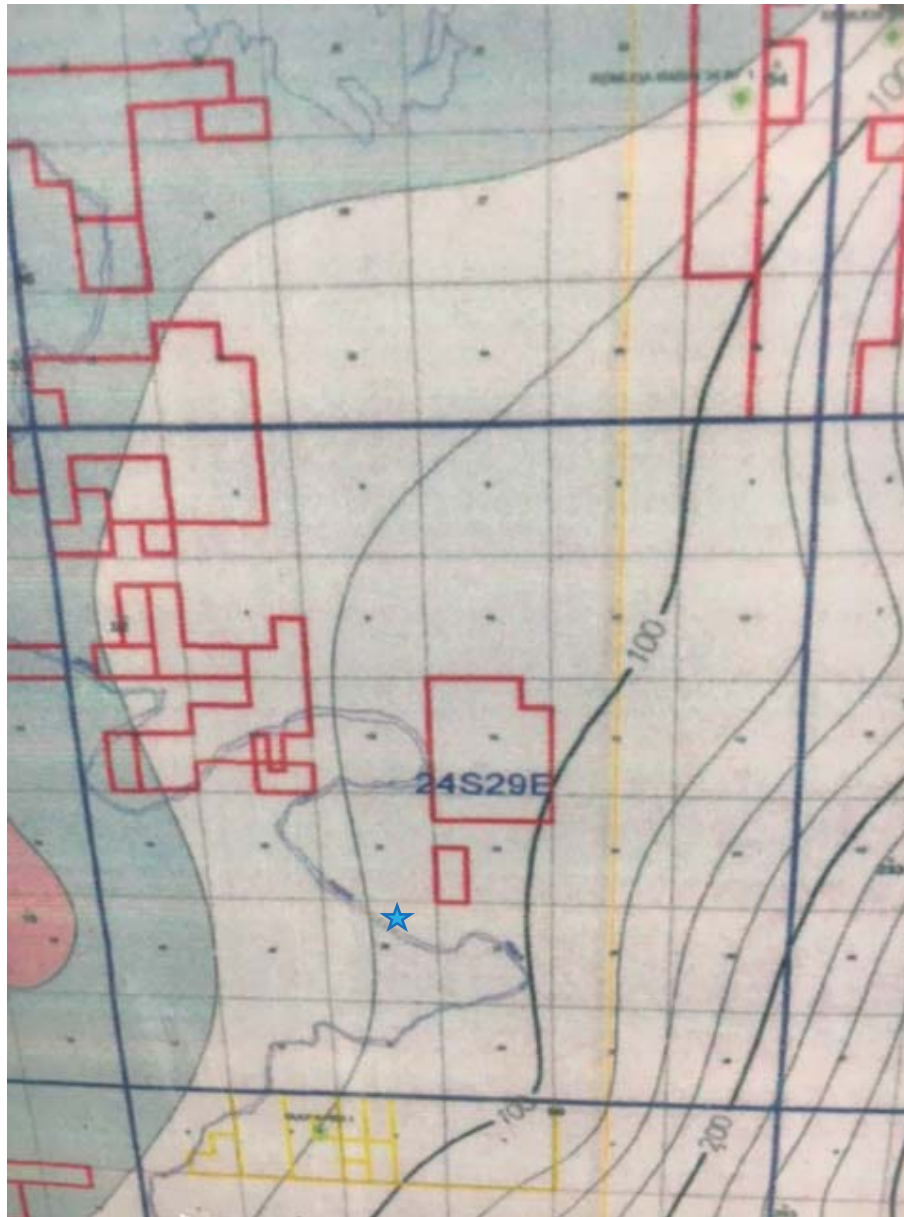
**Oxy, Cedar Canyon 28-2 WT Pump**  
**U/L B, Section 28, T24S, R29E**  
**Groundwater: 75'-100'**

SP1, N 32.19435 W-103.98762

SP2, N 32.19445 W-103.98750

SP3, N 32.19464 W-103.98738

SP4, N 32.19472 W-103.98748

SP5, N 32.19478 W-103.98760

SP6, N 32.19489 W-103.98773
