Release Notification

Site Name	Striker 6 SWD #1	Site Type	Salt Water Disposal
Date Release Discovered	09/18/2019	API# (if applicable)	30-025-44291

SITE CLOSURE REPORT

STRIKER 6 SWD

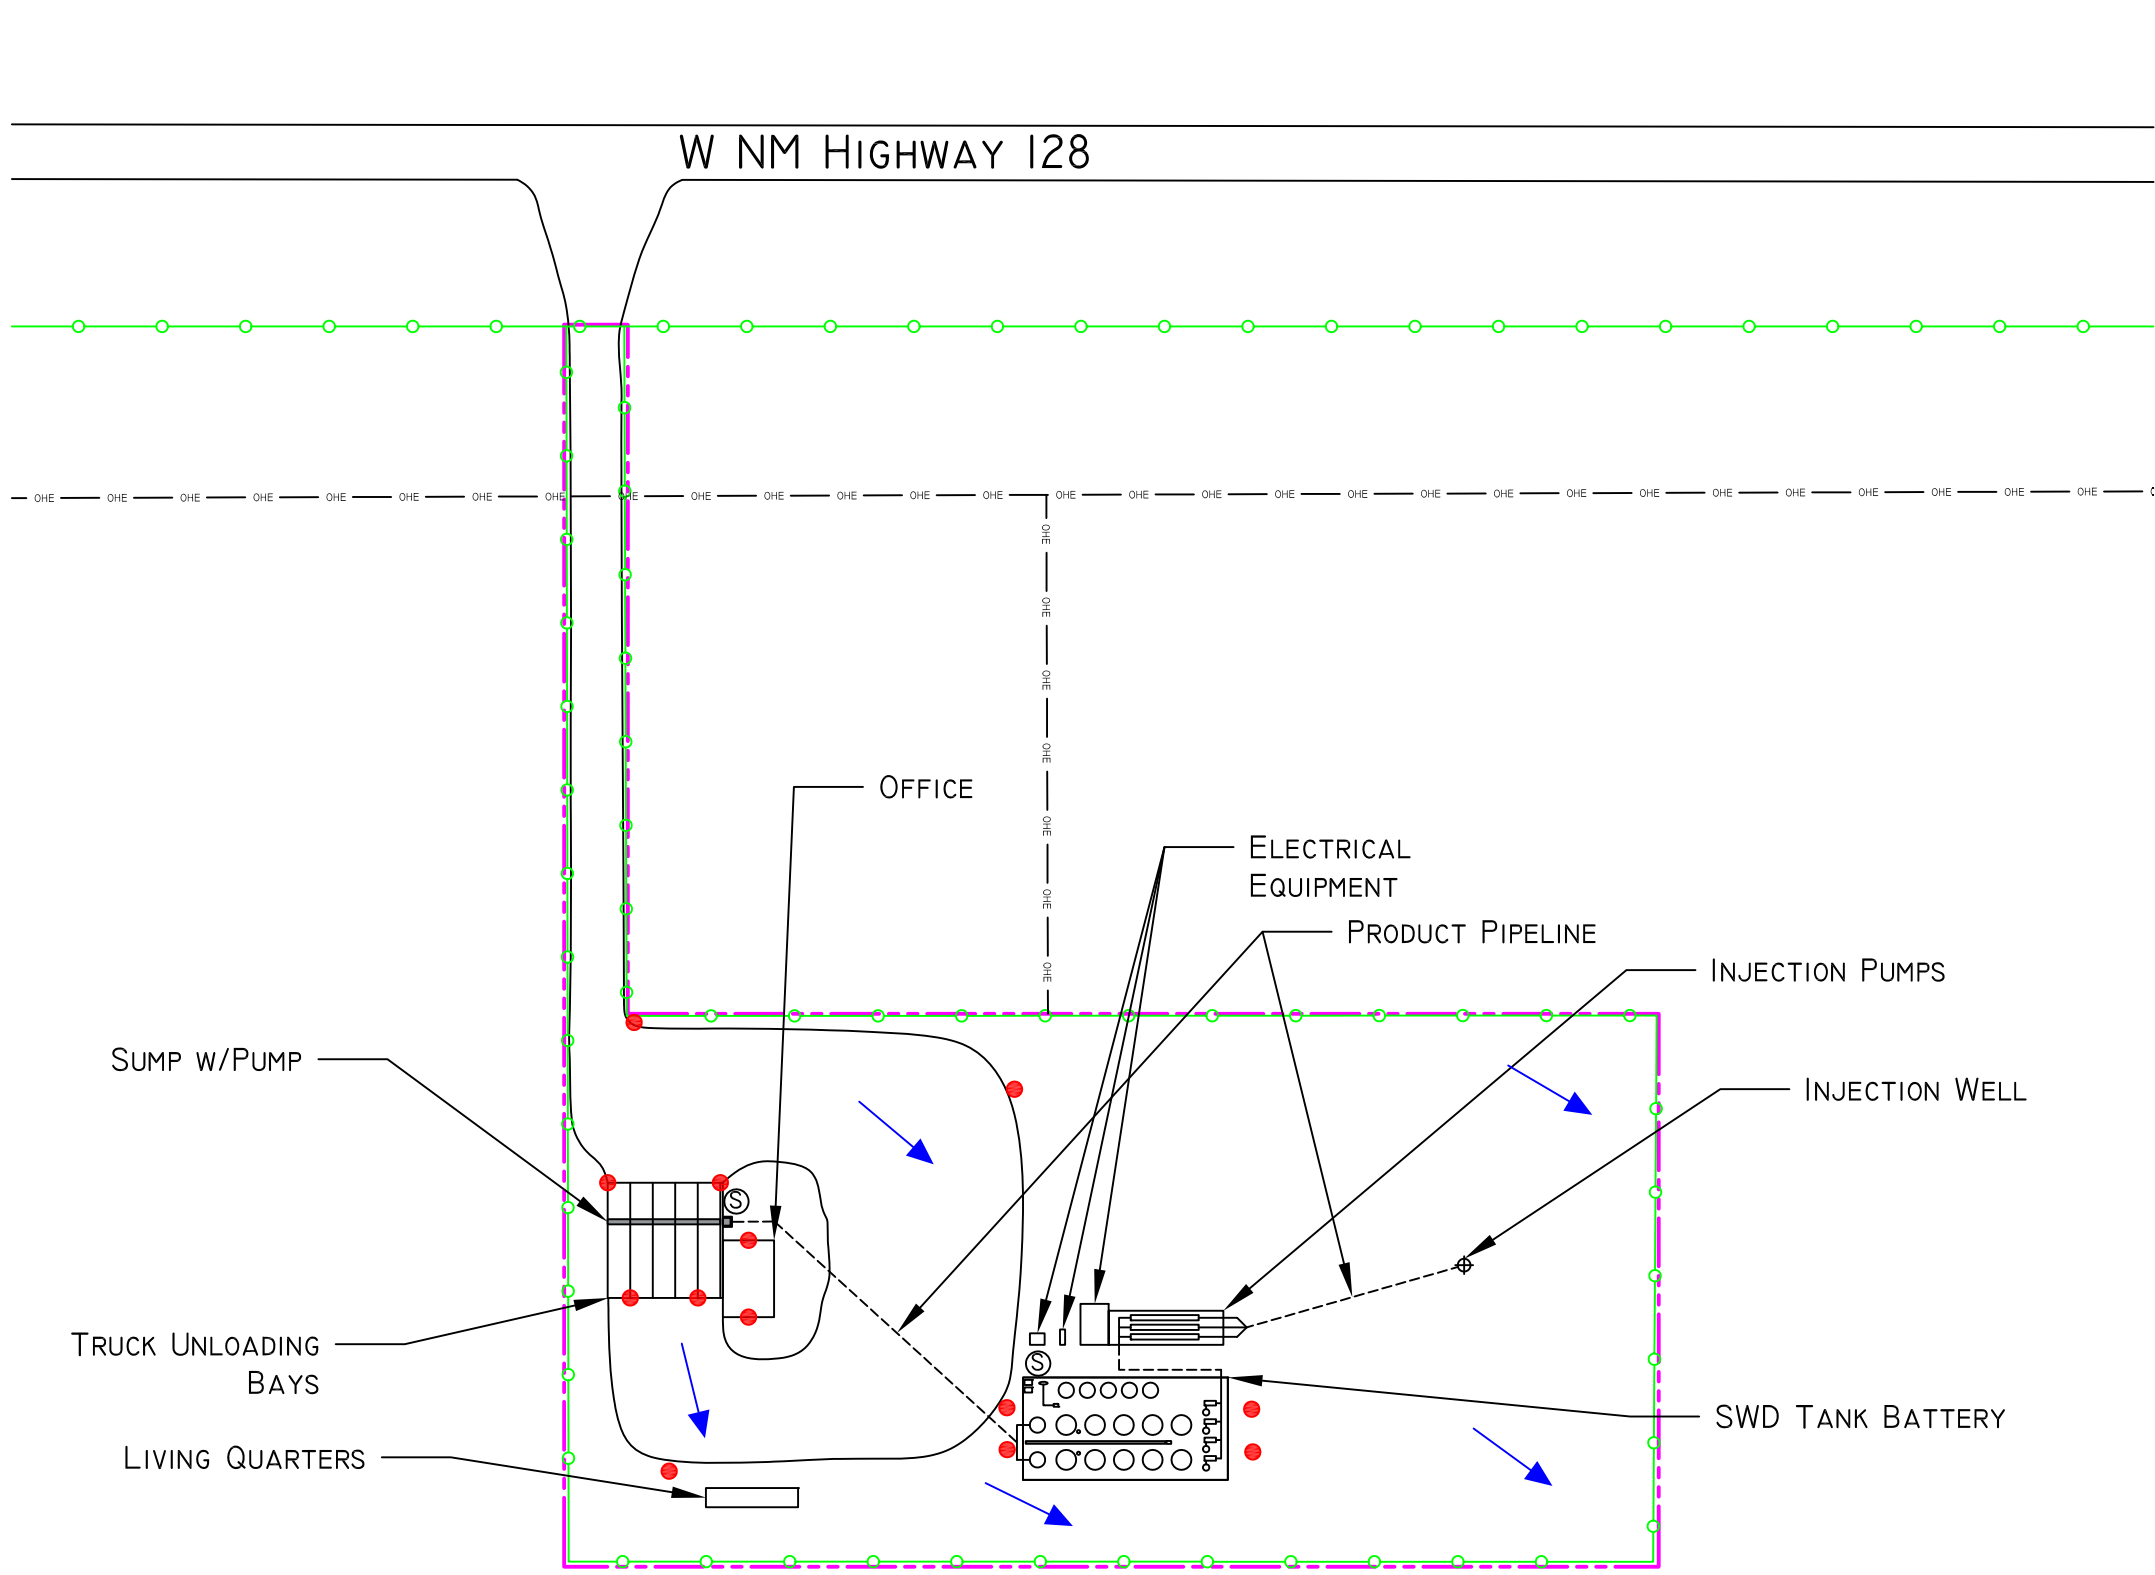
SITE PLAN

24 HR. - 25YR. RAINFALL: 4.6"

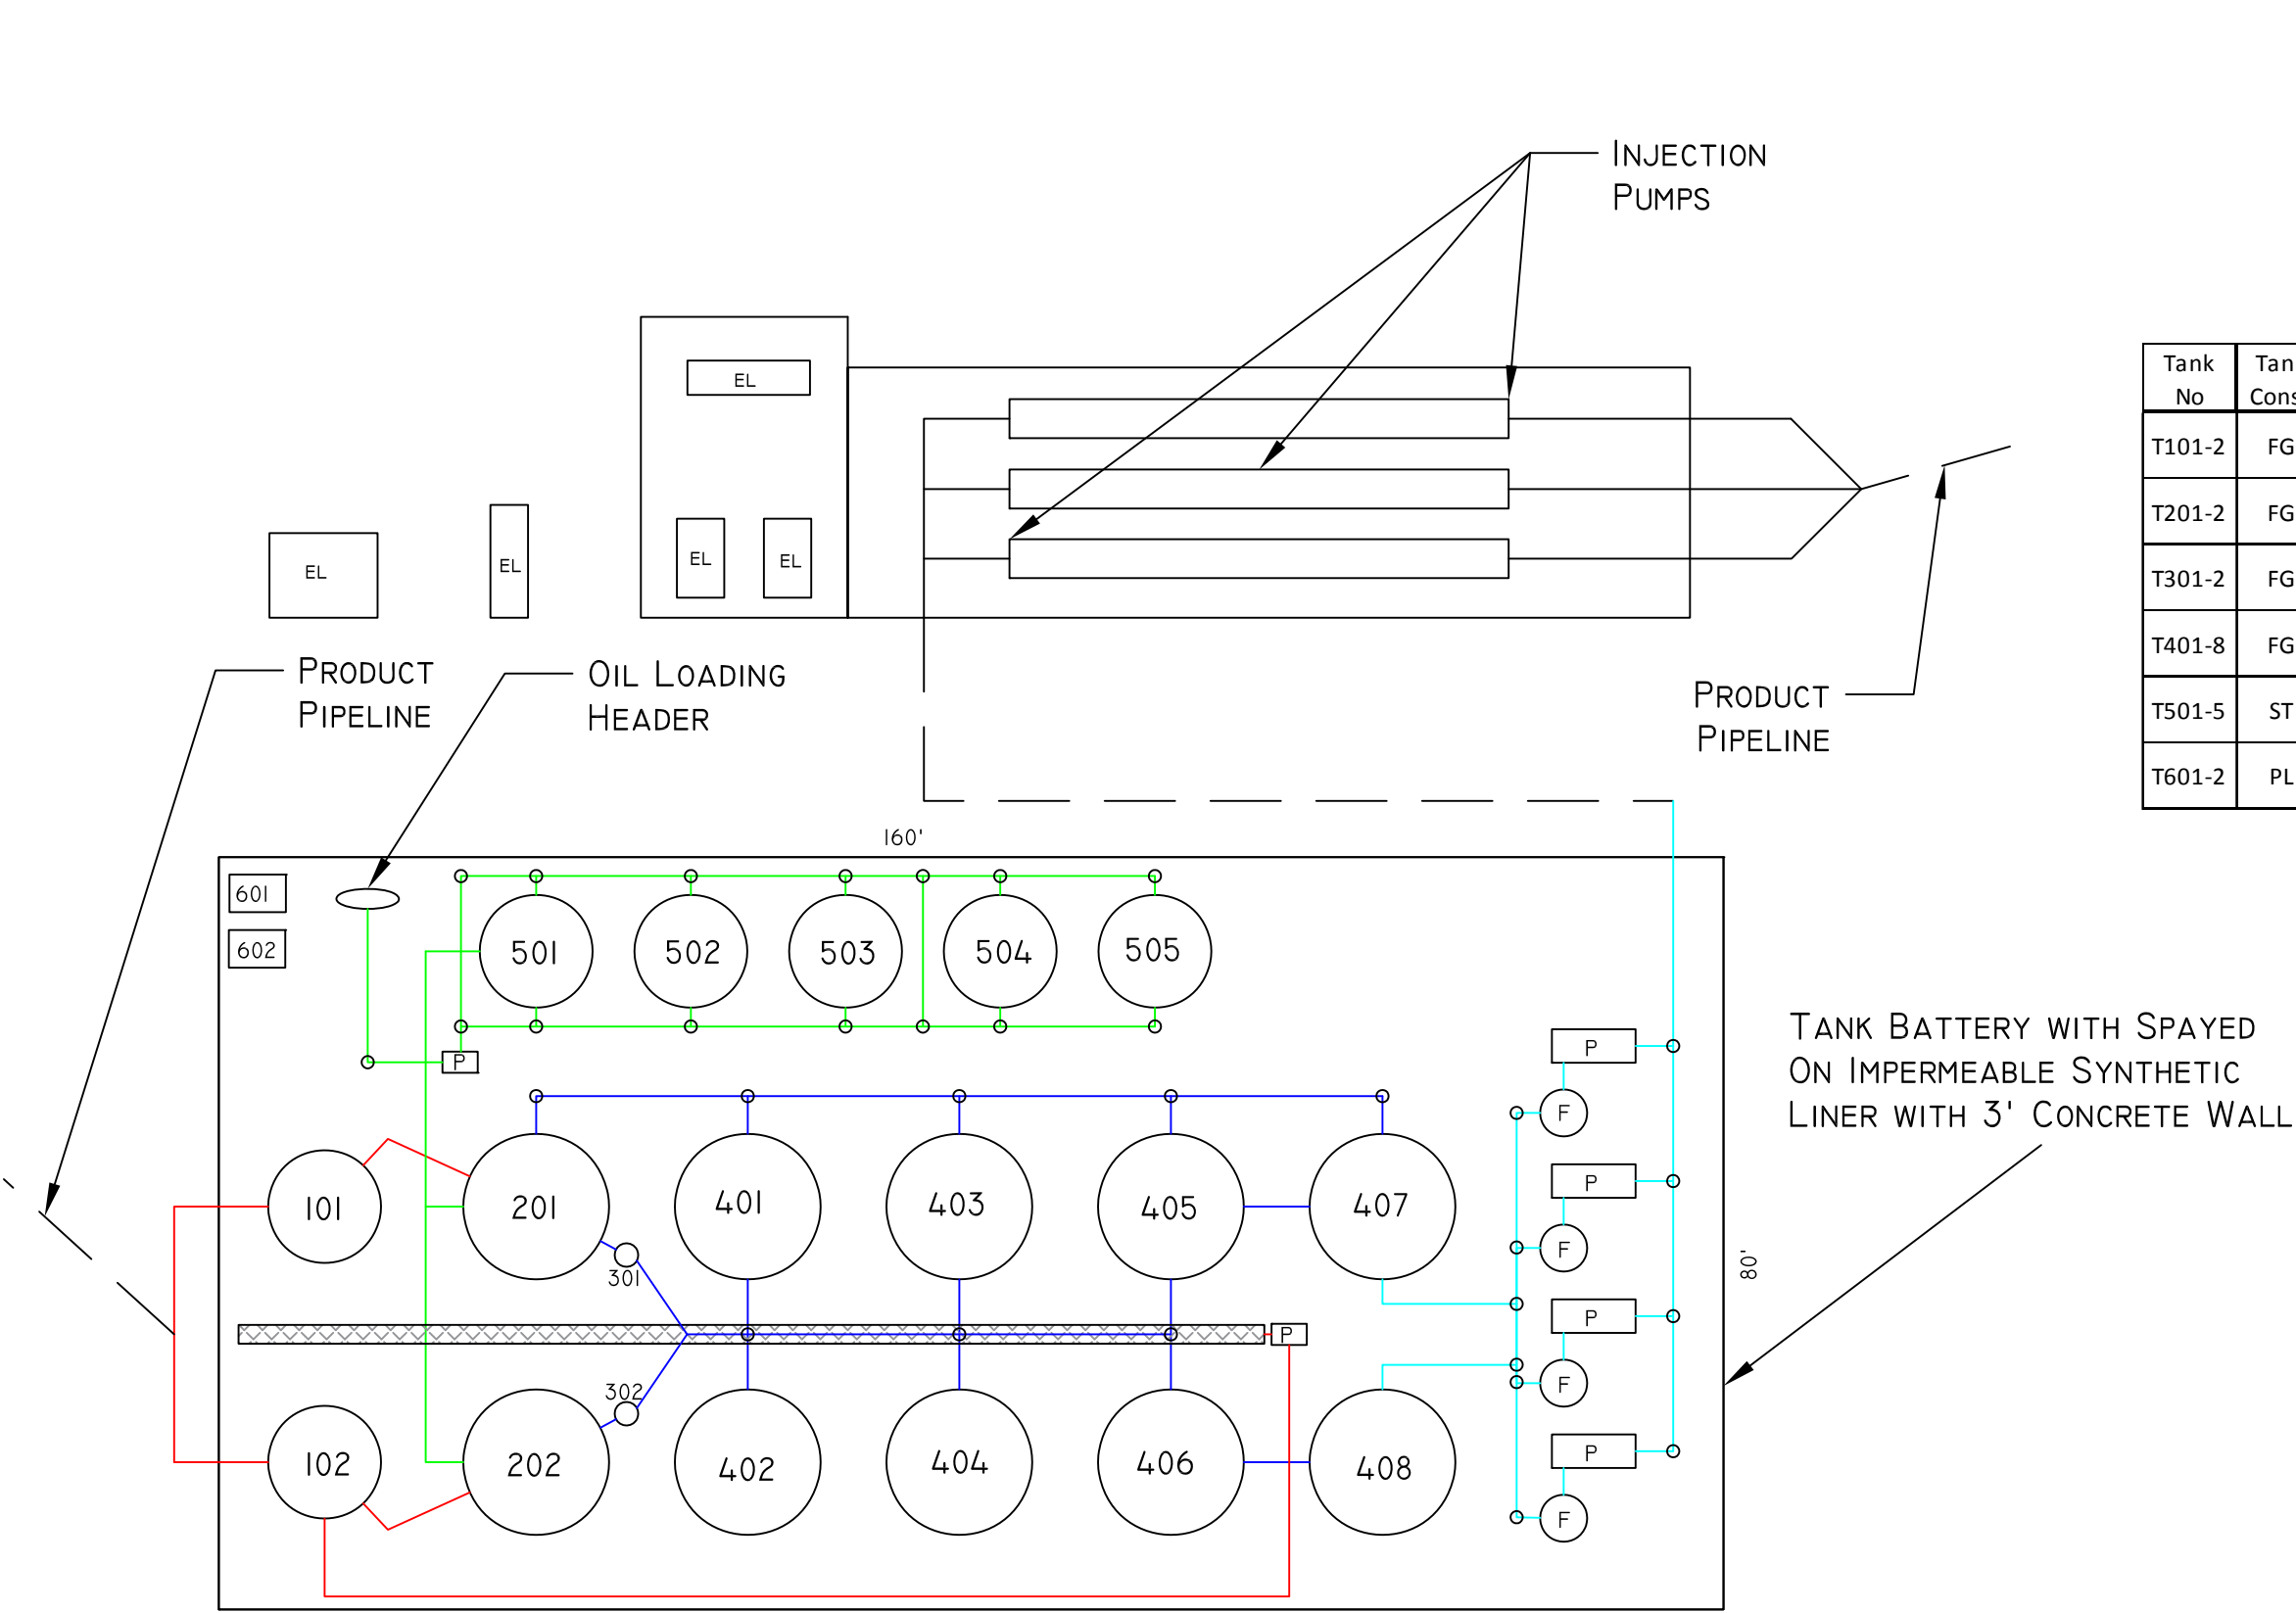
SWD FACILITY LAYOUT

Tank No	Tank Const	Hor/ Vert	Gross Cap. BBLs	Contents	Tank Size	Containment Vol (BBLs)
T101-2	FG	Vertical	760	Sand, SW & Oil	12'x38'	4,689
T201-2	FG	Vertical	1000	SW & Oil	15.5'x30'	4,689
T301-2	FG	Vertical	24	SW & Oil	2.5'x30'	4,689
T401-8	FG	Vertical	780	SW	15.5'x25'	4,689
T501-5	ST	Vertical	400	Oil	12'x20'	4,689
T601-2	PL	Horizontal	550 Gal	Chem	n/a	4,689

TANK BATTERY WITH SPAYED ON IMPERMEABLE SYNTHETIC LINER WITH 3' CONCRETE WALL
