Closure Report

Graham Cracker 2 State
API #: 30-015-42130
RP#: 2RP-5063 & 2RP-5124
GPS: 32.06556 -104.04986
Unit Letter P, Section 2, Township 26 South, Range 28 East
Eddy County, New Mexico

COG Operating, LLC (COG) is pleased to submit the following closure report in response to two illegal dumps that occurred at the Graham Cracker 2 State on November 15, 2019 and December 4, 2019.

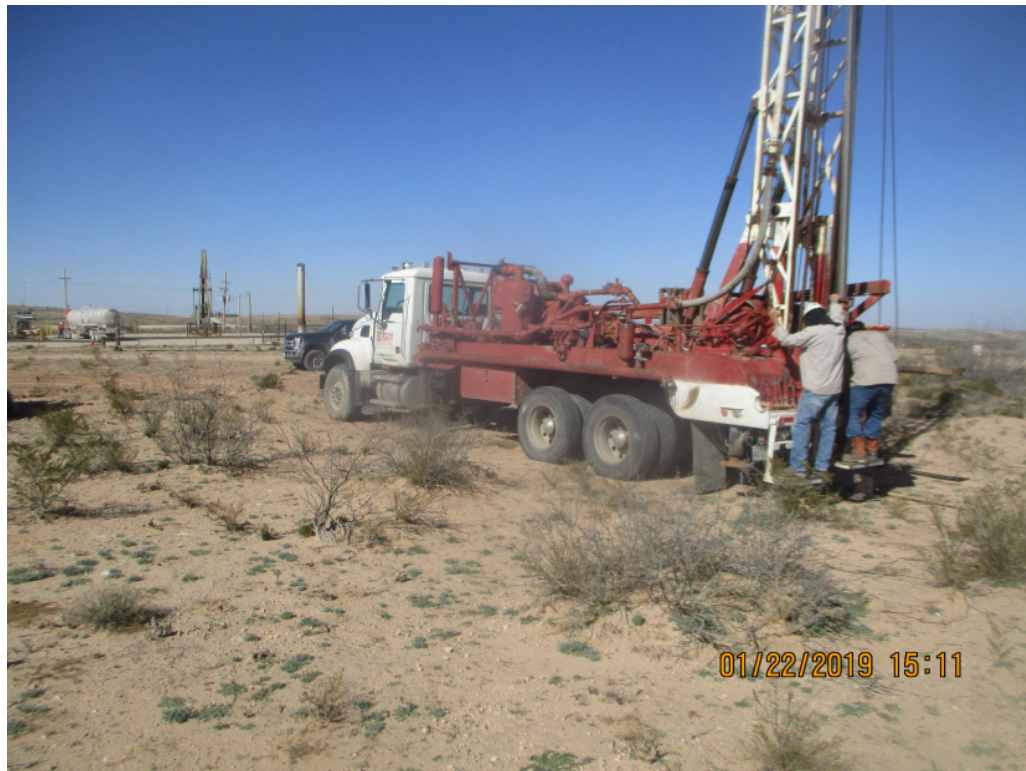
Area of Background Drilling – View to Northwest

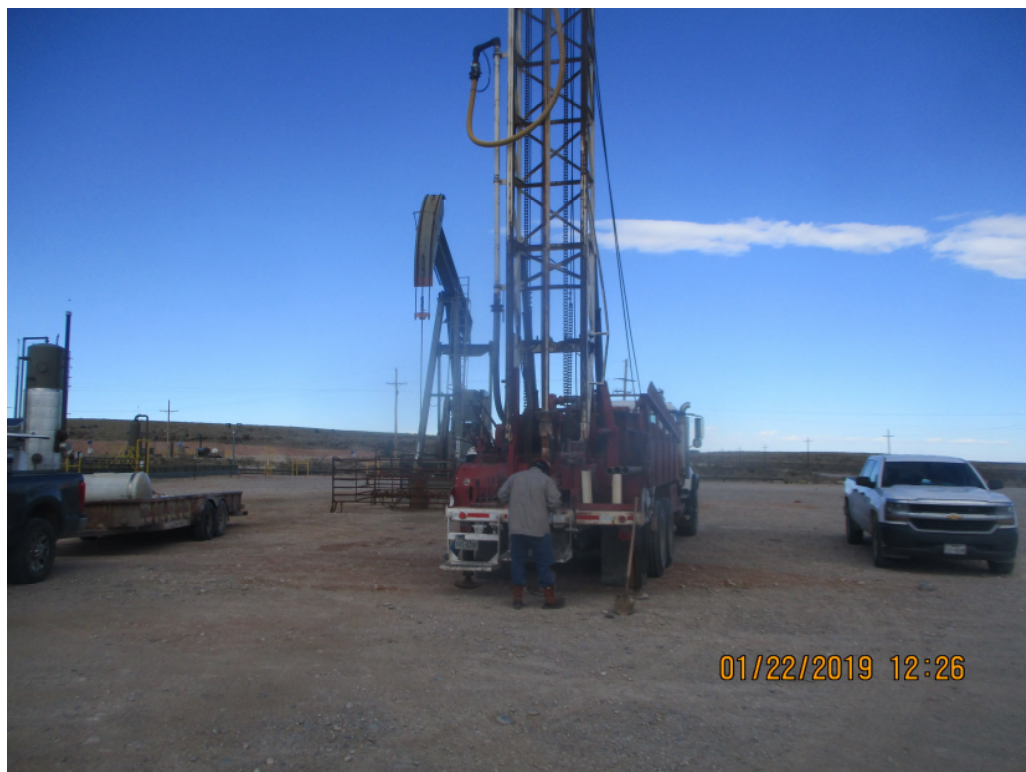
Drilling BH-1 – View to Northwest

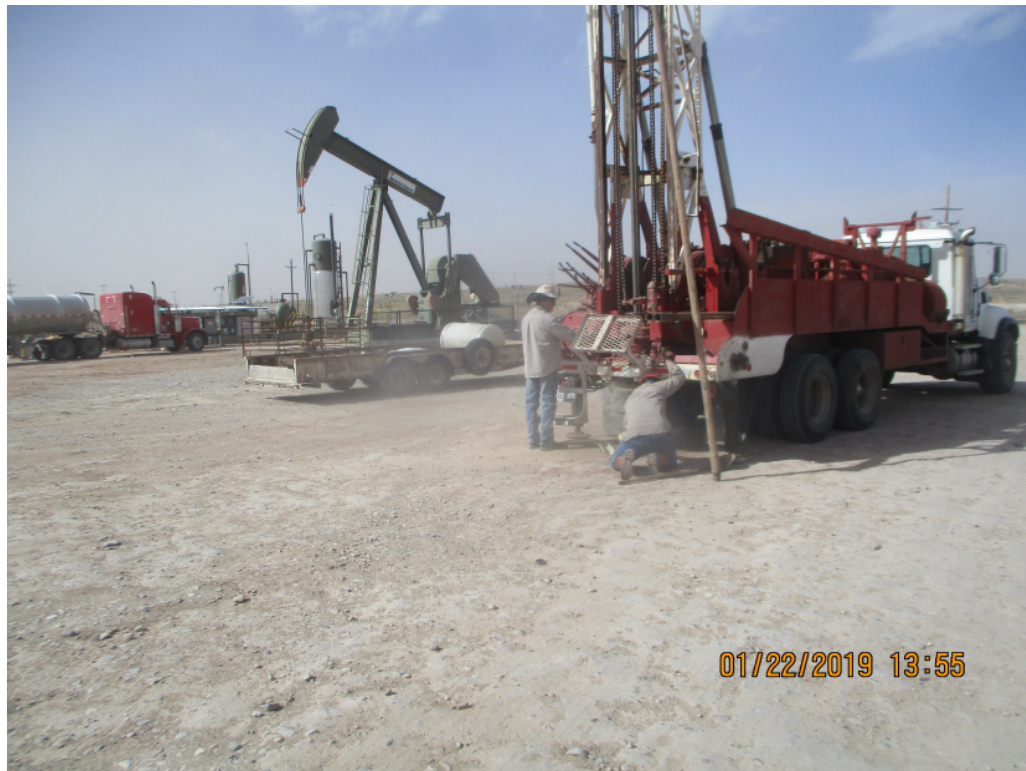
Drilling BH-2 – View to West

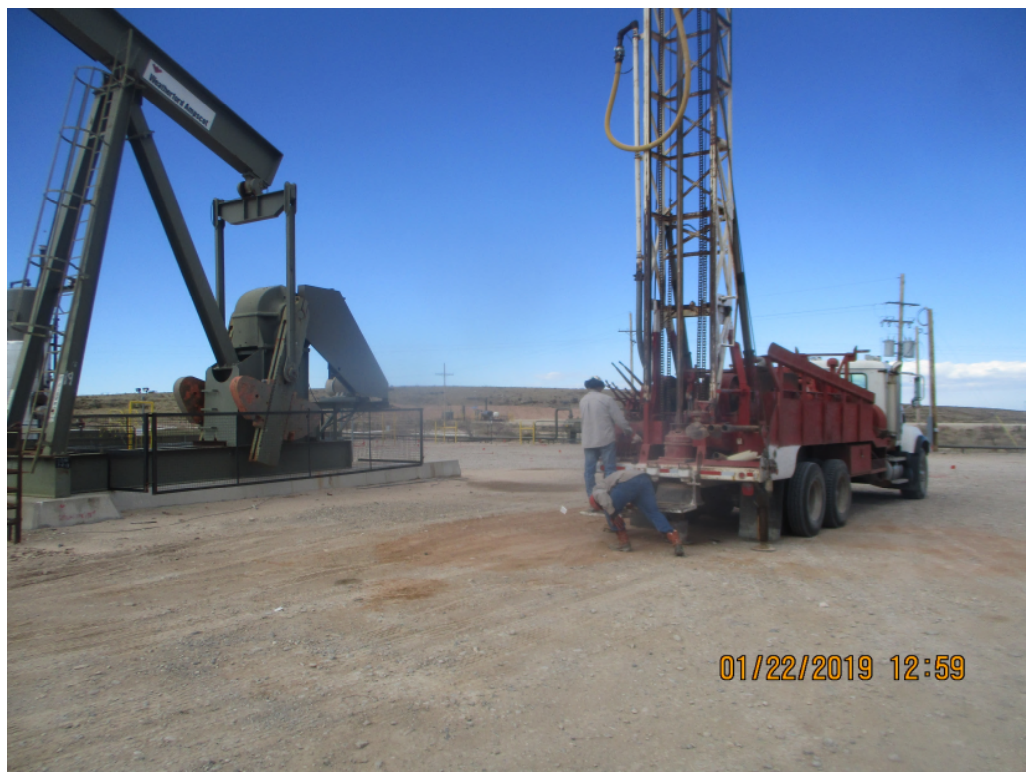
Drilling BH-3 – View to West
