Release Notification M9C0M-190813-C-1410

RE: Closure Request

Poker Lake Unit Big Sinks 14-25-30 Battery Remediation Permit Number 2RP-5598 Eddy County, New Mexico

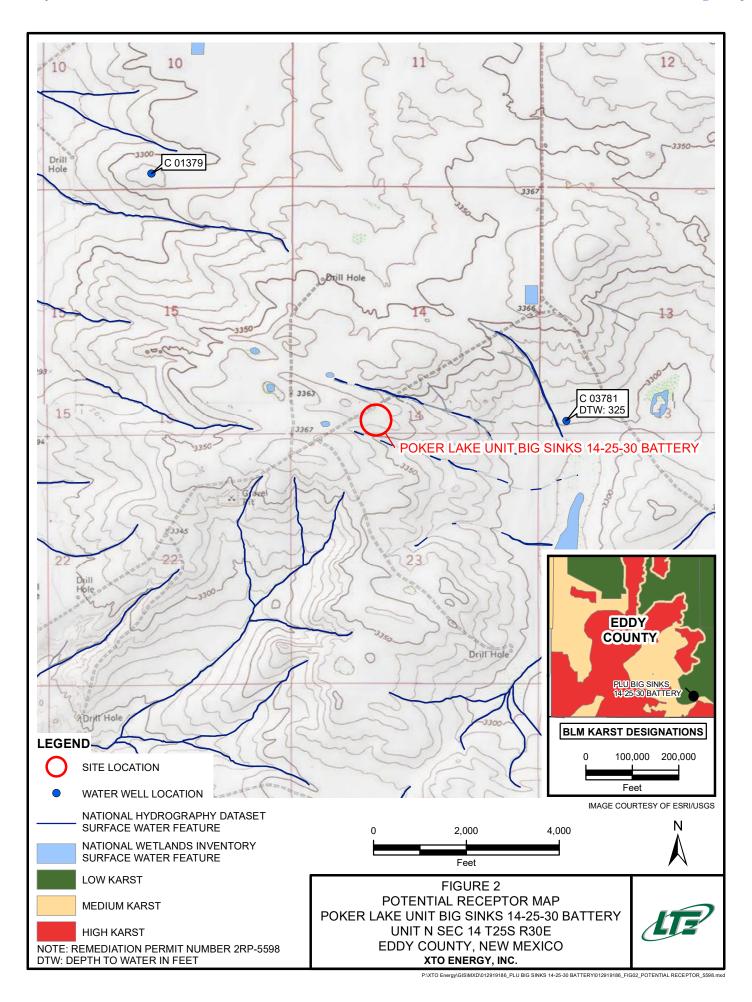
freshwater emergent wetland located approximately 4,833 feet southeast of the Site. The Site is greater than 200 feet from a lakebed, sinkhole, or playa lake and greater than 300 feet from an occupied residence, school, hospital, institution, church, or wetland. The Site is greater than 1,000 feet to a freshwater well or spring and is not within a 100-year floodplain or overlying a subsurface mine. The Site is located in a low potential karst area. The Site Receptors are shown on Figure 2.

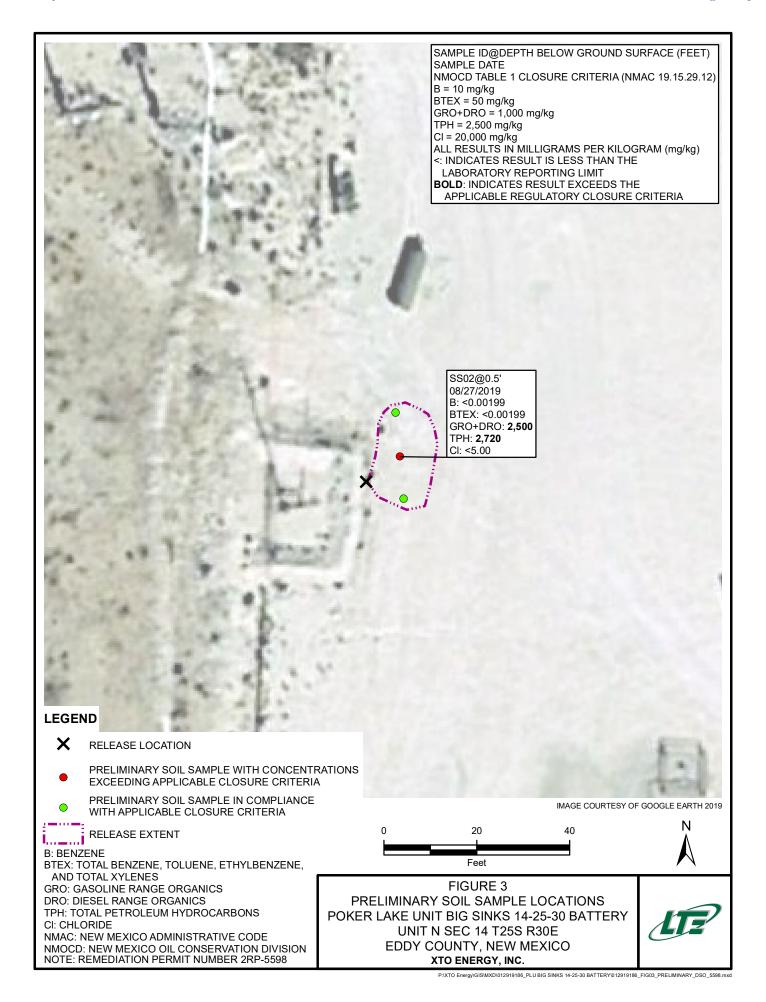
The release extent and preliminary soil sample locations were mapped utilizing a handheld Global Positioning System (GPS) unit and are depicted on Figure 3. Photographic documentation was conducted during assessment of the Site. Photographs are included in Attachment 1.

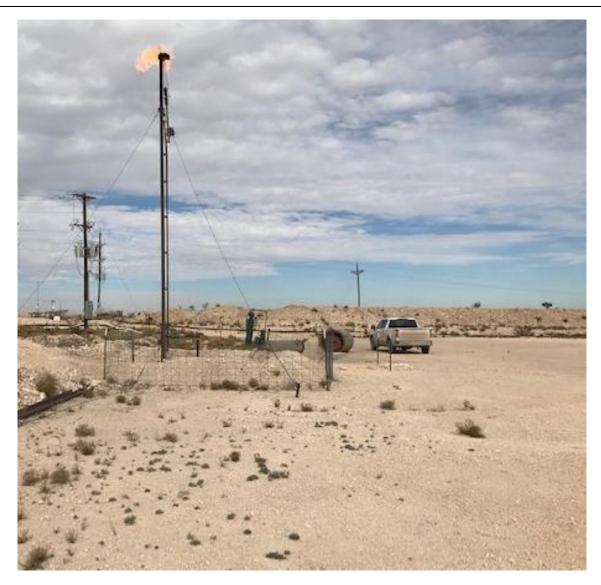
Northern view of point of release and caliche well pad during site assessment activities.

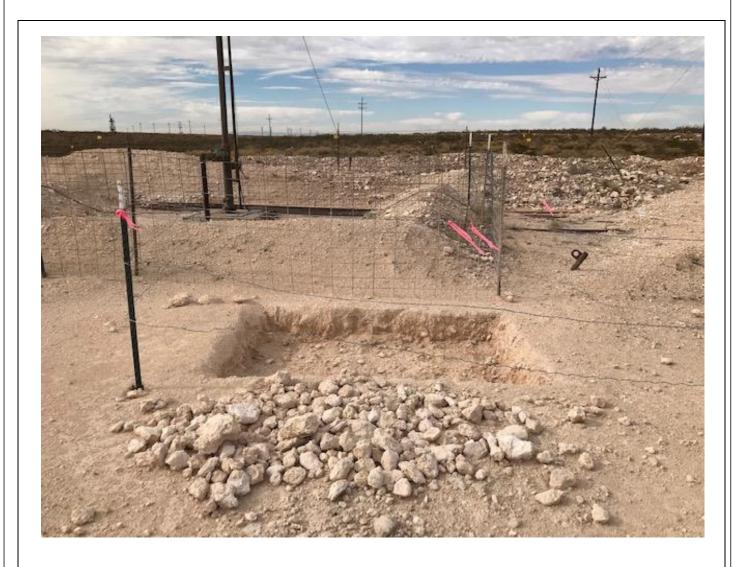
Western view of final excavation extent during confirmation soil sampling activities.

The excavation extent measured approximately 100 square feet in area. A total of approximately 5 cubic yards of impacted soil was removed from the excavation. The impacted soil will be transported and properly disposed of at the R360 landfill facility located in Hobbs, New Mexico.
