SUBJECT: Closure Report for the Madera 19 WB Federal Com 5H Release (1RP-5468), Lea County, New Mexico

Madera 19 WB Federal Com 5H Remediation Closure Report (1RP-5468)  
January 21, 2020

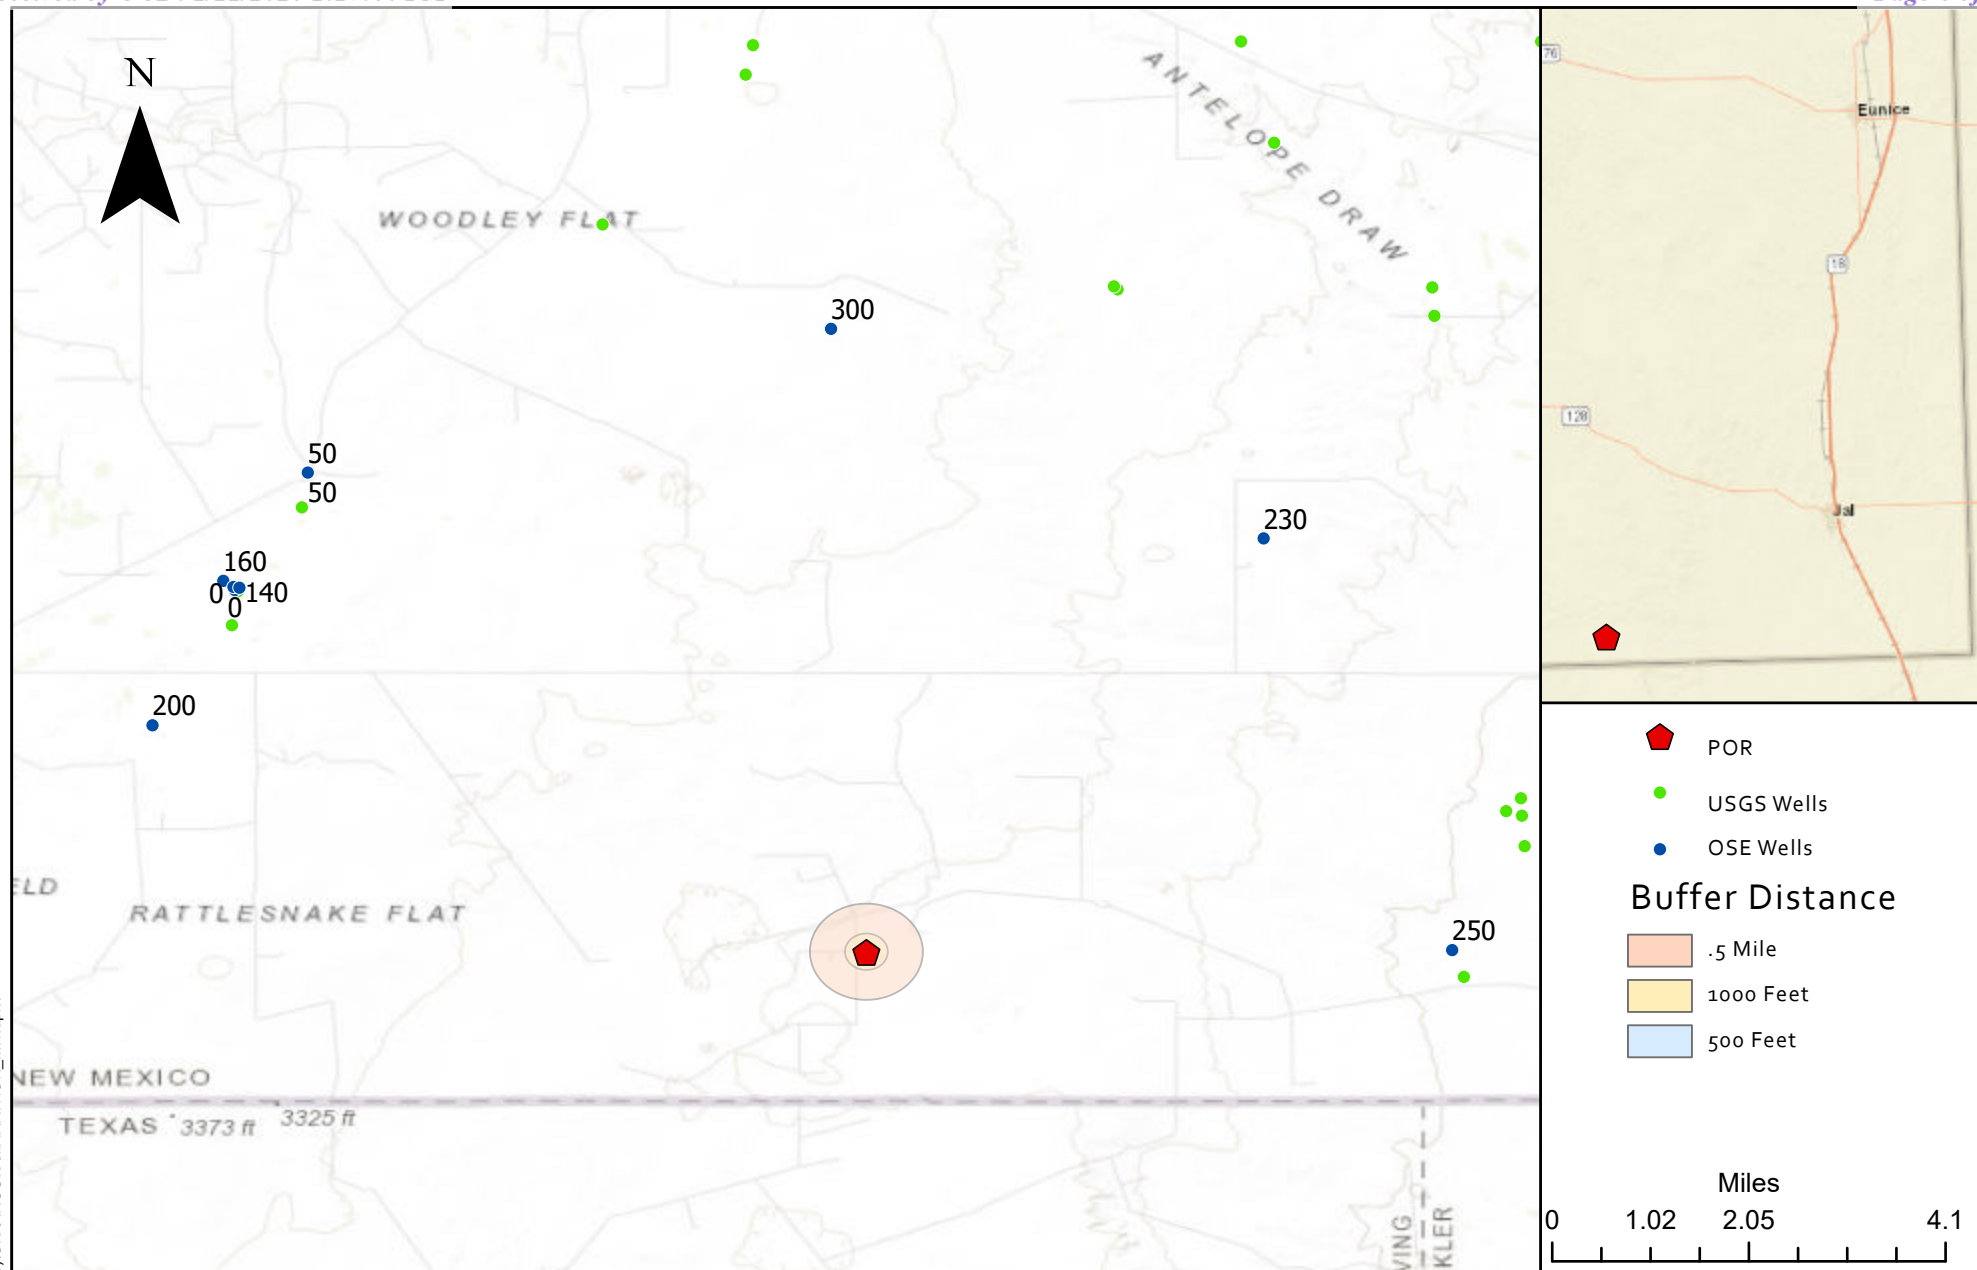
Figure 1

Regional Vicinity & Wellhead Protection Map  
Madera 19 WB Federal Com 5H-Marathon Oil  
Sec. 19 T26S R35E, Lea County, New Mexico

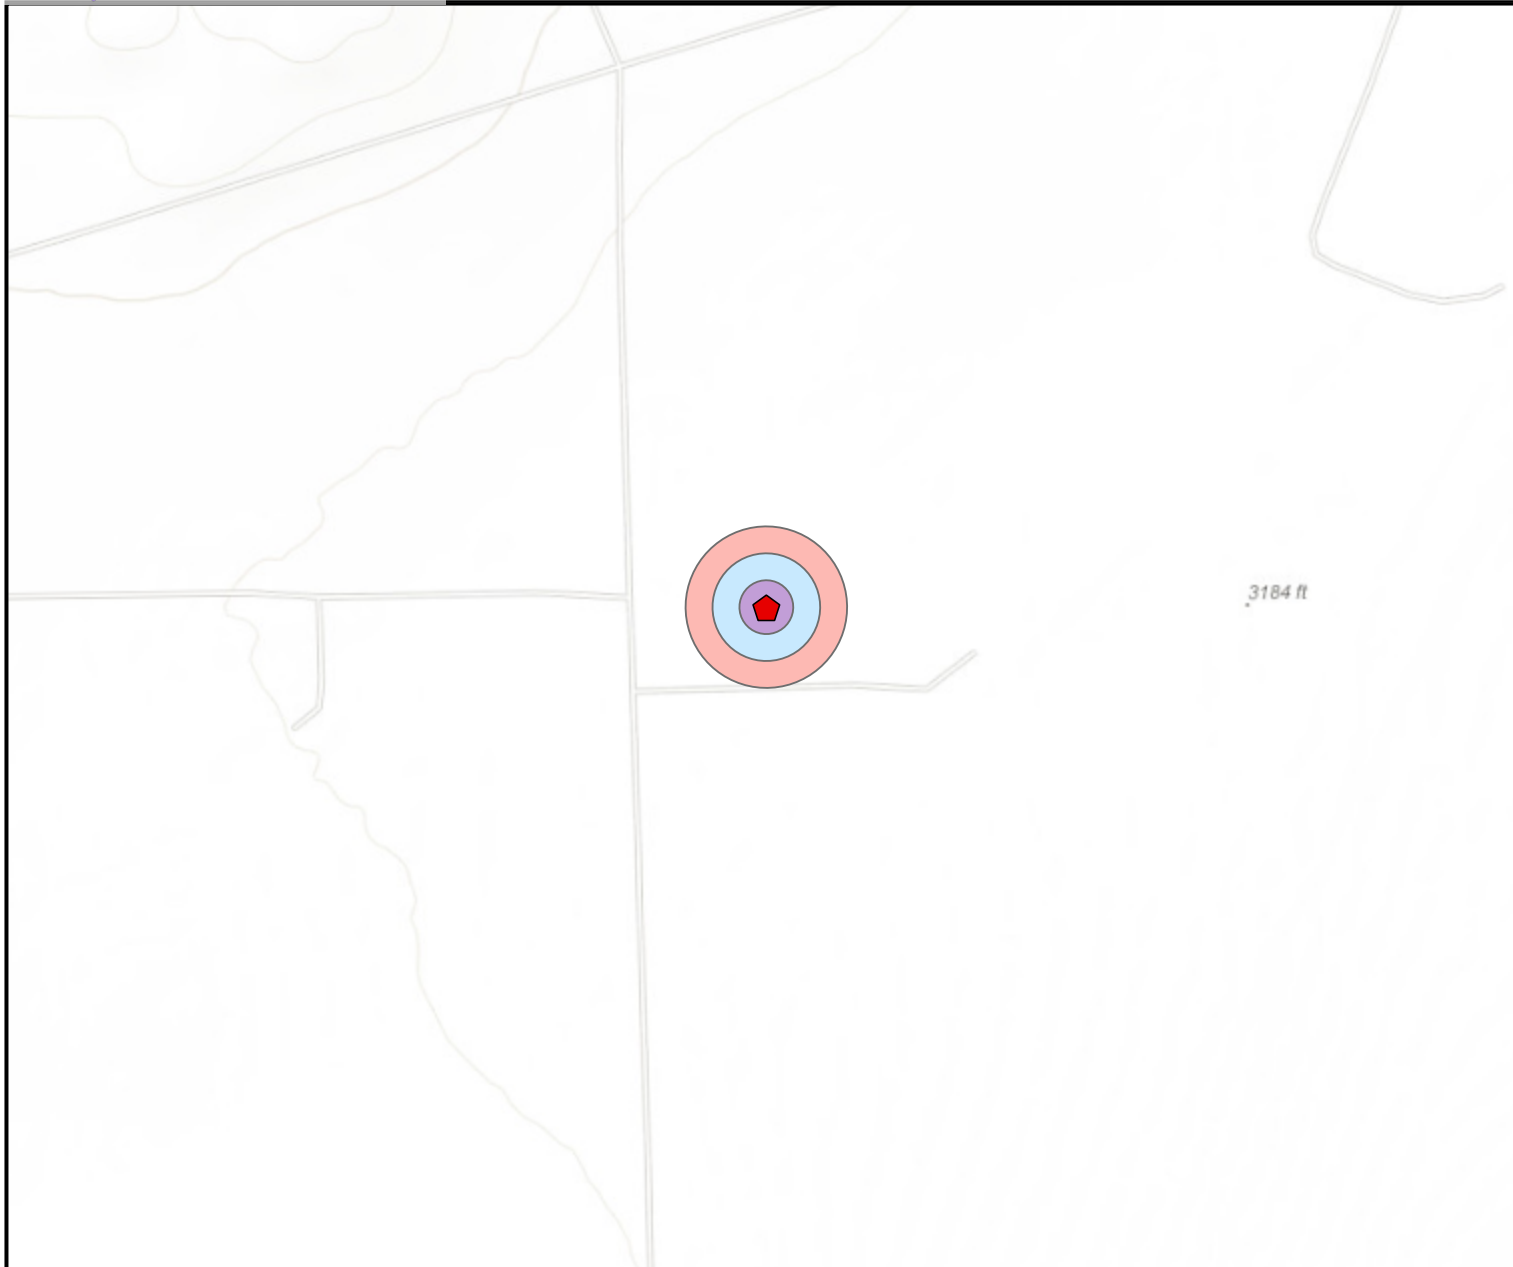
Figure 2

Surface Water Protection Map  
Madera 19 WB Federal Com 5H - Marathon Oil  
UL: N S: 19 T: 26S R: 35E Lea County, New Mexico

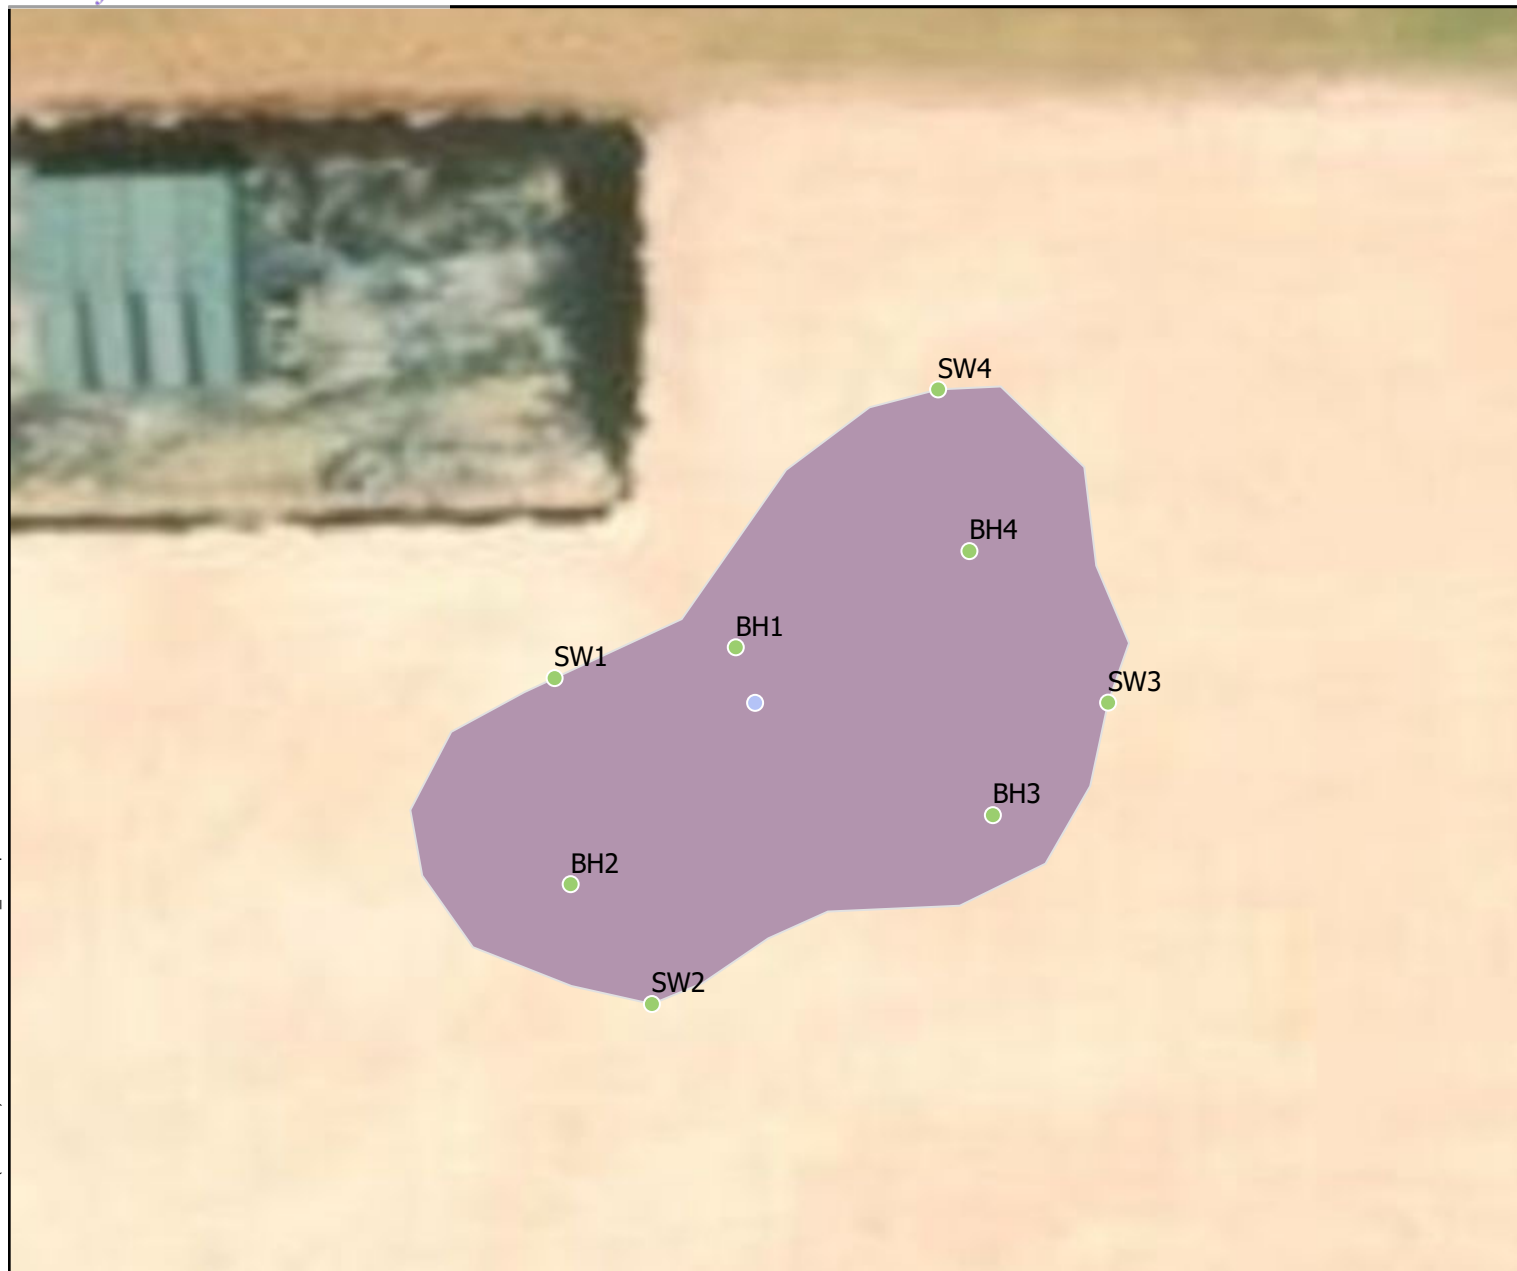
Figure 3A

Figure 3 shows the extent of the excavation and sample locations. Laboratory results are summarized in Table 3. Laboratory reports are included in Appendix D.

Excavation and Closure Sample Location Map  
Madera 19 WB Federal Com 5H- Marathon Oil  
Sec 12 T: 26S R: 35E Lea County, New Mexico

On September 10, 2019, SMA personnel returned to the site to determine the vertical extent as reasonably possible while flowback operation were ongoing. Six samples were collected at six inch (6") intervals to depths of 2'-4'. A total of 10 samples were collected for laboratory analysis for total chloride using EPA Method 300.0 and motor, diesel and gasoline range organics (MRO, DRO, and GRO) by EPA Method 8015D. Table 3 itemizes the samples and field-screening results as well as identifying any variances from the typical specification of two samples per boring. Locations for all samples are depicted on Figure 3.
