Site Assessment Report and Proposed Remediation Workplan

UI7UE-200311-C-1410

Legacy Reserves Operating, LP Hamon Fed Com A #3H

Lea County, New Mexico
Unit Letter O, Section 6, Township 20 South, Range 34 East
Latitude 32.596216 North, Longitude 103.597601 West
NMOCD Reference No. 1RP-pending

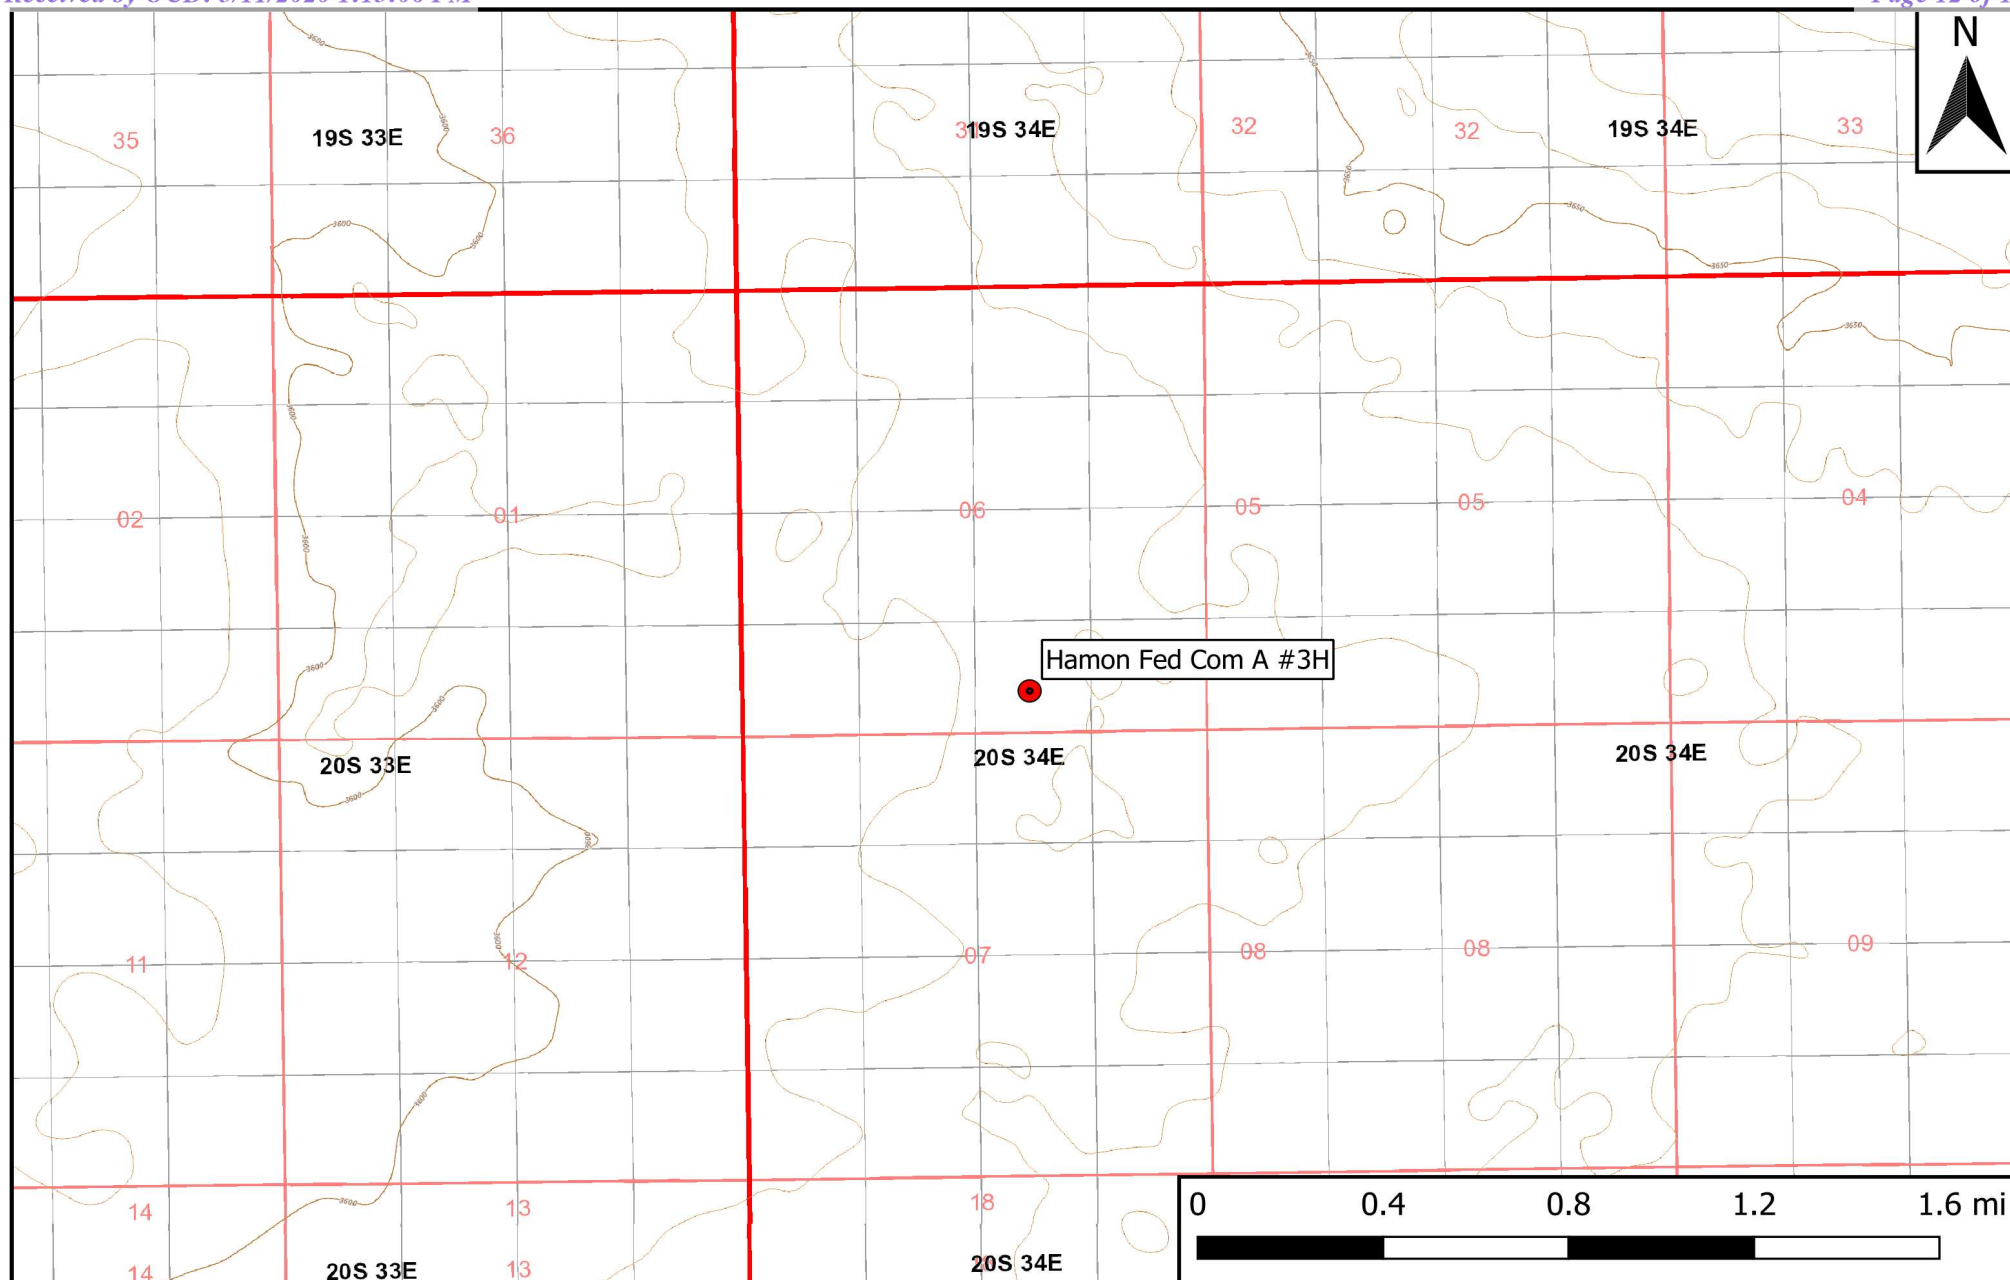
Figure 1

NMOCD Siting Criteria data was gathered from available resources including Bureau of Land Management (BLM) shapefiles; topographic maps; NMOSE and USGS databases; and aerial imagery. The results are depicted on Figures 1 & 2.

Topographic Map

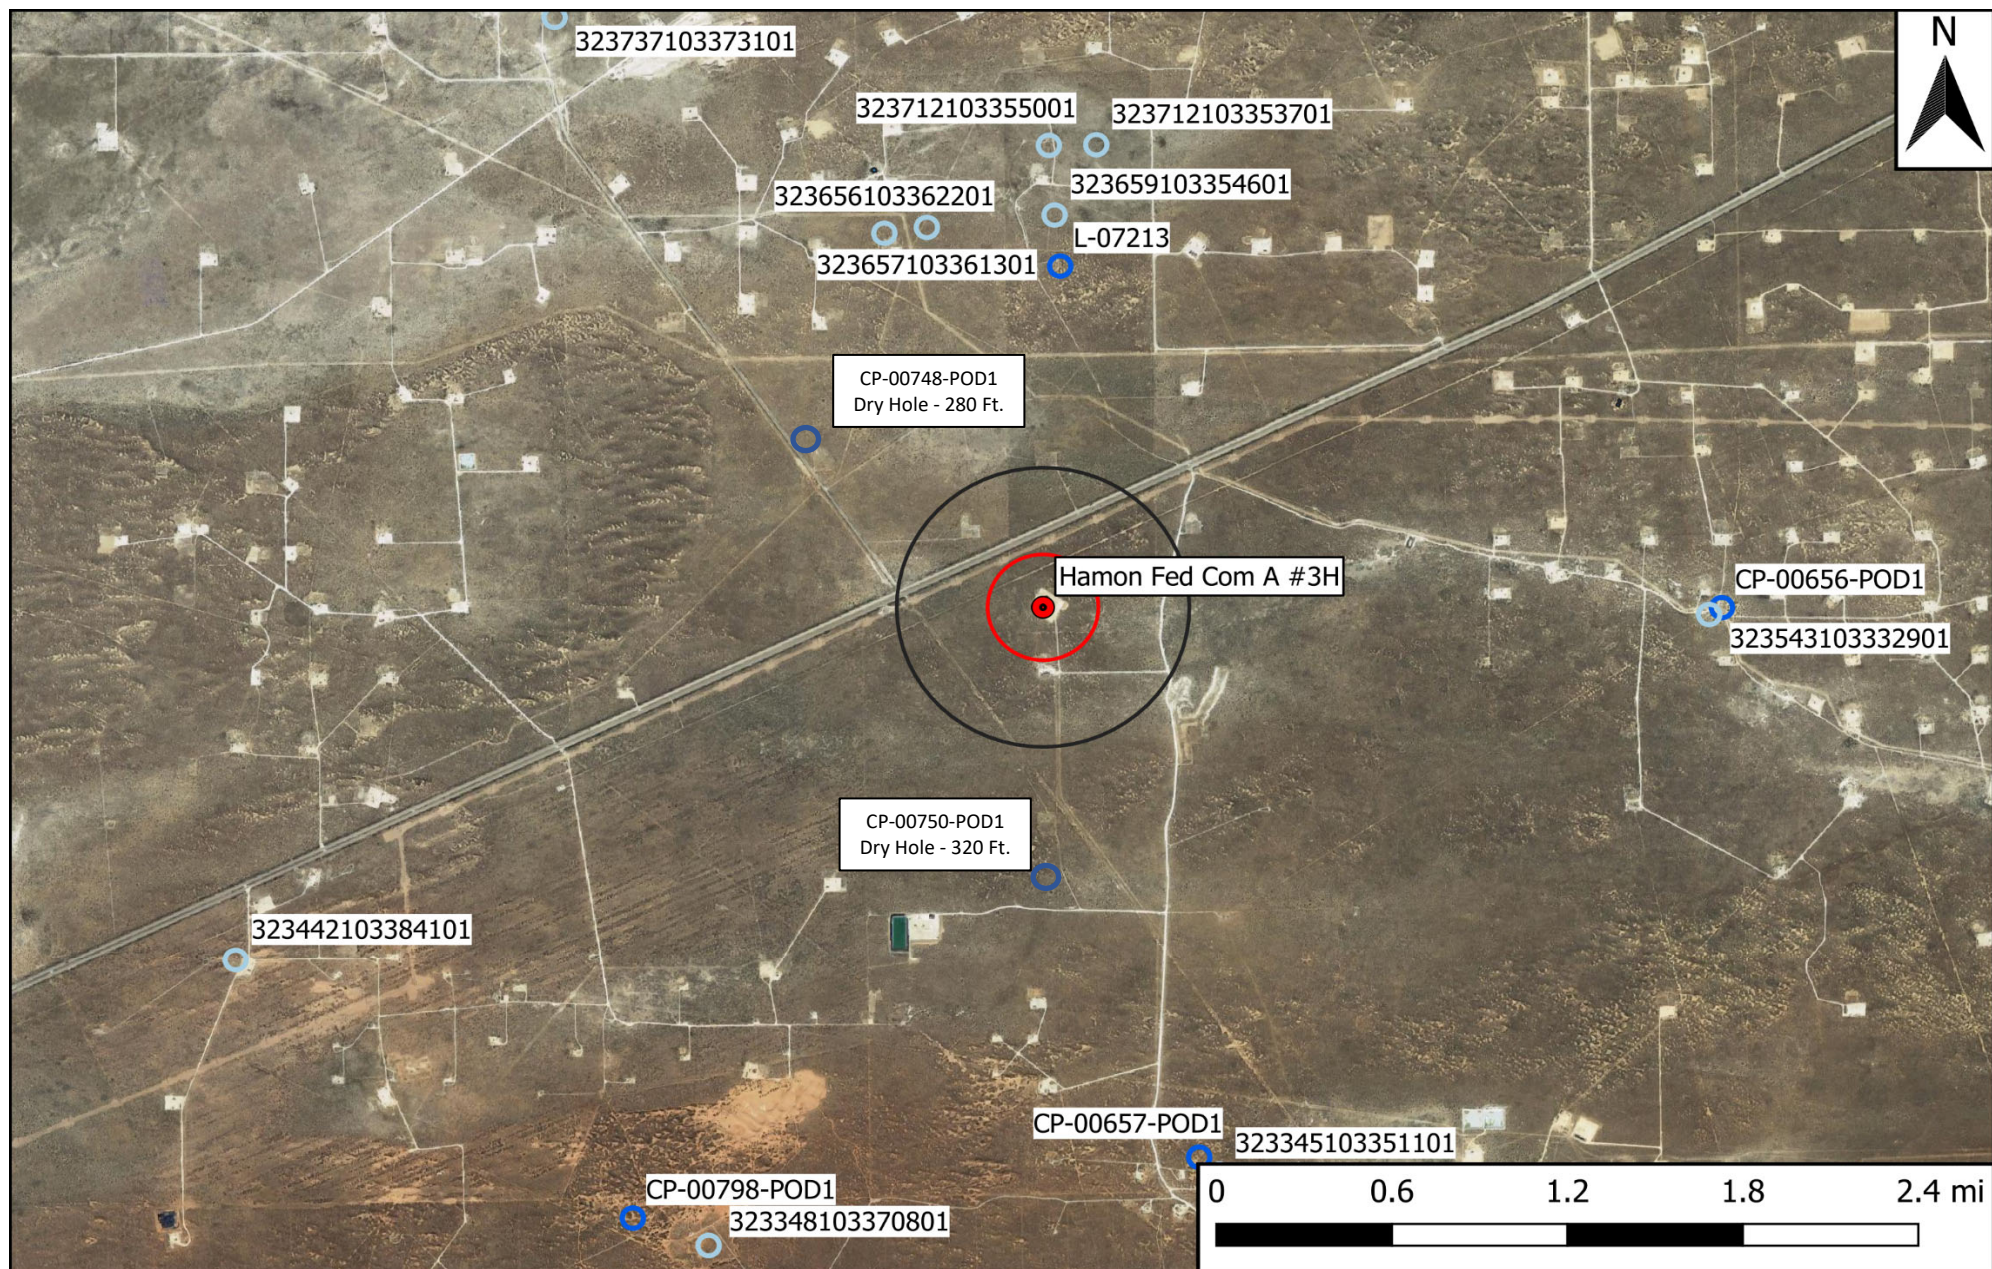
Figure 2

Aerial Proximity Map

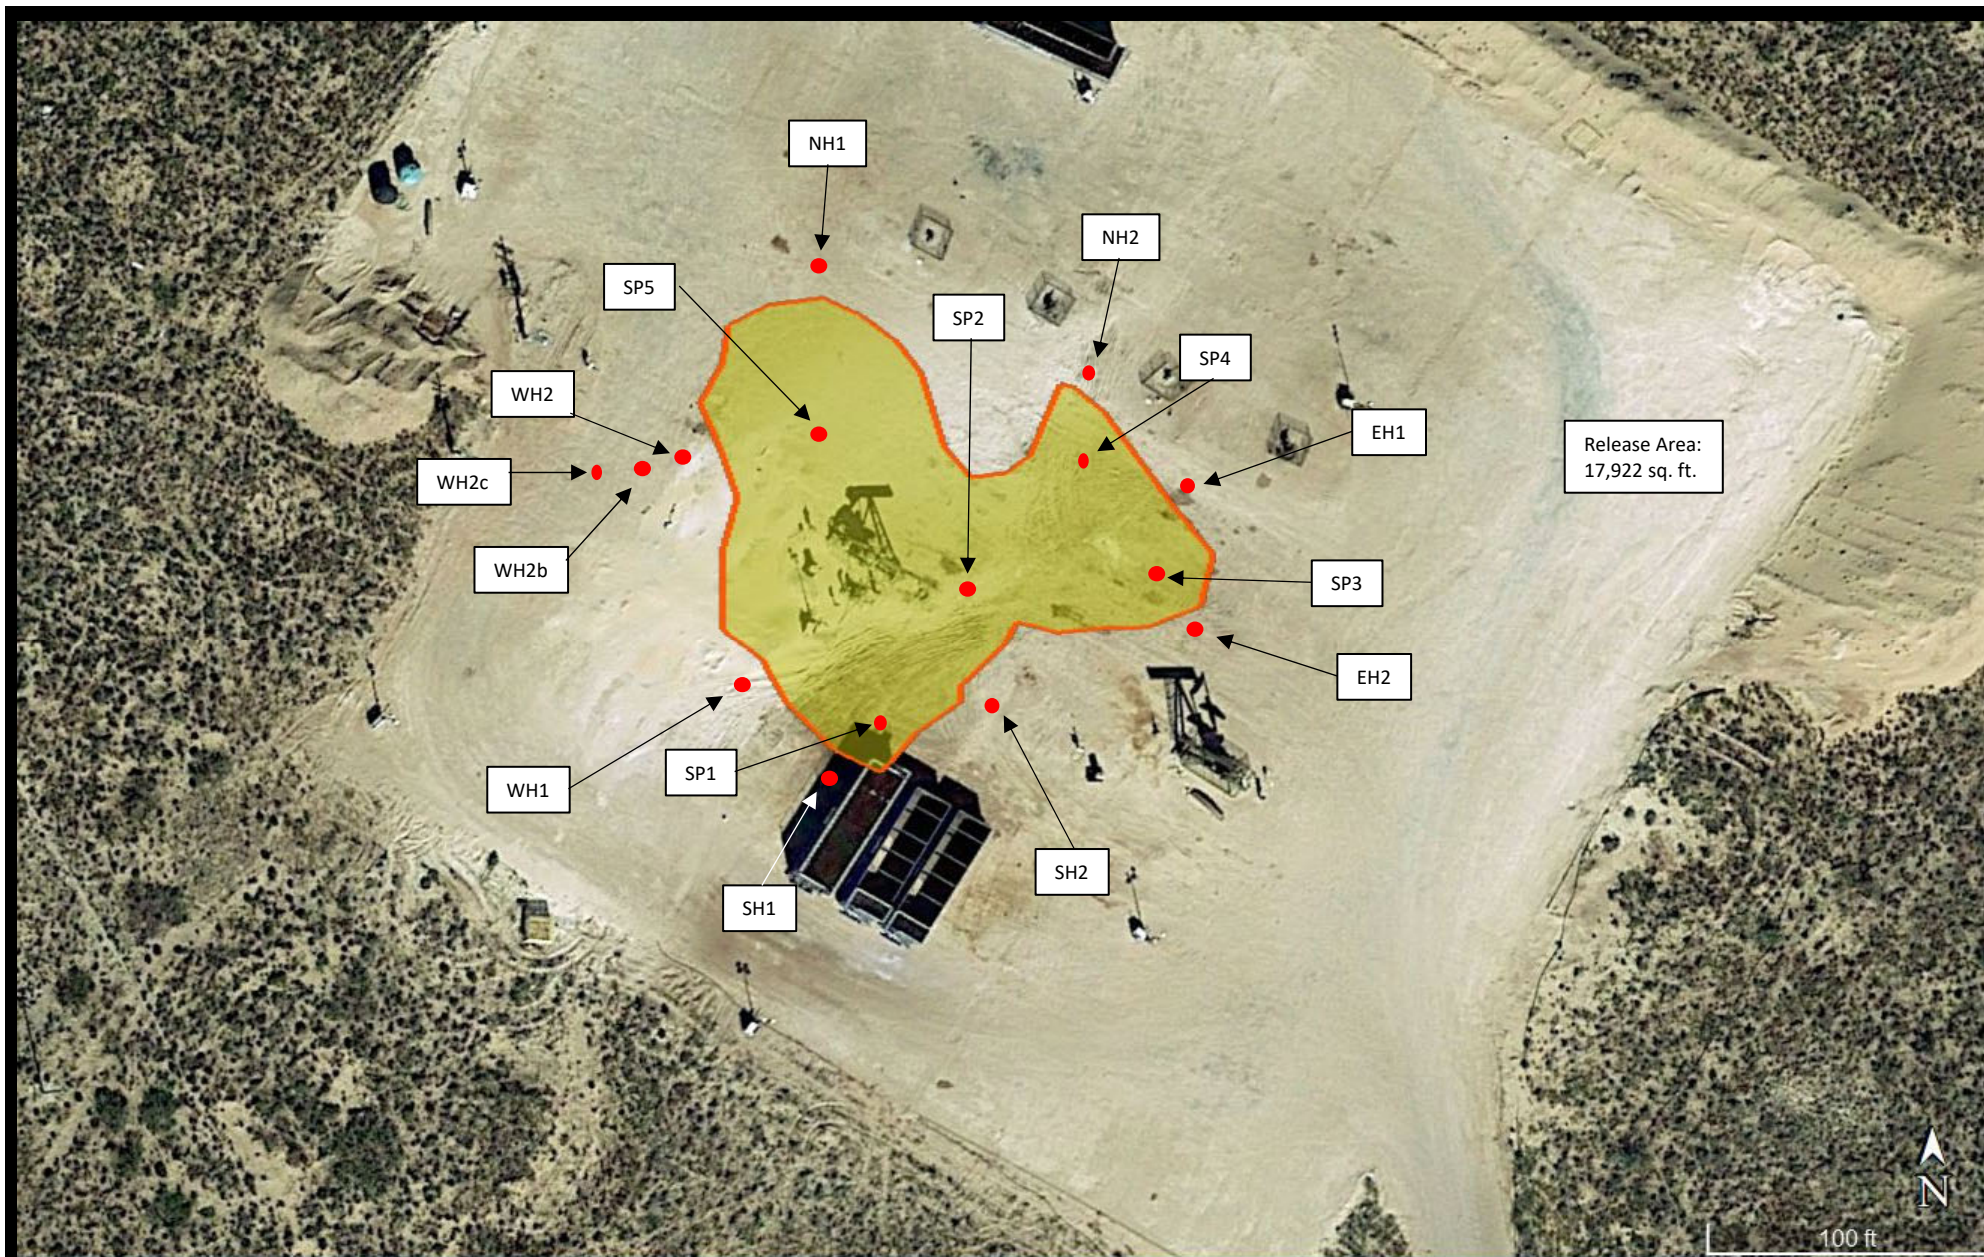
Figure 3

On **December 11, 2019**, Etech conducted an initial site assessment. During the initial site assessment, a series of hand-augered soil bores (SP1 through SP5) were advanced within the release margins in an effort to determine the vertical extent of soil impacts. In addition, hand-augered soil bores (NH1, NH2, EH1, SH1, SH2, WH1 and WH2) were advanced at the inferred edges of the affected area in an effort to determine the horizontal extent of soil impacts. During the advancement of the hand-augered soil bores, field soil samples were collected and field-screened for the presence of Volatile Organic Compounds utilizing a Photoionization Detector (PID) and/or concentrations of chloride utilizing a Hach Quantab® chloride test kit. A "Site & Sample Location Map" is provided as Figure 3. Field data and soil profile logs, if applicable, are provided as Appendix

Site and Sample Location Map

- Utilizing mechanical equipment, excavate impacted soil affected above the NMOCD Closure Criteria within the release margins in the areas characterized by sample points SP1 through SP5. The floor and sidewalls of the excavated area will be advanced until laboratory analytical results from confirmation soil samples indicates concentrations of BTEX, TPH and chloride are below the NMOCD Closure Criteria.
