Release Notification

Site Name: Fiddle Fee 23 X #001H	Site Type Oil & Gas Well
Date Release Discovered 2/10/2020	API# (if applicable) 30-015-44094

Liner Integrity Inspection (Photos Attached)

Liner Inspection Photo Log – Fiddle Fee 23 X #001H

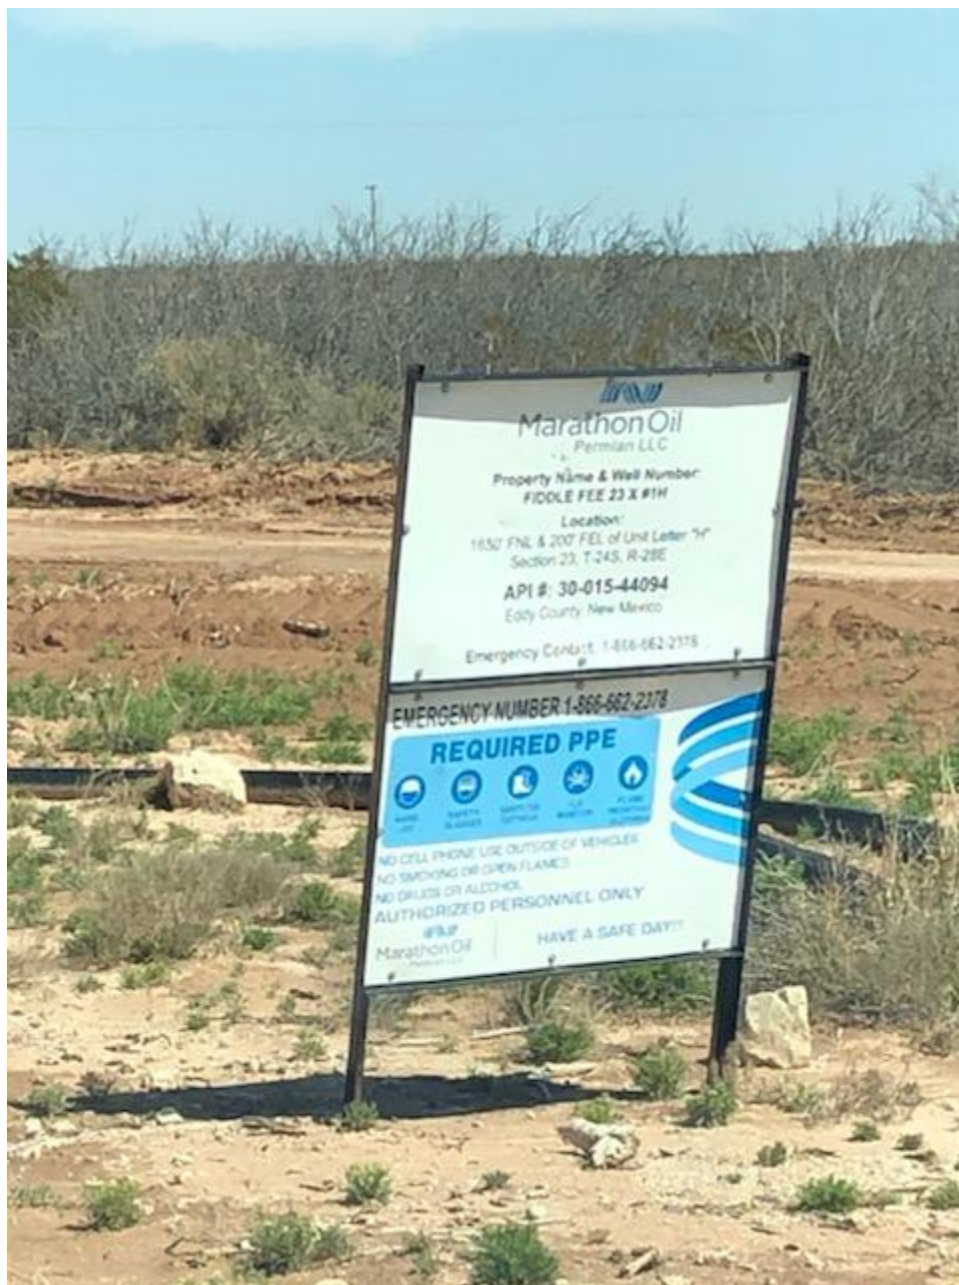
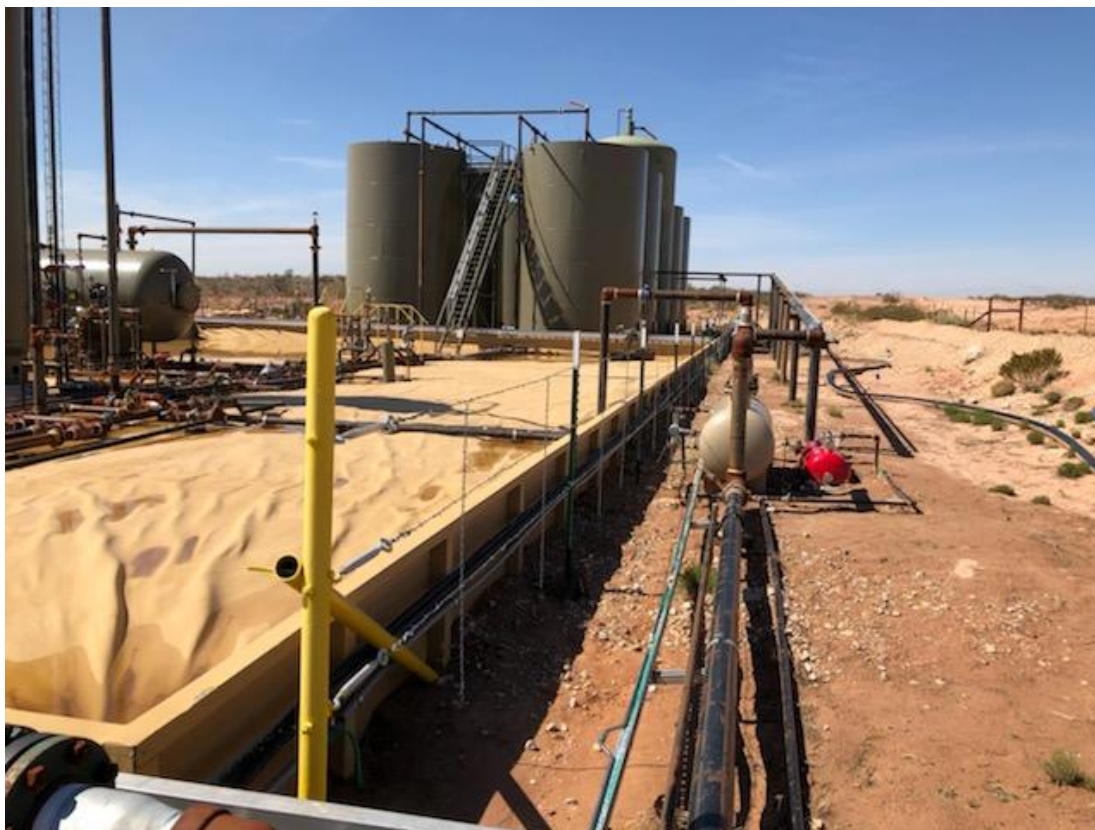
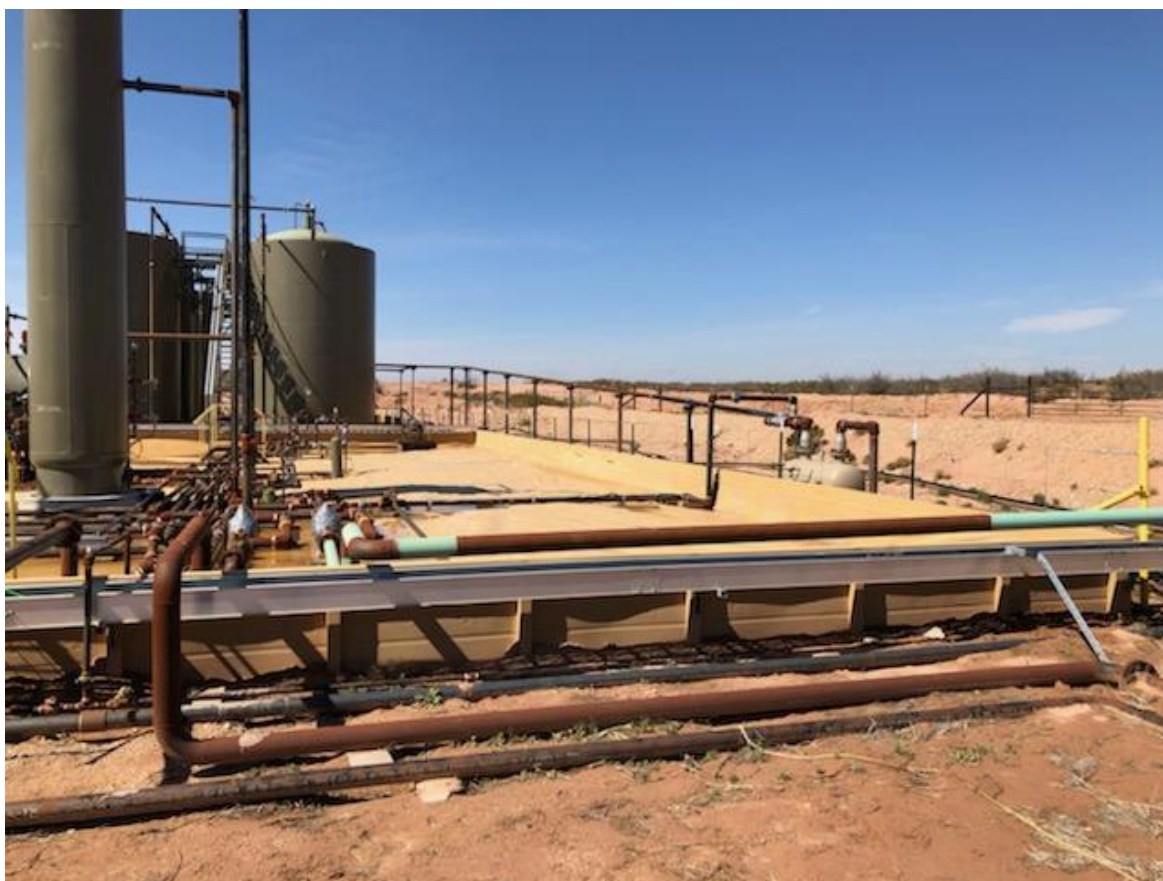
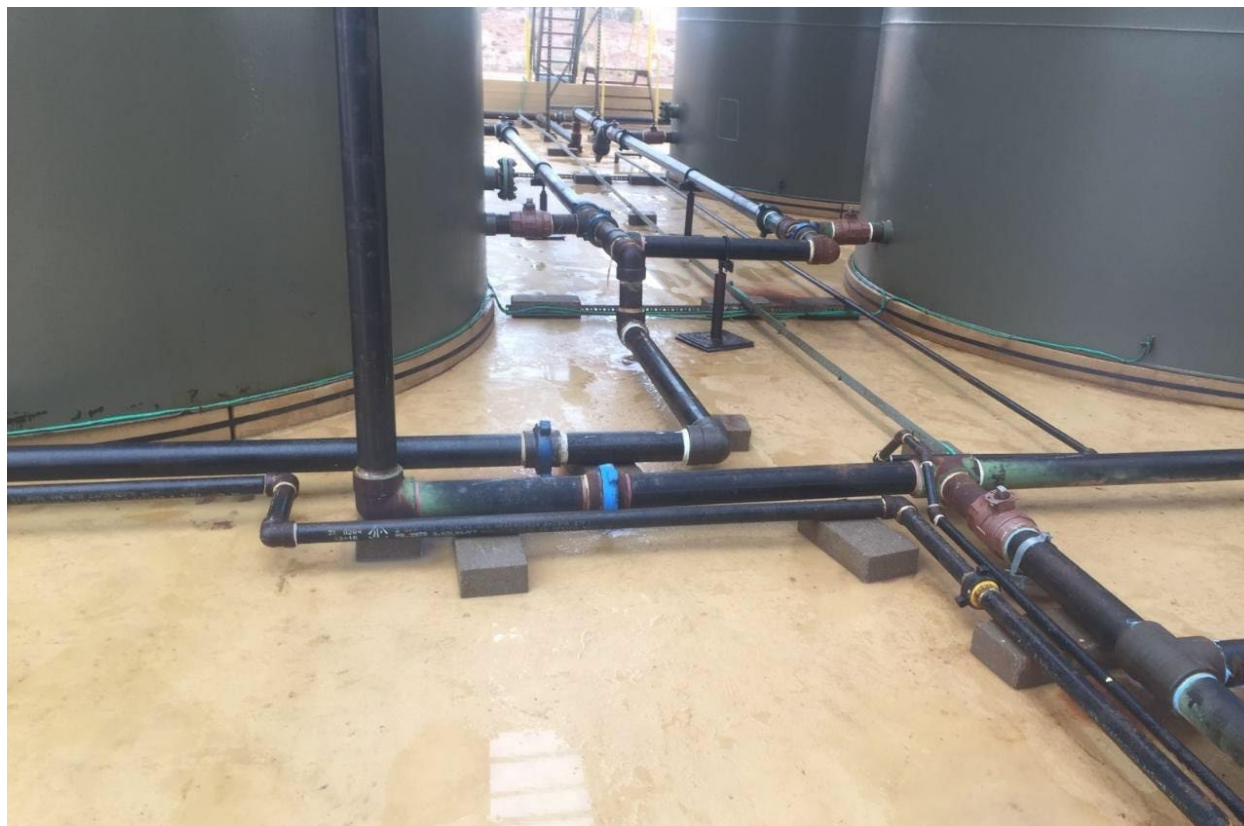
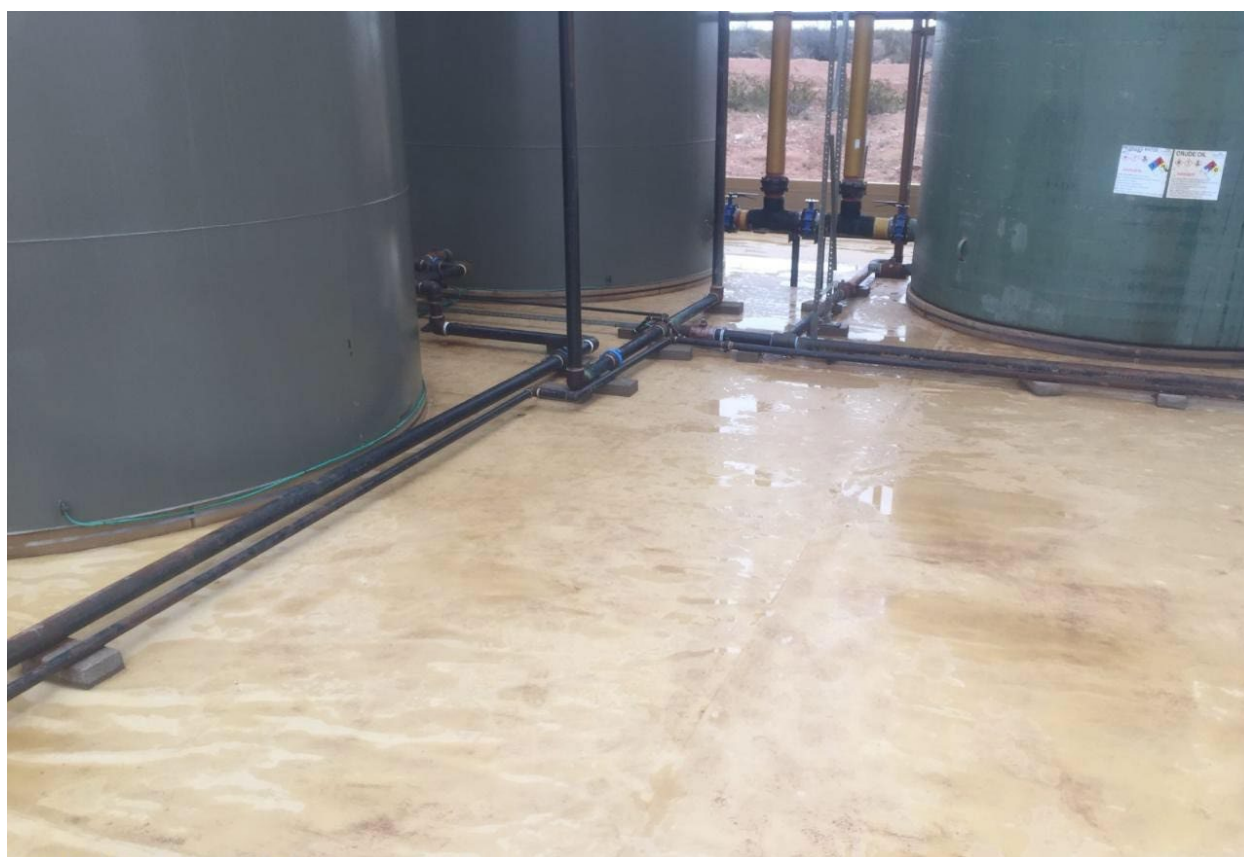
• rainwater from 3/3 & 3/4 rain event in containment (photos)
• no failures seen inside or leading to the outside of containment
• perimeter of containment - no failures
• equipment clean.
