Release Notification

Cause of Release and Affected Area:

The release was attributed to the failure of the gasket on a man may. The release was largely overspray, affecting an area measuring approximately 8,000 sq. ft. on the caliche well pad and 13,500 sq. ft. within the pasture and on the caliche access road.

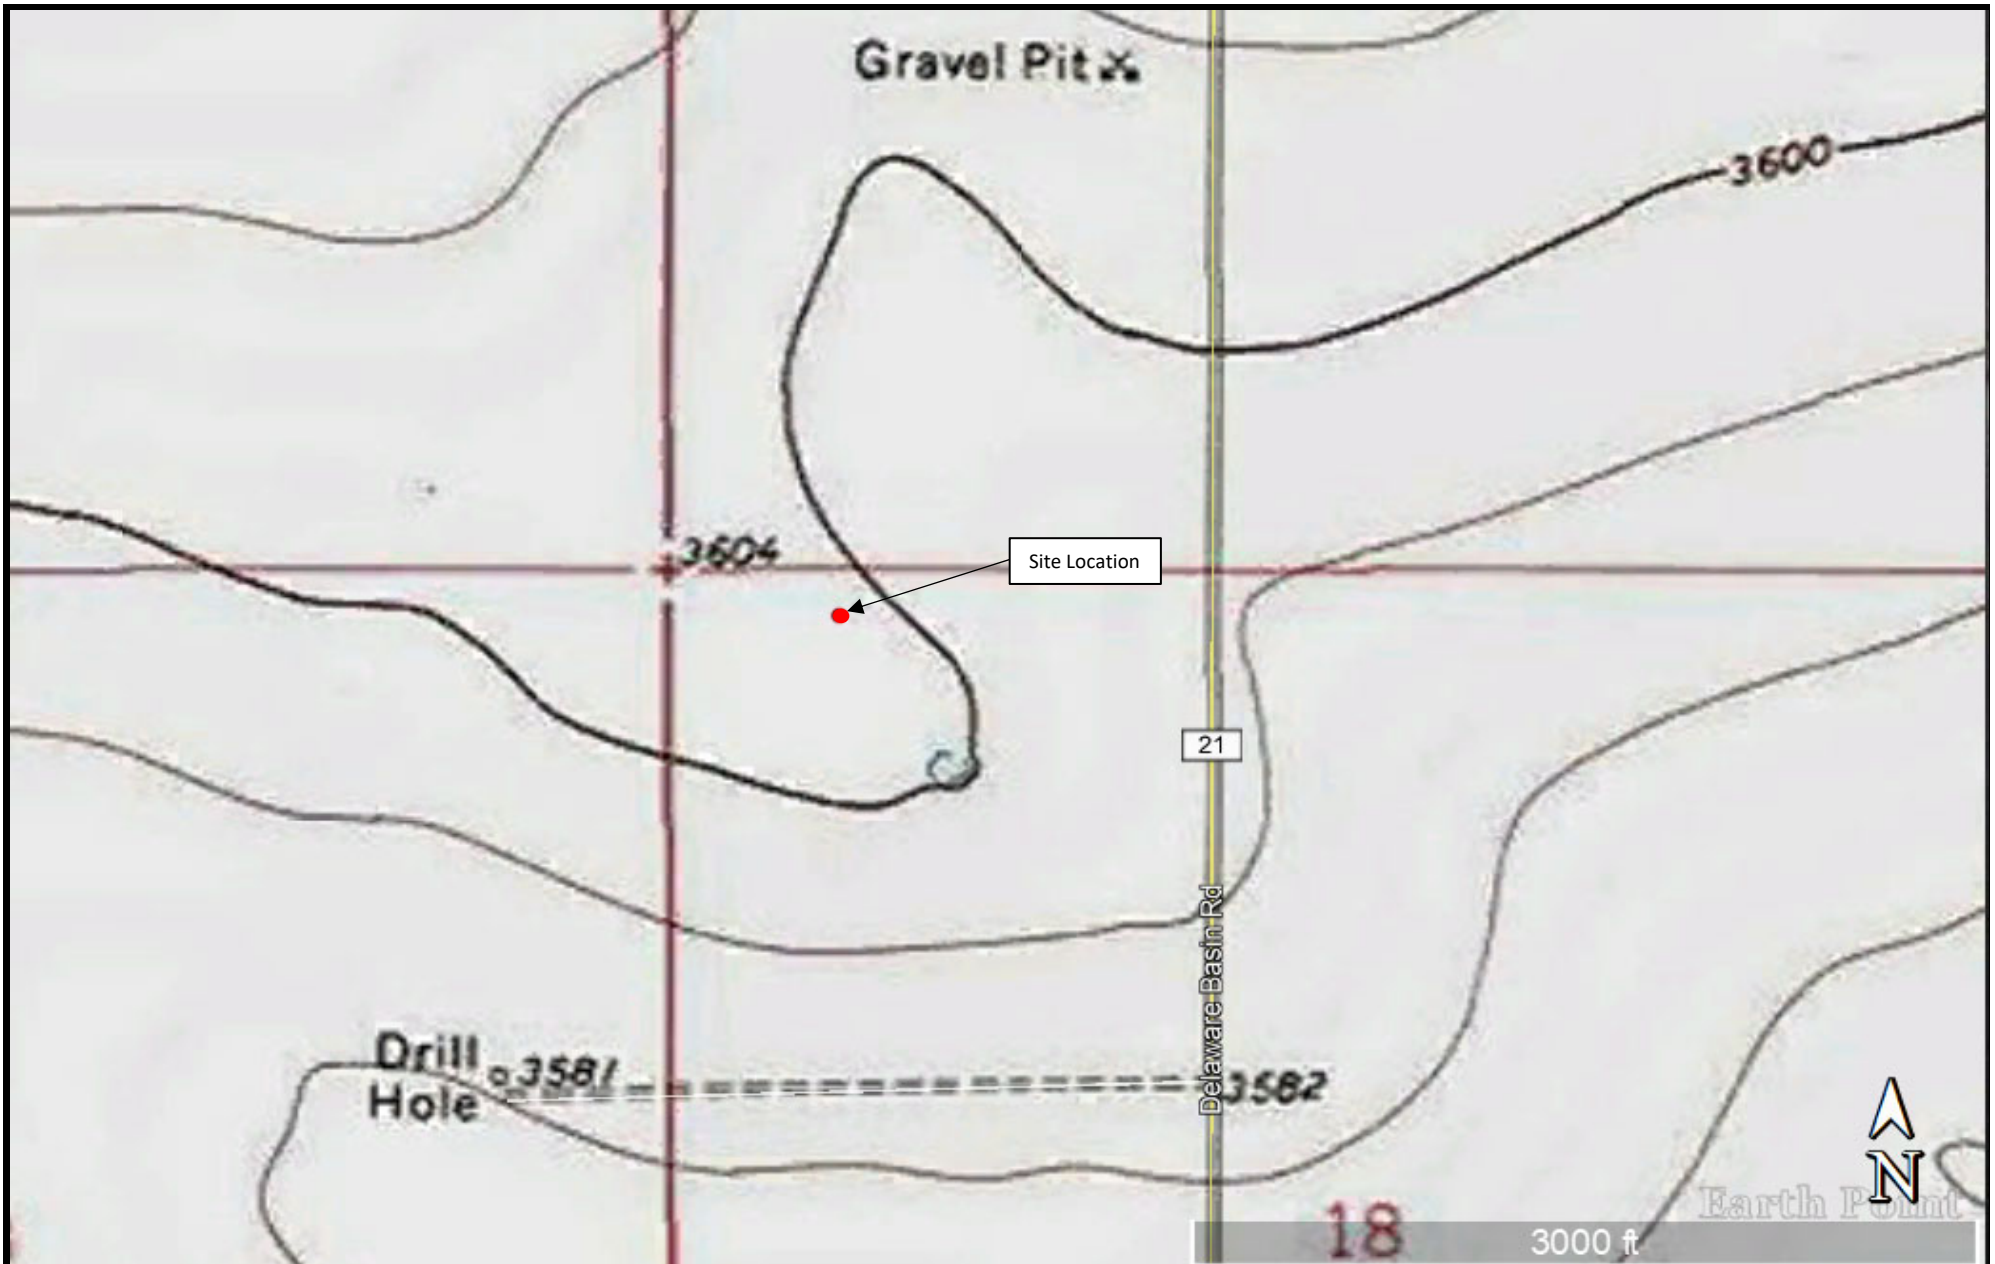
Topographic Map

Figure 1
 Topographic Map
 COG Operating, LLC
 Sebastian Fed Com #001H
 GPS: 32.2243, -103.51539
 Lea County

NMOCD Siting Criteria data was gathered from available resources including Bureau of Land Management (BLM) shapefiles; topographic maps; NMOSE and USGS databases; and aerial imagery. The results are depicted on Figures 1 & 2.

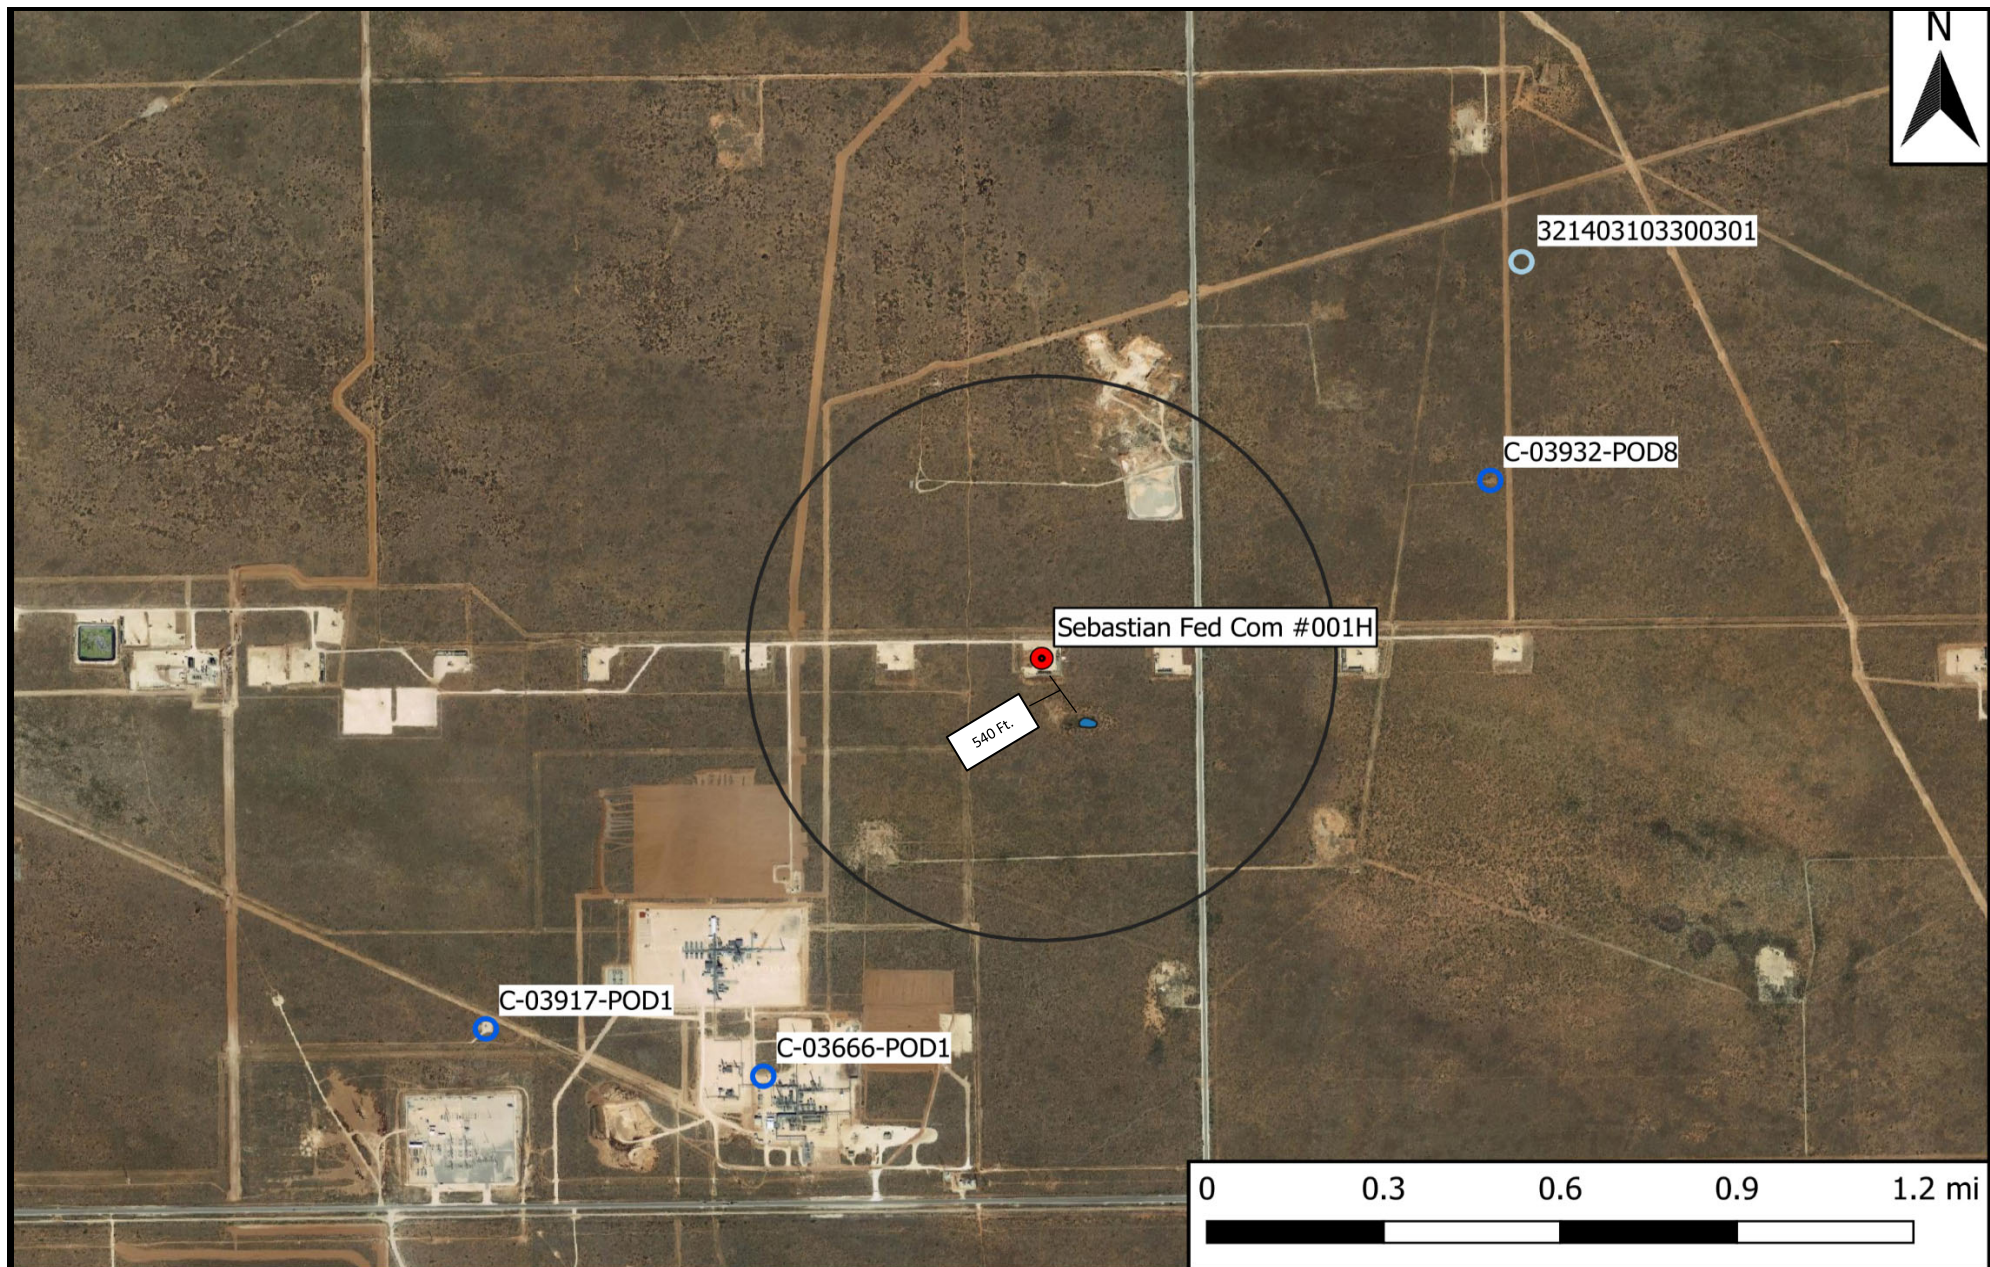
Figure 2

Aerial Proximity Map

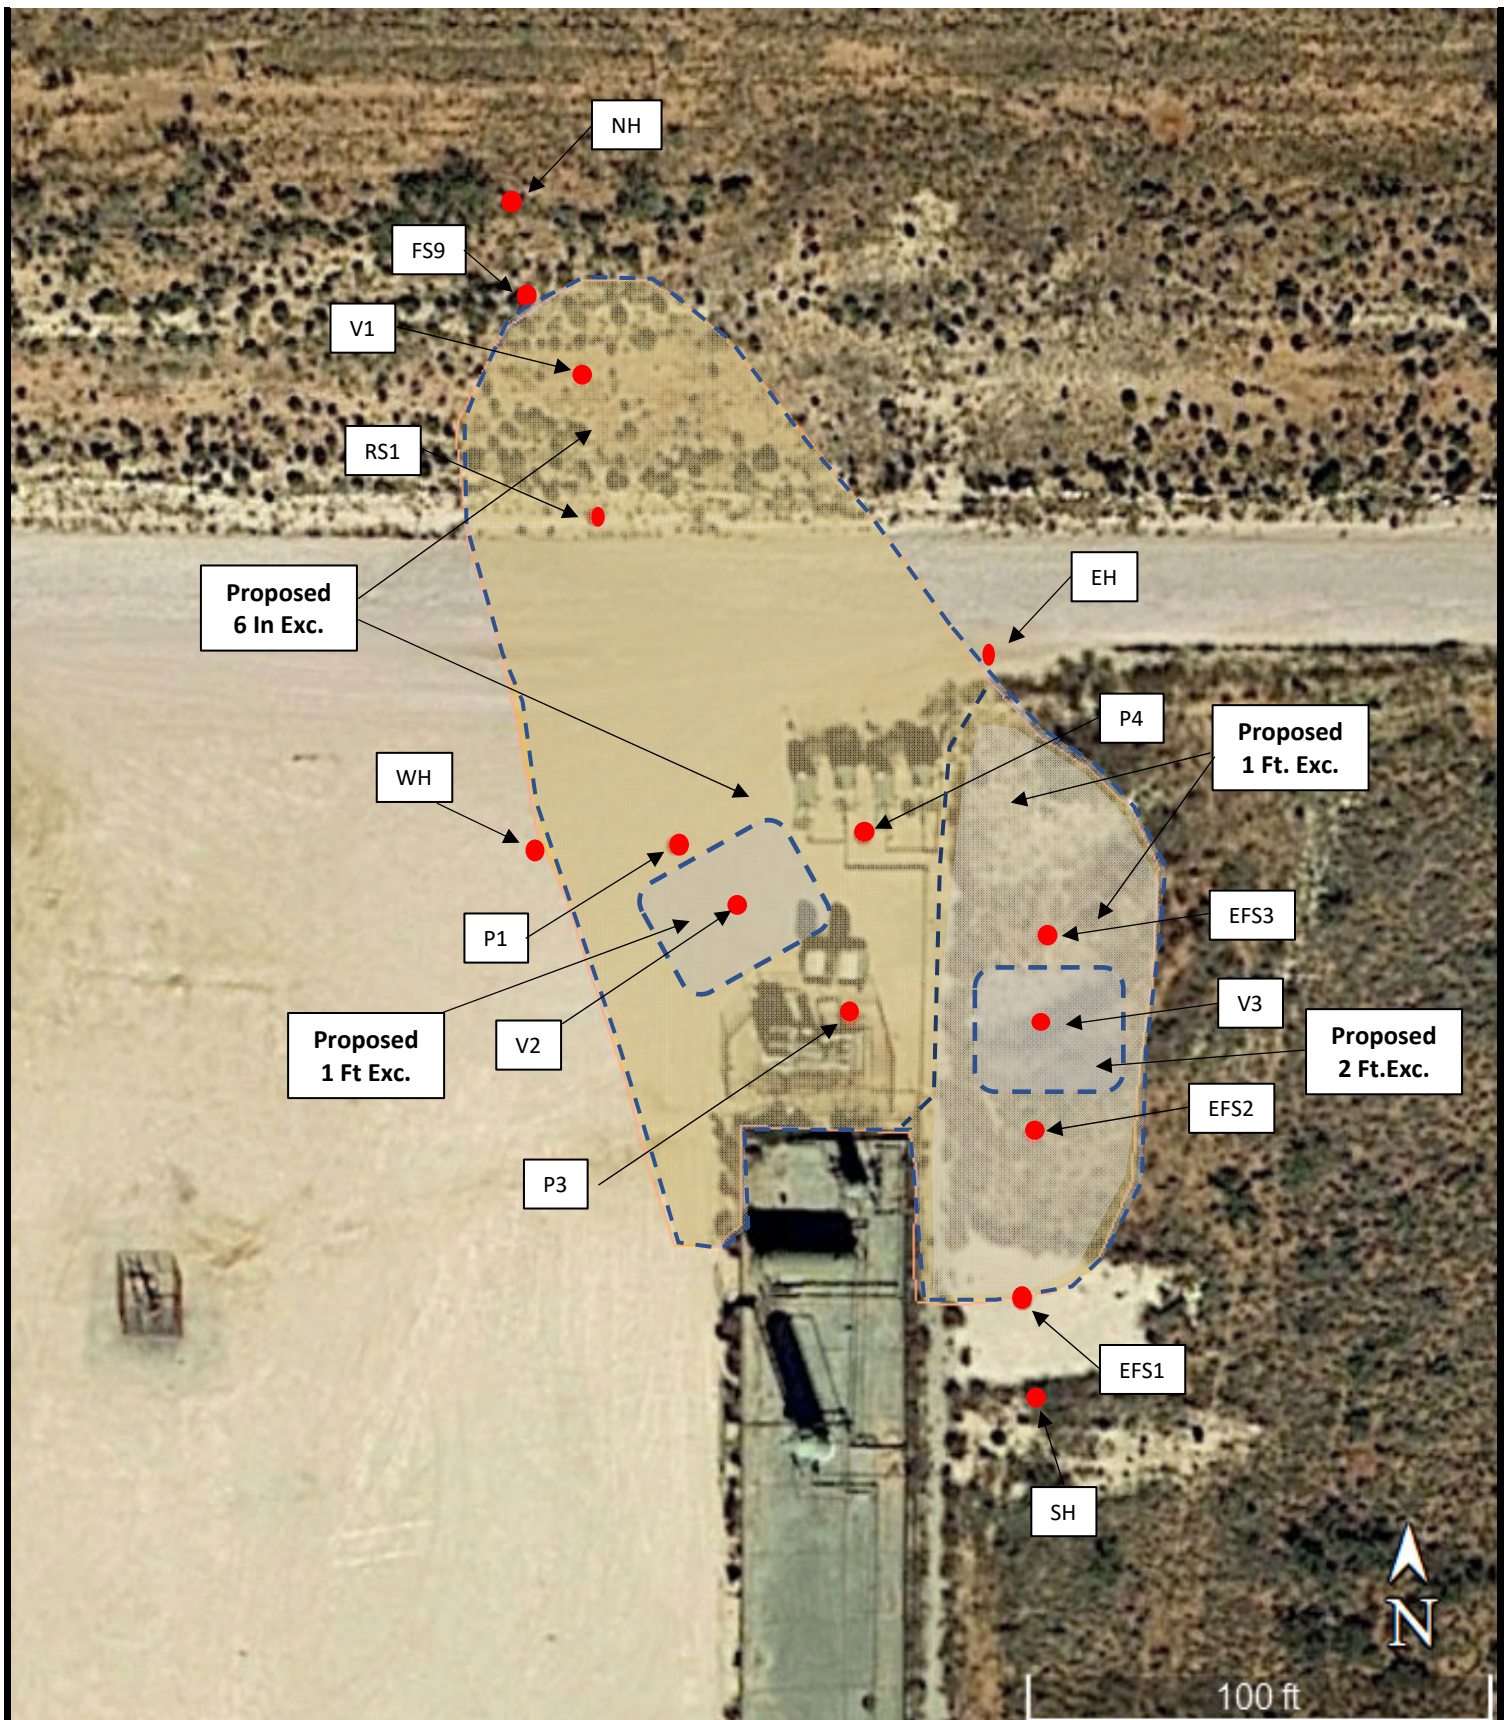
Figure 3

Site and Sample Location Map

- Confirmation Sample Point
- Affected Area
- Proposed Excavation

A minimum of **one (1)** representative five-point composite excavation confirmation soil sample will be collected from the base and sidewalls of the excavated area representing every **500 square feet**. Additional, discrete grab samples will be collected from wet or visibly stained areas inferred to have been affected by the release, as necessary.
