## Release Notification

Site Name Adobe State Battery	Site Type Tank Battery
Date Release Discovered 4/27/2020	API# (if applicable)

## Adobe State Battery Spill 4/27/2020

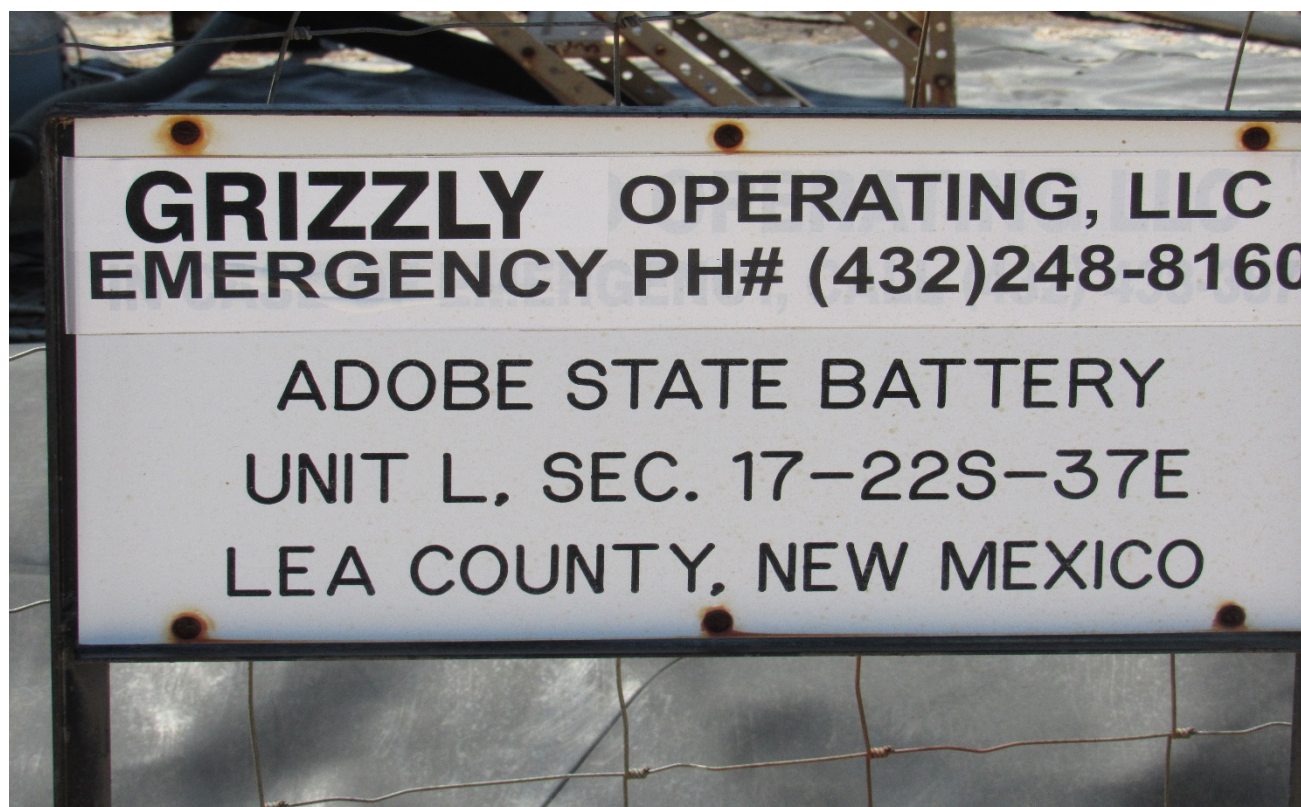
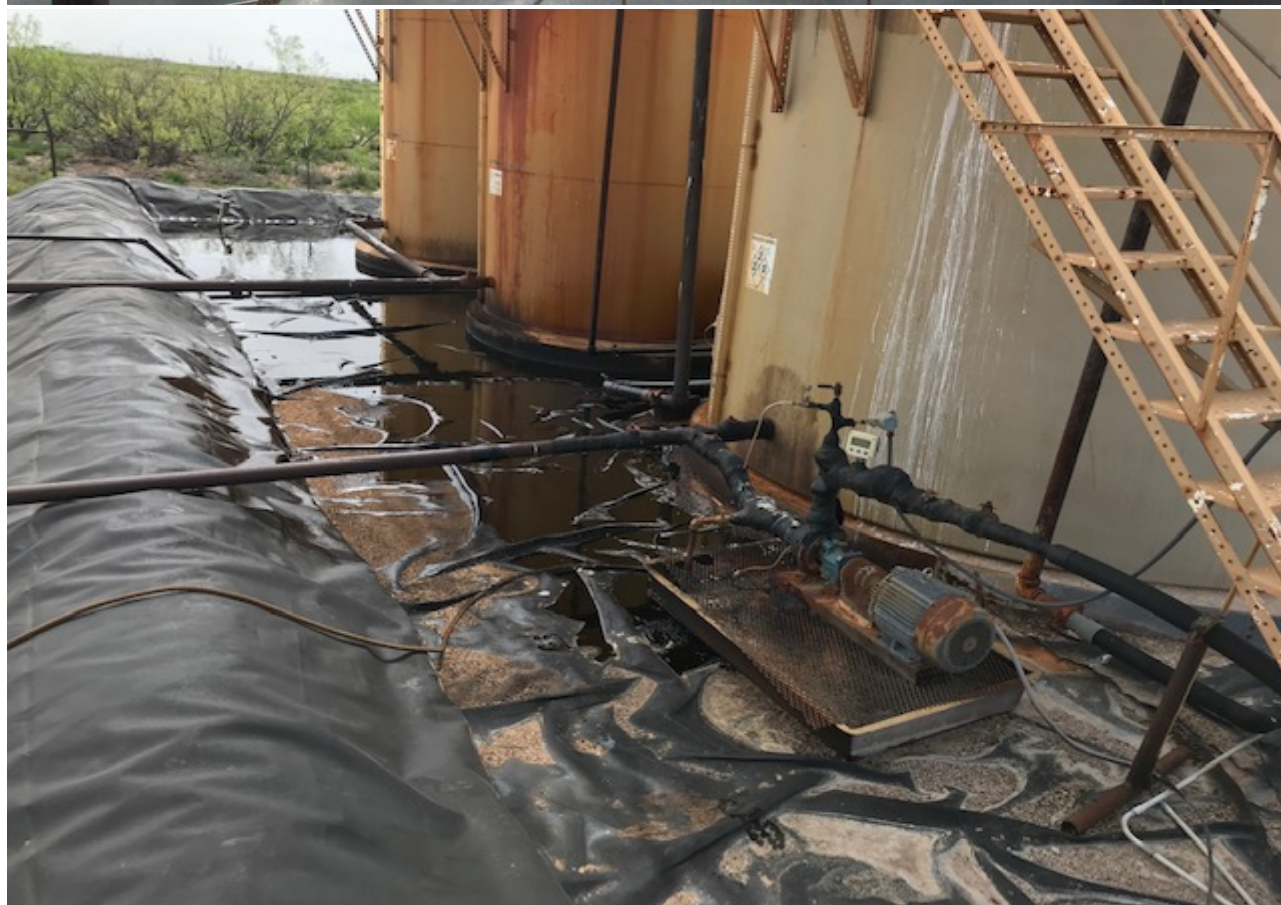
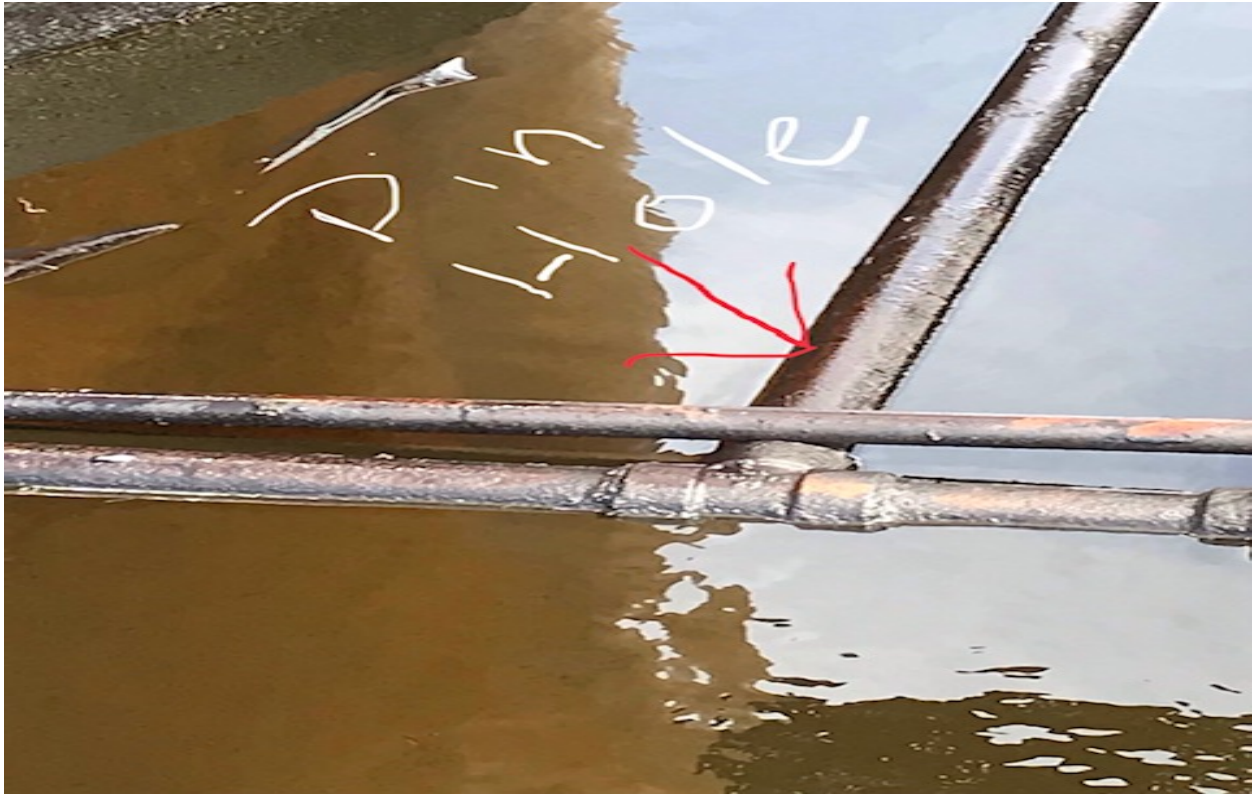
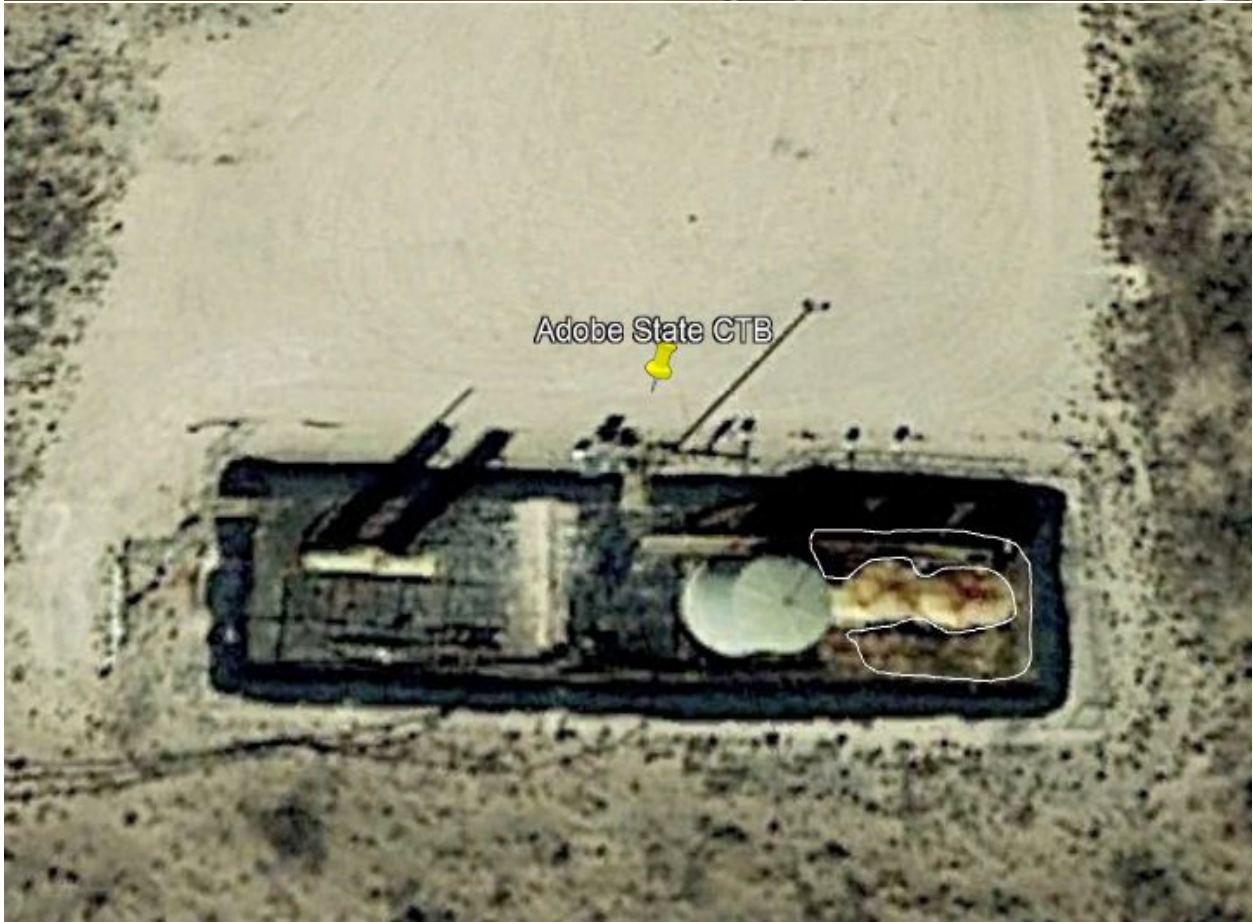
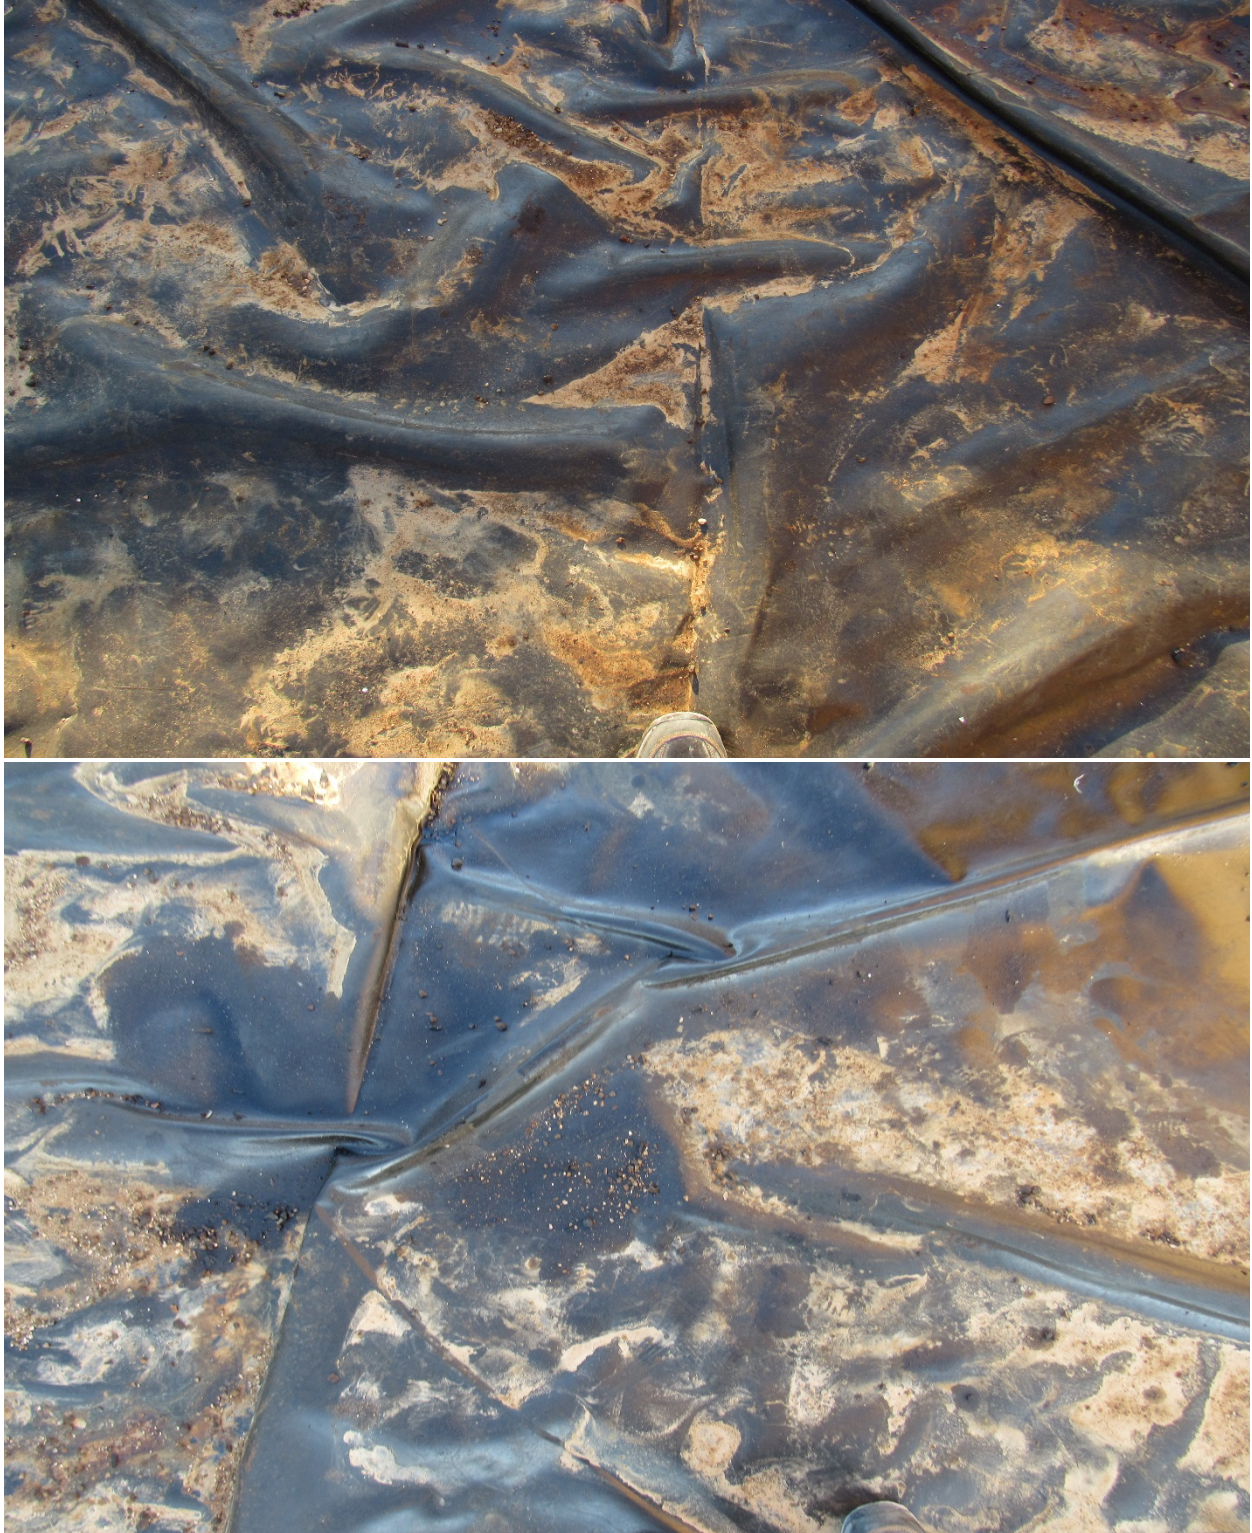
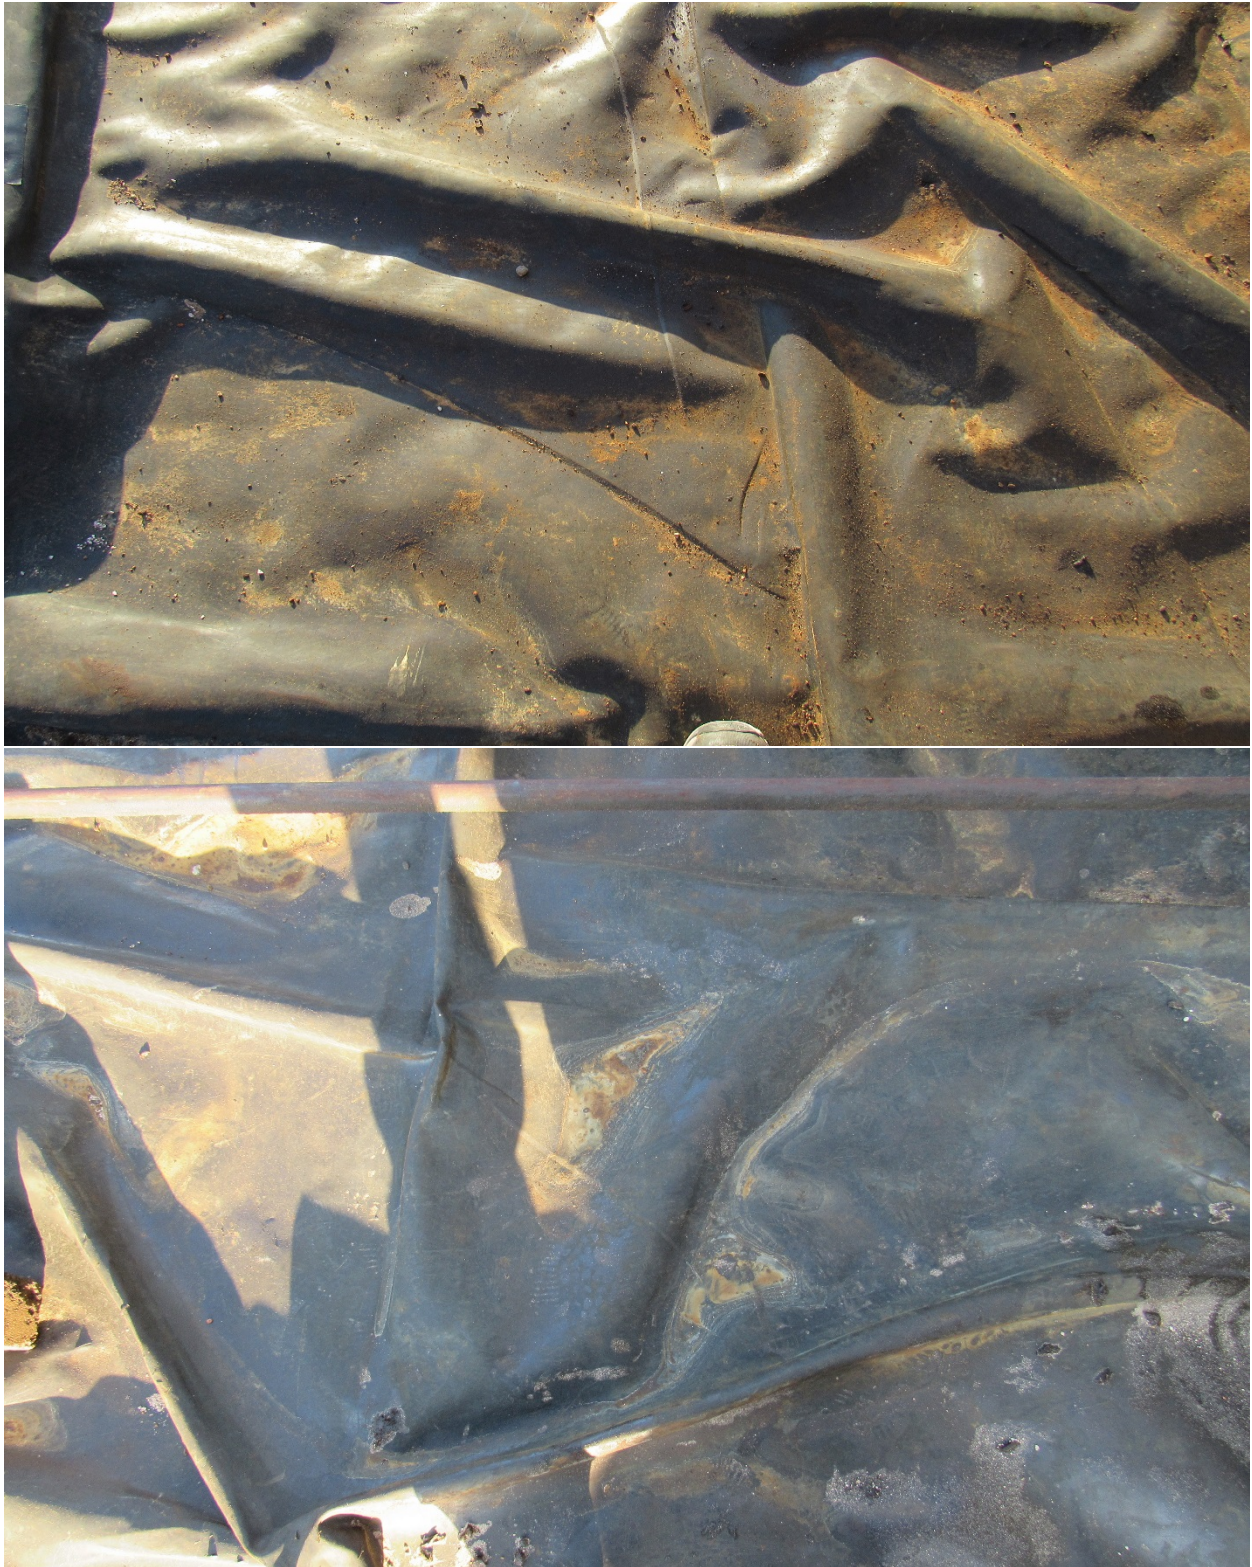
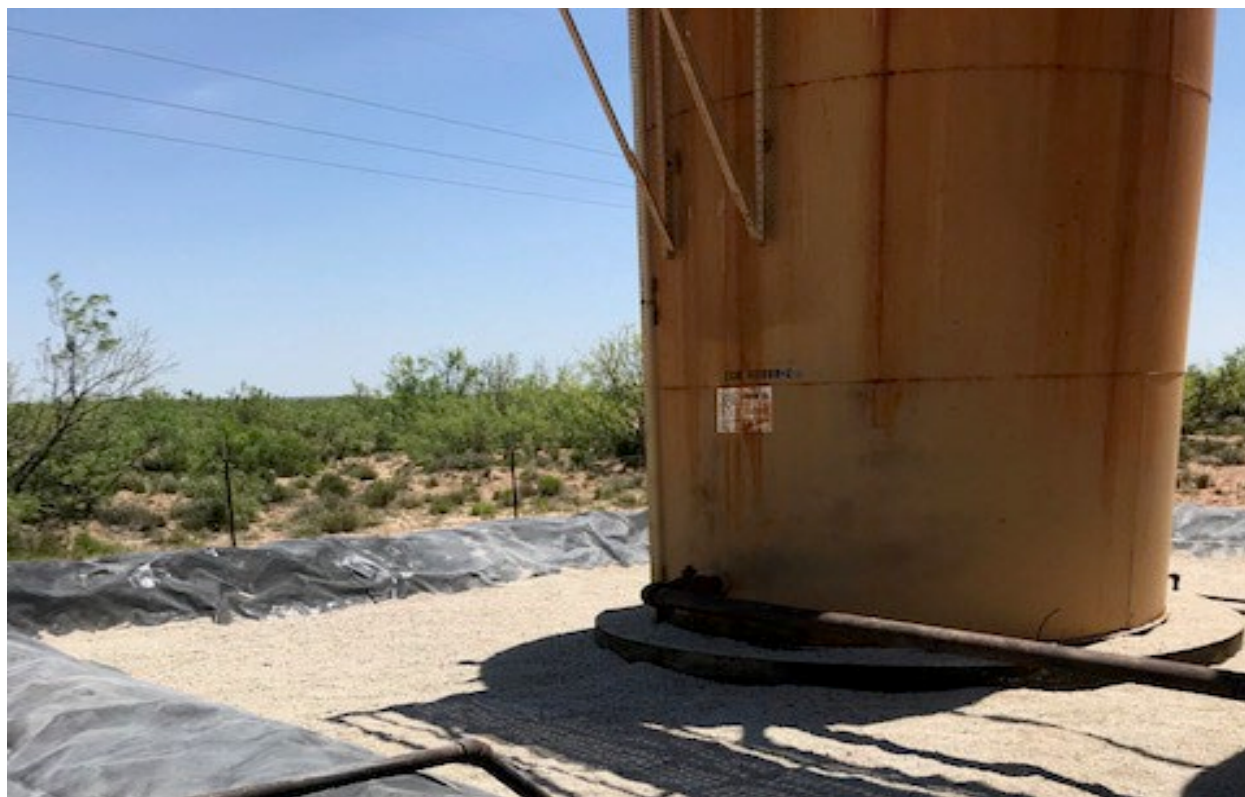
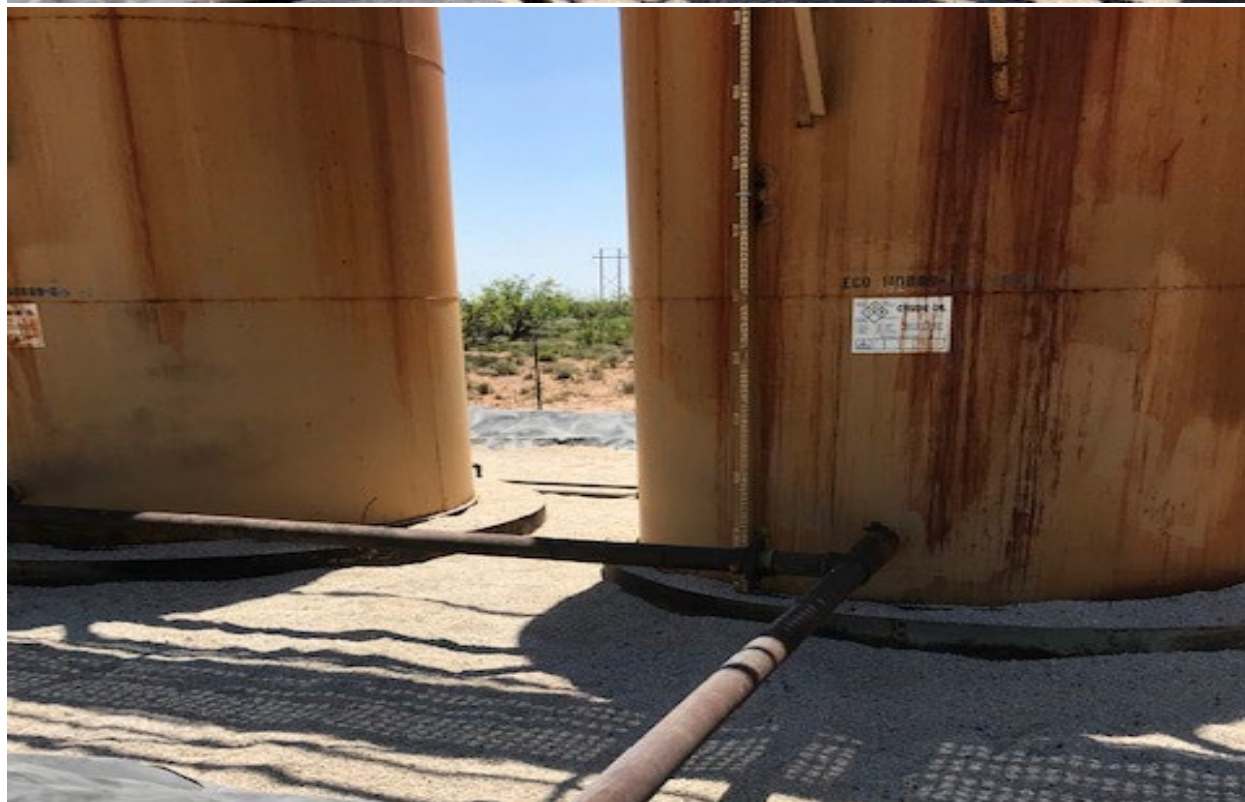
Corrosion on a flowline inside a lined containment, the corrosion was a small pinhole that released oil from the production tank to the lined containment. All liquid was contained inside the berm and nothing was released outside.

On 4/27/2020 at 11:20 AM we found a pinhole had developed from corrosion in the circulating line, causing oil to leave Tank # 1 and into the lined berm of the battery.

Pictures are attached of the spill, the pinhole, the clean inspected berm and the new gravel installed.

We immediately isolated the flowline and called a vac truck to pick up the liquid.

We removed all dirt and pea gravel from the containment and had the liner washed to allow for a proper inspection.

The liner was inspected and we found no holes, so we put new fresh pea gravel into the berm.
