Devon Energy Production Company

Snapping 2 State #3H
CLOSURE REPORT

NAB1835359072
2RP-5122

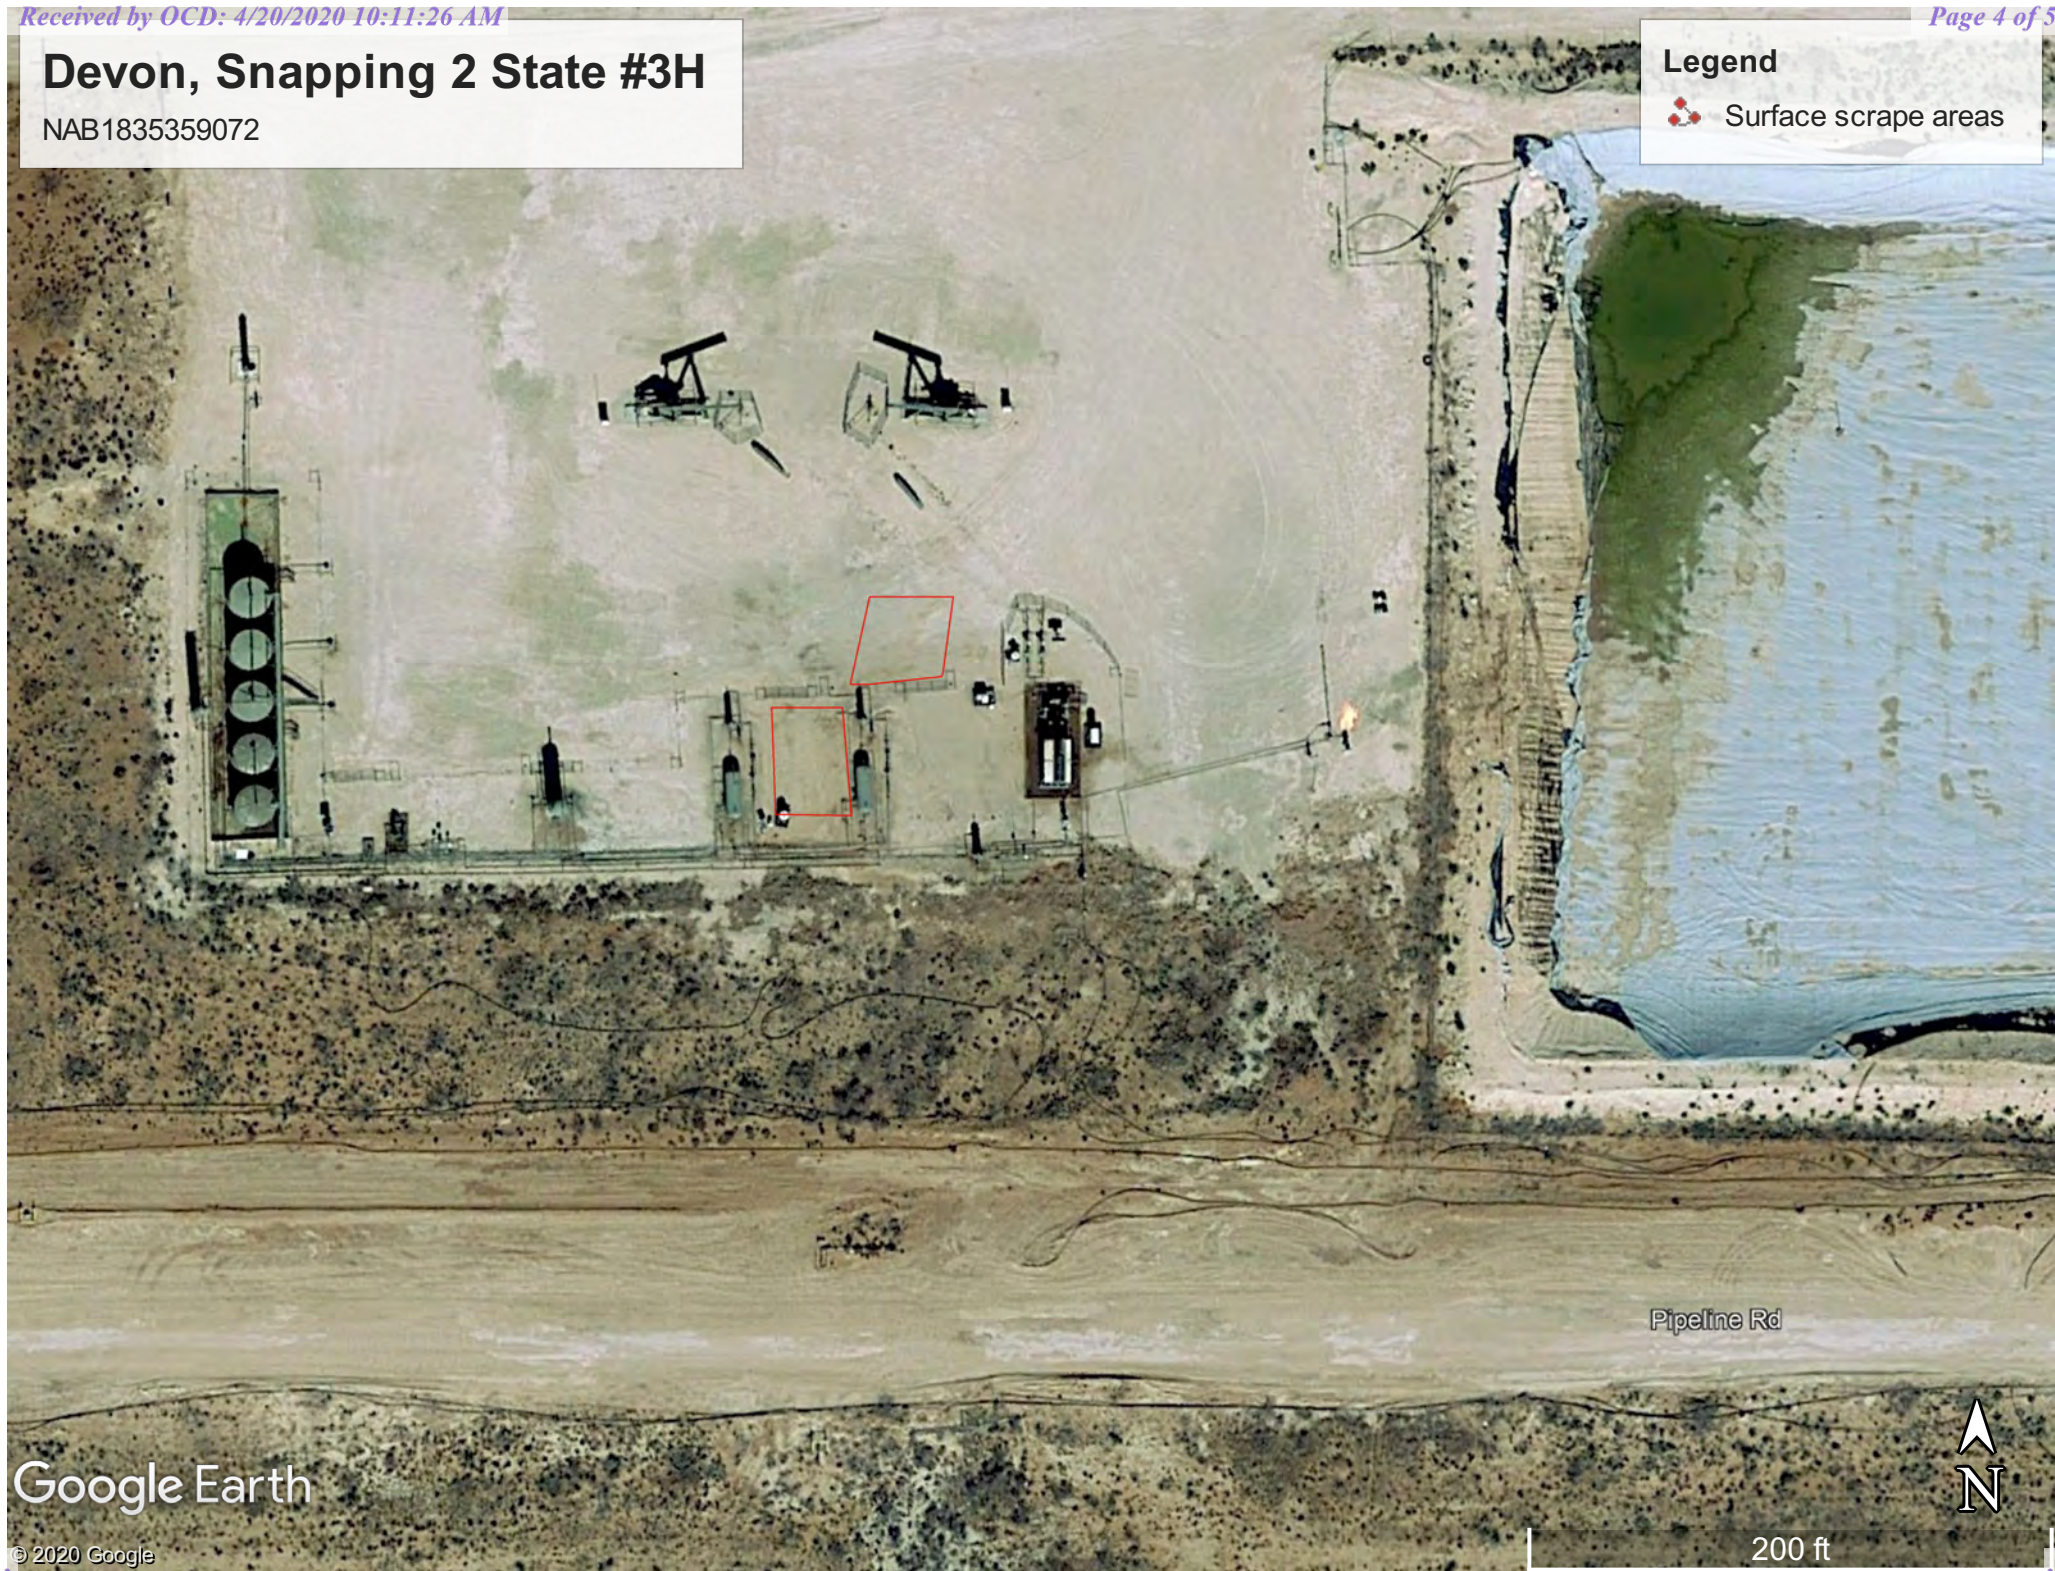
Devon, Snapping 2 State #3H

Surface scrape areas

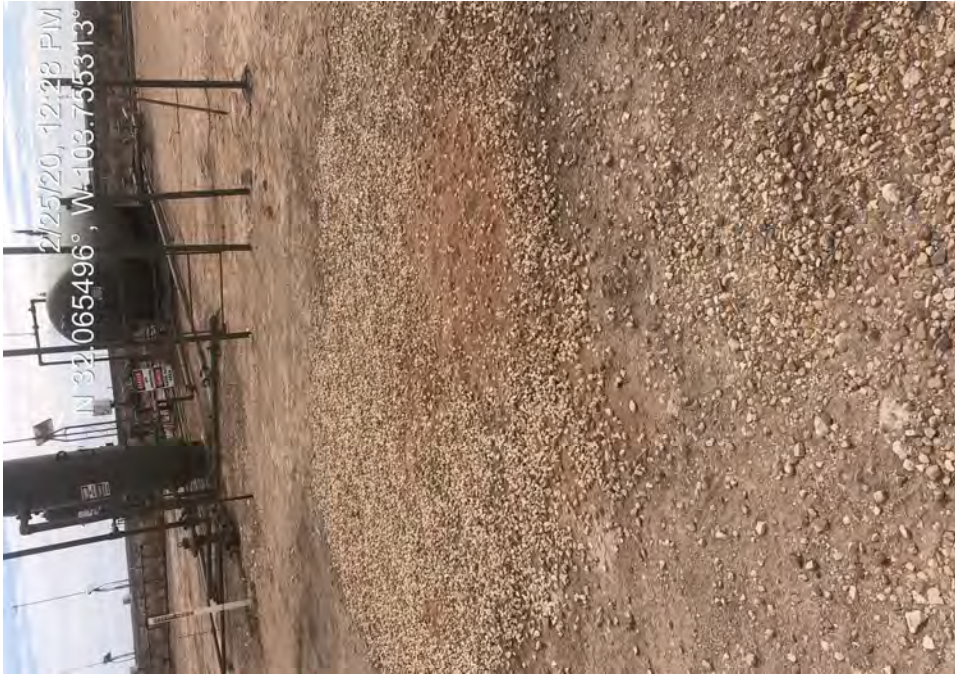
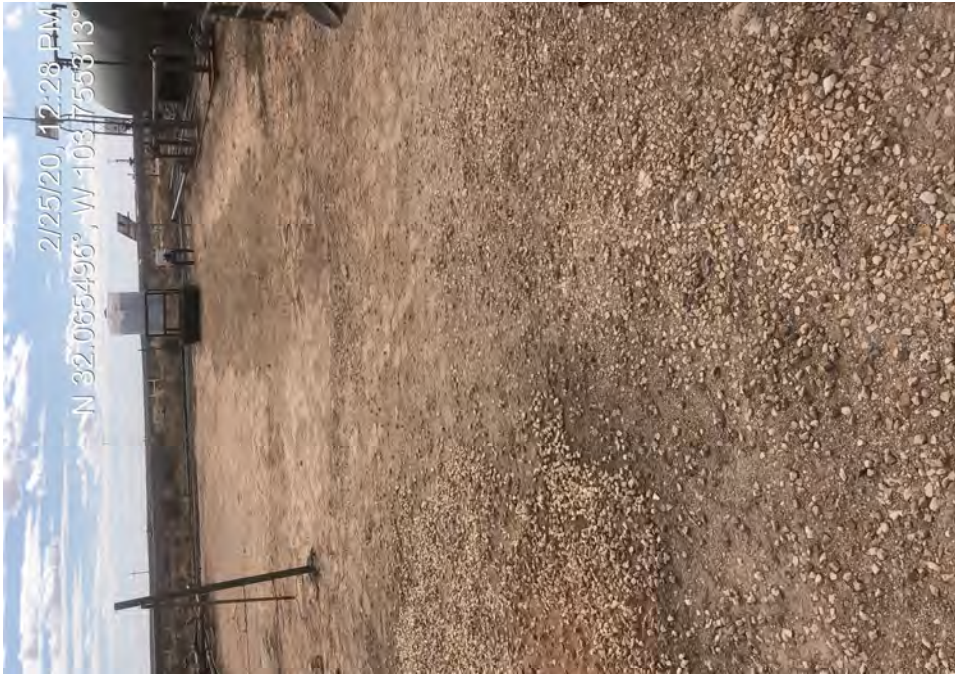
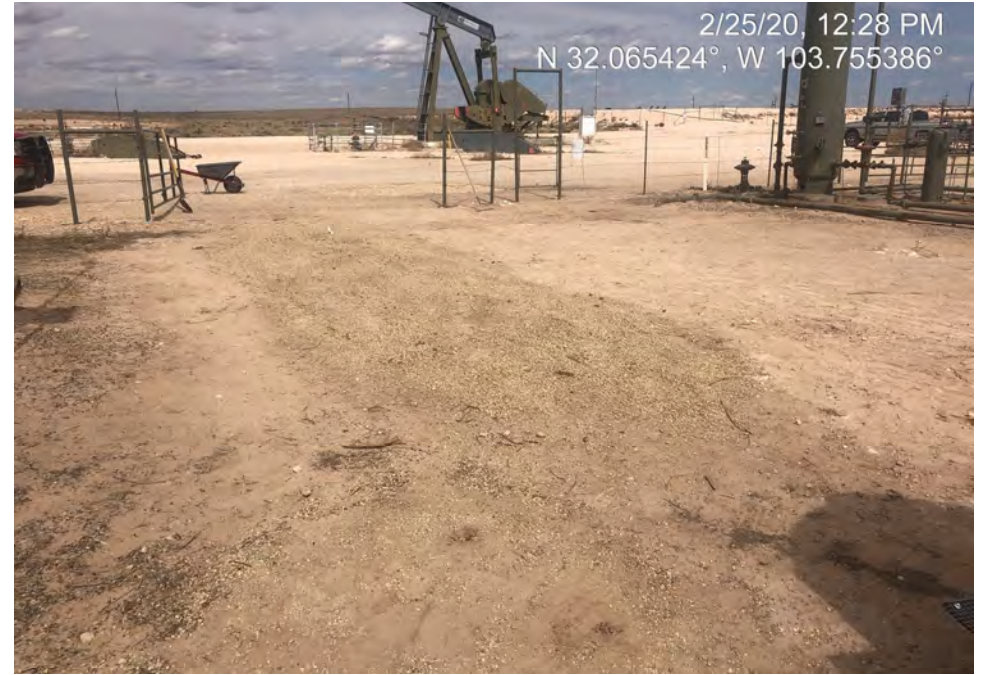
In April of 2020, the release area on the location pad was scraped and pea gravel was put spread around and on the release area. The attached pictures show the area in question with the pea gravel.

Since the work requested in the workplan approval has been completed, SESI, on behalf of Devon Energy, respectfully request closure approval for this release. Confirmation Samples were not taken because the initial sampling proved the site to be clean. Remediation photos were also not taken because the pad was only scraped. However, the Pictures of the pea gravel are included.
