## Release Notification

Site Name	Nash Unit #53 SWD	Site Type	Salt Water Disposal and Bulk Storage Facility
Date Release Discovered	6/11/2019	API# (if applicable)	30-015-39400

**RE:     Deferral Request  
          Nash Unit #53 SWD  
          Remediation Permit Number 2RP-5513  
          Incident ID Number NAB1918643207  
          Eddy County, New Mexico**

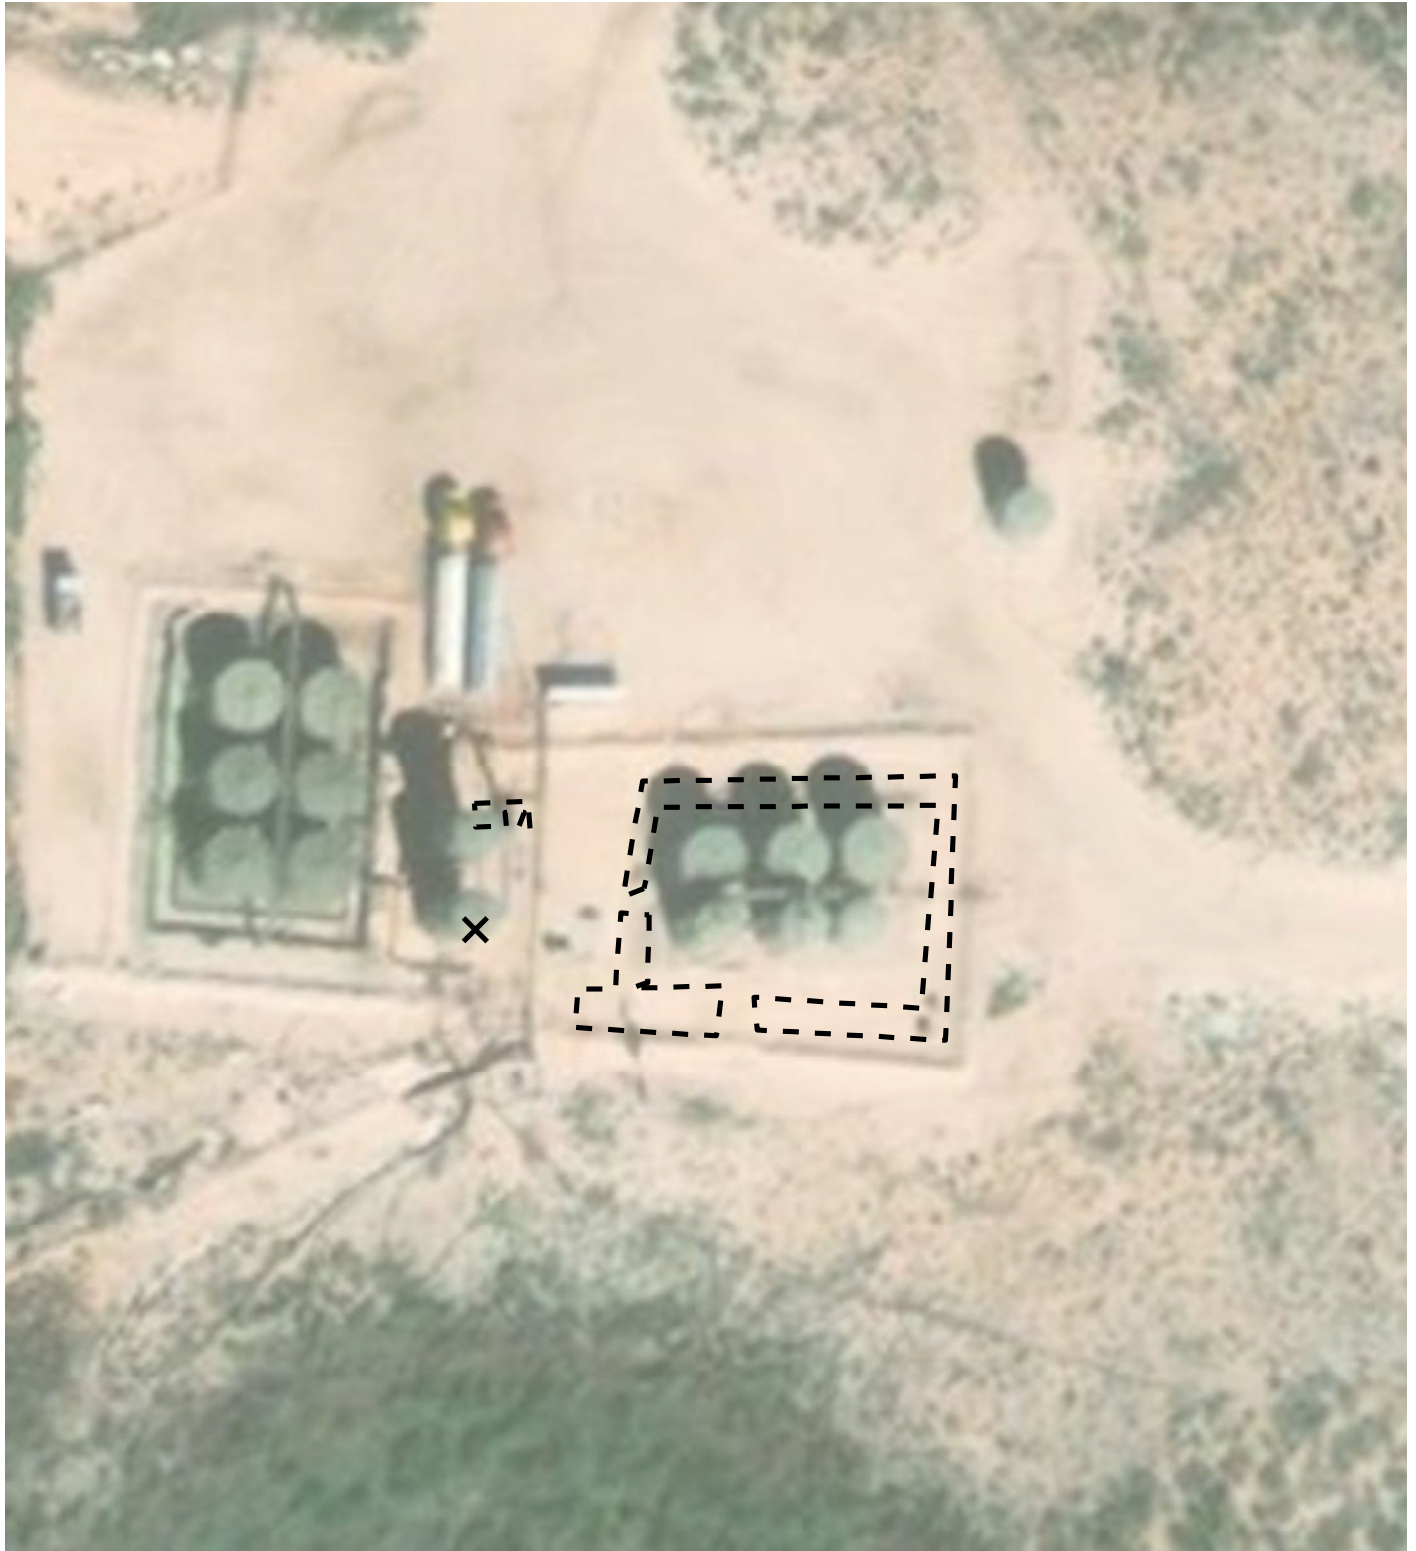
**FIGURE 3**  
**EXCAVATION EXTENTS**  
**NASH UNIT #53 SWD**  
**UNIT H SEC 13 T23S R29E**  
**EDDY COUNTY, NEW MEXICO**  
**XTO ENERGY, INC.**

From September 10 through October 24, 2019 LTE oversaw the excavation of impacted soil within the earthen containment as indicated by visual observations, field screening results, and/or preliminary sampling results. Where possible between active production equipment, earthen material above the engineered clay liner was excavated with a hydrovacuum to expose the clay liner. The clay liner was then visually inspected for integrity by a person familiar with liner construction and production equipment. The locations of final excavation extents are presented on Figure 3.

The final excavation extents on Site measured an estimated 2,065 square feet in area; the eastern excavation within the earthen berm is an estimated 2,020 square feet; the western excavations within the berm total an estimated 940 square feet. An estimated 115 cubic yards of impacted soil were removed during excavation. The impacted soil was transported and properly disposed of at R360 located in Carlsbad, New Mexico.

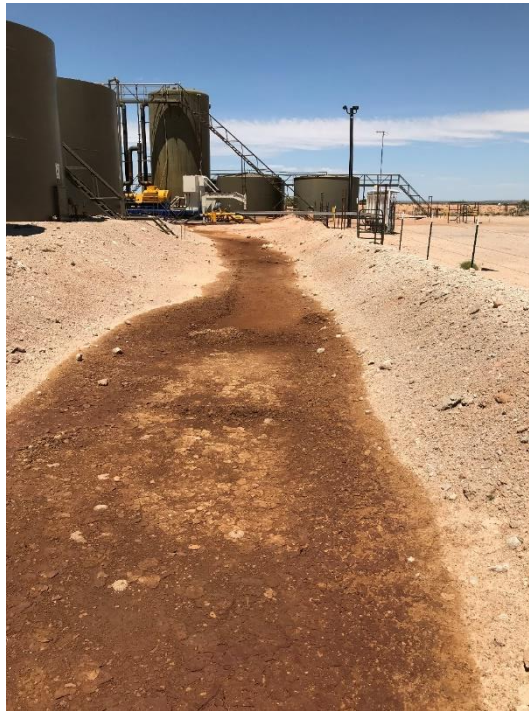
Since the release was contained, LTE personnel visited the Site to inspect impacted material inside the containment and visually inspect the integrity of the clay liner. Surficial staining was observed within the earthen berm above the clay liner. LTE collected and field screened six preliminary soil assessment samples (SS01 through SS04, SS06, and SS08) in the release area from a depth of 0.5 feet bgs using hand-auger equipment decontaminated prior to and between sample points. Two other soil samples (SS05 and SS07) were collected outside of the lined earthen containment to address other reported historical releases, which are included on a Compliance Agreement between XTO and the NMOCD and will be addressed under separate cover. The historical releases, 2RP-4220 and 2RP-4831, are located on the same well pad, outside of the containment. Photographic documentation was conducted during the site visit and inspection of the clay liner and are included in Attachment 1.

**View of the surficial staining on the northern side of the containment facing west.**

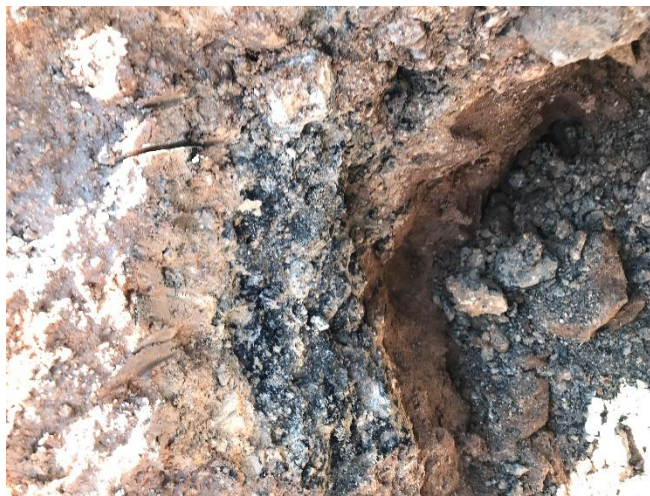
To preserve the integrity of the liner, no confirmation samples were collected in the excavated areas. Instead, the liner was inspected to ensure it was not compromised or damaged. Visual observations indicate the clay liner was not damaged. An inspection of the exposed liner was completed, and photos of the excavation and clay liner are included in the attached photo log.

**Engineered clay liner at the base of the containment.**

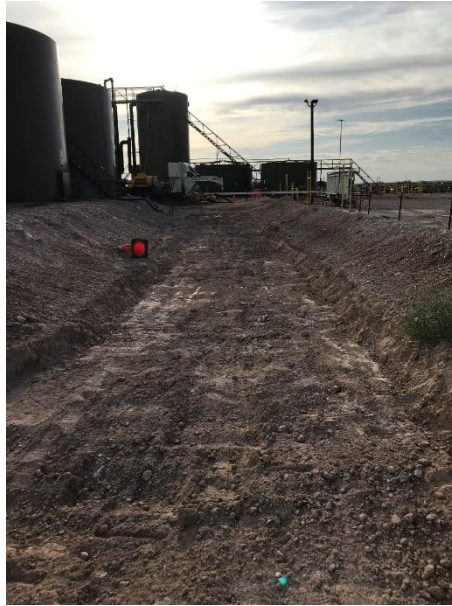
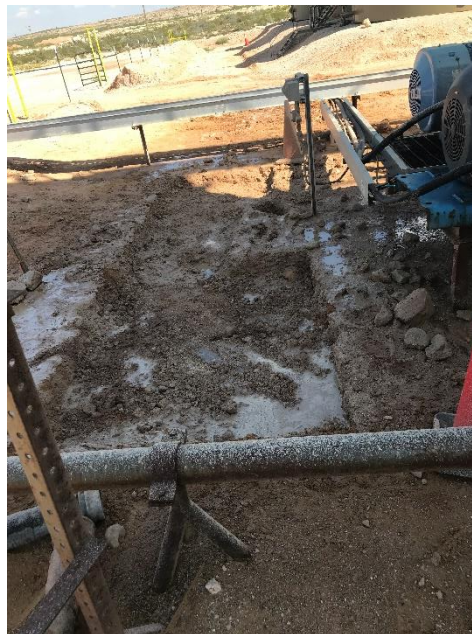
**View of the excavation down to the exposed clay liner.**

A total of approximately 115 cubic yards of impacted earthen material inside the containment were removed from above the engineered clay liner; however, residual impacted soil was left in place for compliance with the XTO safety policy regarding earth moving activities within two feet

XTO requests permission to complete remediation during any future major construction, alteration or final abandonment, whichever occurs first. LTE and XTO do not believe deferment and/or a variance will result in an imminent risk to human health, the environment, or groundwater. No saturated soil remains in place and mass source removal has occurred. Remaining impact is contained by the inspected clay liner and earthen berm, which appears to be intact and undamaged.
