## Release Notification

Site Name	Hackberry 34 CTB	Site Type	Tank Battery
Date Release Discovered	02/29/2020	API#	(if applicable)

**RE: Closure Request  
Hackberry 34 Central Tank Battery  
Incident ID: NRM2007860939  
Eddy County, New Mexico**

FIGURE 2  
 DELINEATION SOIL SAMPLE LOCATIONS  
 HACKBERRY 34 CENTRAL TANK BATTERY  
 UNIT A SEC 34 T19S R31E  
 EDDY COUNTY, NEW MEXICO  
 XTO ENERGY, INC.

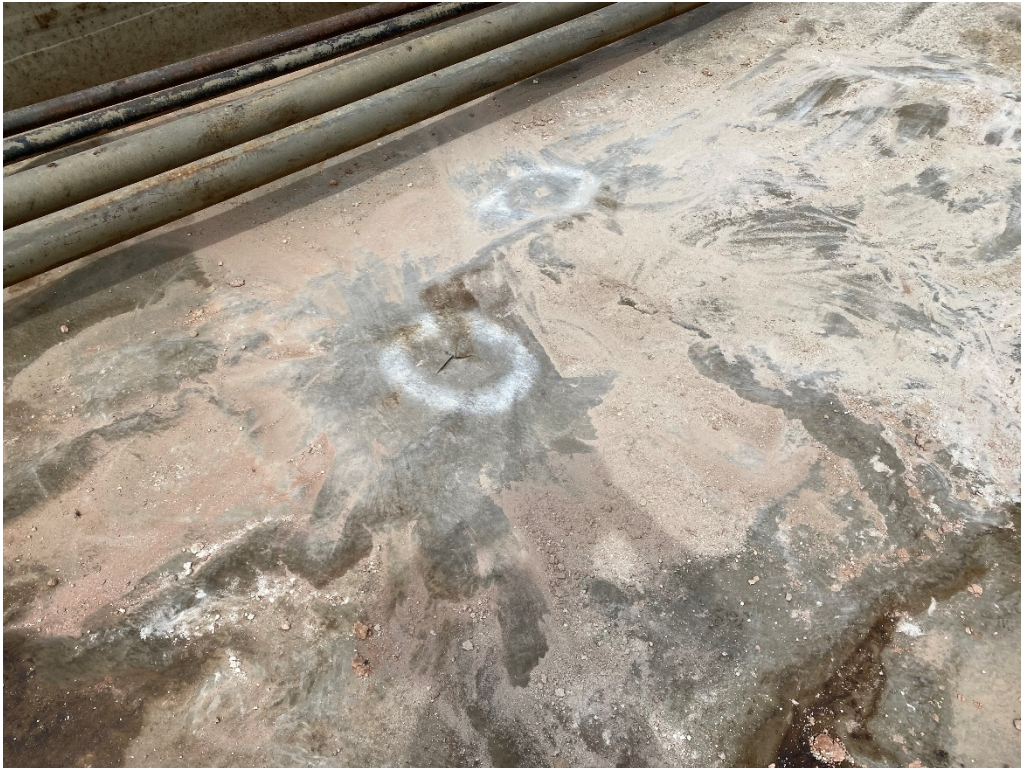
**Photograph 1:** View of location of BH01.

On April 1, 2020, LTE evaluated the release based on information provided on the Form C-141 and visual observations. LTE personnel advanced a borehole via hand-auger at one location within the lined tank battery containment on the southwest corner of the tank battery, on the western edge of the caliche well pad. Site assessment activities and vertical delineation soil sampling was completed at the location of the tear in the liner found during the liner integrity inspection conducted by XTO. Three soil samples were collected at approximately 0.5 feet, 2 feet, and 4 feet bgs (BH01 through BH01B). Soil from the discrete borehole soil samples was field screened for volatile aromatic hydrocarbons and chloride utilizing a calibrated photo-ionization detector (PID) and Hach® chloride QuanTab® test strips, respectively. Field screening results and observations for each sample were documented on a lithologic/soil sampling log and are included as Attachment 1. The borehole was backfilled with the soil removed and XTO repaired the liner. The borehole delineation soil sample location is depicted on Figure 2. Photographic documentation was conducted during the Site visit. The photographic log is included in Attachment 2.

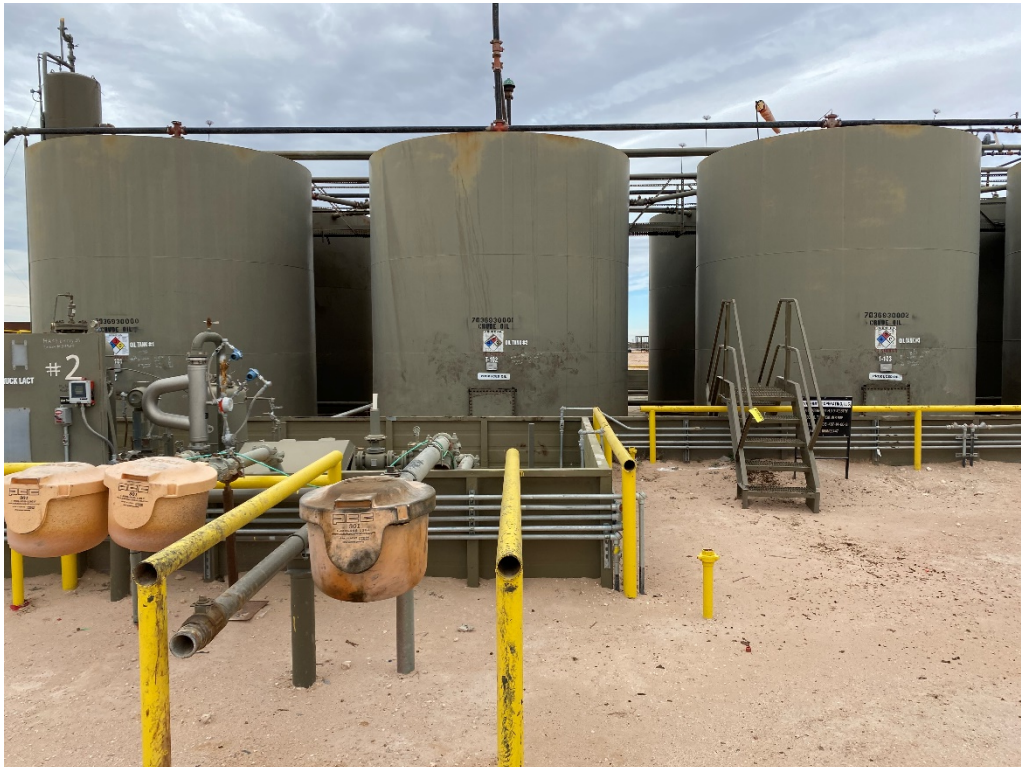
**Photograph 2:** View of tank battery containment where release occurred.

On February 29, 2020, an overflow line was opened, resulting in the release of 20 barrels (bbls) of crude oil into an impermeable containment. A vacuum truck was immediately dispatched to the Site to recover freestanding fluids, of which approximately 20 bbls of crude oil were recovered. XTO reported the release to the New Mexico Oil Conservation Division (NMOCD) on a Release Notification and Corrective Action Form C-141 (Form C-141) on March 13, 2020. A 48-hour advance notice of liner inspection was provided via email to NMOCD District 2 and, upon inspection, the liner was determined to be insufficient.
