Report Type: Revised Closure 1RP-5480

Site:	Cabo Blanco State #001H					
Company:	COG Operating LLC					
Section, Township and Range	Unit B	Sec. 04	T 24S	R 33E		
Lease Number:	API No.					
County:	Lea County					
GPS:	32.2532			-103.5744		
Surface Owner:	State					
Directions:	From the intersection of HWY 128 and CR 2 Turn North on HWY 128 and go 2.97 miles and turn west and go .27 miles and arrive.

Re: Revised - Closure Report for the COG Operating, LLC, Cabo Blanco State #001H, Unit B, Section 04, Township 24 South, Range 33 East, Lea County, New Mexico. 1RP-5480

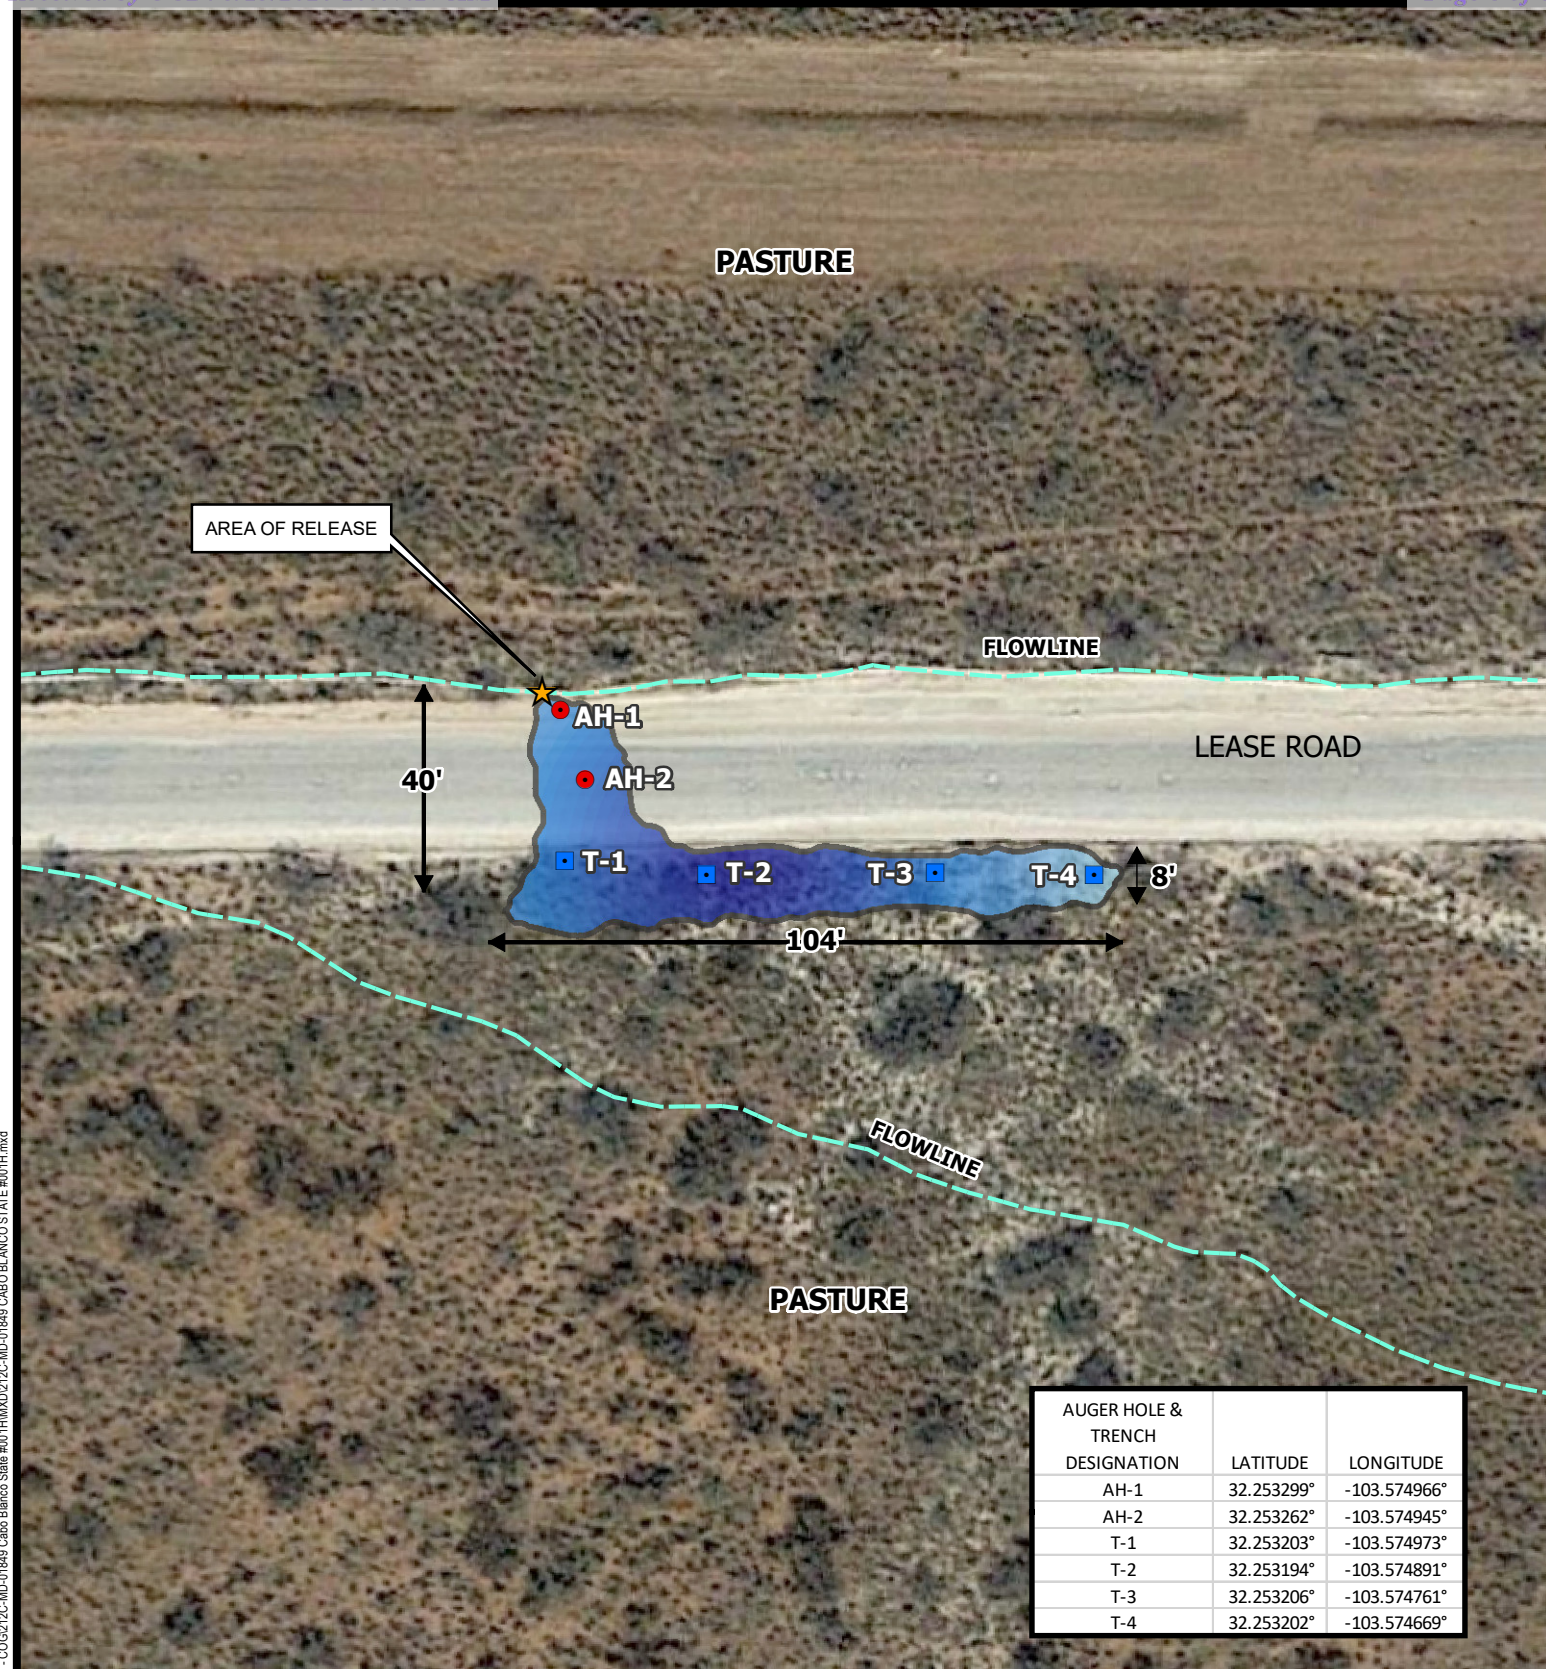
FIGURE
3

On July 16, 2019, Tetra Tech personnel were onsite to evaluate and sample the release area. A total of two (2) auger holes (AH-1 and AH-2) were installed near the source area and on the lease road to total depths ranging from 0-6" and 3.5' below surface. Deeper samples were not collected due to a dense formation in the area. Selected soil samples were collected and submitted to the laboratory for TPH analysis by EPA method 8015 modified, BTEX by EPA Method 8021B, and Chloride by EPA method 300.0. Copies of laboratory analysis and chain-of-custody documentation are included in Appendix C. The results of the sampling are summarized in Table 1. The sample locations are shown on Figure 3.

On July 30, 2019, Tetra Tech personnel returned to the site and install four (4) backhoe sample trenches (T-1 through T-4) to assess the pasture area. Selected soil samples were collected and submitted to the laboratory for TPH analysis by EPA method 8015 modified, BTEX by EPA Method 8021B, and Chloride by EPA method 300.0. Copies of laboratory analysis and chain-of-custody documentation are included in Appendix C. The results of the sampling are summarized in Table 1. The sample locations are shown on Figure 3.

AUGER HOLE & TRENCH DESIGNATION	LATITUDE	LONGITUDE
AH-1	32.253299°	-103.574966°
AH-2	32.253262°	-103.574945°
T-1	32.253203°	-103.574973°
T-2	32.253194°	-103.574891°
T-3	32.253206°	-103.574761°
T-4	32.253202°	-103.574669°

- AUGER HOLE SAMPLE LOCATIONS
- TRENCH SAMPLE LOCATION
- FLOWLINE
- AFFECTED SPILL AREA

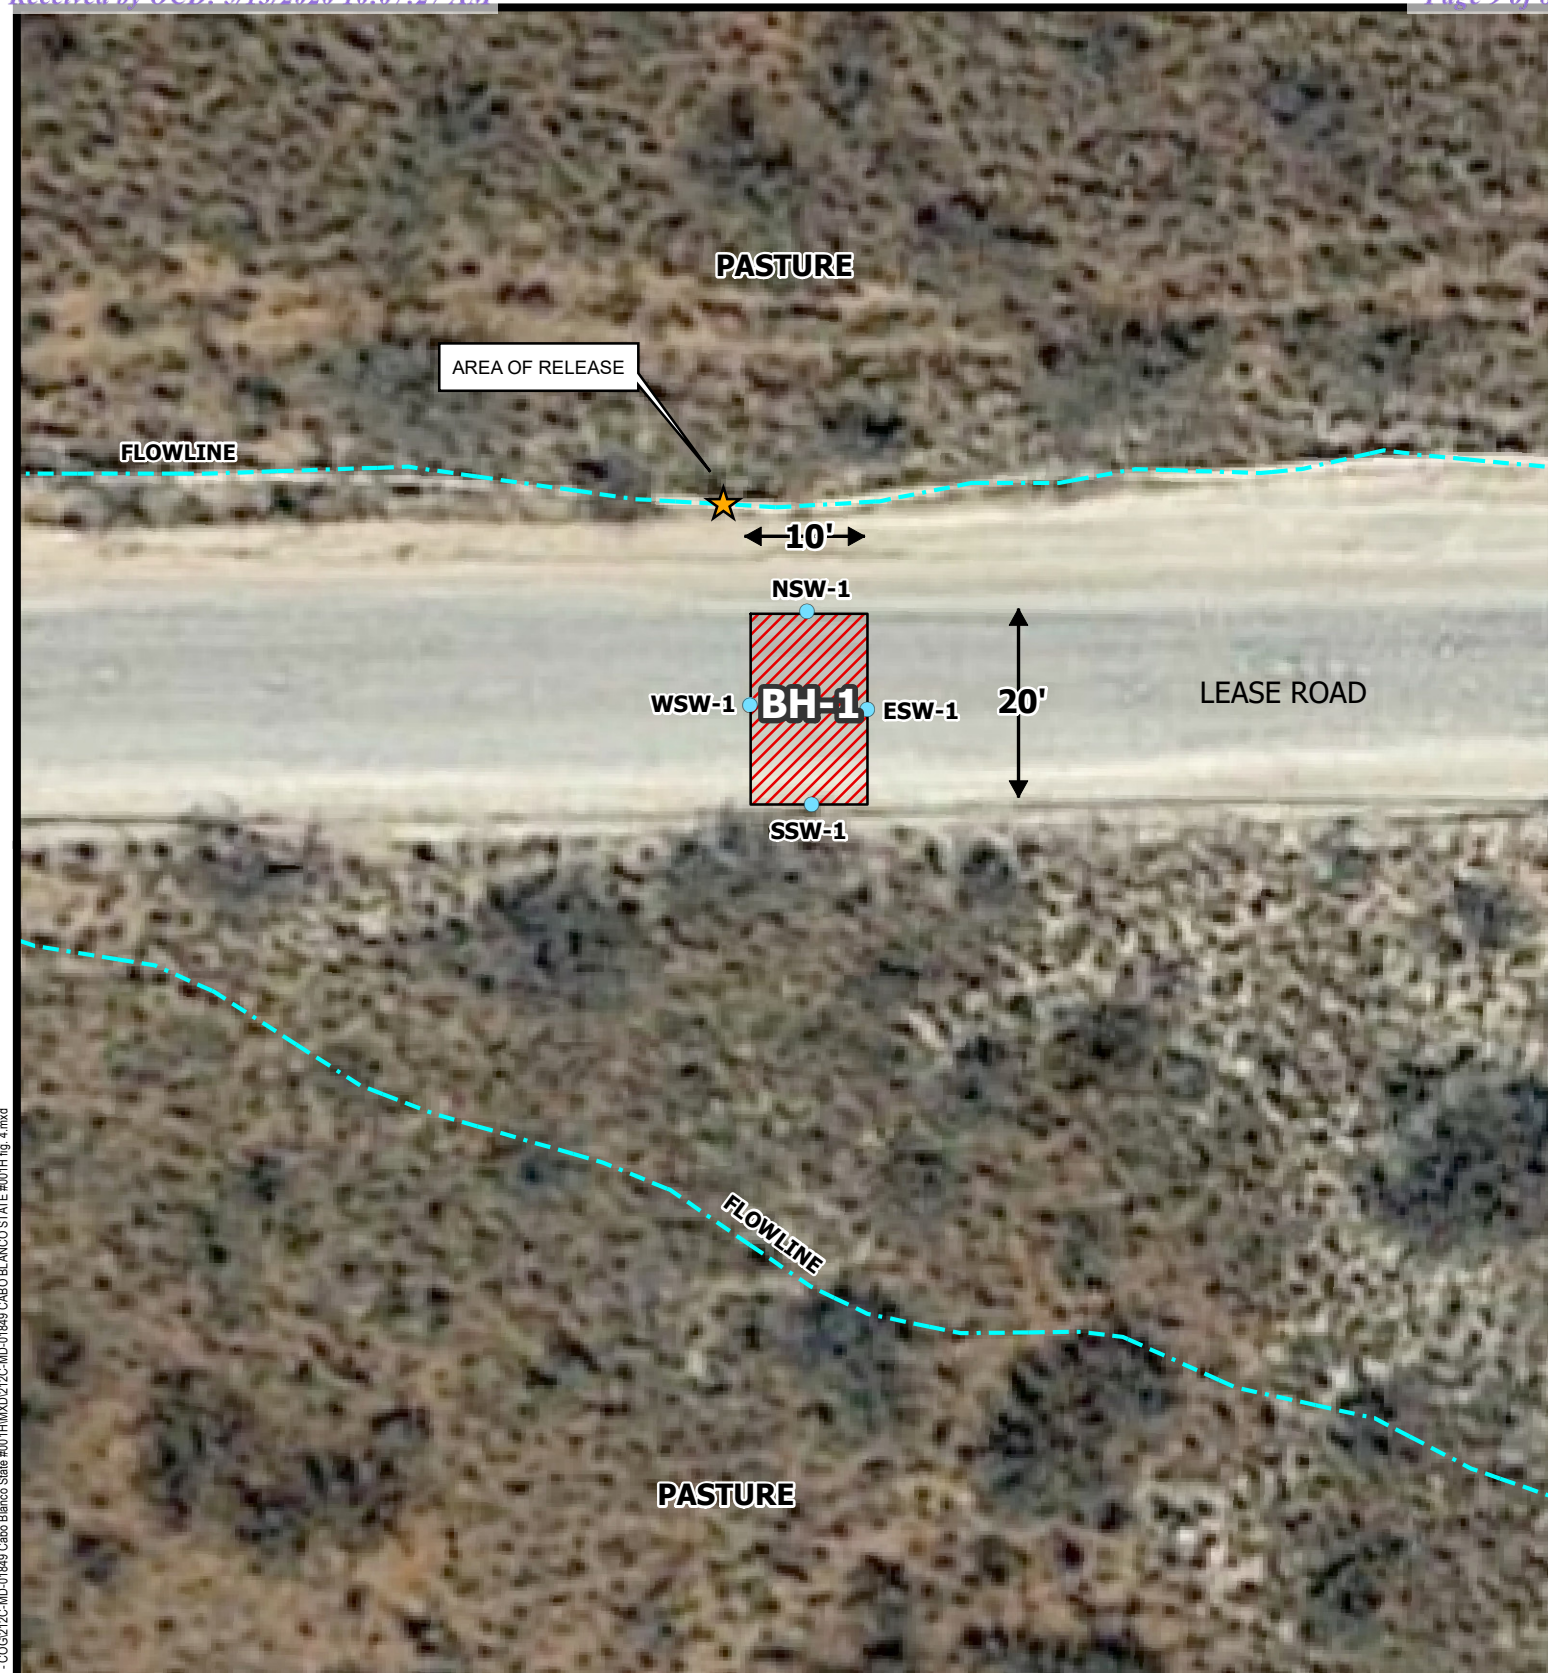
- BH** BOTTOM HOLE SAMPLE LOCATION
- SIDEWALL SAMPLE LOCATIONS
- FLOWLINE
- ▨ 2.0' bgs EXCAVATION DEPTH AREA

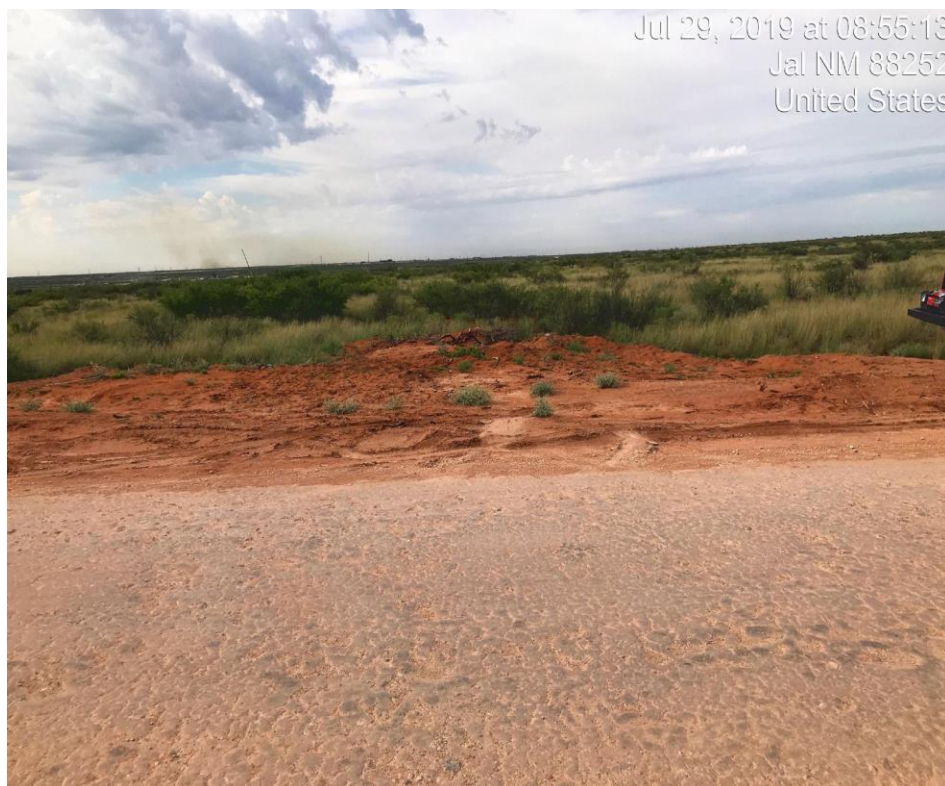
View South –Area of AH-2

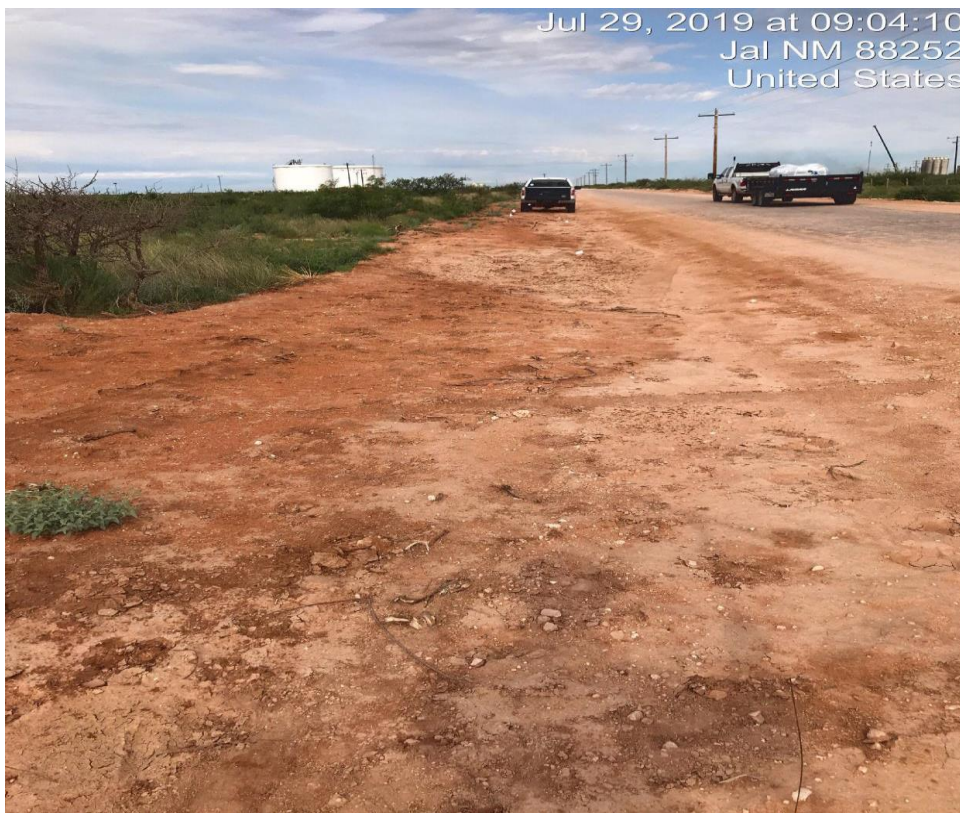
View West – Area of T-1, T2,T3, and T4

View East- Area of T-1, T2,T3, and T4

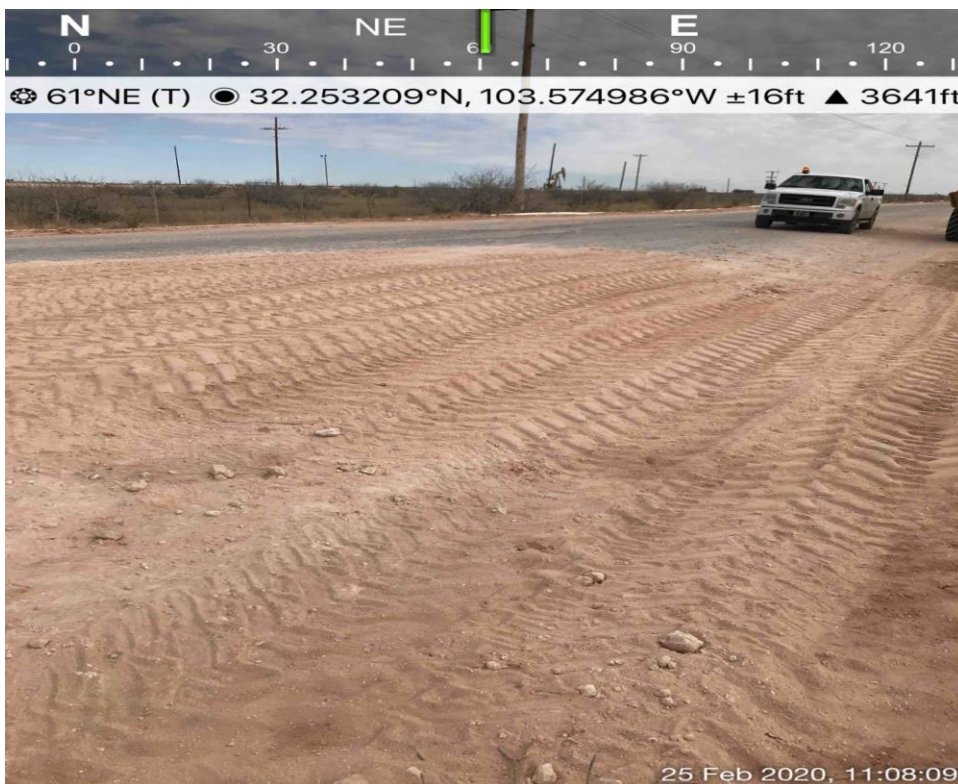
View Northeast- Area Backfilled
