Remediation Plan

May 22, 2020

Re: Monument ABO Battery
Case # NRM2005941614

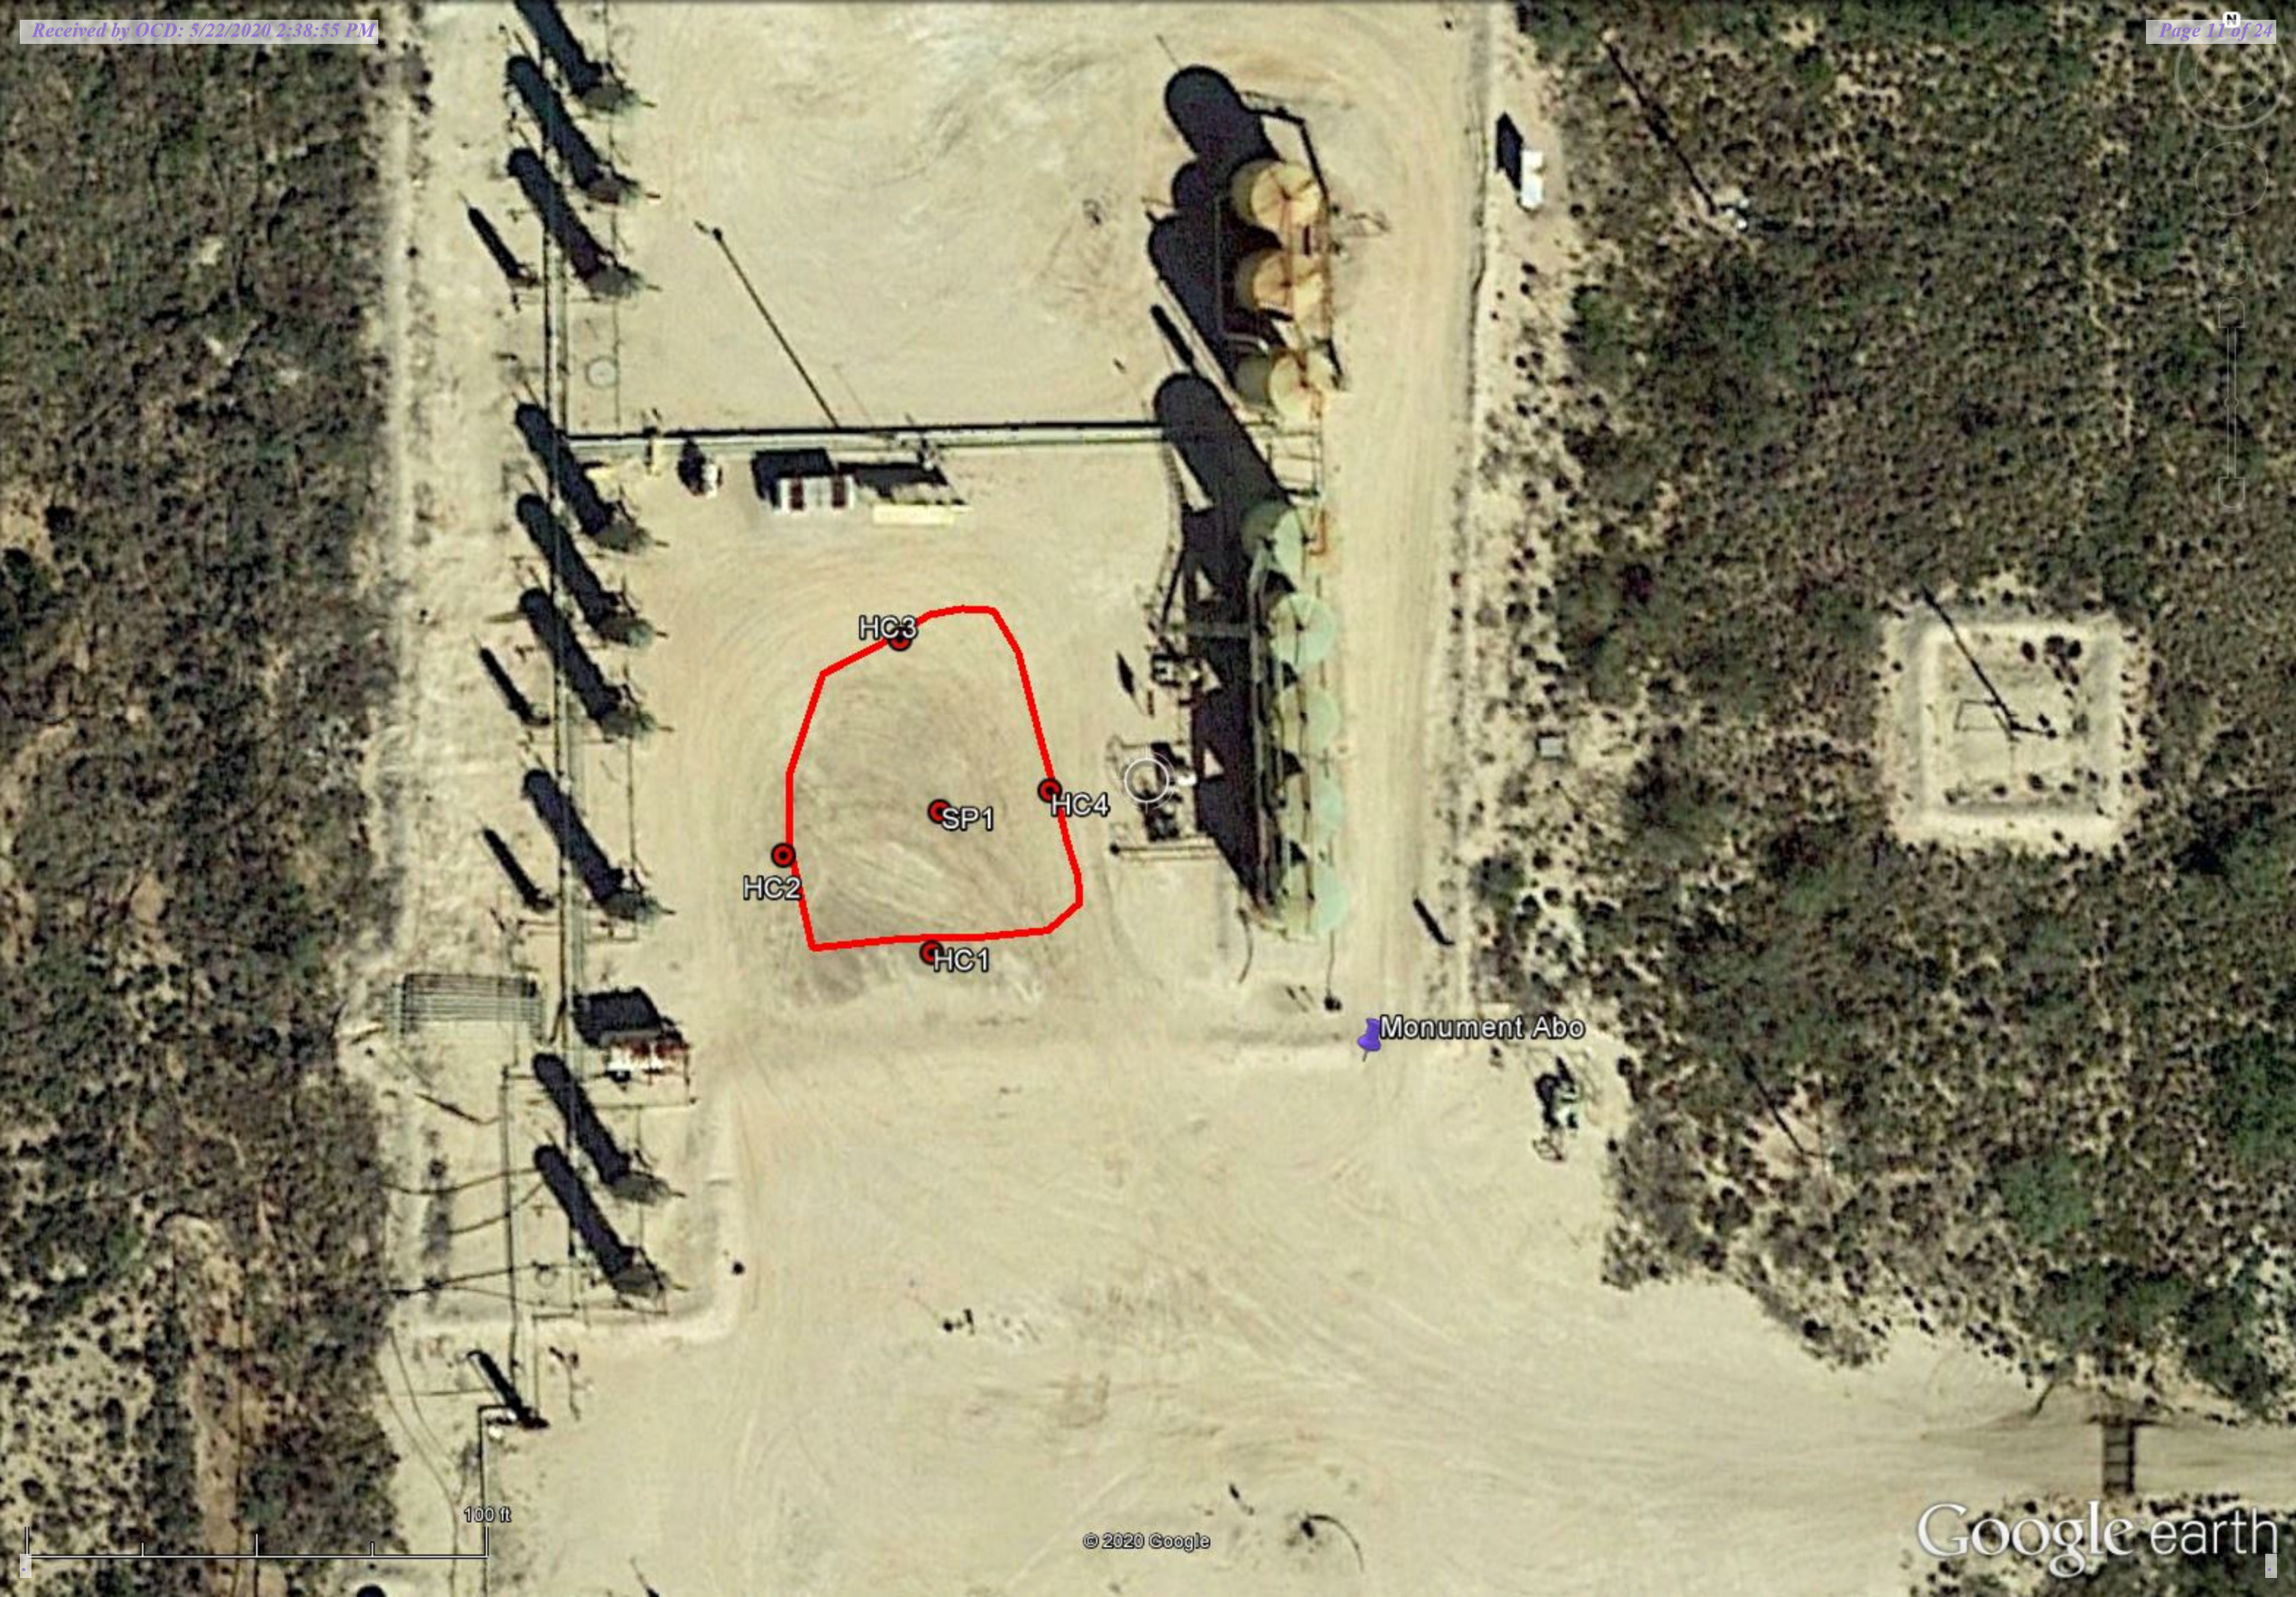
Monument Abo

HC3
HC4
SP1
HC2
HC1

NEDU Injection Line

Apache Corporation proposes that the release area be excavated to a depth of 1 foot. All excavated material (180 yards) will be hauled to an NMOCD approved facility. After the excavation is complete final 5 point bottom and wall composite samples will be collected not to exceed 200 square feet and submitted to a commercial laboratory for analysis of chloride, TPH, and BTEX. Once analytical data confirms that the excavation meet table 1 standards for releases less than 50 feet to groundwater the excavation will be backfilled with clean imported caliche and the pad restored. The remediation will be completed within 90 days of NMOCD approval of the plan.
