April 15, 2020

Vertex Project #: 19E-03610-001

**Spill Closure Report:** Dark Canyon (Carlsbad 960 SWD)  
Unit I, Section 23, Township 23 South, Range 26 East)  
API: 30-015-45033  
County: Eddy  
Incident Report: 2RP-5675

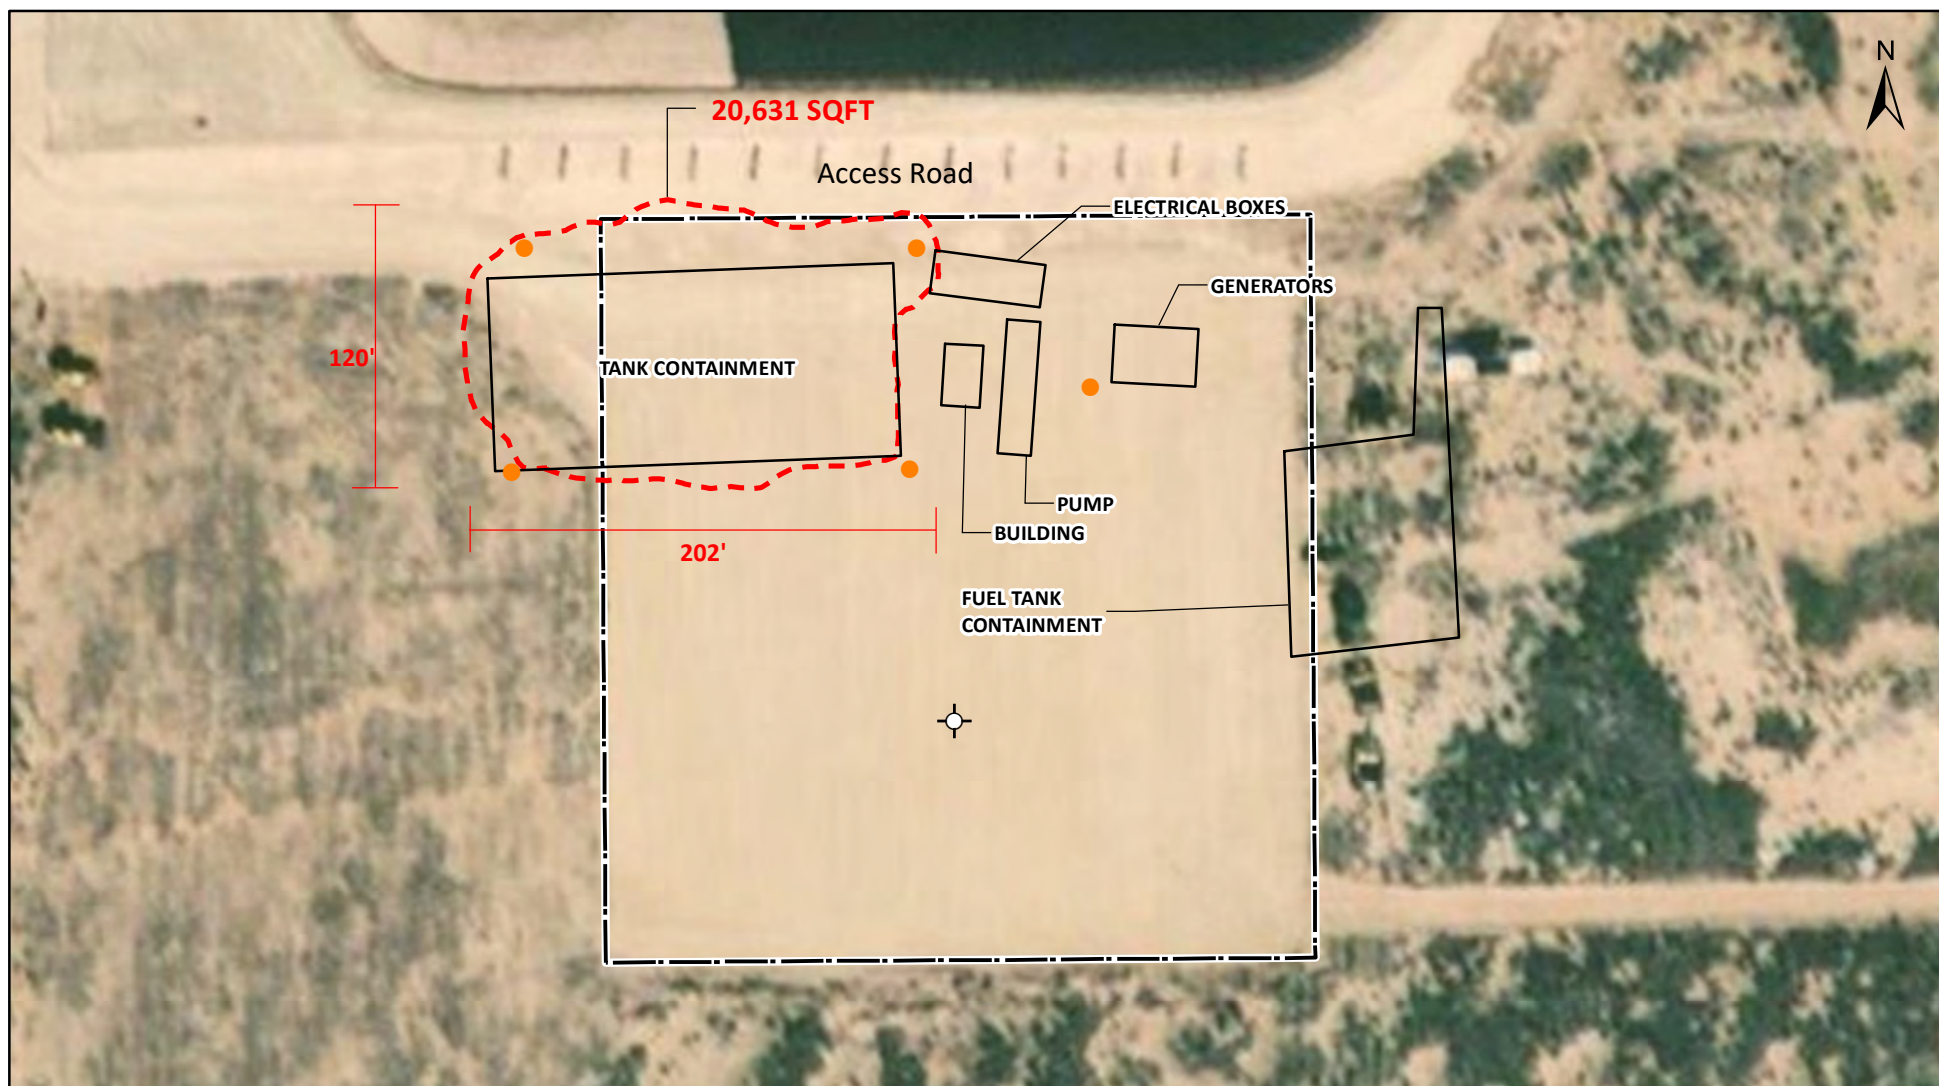
DRAWN: NM	FIGURE: <b>1</b>
APPROVED: DW	
DATE: OCT 01/19

Dark Canyon is typical of oil and gas exploration and production sites on the western portion of the Permian Basin, and is currently used for oil and gas production and storage and salt water disposal (SWD). The following sections specifically describe the release area on the northwest corner of the constructed pad where the storage tanks are located and on an adjacent access road running along the north edge of the site, as shown on Figure 1 (Attachment 2).

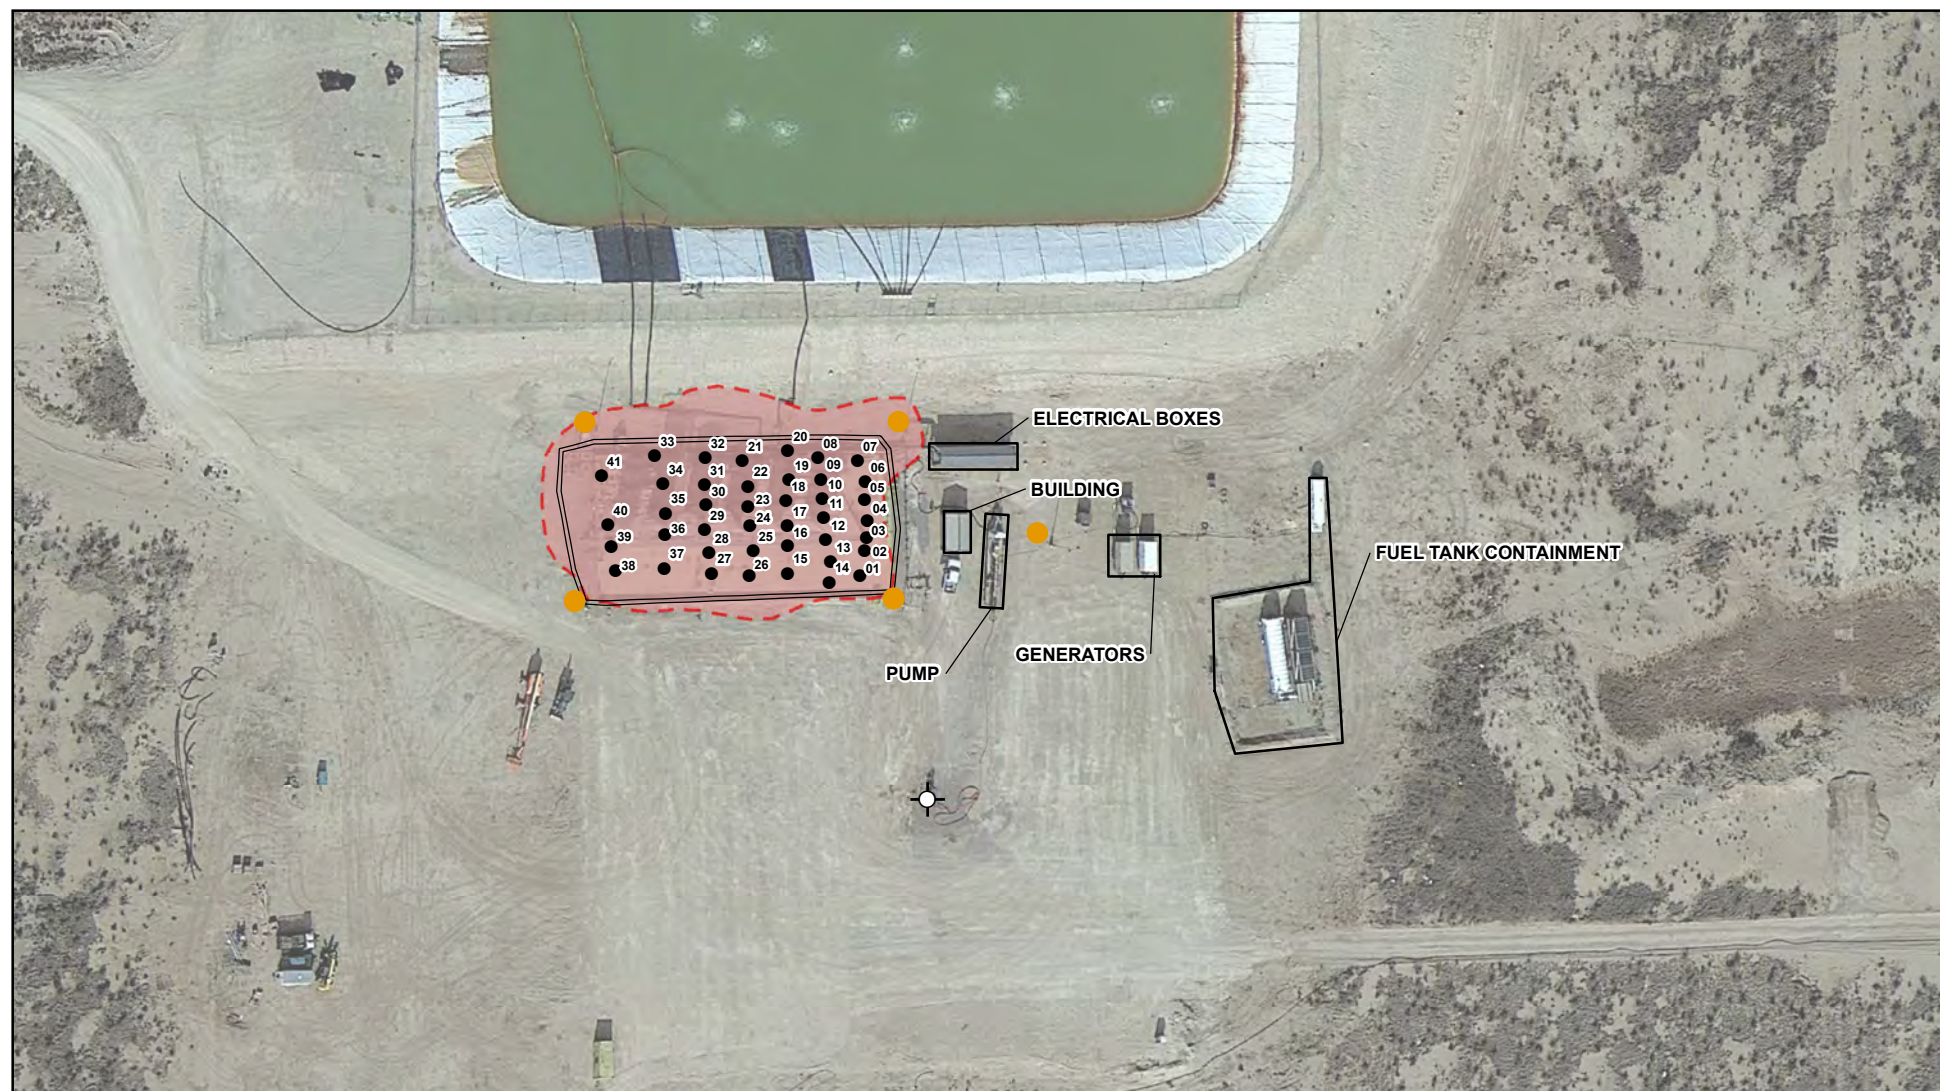
This revised letter provides an updated description of the release assessment and remediation activities, as well as a revised Figure 2. The Figure 2 in the original report used an outdated aerial photo showing the site before it was fully constructed, and based on that photo, it appeared that part of the release went off-pad. The revised figure in this report uses a more recent aerial photo that shows the full scale of the developed site and shows that the release was actually limited to the constructed pad. This revised letter also demonstrates that closure criteria established in Table I of *19.15.29.12 New Mexico Administrative Code* (NMAC) have been met for all sample points and applicable regulations were followed. This document is intended to serve as a final report to obtain approval from NM OCD for closure of this release.

A GeoExplorer 7000 Series Trimble global positioning system (GPS) unit was used to map the approximate center of each five-point composite sample. These confirmation sampling locations are presented on Figure 2 (Attachment 2). Relevant equipment and prominent features/reference points at the site were mapped as well.

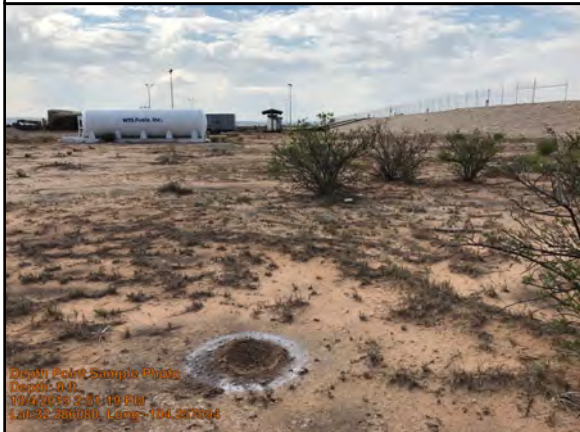
Sample Point ID: Background19-01

Depth: 0 ft.

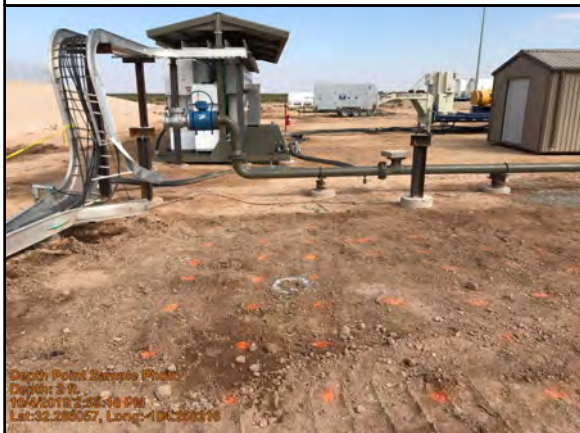
Sample Point ID: BH19-02

Depth: 2 ft.

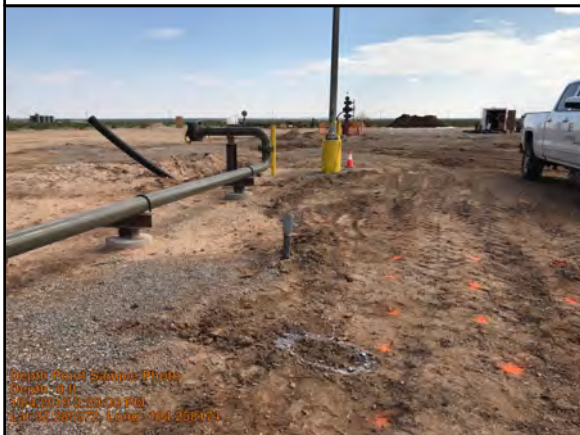
Sample Point ID: BH19-04

Depth: 0 ft.

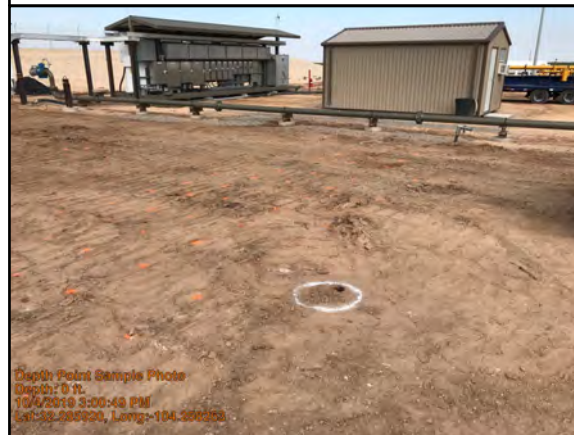
Sample Point ID: BH19-05

Depth: 0 ft.

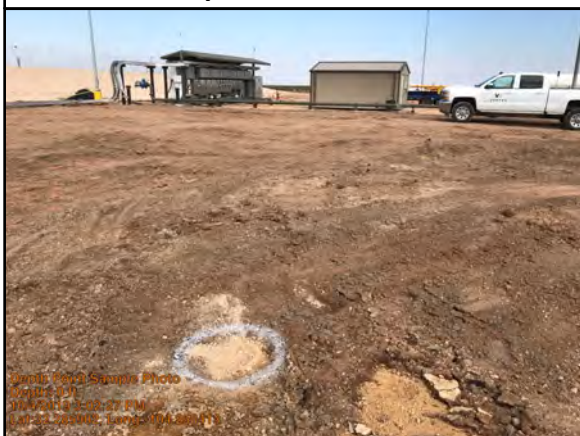
Sample Point ID: BH19-06

Depth: 0 ft.

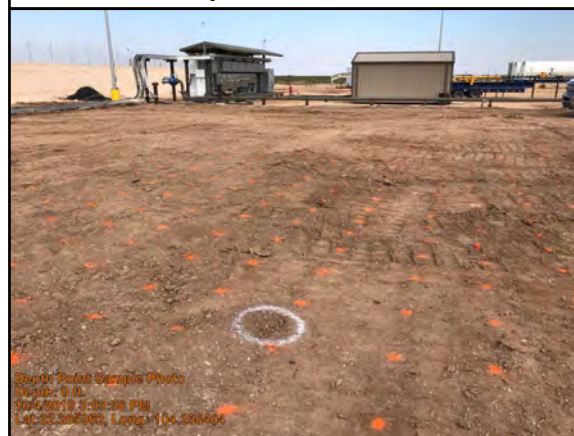
Sample Point ID: BH19-07

Depth: 0 ft.

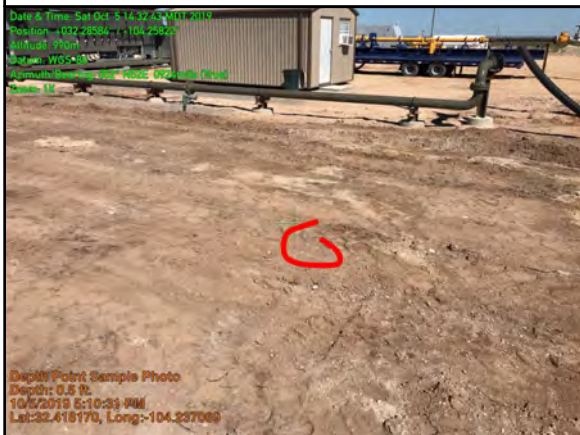
Sample Point ID: ES-Base19-01

Depth: 0.5 ft.

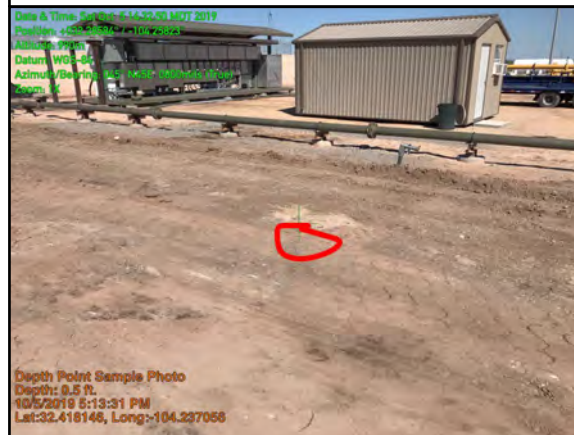
Sample Point ID: ES-Base19-02

Depth: 0.5 ft.

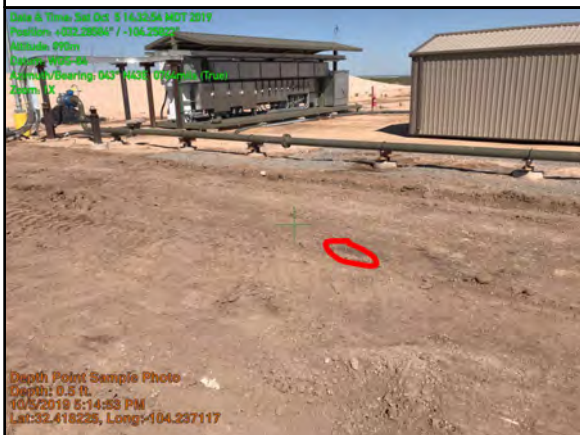
Sample Point ID: ES-Base19-03

Depth: 0.5 ft.

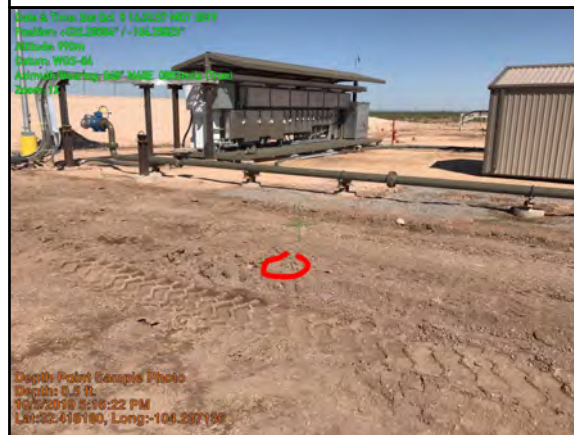
Sample Point ID: ES-Base19-04

Depth: 0.5 ft.

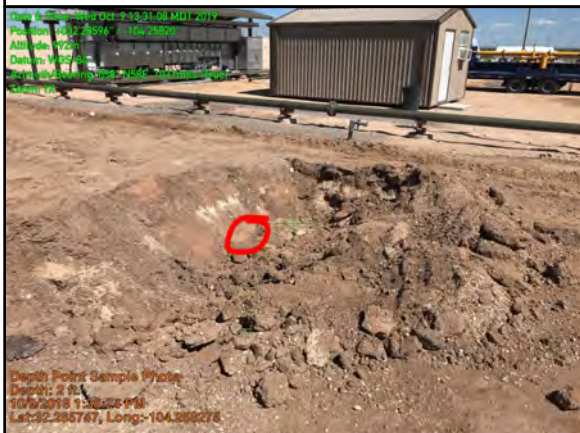
Sample Point ID: ES-Base19-02

Depth: 2 ft.

Initial laboratory analyses for 11 of the 41 confirmation samples showed exceedance of NM OCD Closure Criteria for TPH. On October 9, 2019, additional remediation was conducted at those locations in exceedance of closure criteria and composite confirmation samples were re-collected for submission to the laboratory. Following lab verification that the remaining contaminants had been fully removed, the site was backfilled on October 14, 2019.

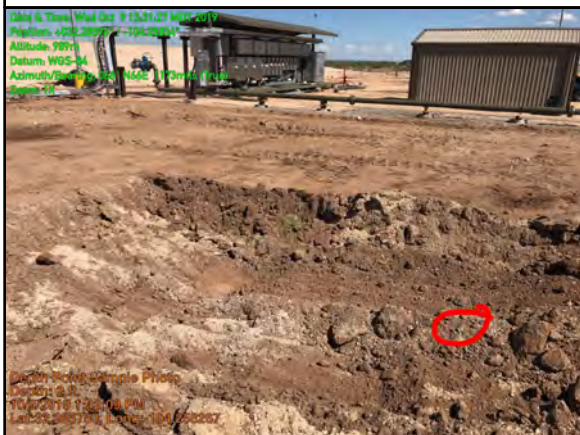
Sample Point ID: ES-Base19-12

Depth: 2 ft.

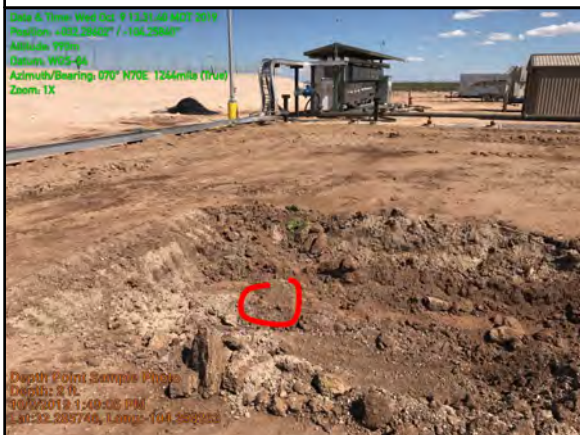
**Sample Point ID: ES-Base19-19**

**Depth: 2 ft.**

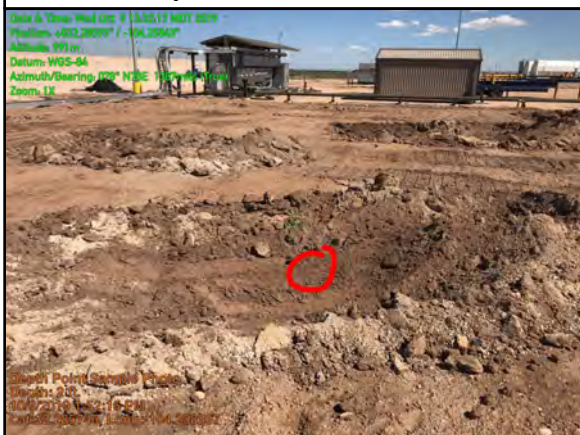
**Sample Point ID: ES-Base19-24**

**Depth: 2 ft.**
