Closure Report

2RP-5584

Site Name:	Mesquite Moutray SWD Facility	Incident ID: NAB1923155619
Company:	Oxy, Permian	
Legal Description:	U/L P, Sec 21, T24S, R29E	
County:	Eddy County, NM	
GPS Coordinates:	N 32.19866 W -103.98095

Date of Release:	7/6/2019
Type of Release:	Produced water
Source of Release:	Stress/Fatigue of 4" Poly Produced Water Transfer Line
Volume of Release:	24 bbls
Volume Recovered:	23 bbls

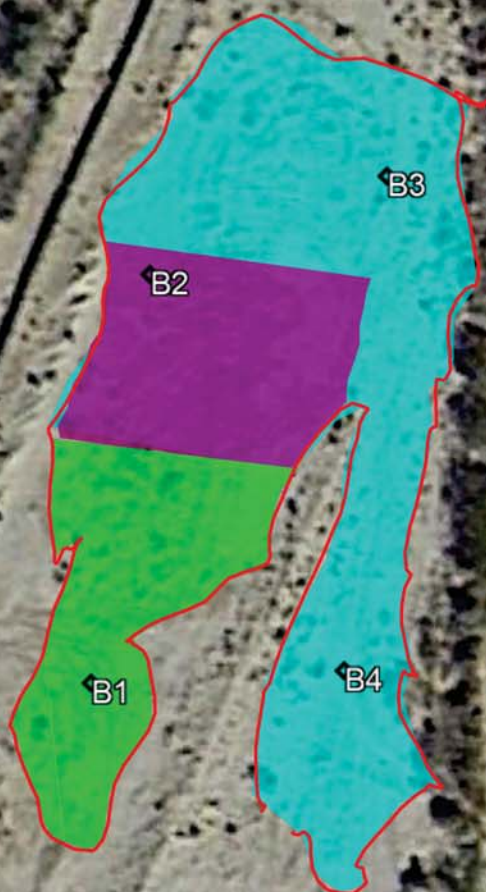
Oxy Mesquite Moutray SWD

Remediation Parameters:	Excavated the areas of SP1, SP5, and SP6 to a depth of 2 feet. Excavate SP2 to a depth of 3 feet. Excavated the area of SP3 and SP4 to a depth of 4 feet. Bottom confirmation samples have been collected every 75 feet. been obtained for all depths. Backfilled entire site with clean soil.
Remediation Activities:	6/18/20 through 7/9/20

Leak Date: 7-6-19
Eddy County, NM
2RP-5584

- 2 ft Excavation
- 3 ft Excavation
- 4 ft Excavation
- Confirmation Sample Points
- Leak area

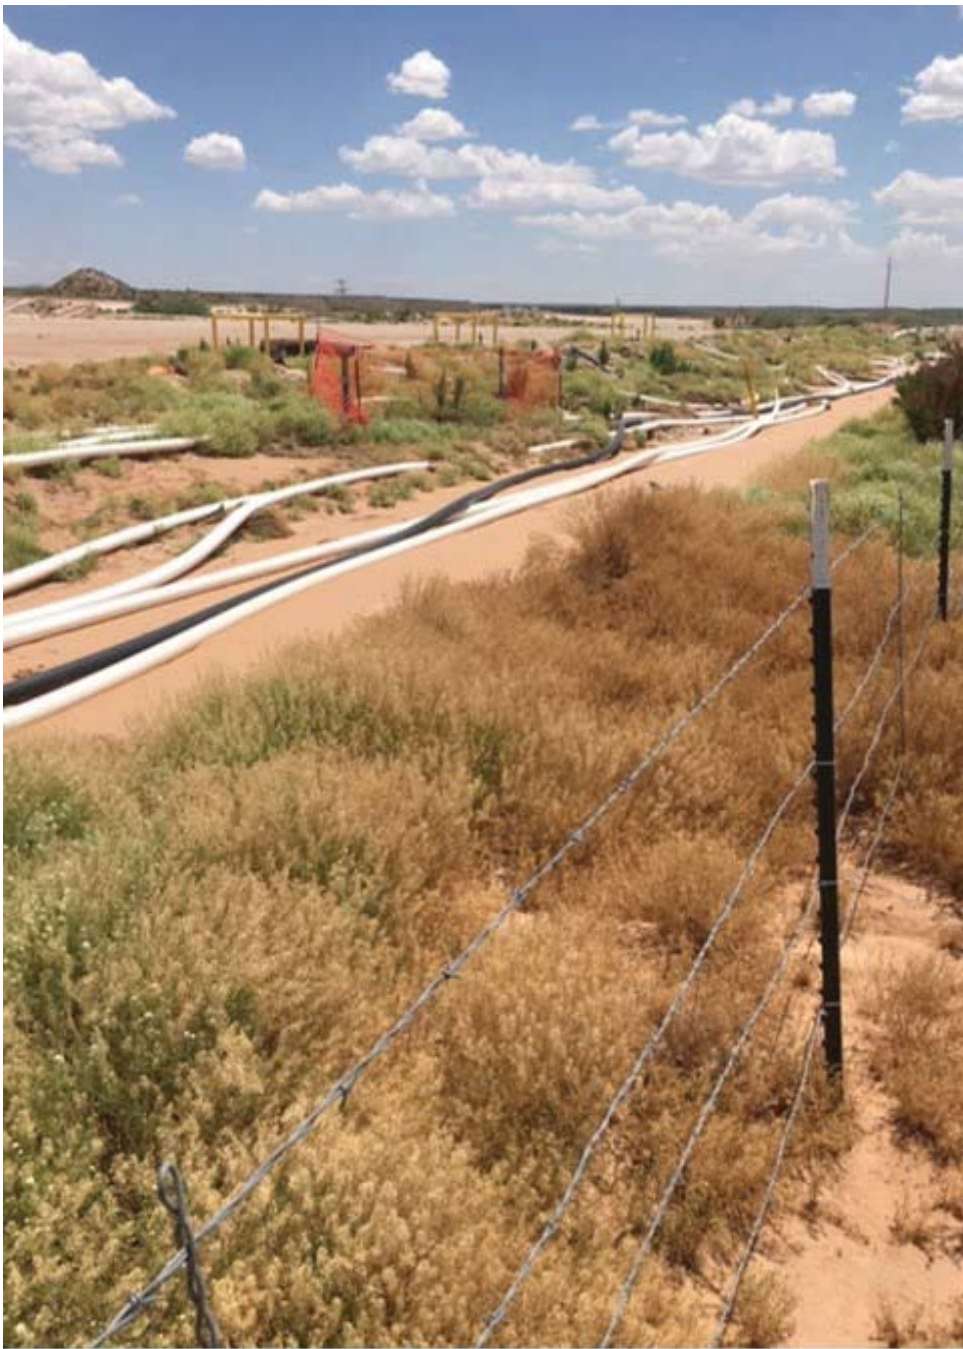
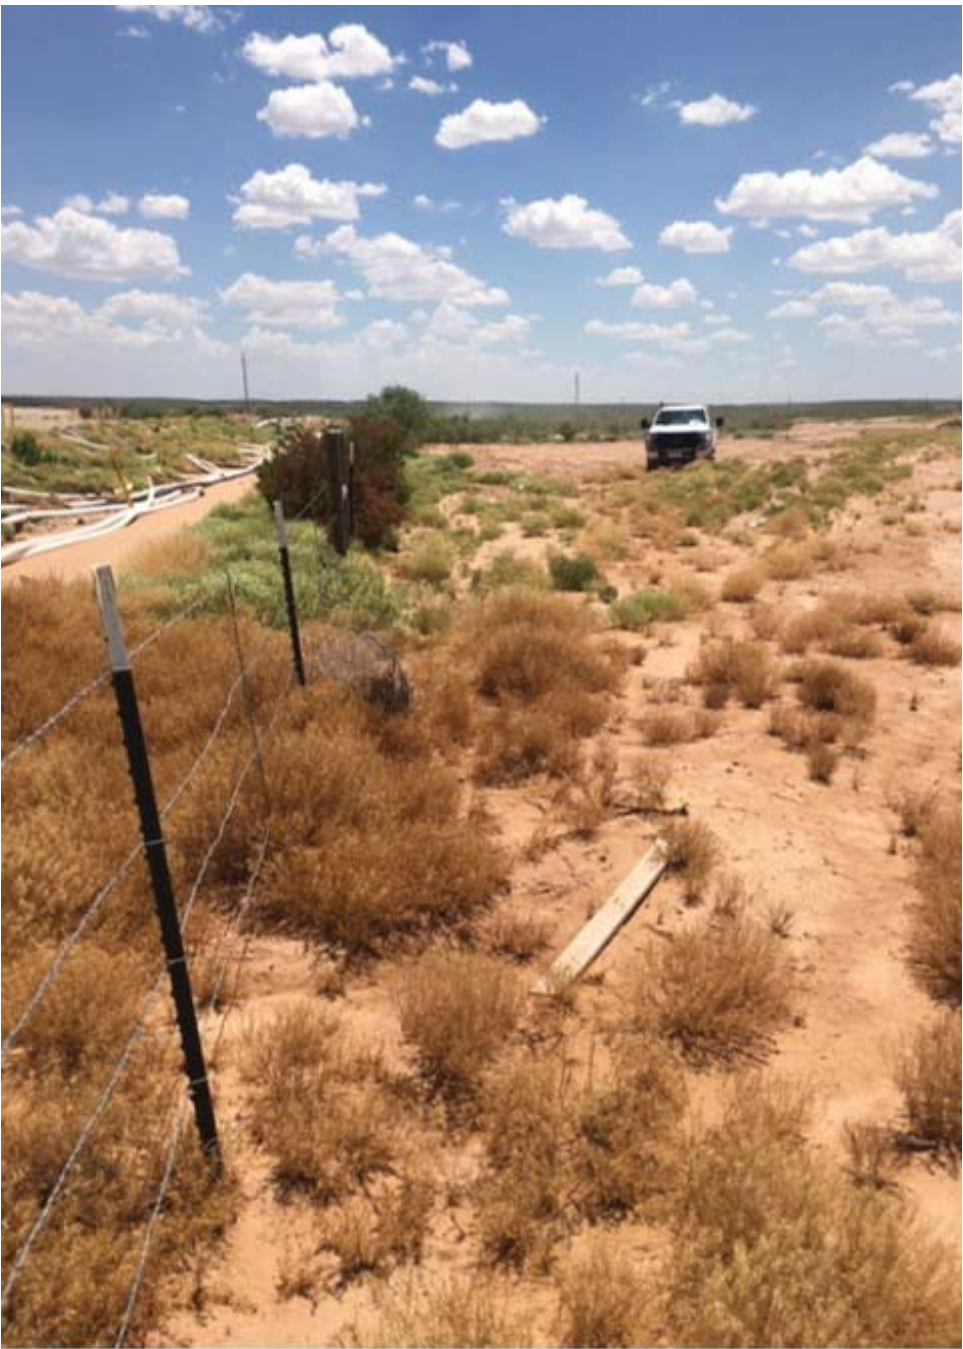
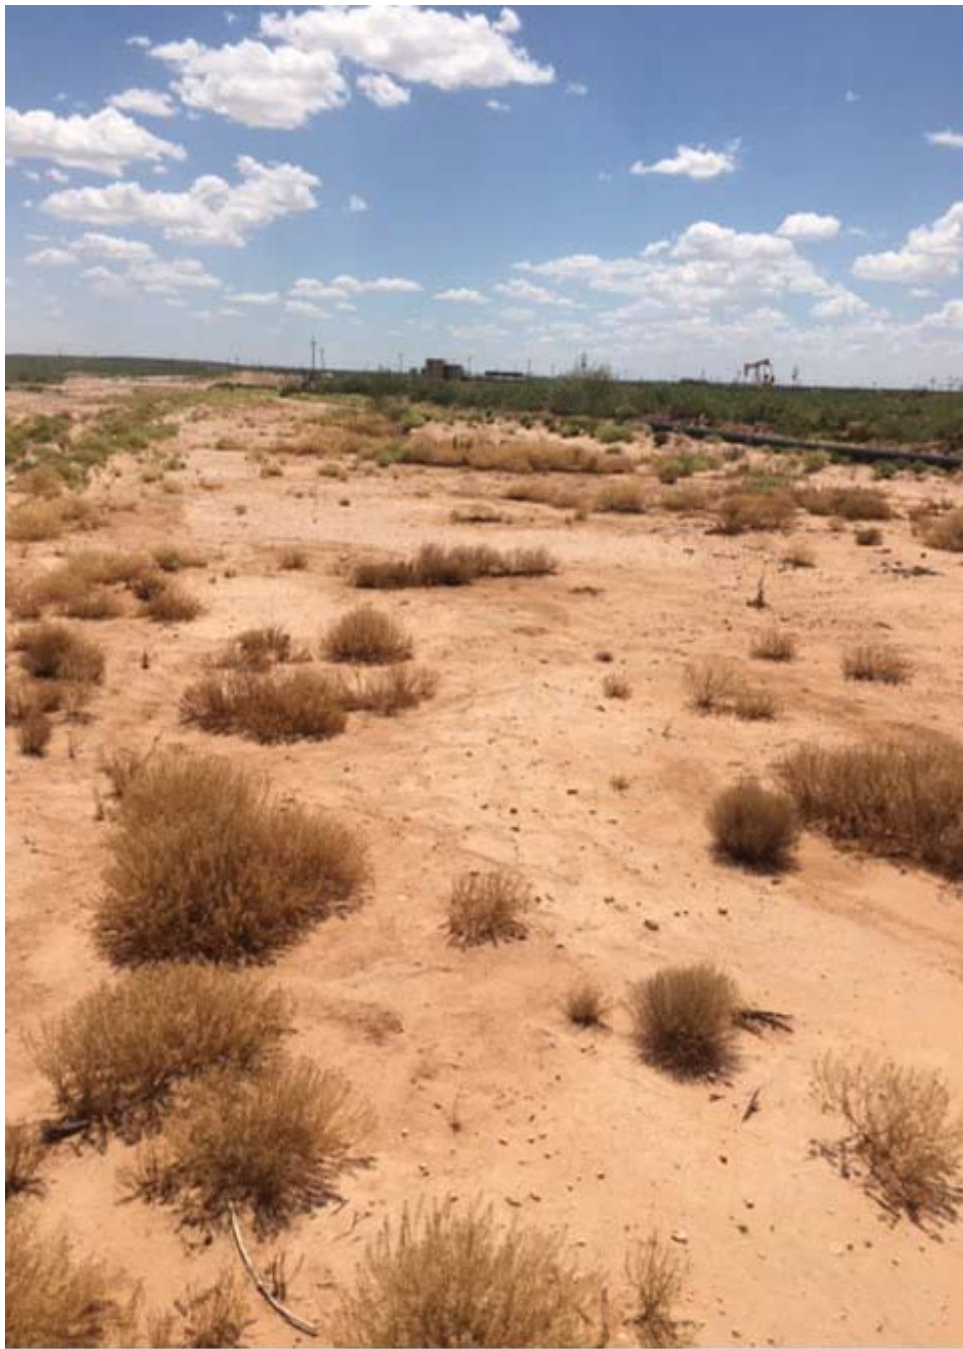
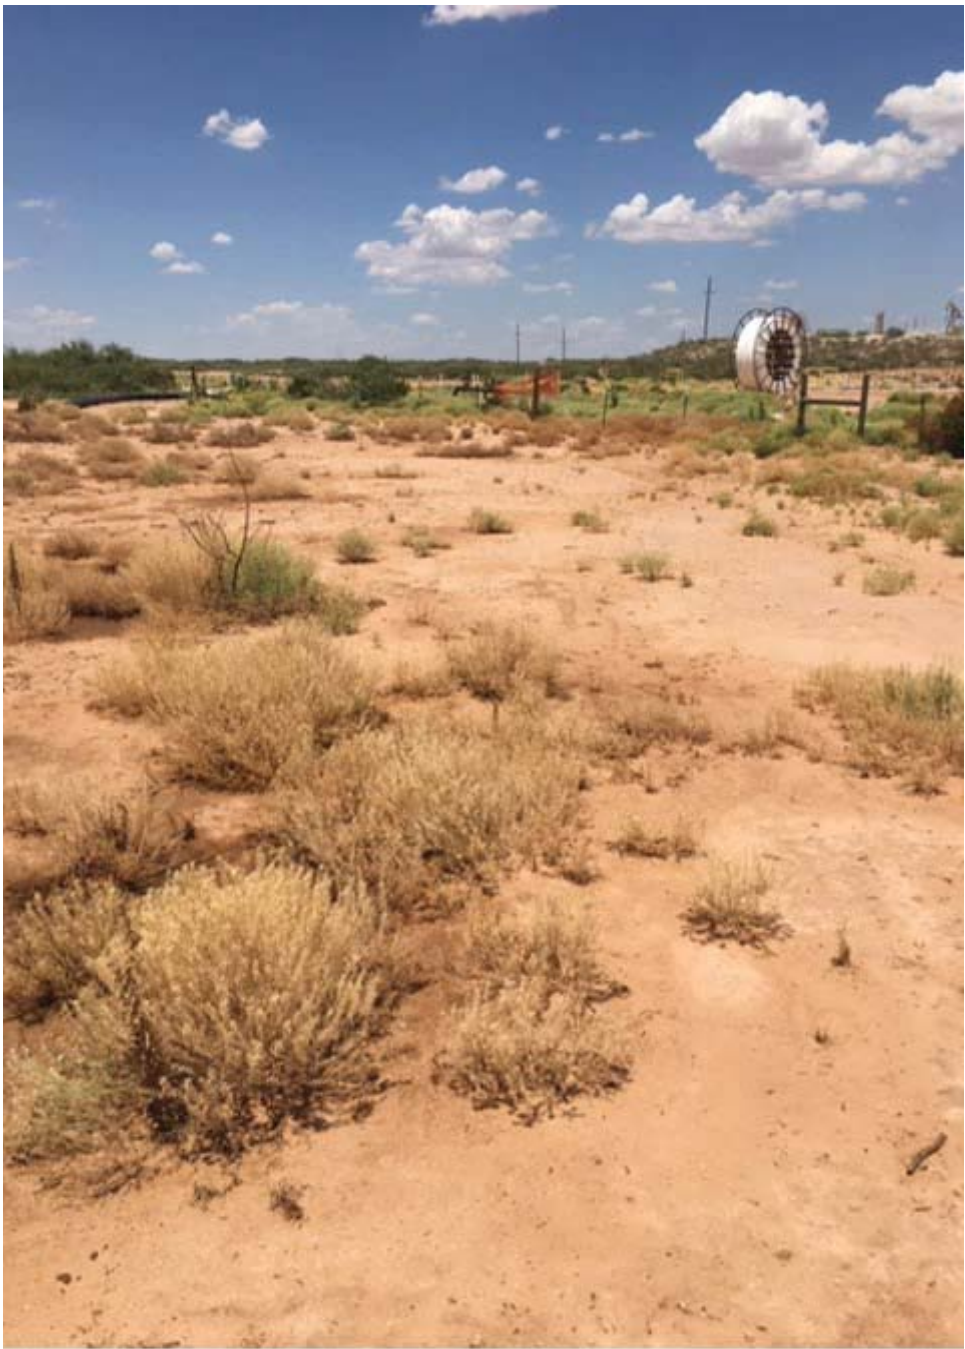
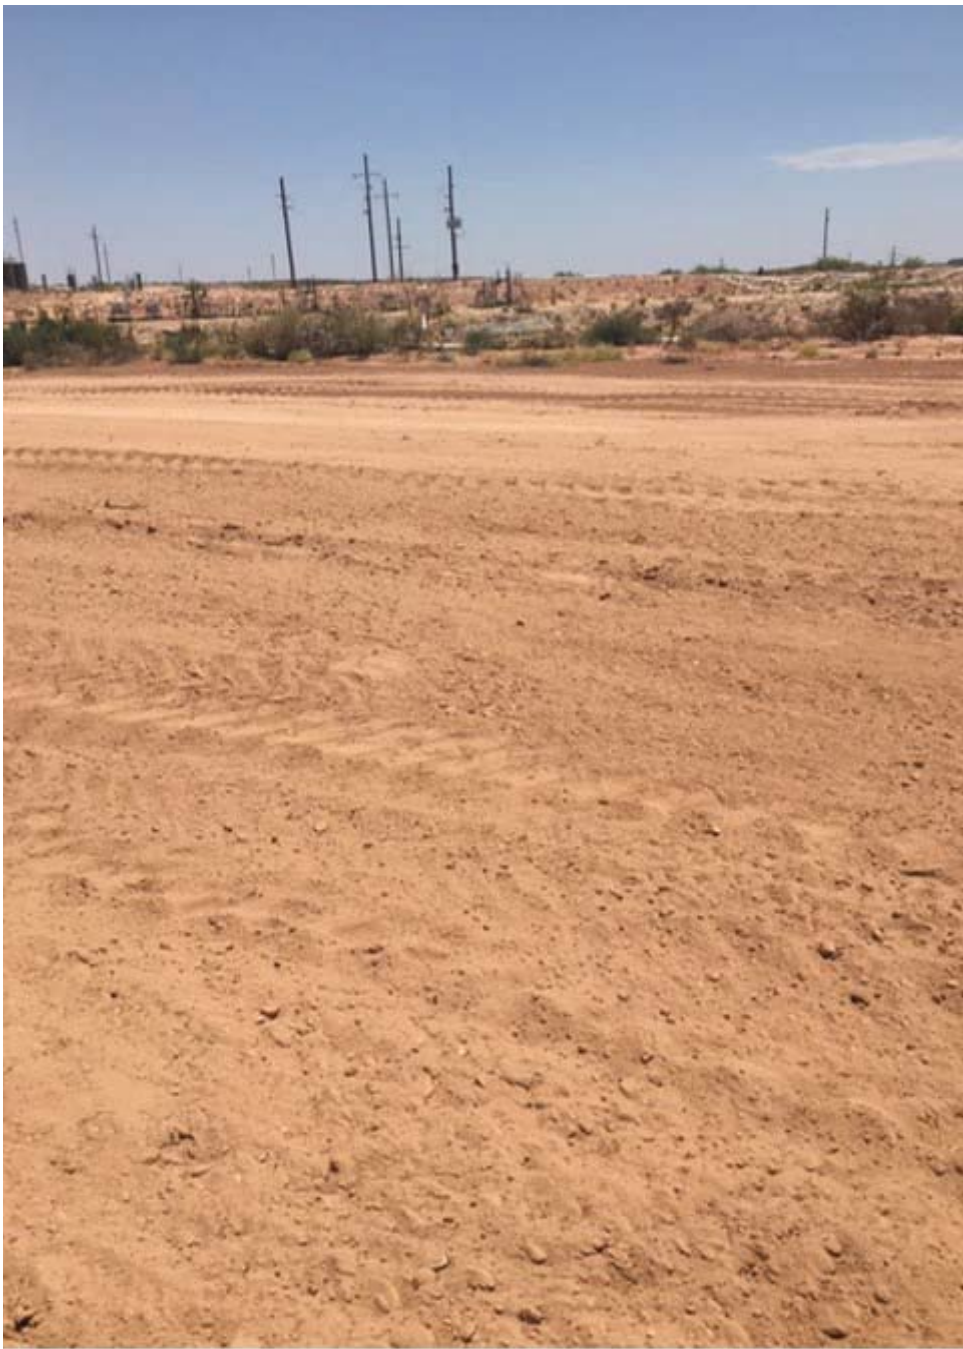
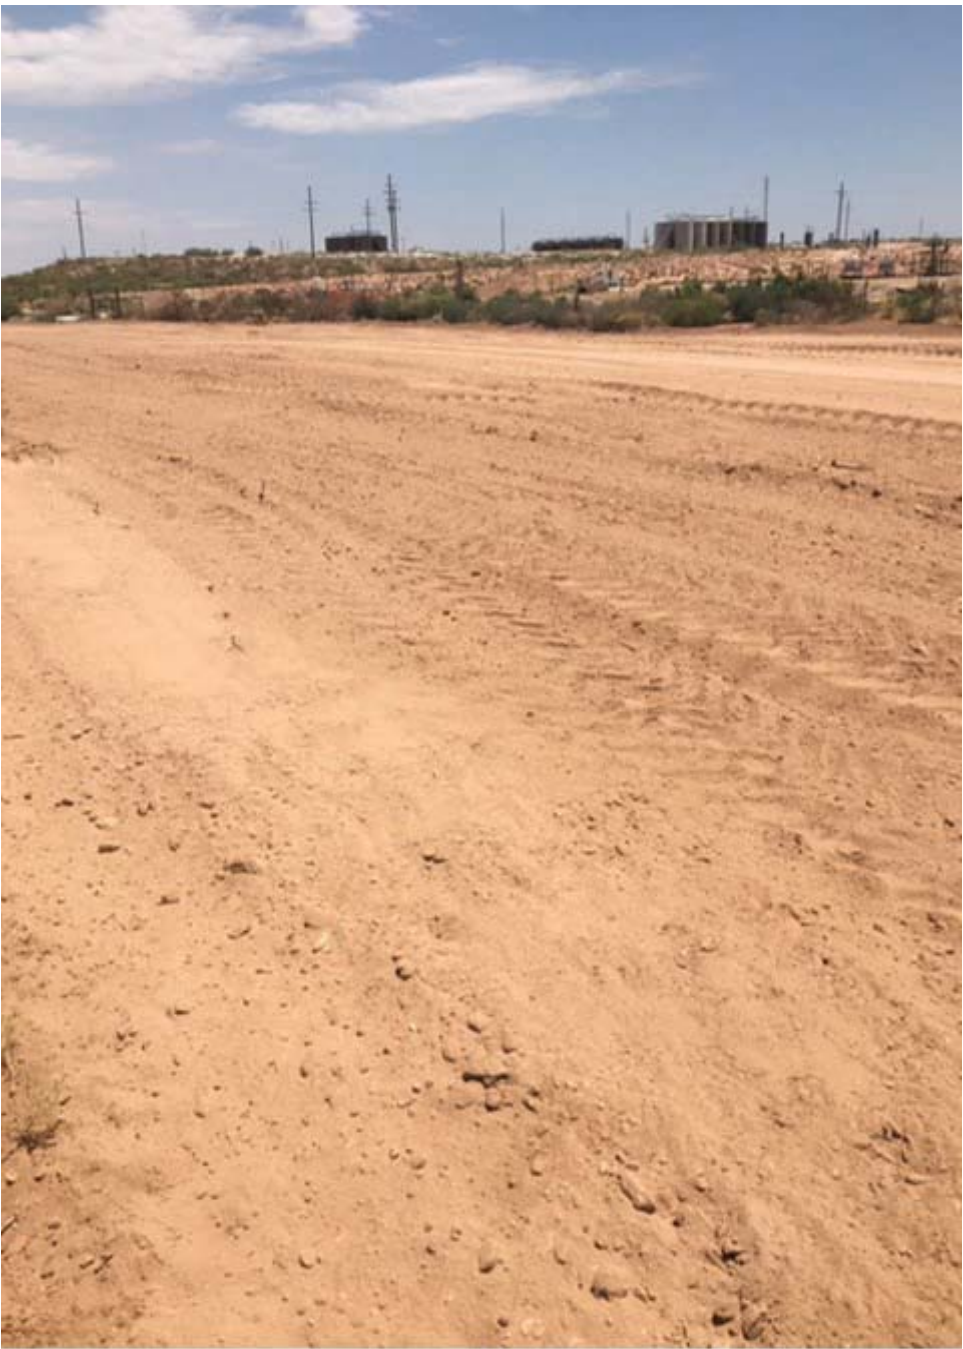
Initial C-141	signed and included	
C-141, page 6	signed and included	
Site Diagram	Google Earth map with excavation depths & confirmation sample points	
Pictures	Remediation photos	
Lab Summary/Analysis	Confirmation lab summary/analysis report for 6/30/20	
Depth to Groundwater	USGS Info
