Release Notification

Site Name	Myox 21 State Com West CTB	Site Type	Tank Battery
Date Release Discovered	March 30, 2020	API# (if applicable)

RE: Closure Request
Myox 21 State Com West CTB/ Red Hills Truck Station
Incident Number NRM2010833956
Lea County, New Mexico

LT Environmental, Inc. (LTE), on behalf of COG Operating, LLC (COG), presents the following Closure Request detailing site assessment, excavation, and soil sampling activities related to a release associated with the Myox 21 State Com West CTB located in Unit N, Section 21, Township 25 South, Range 28 East, in Eddy County, New Mexico (Figure 1, inset). The purpose of the site assessment and soil sampling activities was to confirm the presence or absence of impacts to soil following the release of crude oil at the Plains Pipeline Red Hills Truck Station (Site) located in Unit O, Section 4, Township 26 South, Range 32 East, in Lea County, New Mexico (Figure 1). Based on field observations, field screenings, and laboratory analytical results from the soil sampling activities, Concho is submitting this Closure Request and requesting no further action (NFA) for Incident Number NRM2010833956.

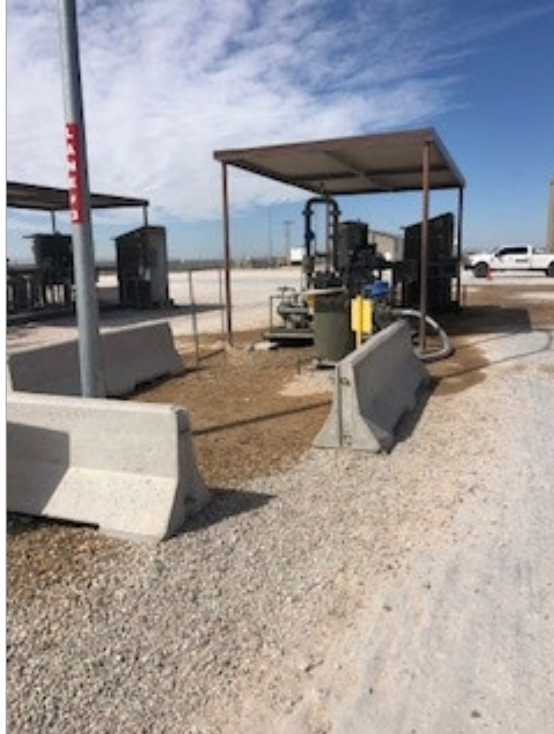
Photograph 1: View of release near equipment facing west.

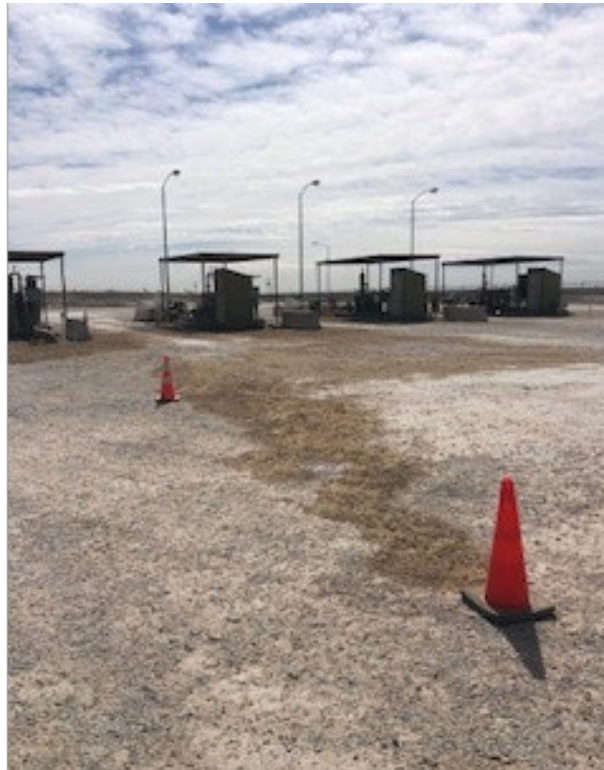
Photograph 2: View of release extent on pad facing southeast.

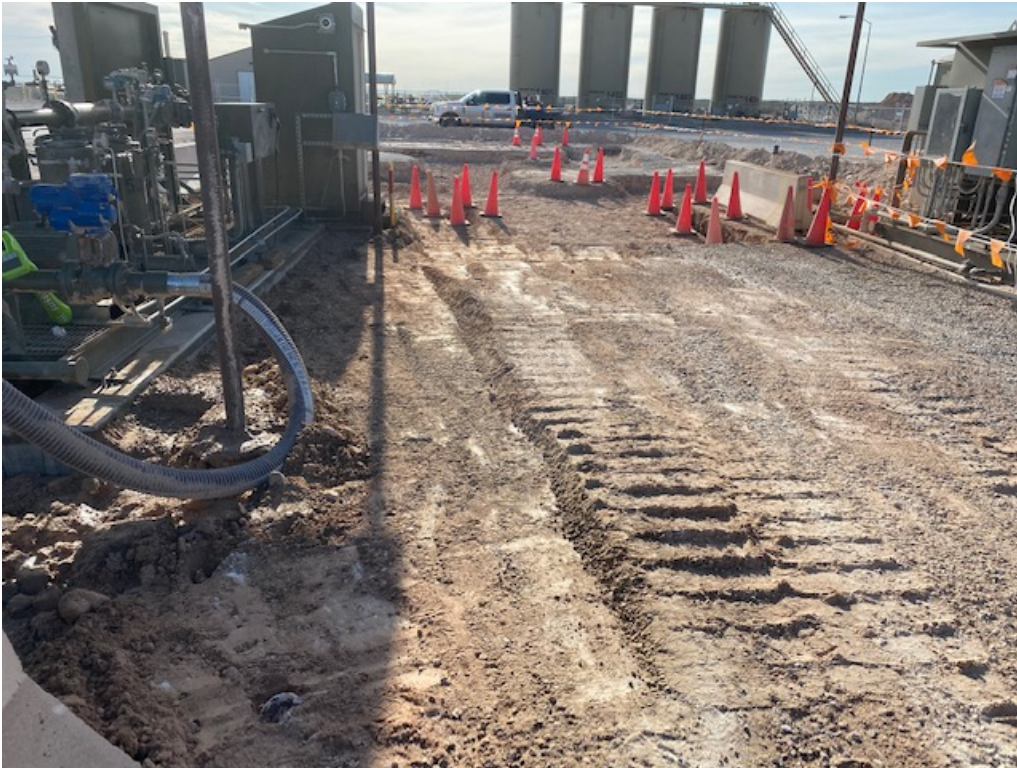
Photograph 3: View of excavation in between equipment facing west.

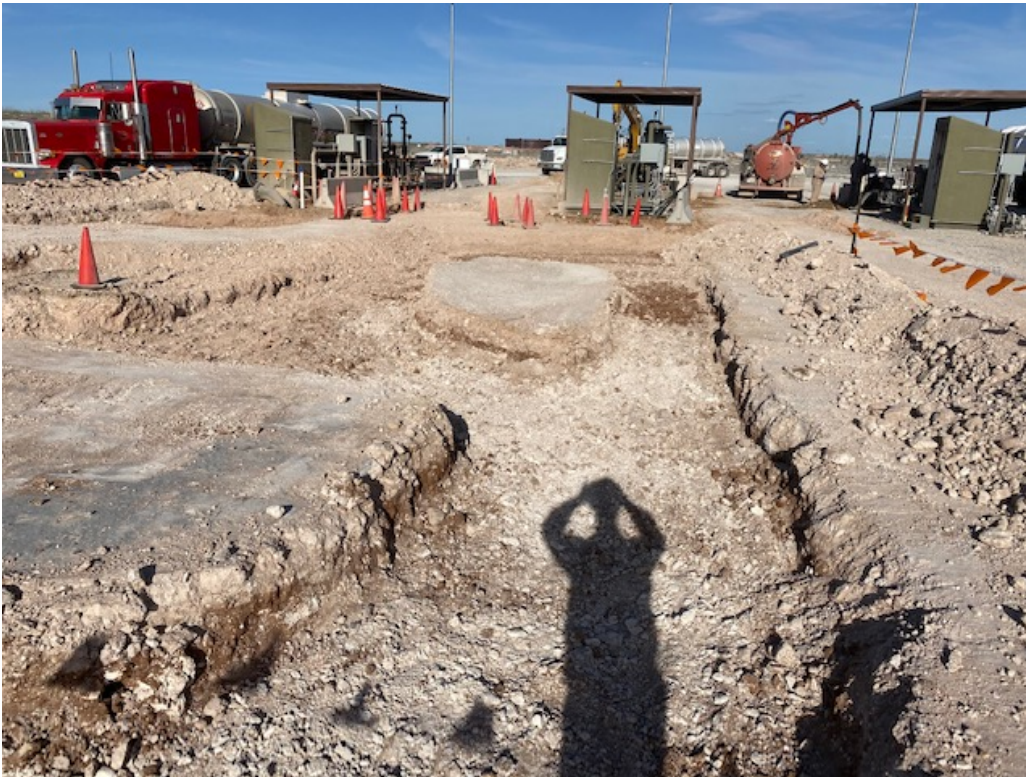
Photograph 4: View of excavation facing east.

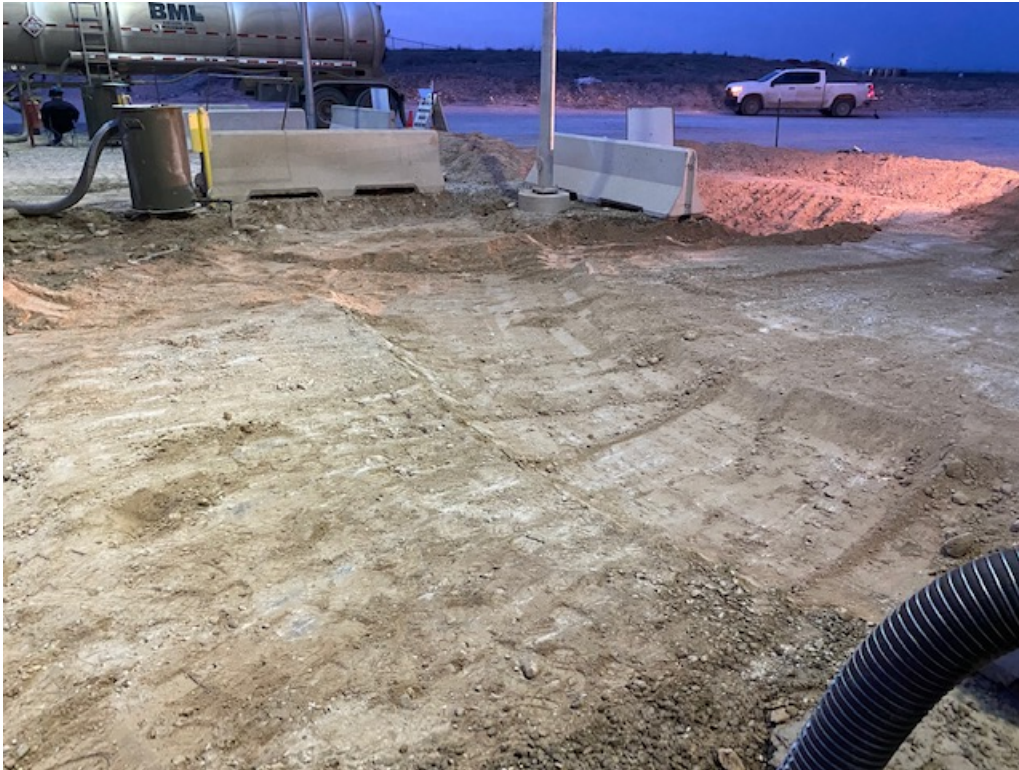
Photograph 5: View of excavation east of equipment facing northeast.

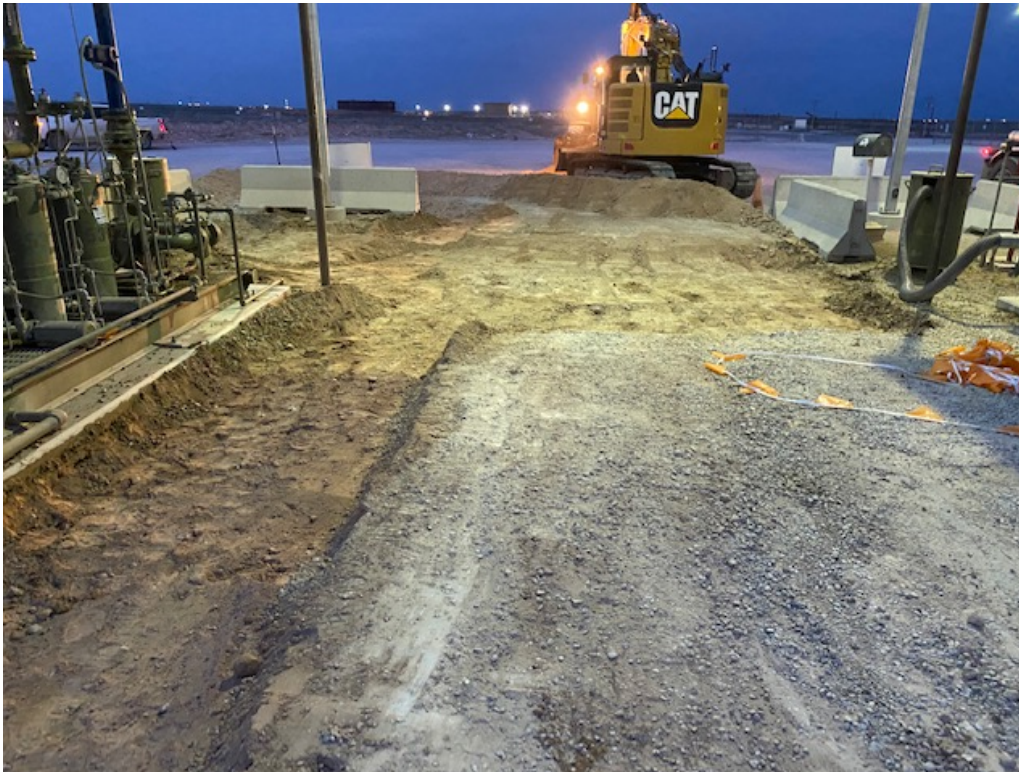
Photograph 6: View of excavation facing east.

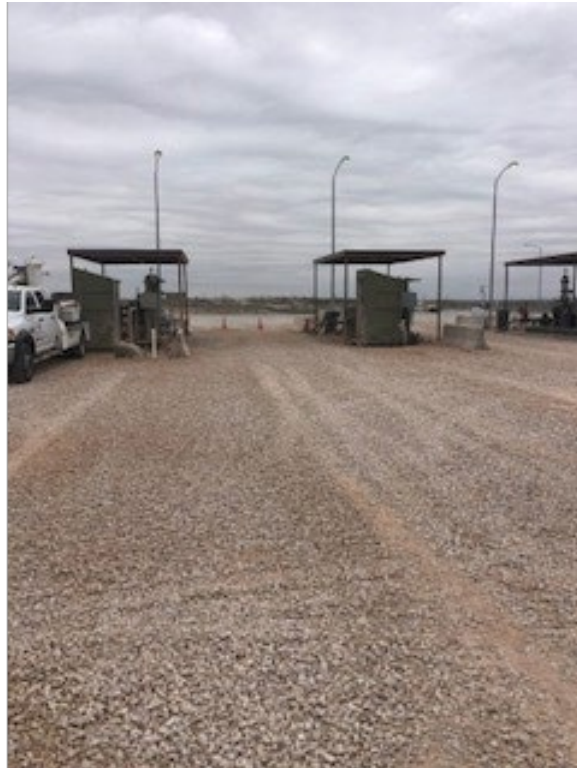
Photograph 7: View of final backfill facing east.

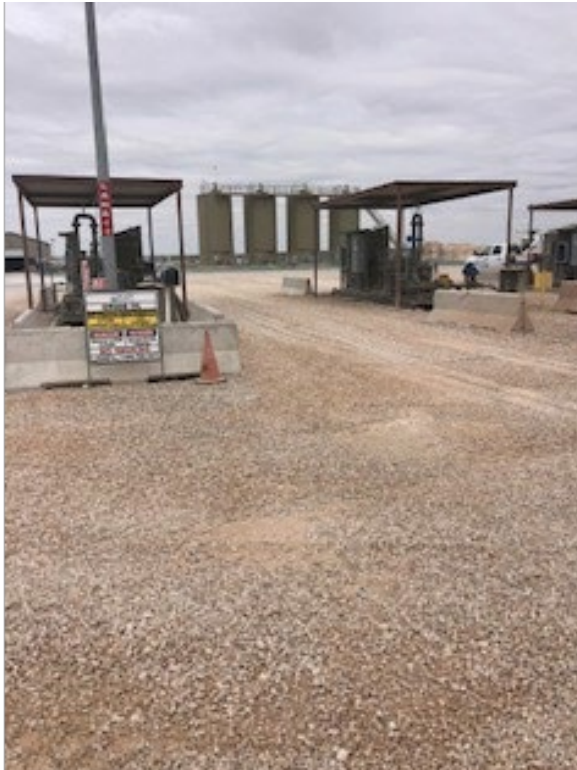
Photograph 8: View of final backfill facing west.
