**Closure Report****1RP-5595****Site Description**

Site Name:	SMU Federal #15	<b>API: 30-025-20513</b>
Company:	Oxy, Permian	
Legal Description:	U/L J, Section 15, T24S, R37E	
County:	Lea County, NM	
GPS Coordinates:	N 32.21546 W -103.14835

# Oxy, SMU Federal #15

Leak Date: 5-11-19  
Lea County, NM  
1RP-5595  
API: 30-025-20513

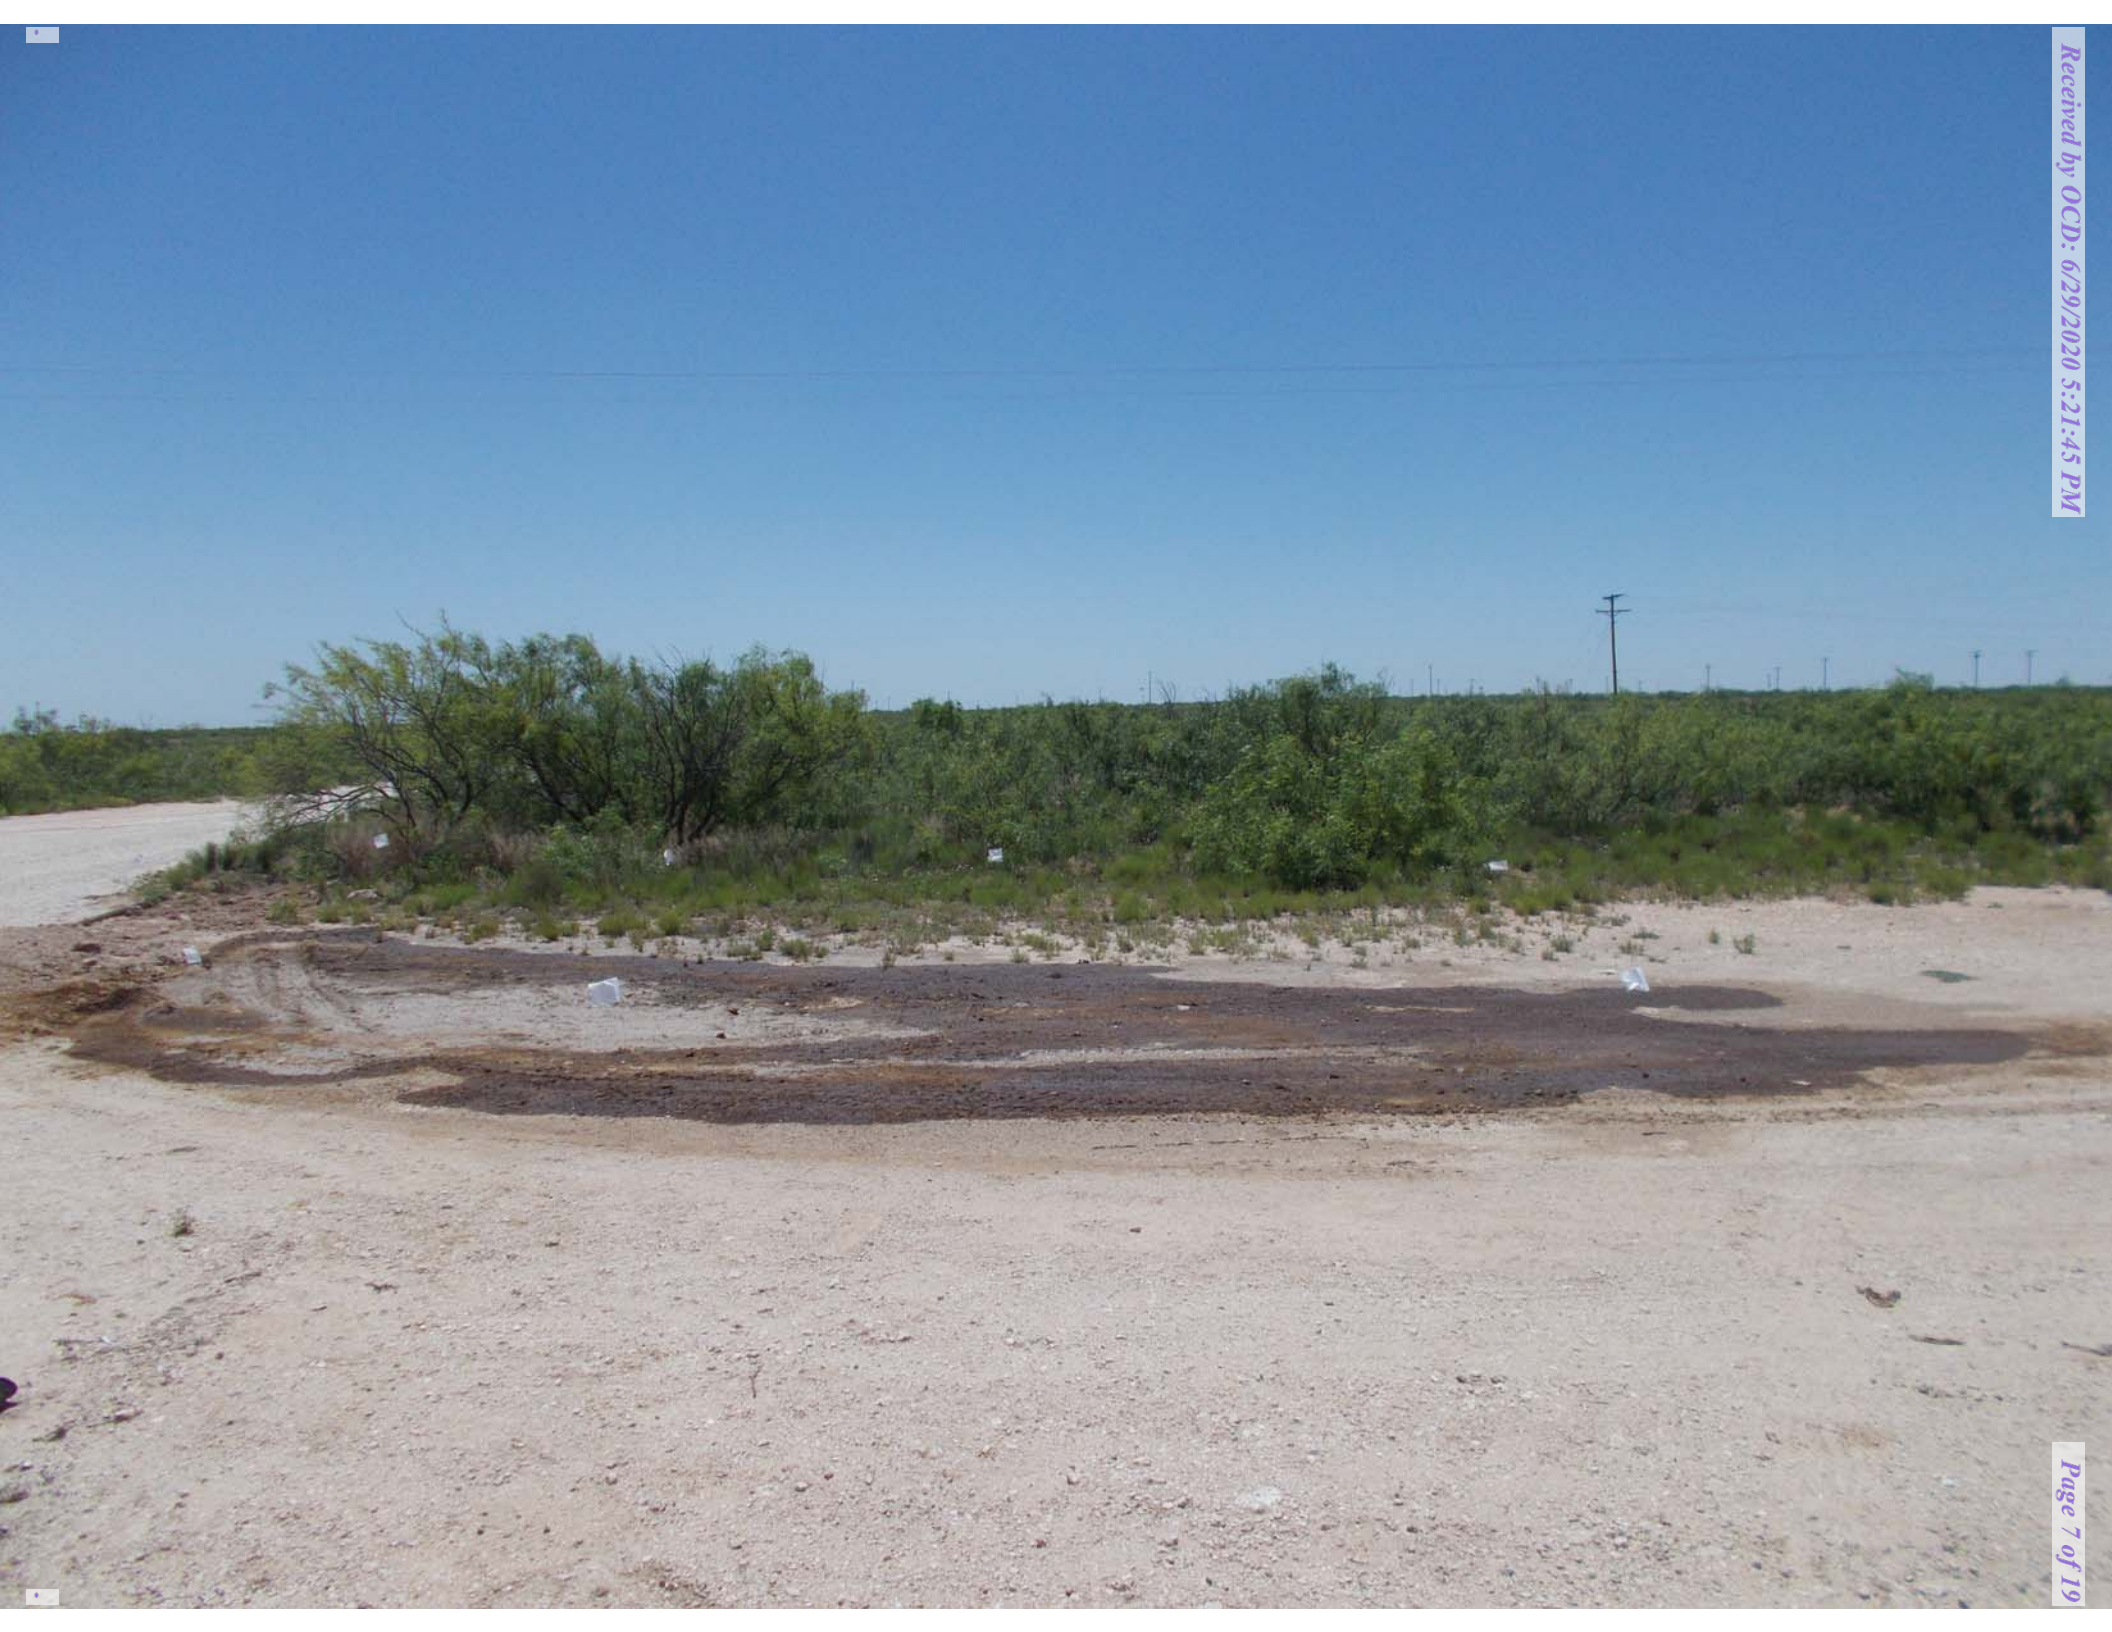
Oxy SMU Federal #15 (5-11-19)

Confirmation Sample Points:

B1, N 32.21548 W -103.14837

B2, N 32.21545 W -103.14832

SW1, N 32.21548 W -103.14830

SW2, N 32.21542 W -103.14833

SW3, N 32.21550 W -103.14844
